Flood Control Project Maintenance
2008 Structure Summary Report
Overall Unit and Item Ratings

San Joaquin County Flood Control District

2008 Structure Inspection Results

**Flood Control Project Maintenance
Inspection Report - Structure 2008**

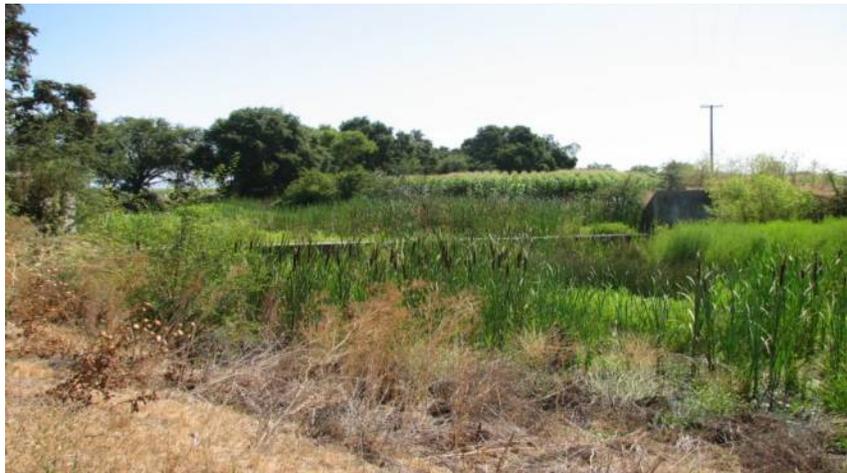
Report Line	1
Location	
Category	Structures & Concrete Lined Channels
Item	Vegetation & Obstructions
<p>view looking back towards weir vegetation is thick on both sides of structure does not appear to obstruct flow recommend to remove vegetation either manually or with herbicides</p>

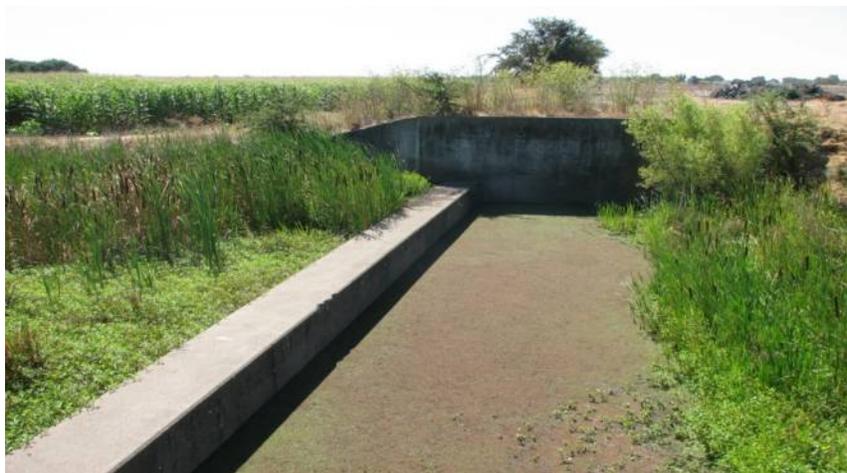
Report Line	4
Location	
Category	Structures & Concrete Lined Channels
Item	Concrete Surfaces
<p>weir from Corps of Engineers gauging house 37.93827 -120.99013</p>

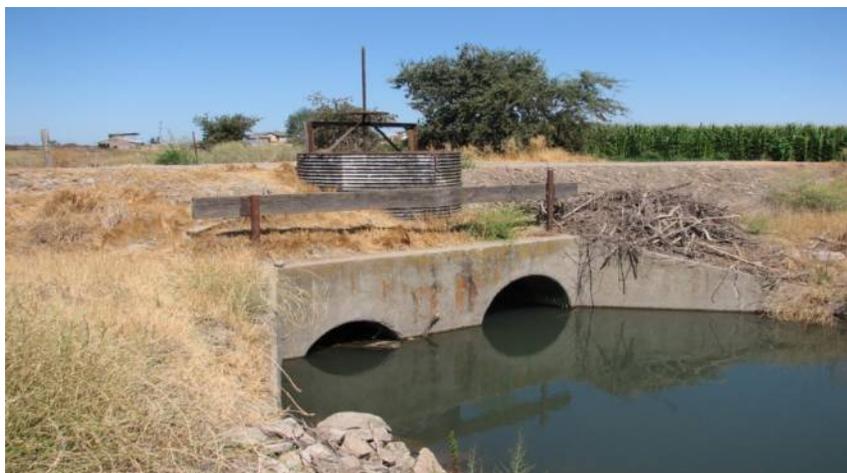
Report Line	4
Location	
Category	Structures & Concrete Lined Channels
Item	Concrete Surfaces
<p>View of intake side of the control structure and screw gate</p>

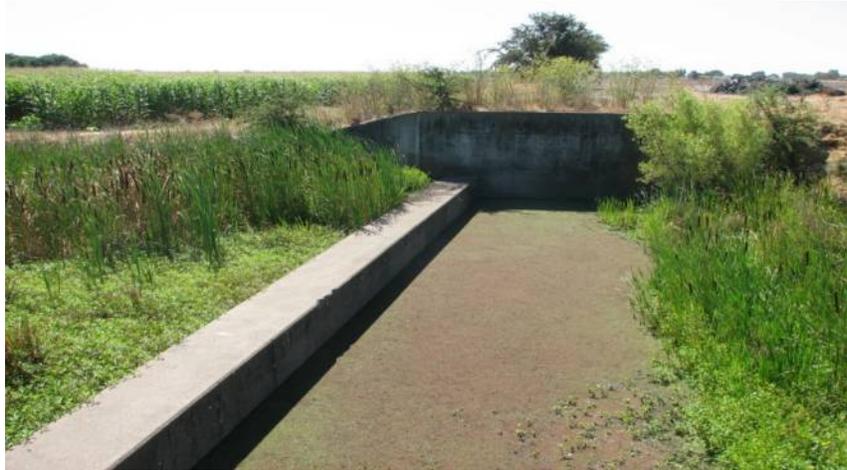
Report Line	5
Location	
Category	Structures & Concrete Lined Channels
Item	Concrete Foundations
Weir from Corps of Engineers gauging house 37.93827 -120.99013

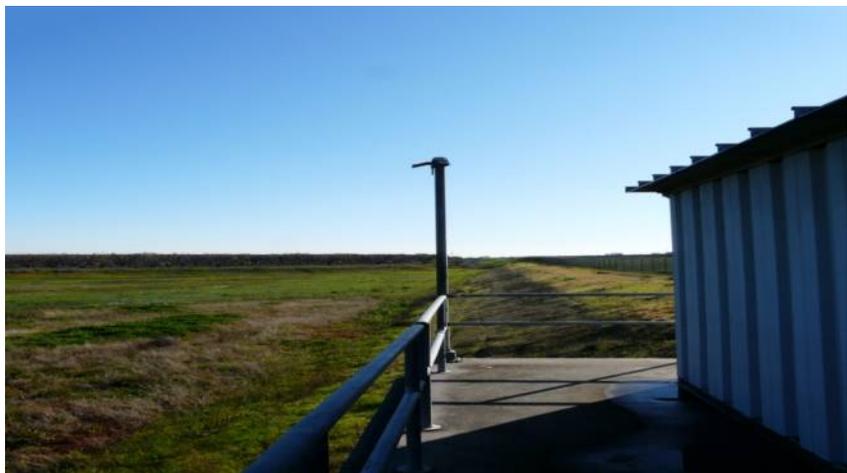
Report Line	5
Location	
Category	Pump Stations
Item	Safety
View of one of the exterior lights with the light missing on the basin side of the station.

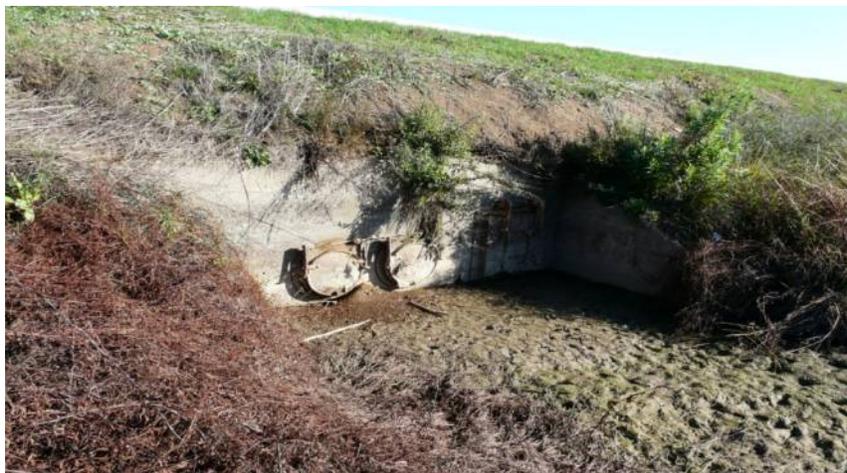
Report Line	18
Location	
Category	Pump Stations
Item	Flap Gates

View of flap gates for the pressure pipes (left) and gravity channel (right). Flap gates close completely and the silt does not affect their operation.

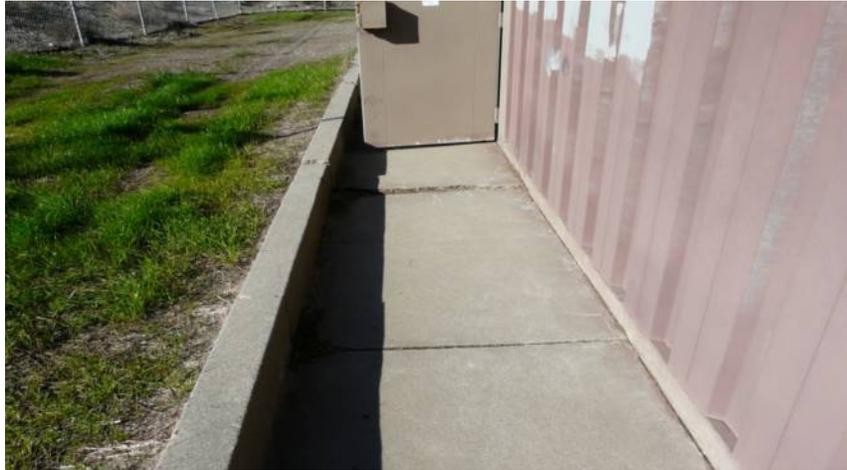
Report Line	3
Location	
Category	Pump Stations
Item	Plant Building

View of sidewalk in front of building. Note the crack in the sidewalk before the door.

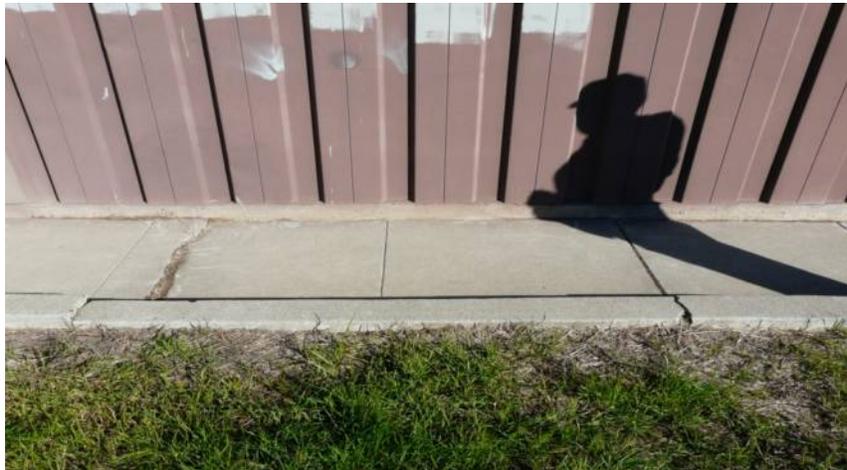
Report Line	3
Location	
Category	Pump Stations
Item	Plant Building

View of the cracking and settlement of the sidewalk in sidewalk in front of pump station building.

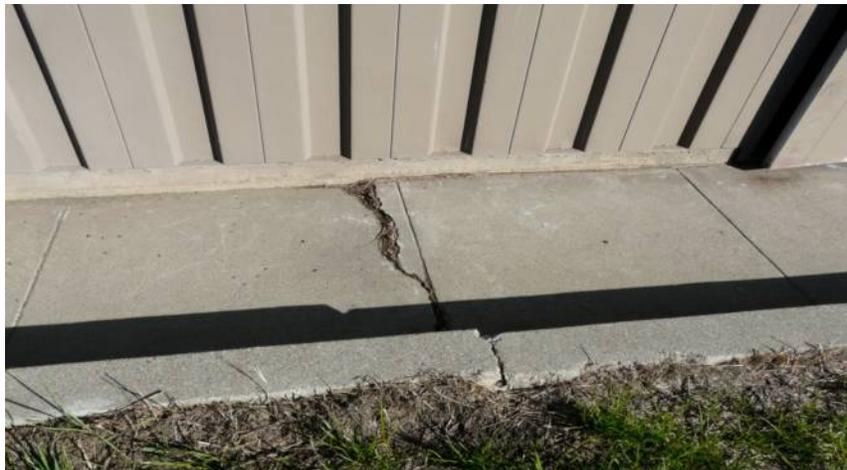
Report Line	3
Location	
Category	Pump Stations
Item	Plant Building

Additional view of sidewalk. Note the settlement in the sidewalk.

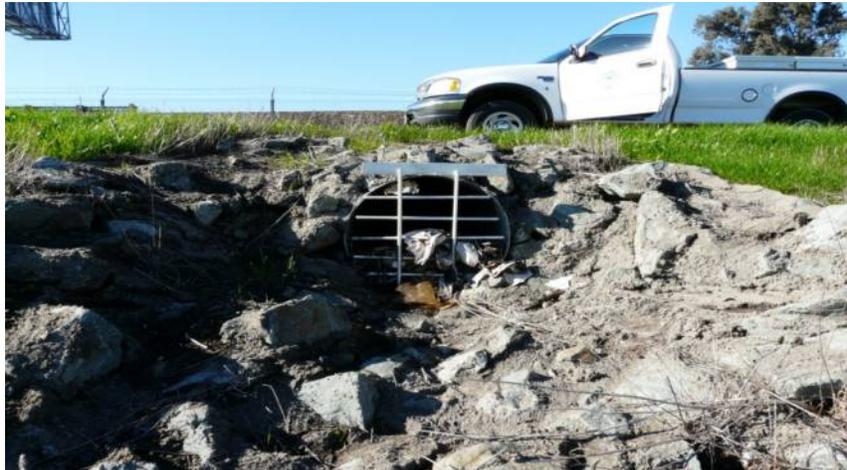
12	Pump Stations	Trash Racks		A	Trash rack at the station appears to be in good condition and clear of debris. There is trash at one of the inlet pipes to the basin that may impede flow into the basin but should not affect the pump station's operation.	°	Y	12
13	Pump Stations	Trash Rakes		N	There are no automatic trash rakes on this station. Trash racks are manually cleared by County workers.	°		13
14	Pump Stations	Sluice / Slide Gates		A	The slide gate was not closely inspected or opened or closed, but appears to be in acceptable condition.	°	Y	14
15	Pump Stations	Electric Gate Operators		N	There are no electronic gate operators at this station.	°		15

Report Line	12
Location	
Category	Pump Stations
Item	Trash Racks
View of one of the inlet pipes to the station with debris inside.

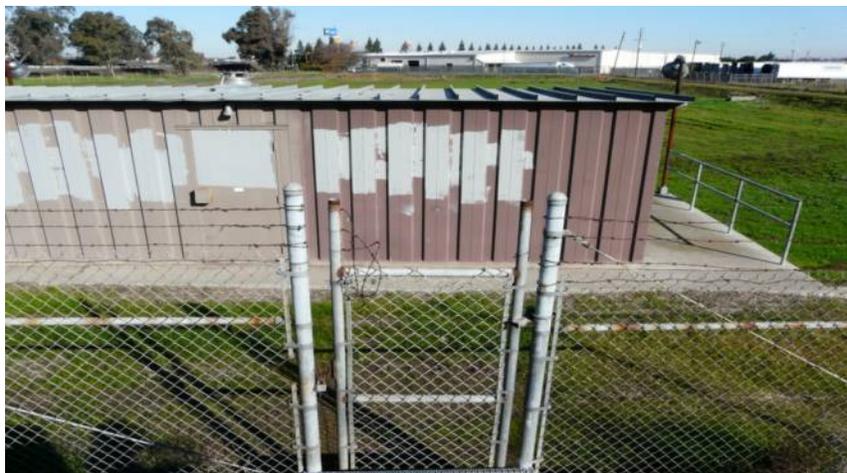
Report Line	20
Location	
Category	Pump Stations
Item	Security Fencing

View of the barbed wire on the gate to the station. The wire is not connected to both sides and does not currently function as a deterrent.

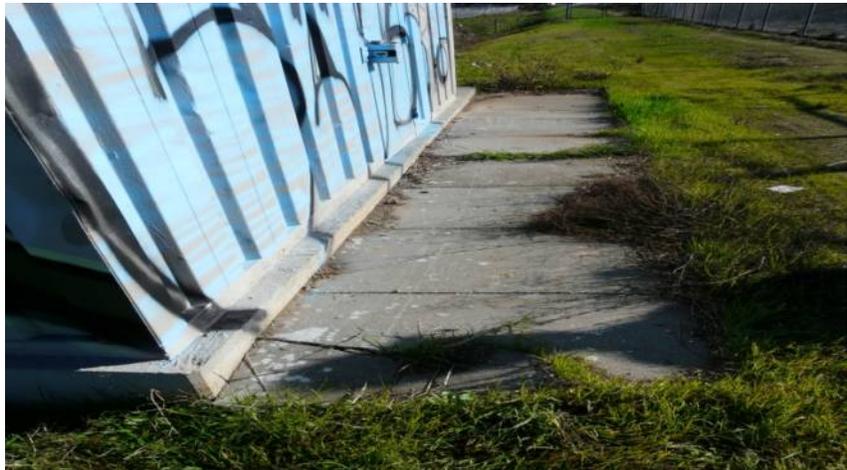
Report Line	3
Location	
Category	Pump Stations
Item	Plant Building

View of the sidewalk in front of station. Note the minor cracking in the sidewalk and some subsidence in the near corner of the sidewalk.

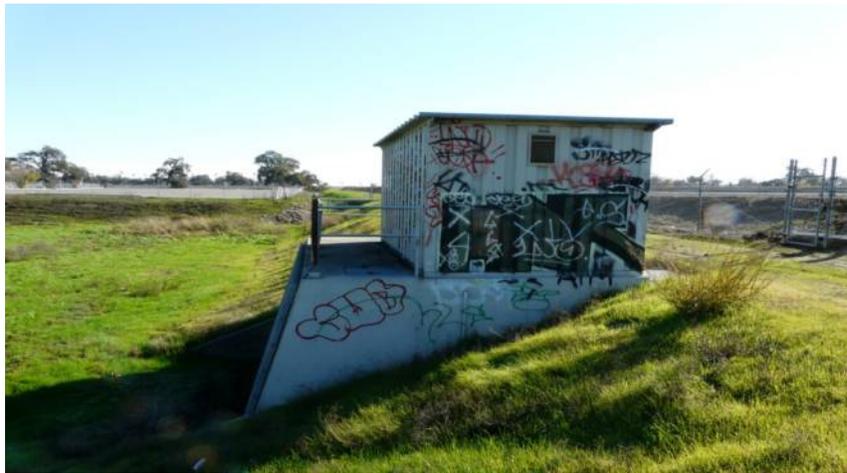
Report Line	5
Location	
Category	Pump Stations
Item	Safety
Side view of station. Note the missing exterior lights. Light poles have been cut off and capped.

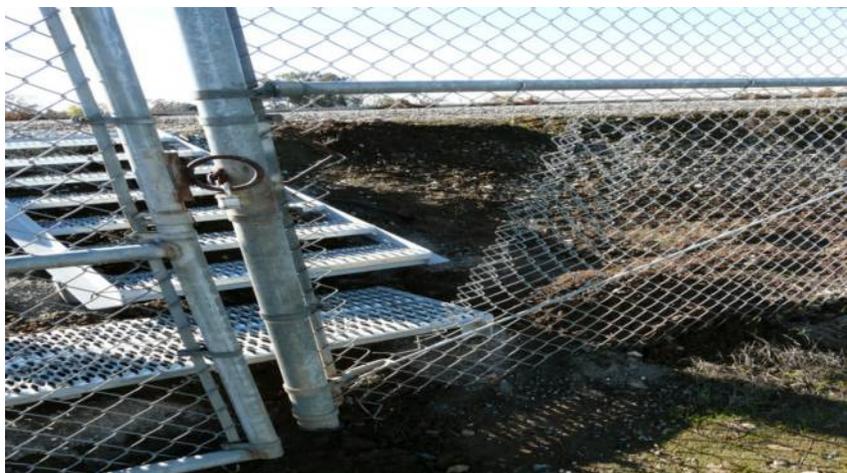
Report Line	20
Location	
Category	Pump Stations
Item	Security Fencing

View of fence next to gate. A hole has been created in the fence allowing people to access the station area.
