**Flood Control Project Maintenance**  
**2009 Structure Summary Report**  
**Overall Unit and Item Ratings**

## San Joaquin County Flood Control and Water Conservation District

**Unit Cover Sheet**

**2009 Structure Inspection Results**

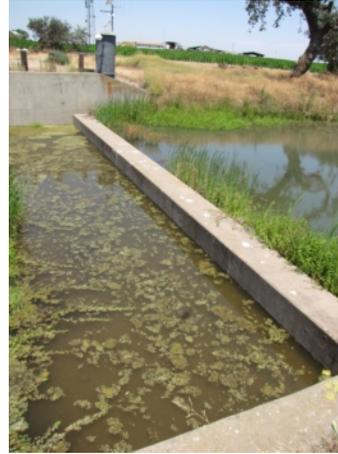
Levee Mile Report Line	1
Start Levee Mile	0.00
End Levee Mile	0.00
Location	
Category	Structures
Item	Photo Documentation
View of weir from left bank looking slightly upstream.	
dpesaven_20090731_14.jpg

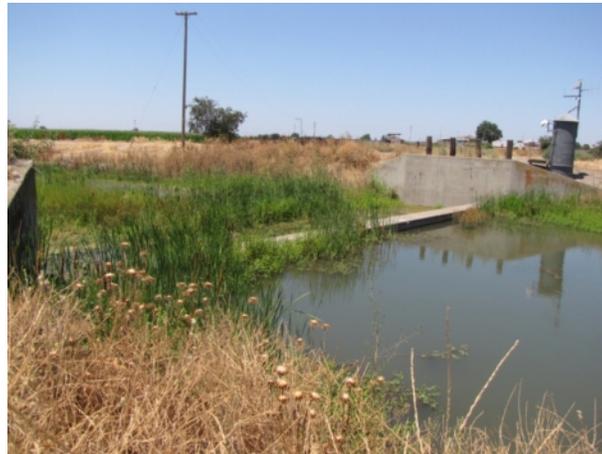
Levee Mile Report Line	1
Start Levee Mile	0.00
End Levee Mile	0.00
Location	
Category	Structures
Item	Photo Documentation
View of weir from left bank looking slightly downstream.	
dpesaven_20090731_15.jpg

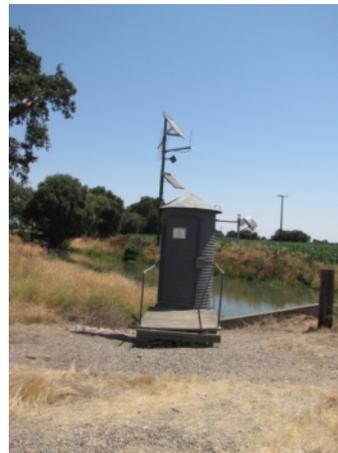
Levee Mile Report Line	1
Start Levee Mile	0.00
End Levee Mile	0.00
Location	
Category	Structures
Item	Photo Documentation
View of USACE gauging station.	
dpesaven_20090731_16.jpg

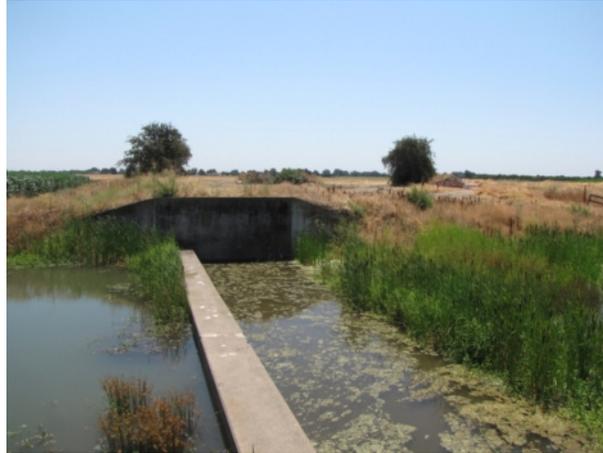
Levee Mile Report Line	1
Start Levee Mile	0.00
End Levee Mile	0.00
Location	
Category	Structures
Item	Photo Documentation
View of weir from USACE gauging station.	
dpesaven_20090731_17.jpg

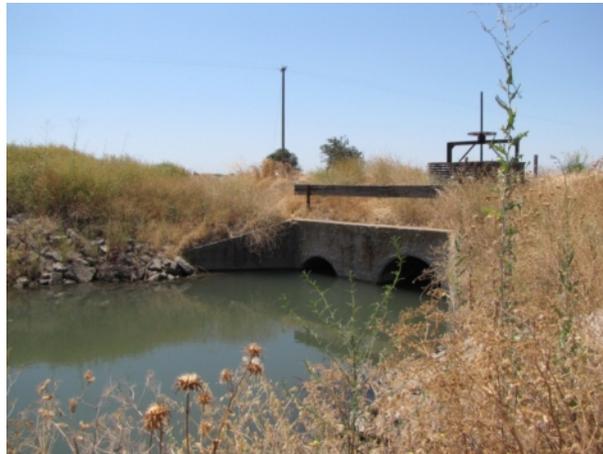
Levee Mile Report Line	1
Start Levee Mile	0.00
End Levee Mile	0.00
Location	
Category	Structures
Item	Photo Documentation
View of Duck Creek flow control looking downstream.	
dpesaven_20090731_18.jpg

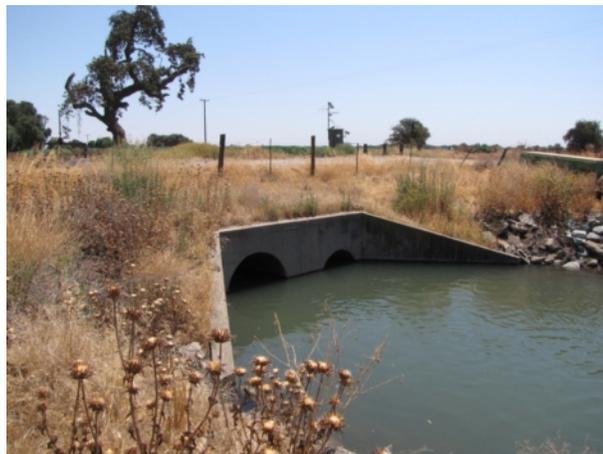
Levee Mile Report Line	1
Start Levee Mile	0.00
End Levee Mile	0.00
Location	
Category	Structures
Item	Photo Documentation
View of Duck Creek culverts looking upstream.	
dpesaven_20090731_19.jpg

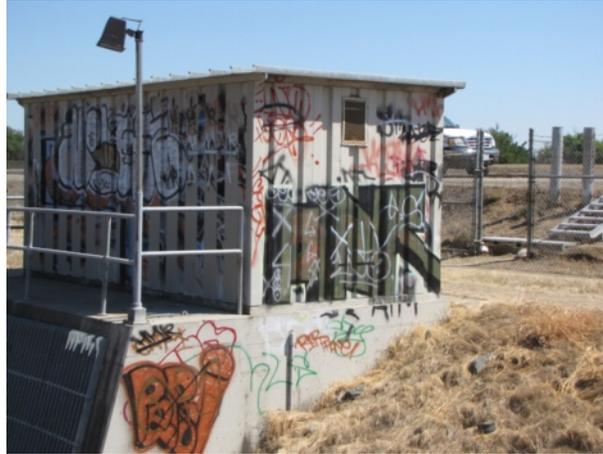
dpesaven\_20090731\_51.jpg

View of the north-west corner of the plant building.

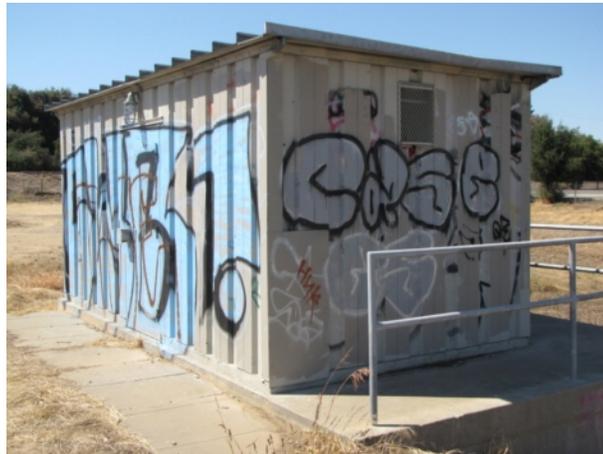
dpesaven\_20090731\_52.jpg

View of the south-east corner of the plant building.

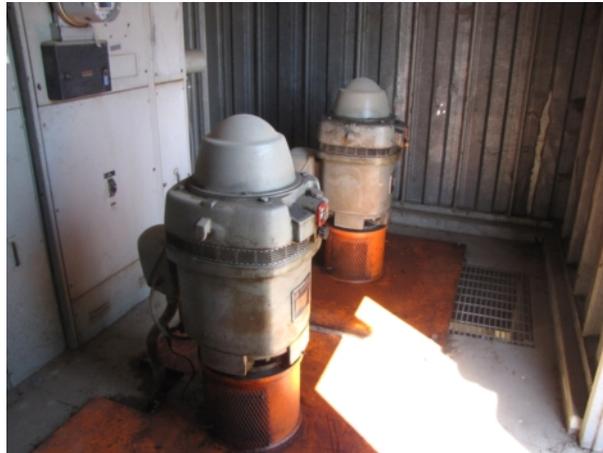
dpesaven\_20090731\_48.jpg

View of the pumps at this station.

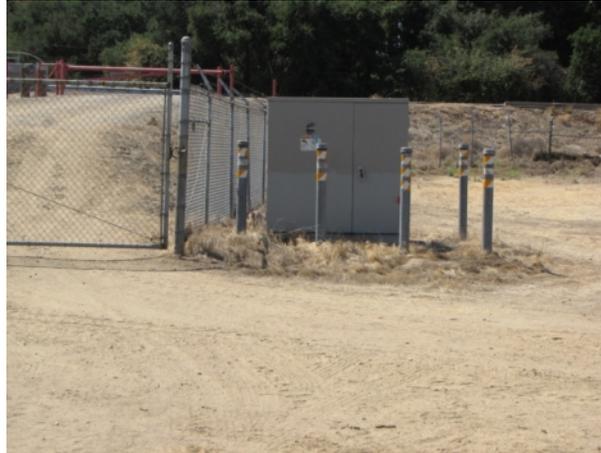
Levee Mile Report Line	8
Start Levee Mile	0.00
End Levee Mile	0.00
Location	
Category	Pump Stations
Item	Power
View of the transformer supplying power to the station.	
dpesaven_20090731_47.jpg

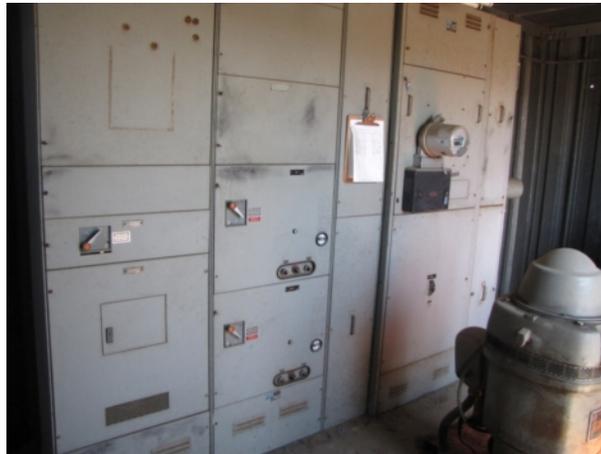
Levee Mile Report Line	10
Start Levee Mile	0.00
End Levee Mile	0.00
Location	
Category	Pump Stations
Item	Pump Control Systems
View of the pump control & power panels.	
dpesaven_20090731_49.jpg

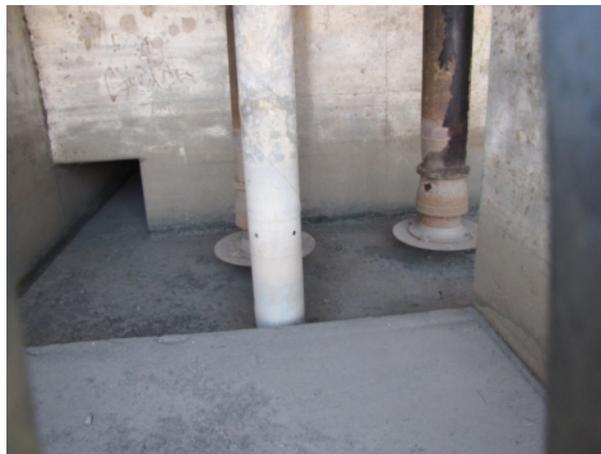
Levee Mile Report Line	11
Start Levee Mile	0.00
End Levee Mile	0.00
Location	
Category	Pump Stations
Item	Sumps/Wet Well
View of the sump, the two intake pipes and the low flow channel.	
dpesaven_20090731_50.jpg

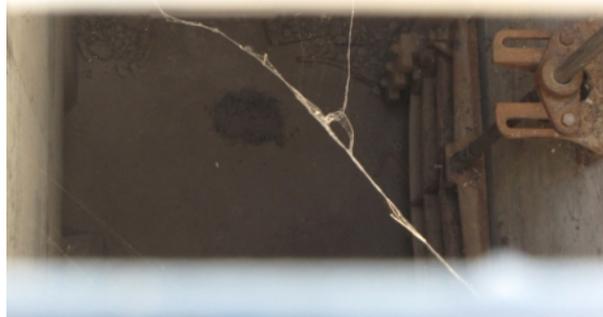
Levee Mile Report Line	14
Start Levee Mile	0.00
End Levee Mile	0.00
Location	
Category	Pump Stations
Item	Sluice / Slide Gates
View of the screw gate for the low flow channel.	
dpesaven_20090731_44.jpg

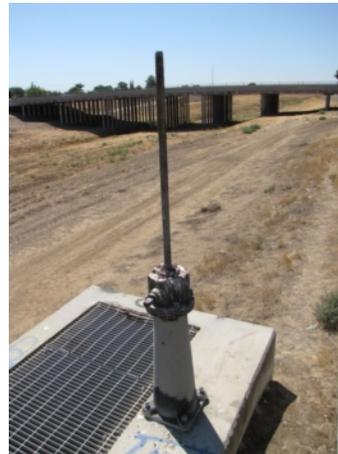
Levee Mile Report Line	16
Start Levee Mile	0.00
End Levee Mile	0.00
Location	
Category	Pump Stations
Item	Manual Gate Operators
View of the screw gate operator for the low flow channel.	
dpesaven_20090731_43.jpg

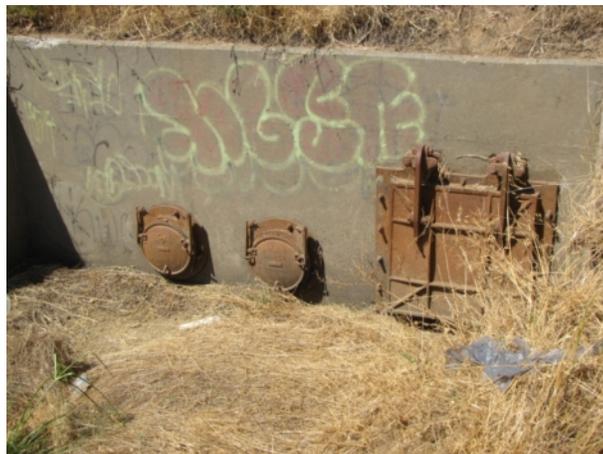
Levee Mile Report Line	18
Start Levee Mile	0.00
End Levee Mile	0.00
Location	
Category	Pump Stations
Item	Flap Gates
View of the two pressurized pipe and low flow channel outfall & flap gates.	
dpesaven_20090731_45.jpg

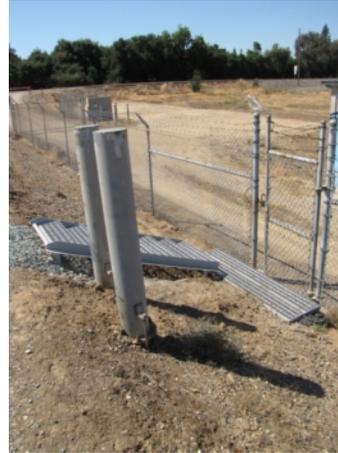
Levee Mile Report Line	21
Start Levee Mile	0.00
End Levee Mile	0.00
Location	
Category	Pump Stations
Item	Intake and Discharge Pipes
View of siphon breakers at crown of levee.	
dpesaven_20090731_46.jpg

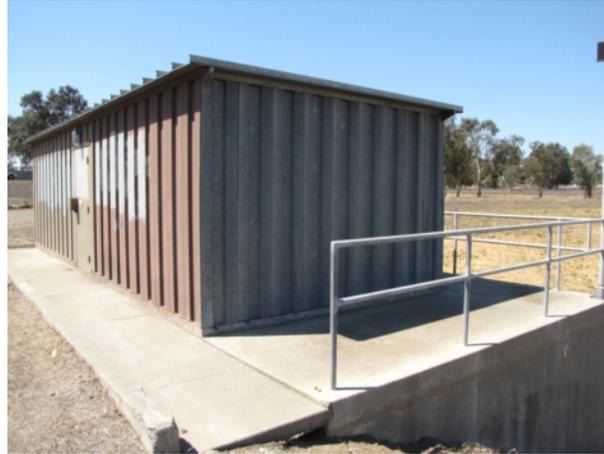
Levee Mile Report Line	3
Start Levee Mile	0.00
End Levee Mile	0.00
Location	
Category	Pump Stations
Item	Plant Building
View of the south-east corner of the pump plant building.	
dpesaven_20090731_39.jpg

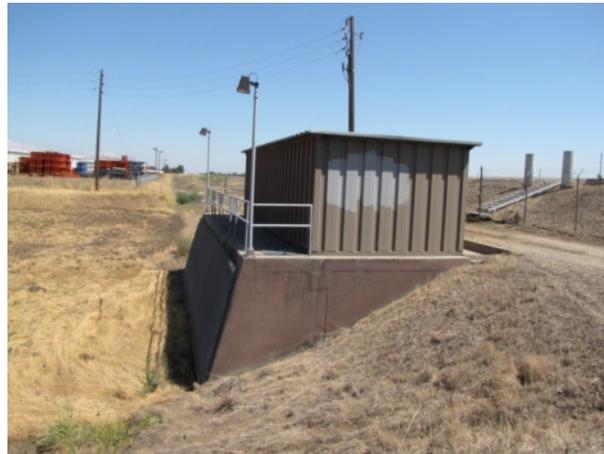
Levee Mile Report Line	3
Start Levee Mile	0.00
End Levee Mile	0.00
Location	
Category	Pump Stations
Item	Plant Building
View of the north-west corner of the plant building.	
dpesaven_20090731_40.jpg

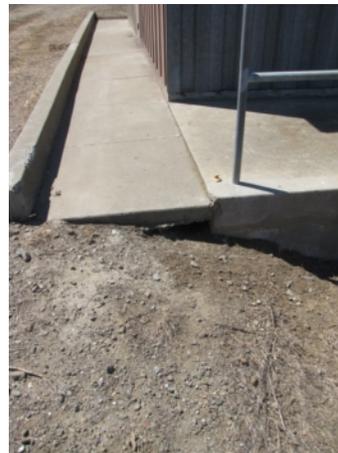
Levee Mile Report Line	3
Start Levee Mile	0.00
End Levee Mile	0.00
Location	
Category	Pump Stations
Item	Plant Building
Minor erosion occurring under the sidewalk in front of the plant building. Repairs should be made to prevent damage to the sidewalk.	
dpesaven_20090731_41.jpg

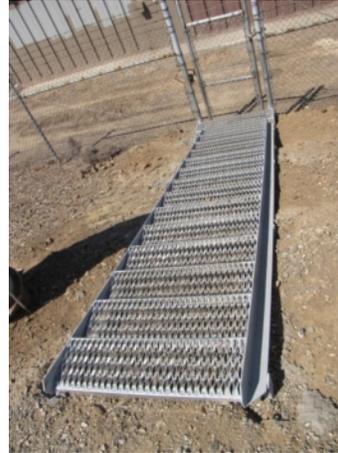
Levee Mile Report Line	5
Start Levee Mile	0.00
End Levee Mile	0.00
Location	
Category	Pump Stations
Item	Safety
View of the plant's steps leading from the crown of the levee to the plant.	
dpesaven_20090731_42.jpg

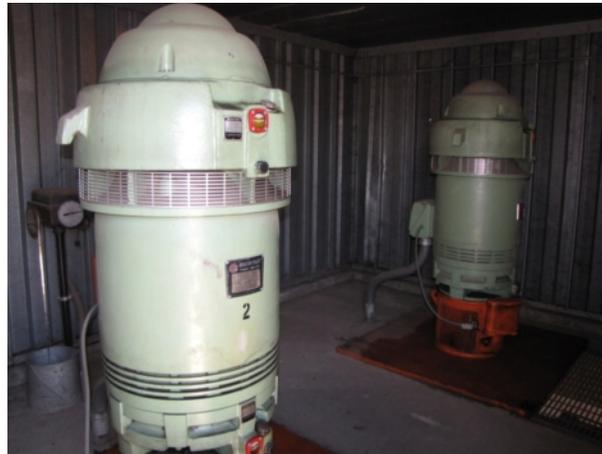
Levee Mile Report Line	7
Start Levee Mile	0.00
End Levee Mile	0.00
Location	
Category	Pump Stations
Item	Pumps
View of the pumps located at this plant.	
dpesaven_20090731_36.jpg

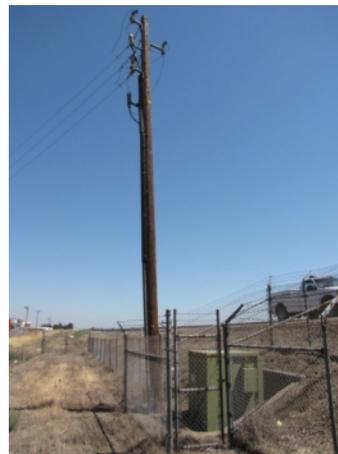
Levee Mile Report Line	8
Start Levee Mile	0.00
End Levee Mile	0.00
Location	
Category	Pump Stations
Item	Power
View of the power pole and transformer supplying power to the pump station.	
dpesaven_20090731_33.jpg

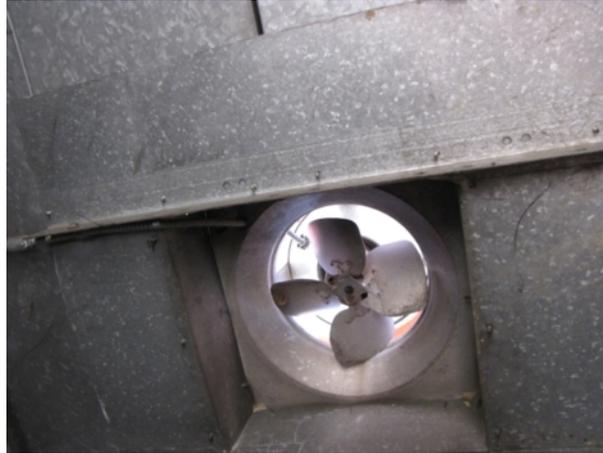
Levee Mile Report Line	9
Start Levee Mile	0.00
End Levee Mile	0.00
Location	
Category	Pump Stations
Item	Motors, Engines, Fans & Gear Reducers
Exhaust fan in ceiling of plant. The circuit breaker was off for the fan, it was left off.	
dpesaven_20090731_35.jpg

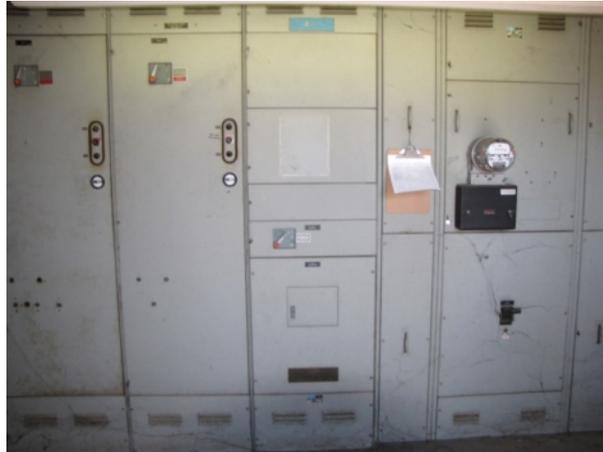
Levee Mile Report Line	10
Start Levee Mile	0.00
End Levee Mile	0.00
Location	
Category	Pump Stations
Item	Pump Control Systems
View of the control and power panels for the pump plant.	
dpesaven_20090731_34.jpg

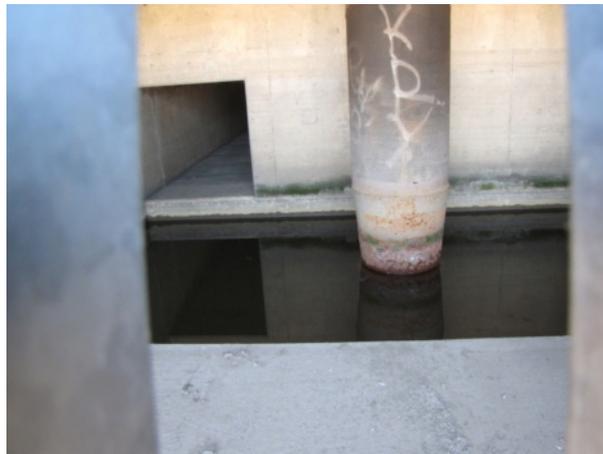
Levee Mile Report Line	11
Start Levee Mile	0.00
End Levee Mile	0.00
Location	
Category	Pump Stations
Item	Sumps/Wet Well
View of the sump, one of the intake pipes and the low flow channel.	
dpesaven_20090731_38.jpg

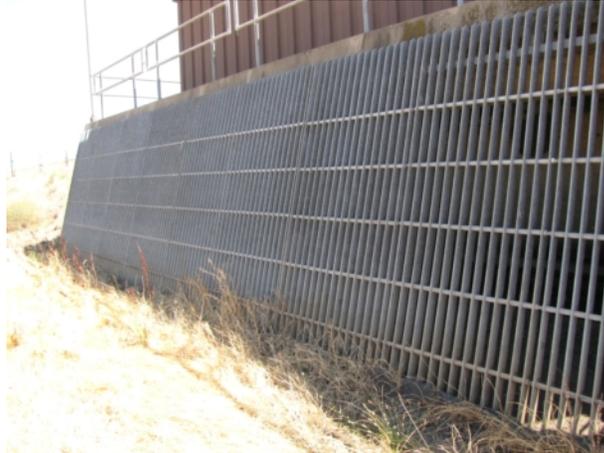
Levee Mile Report Line	12
Start Levee Mile	0.00
End Levee Mile	0.00
Location	
Category	Pump Stations
Item	Trash Racks
View of the trash rack at this plant.	
dpesaven_20090731_37.jpg

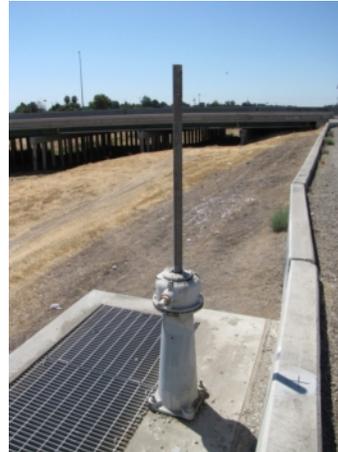
Levee Mile Report Line	16
Start Levee Mile	0.00
End Levee Mile	0.00
Location	
Category	Pump Stations
Item	Manual Gate Operators
View of the screw gate operator for the low flow channel.	
dpesaven_20090731_30.jpg

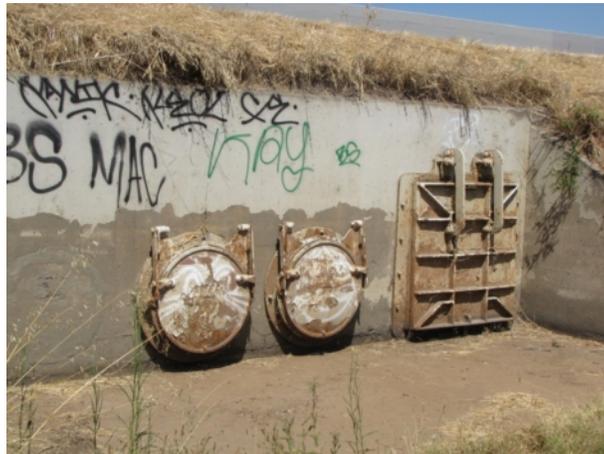
Levee Mile Report Line	18
Start Levee Mile	0.00
End Levee Mile	0.00
Location	
Category	Pump Stations
Item	Flap Gates
View of the low flow and pressurized pipe outfalls & flap gates.	
dpesaven_20090731_31.jpg

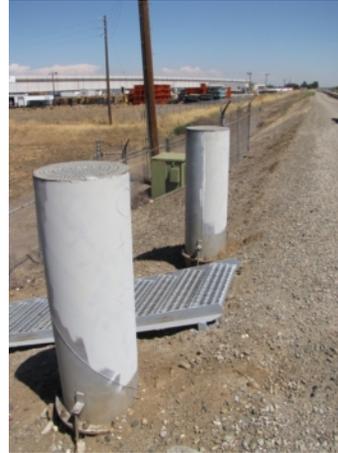
Levee Mile Report Line	21
Start Levee Mile	0.00
End Levee Mile	0.00
Location	
Category	Pump Stations
Item	Intake and Discharge Pipes
View of the siphon breakers at the crown of the levee.	
dpesaven_20090731_32.jpg

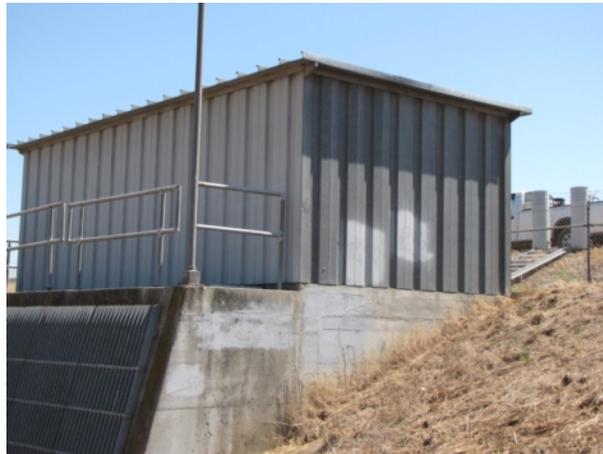
dpesaven\_20090731\_24.jpg

View of the north-west corner of the plant building.

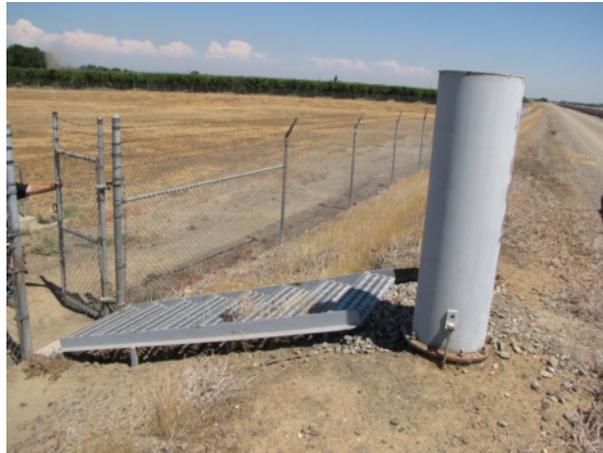
dpesaven\_20090731\_26.jpg

View of steps from the crown of the levee to the pump plant.

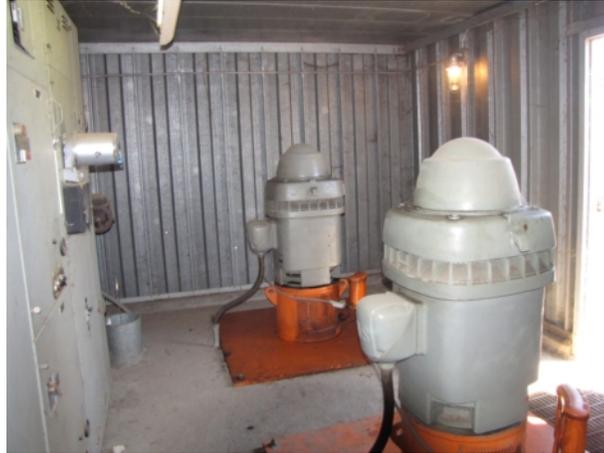
Levee Mile Report Line	7
Start Levee Mile	0.00
End Levee Mile	0.00
Location	
Category	Pump Stations
Item	Pumps
View of the pumps located at this station.	
dpesaven_20090731_20.jpg

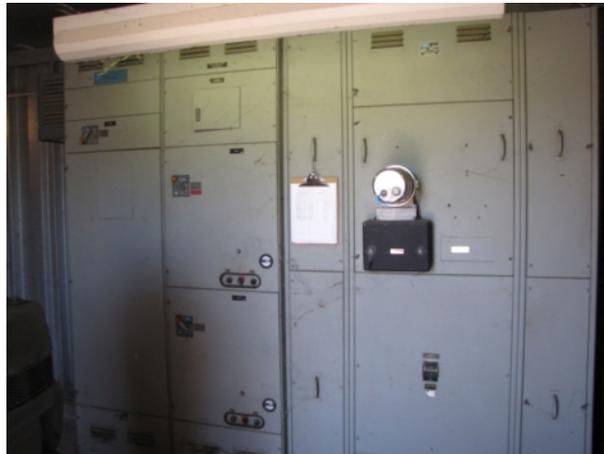
Levee Mile Report Line	10
Start Levee Mile	0.00
End Levee Mile	0.00
Location	
Category	Pump Stations
Item	Pump Control Systems
View of the power and control panels.	
dpesaven_20090731_21.jpg

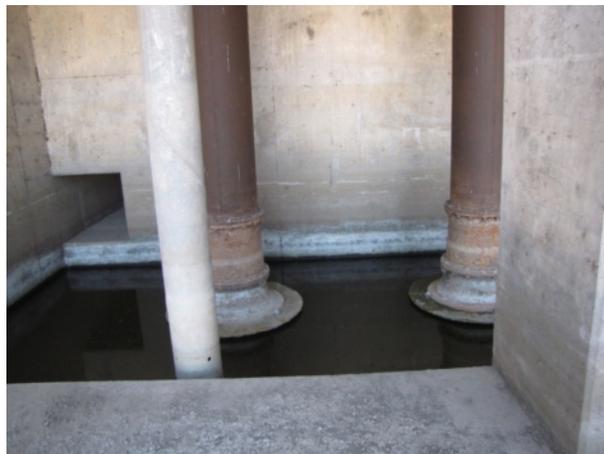
Levee Mile Report Line	11
Start Levee Mile	0.00
End Levee Mile	0.00
Location	
Category	Pump Stations
Item	Sumps/Wet Well
View of the sump and pump intakes. The low flow channel can be seen on the left.	
dpesaven_20090731_22.jpg

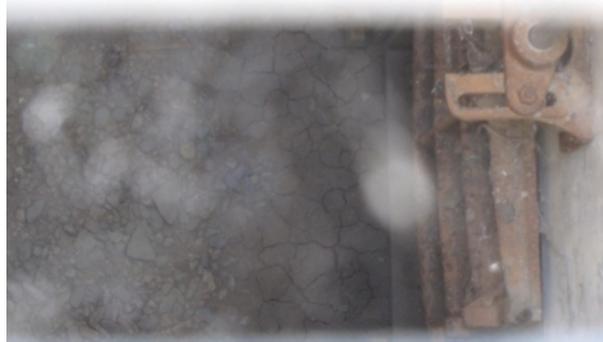
Levee Mile Report Line	14
Start Levee Mile	0.00
End Levee Mile	0.00
Location	
Category	Pump Stations
Item	Sluice / Slide Gates
View of the slide gate for the low flow channel.	
dpesaven_20090731_28.jpg

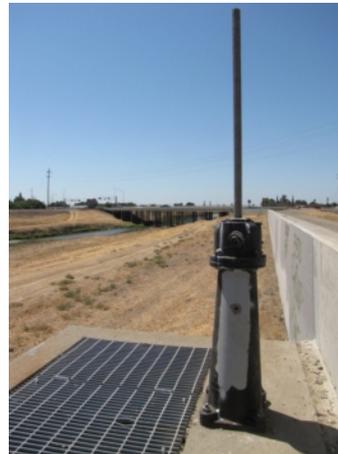
Levee Mile Report Line	16
Start Levee Mile	0.00
End Levee Mile	0.00
Location	
Category	Pump Stations
Item	Manual Gate Operators
View of the screw gate operator for the slide gate.	
dpesaven_20090731_27.jpg

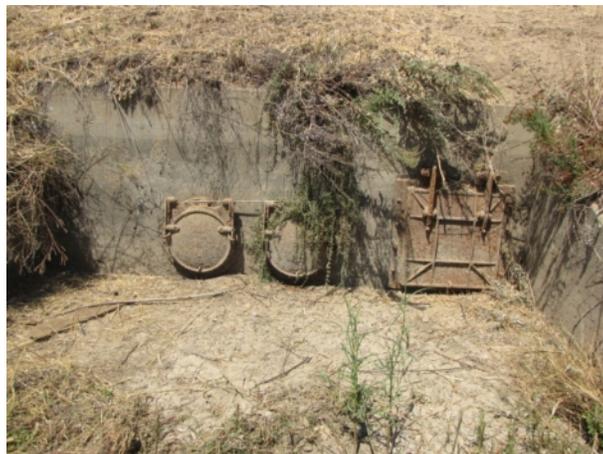
Levee Mile Report Line	18
Start Levee Mile	0.00
End Levee Mile	0.00
Location	
Category	Pump Stations
Item	Flap Gates
View of flag gates for the low flow and pressurized pipe outfalls.	
dpesaven_20090731_29.jpg

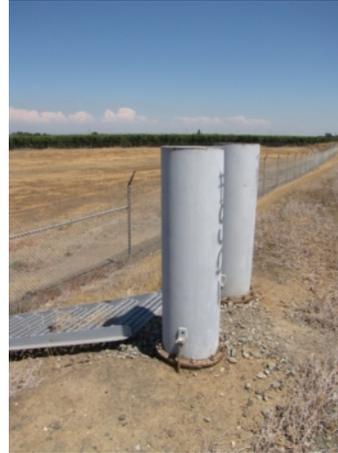
Levee Mile Report Line	21
Start Levee Mile	0.00
End Levee Mile	0.00
Location	
Category	Pump Stations
Item	Intake and Discharge Pipes
View of the siphon breakers at the crown of the levee.	
dpesaven_20090731_25.jpg
