Flood Control Project Maintenance
2010 Structure Summary Report
Overall Unit and Item Ratings

San Joaquin County Flood Control and Water Conservation District

Flood Control Project Maintenance**Unit Cover Sheet****2010 Structure Inspection Results****San Joaquin County Flood Control and Water Conservation District**

Structure
Duck Creek Diversion Weir And Control Structure

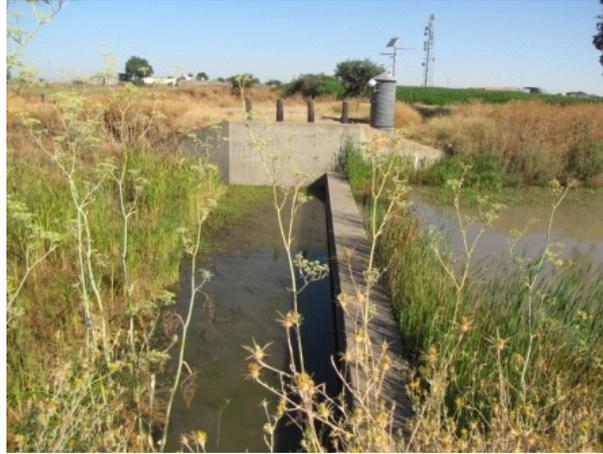
Levee Mile Report Line	1
Start Levee Mile	0.00
End Levee Mile	0.00
Location	
Category	Structures
Item	Photo Documentation
View of the weir from the left bank.	
dpesaven_t_20100824_108.jpg

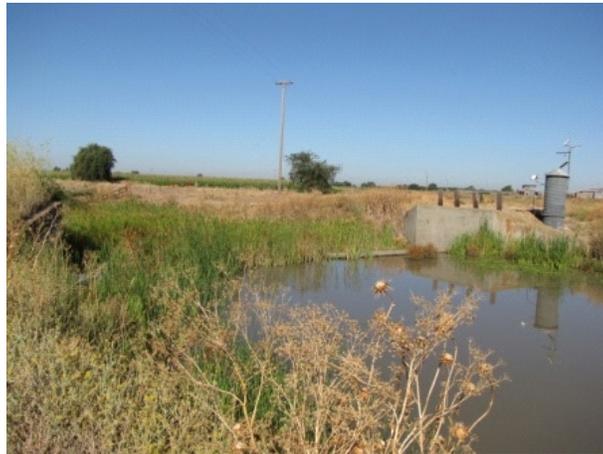
Levee Mile Report Line	1
Start Levee Mile	0.00
End Levee Mile	0.00
Location	
Category	Structures
Item	Photo Documentation
View of the weir and structure from the left bank looking downstream toward the Duck Creek Diversion Channel.	
dpesaven_t_20100824_109.jpg

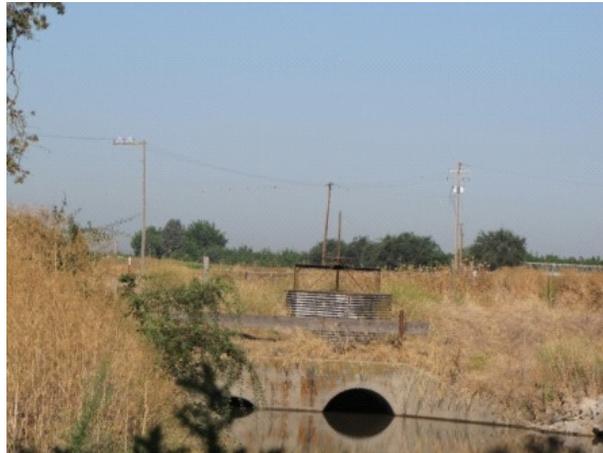
Levee Mile Report Line	1
Start Levee Mile	0.00
End Levee Mile	0.00
Location	
Category	Structures
Item	Photo Documentation
View of the upstream side of the flow control structure and culverts looking downstream toward the Duck Creek.	
dpesaven_t_20100824_110.jpg

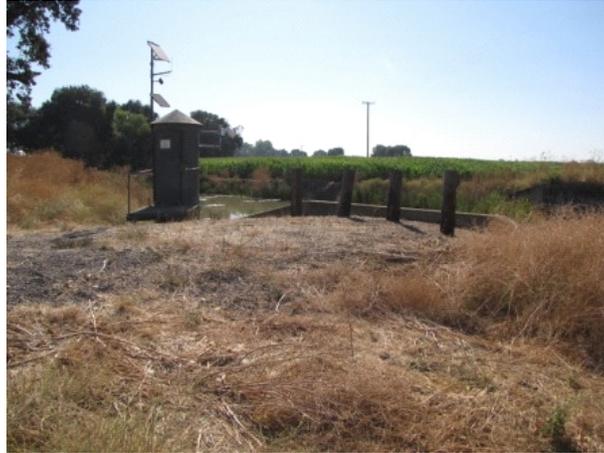
Levee Mile Report Line	1
Start Levee Mile	0.00
End Levee Mile	0.00
Location	
Category	Structures
Item	Photo Documentation
View of the USACE gauging station and right bank of the structure.	
dpesaven_t_20100824_111.jpg

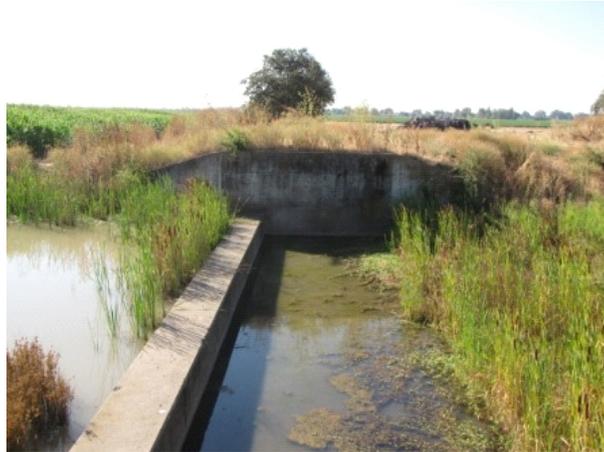
Levee Mile Report Line	1
Start Levee Mile	0.00
End Levee Mile	0.00
Location	
Category	Structures
Item	Photo Documentation
View of the wier from the right bank.	
dpesaven_t_20100824_112.jpg

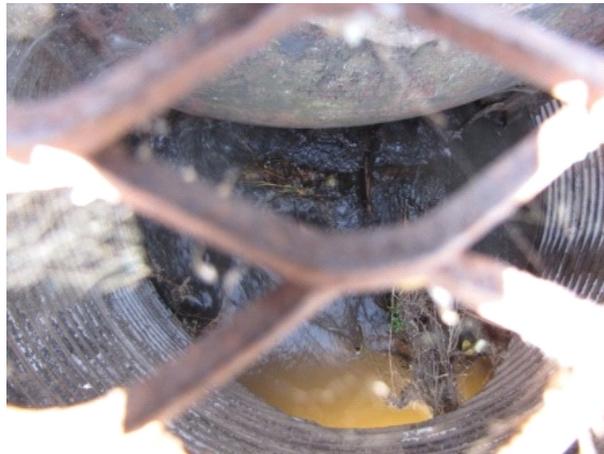
Levee Mile Report Line	1
Start Levee Mile	0.00
End Levee Mile	0.00
Location	
Category	Structures
Item	Photo Documentation
View of the sluice gate inside the riser at flow control structure.	
dpesaven_t_20100824_113.jpg

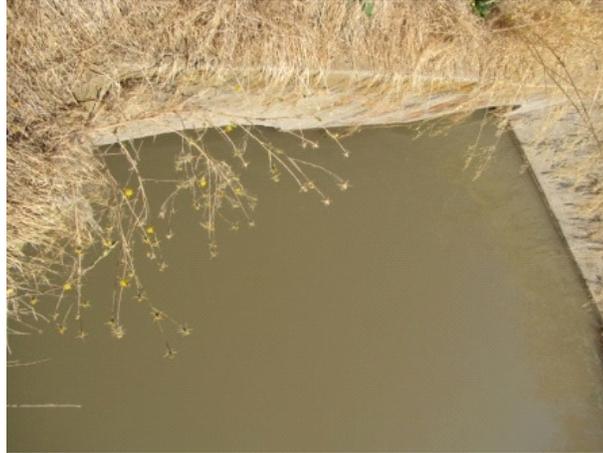
Levee Mile Report Line	1
Start Levee Mile	0.00
End Levee Mile	0.00
Location	
Category	Structures
Item	Photo Documentation
View of the downstream side of the flow control structure at the culvert outlets.	
dpesaven_t_20100824_114.jpg

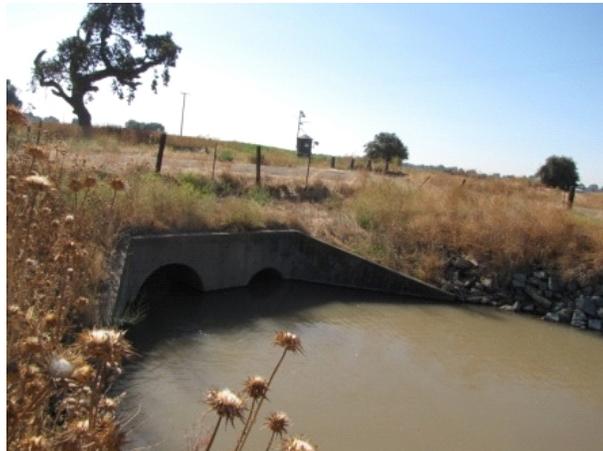
Levee Mile Report Line	1
Start Levee Mile	0.00
End Levee Mile	0.00
Location	
Category	Structures
Item	Photo Documentation
View of the downstream side of the flow control structure at the culverts.	
dpesaven_t_20100824_115.jpg

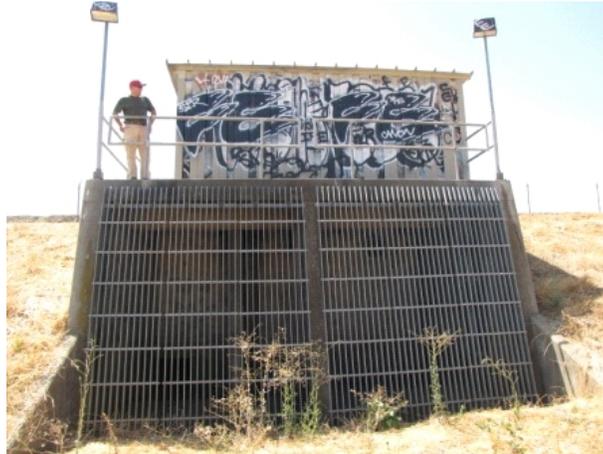
Levee Mile Report Line	3
Start Levee Mile	
End Levee Mile	
Location	
Category	Pump Stations
Item	Plant Building
View of the station from the detention basin.	
dpesaven_t_20100906_157.jpg

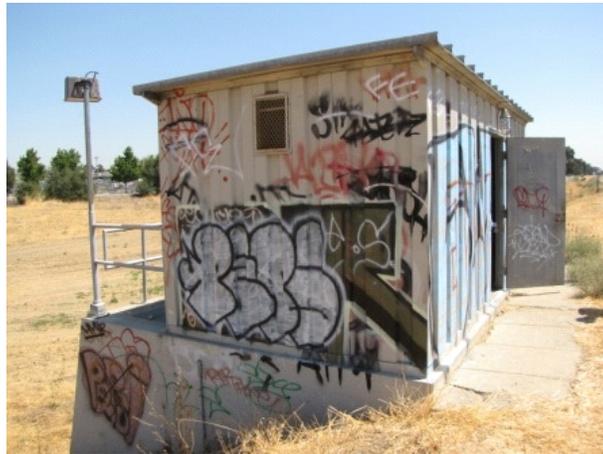
Levee Mile Report Line	3
Start Levee Mile	
End Levee Mile	
Location	
Category	Pump Stations
Item	Plant Building
View of the station from the south-west.	
dpesaven_t_20100906_158.jpg

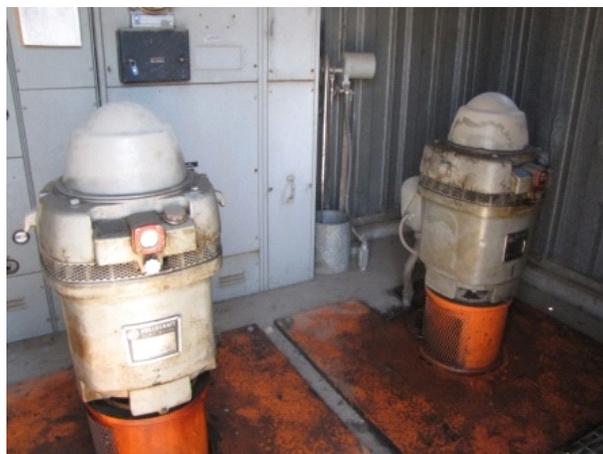
Levee Mile Report Line	7
Start Levee Mile	0.00
End Levee Mile	0.00
Location	
Category	Pump Stations
Item	Pumps
View of the pumps.	
dpesaven_t_20100906_163.jpg

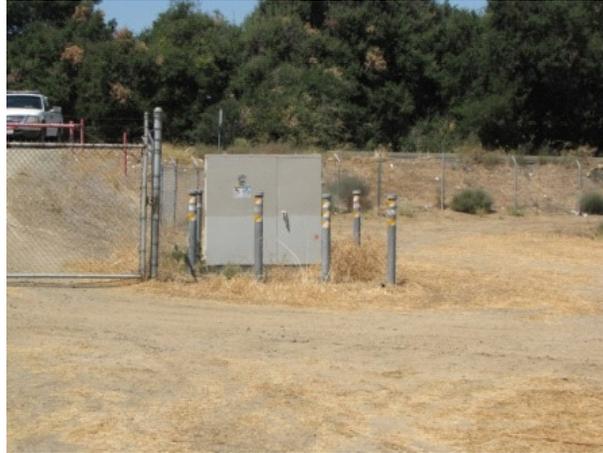
Levee Mile Report Line	8
Start Levee Mile	0.00
End Levee Mile	0.00
Location	
Category	Pump Stations
Item	Power
View of the transformer providing power to the station.	
dpesaven_t_20100906_162.jpg

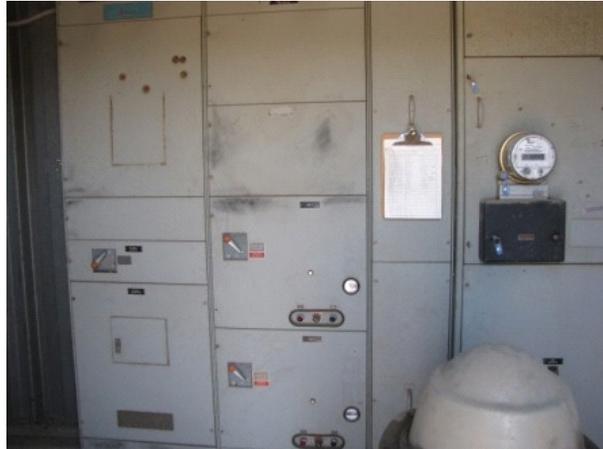
Levee Mile Report Line	10
Start Levee Mile	0.00
End Levee Mile	0.00
Location	
Category	Pump Stations
Item	Pump Control Systems
View of the pump control and power cabinets.	
dpesaven_t_20100906_164.jpg

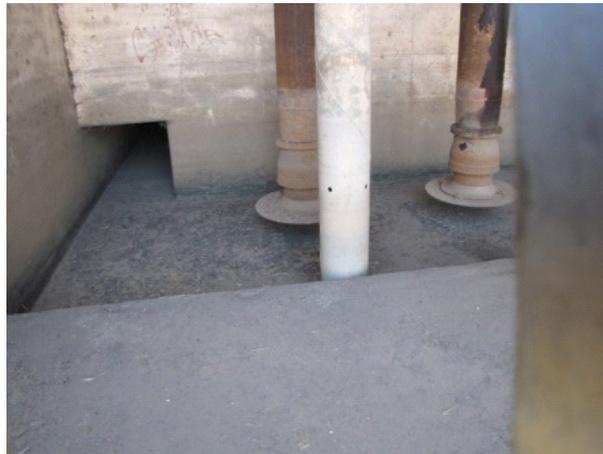
Levee Mile Report Line	11
Start Levee Mile	0.00
End Levee Mile	0.00
Location	
Category	Pump Stations
Item	Sumps/Wet Well
View of the sump under the station.	
dpesaven_t_20100906_165.jpg

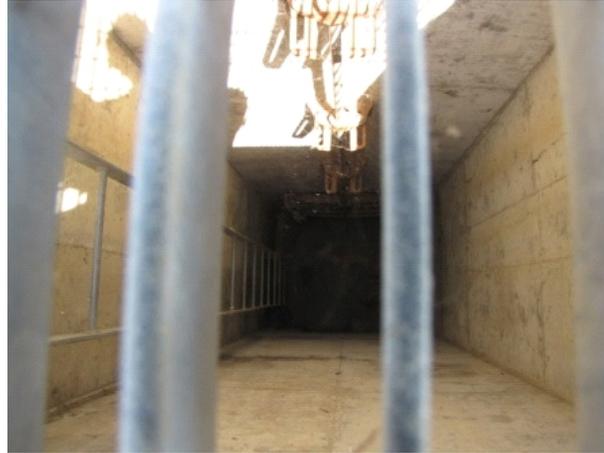
Levee Mile Report Line	14
Start Levee Mile	0.00
End Levee Mile	0.00
Location	
Category	Pump Stations
Item	Sluice / Slide Gates
View of the sluice gate.	
dpesaven_t_20100906_159.jpg

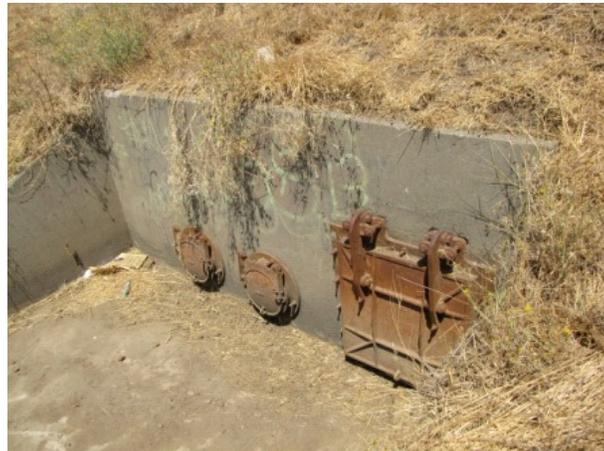
Levee Mile Report Line	18
Start Levee Mile	0.00
End Levee Mile	0.00
Location	
Category	Pump Stations
Item	Flap Gates
View of the flap gates.	
dpesaven_t_20100906_160.jpg

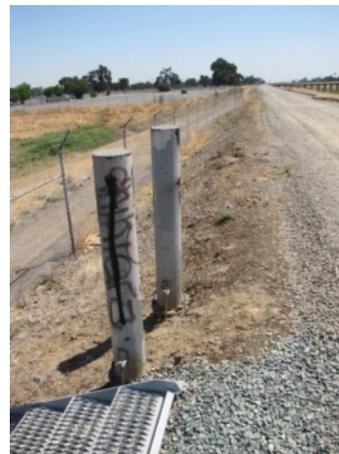
Levee Mile Report Line	21
Start Levee Mile	0.00
End Levee Mile	0.00
Location	
Category	Pump Stations
Item	Intake and Discharge Pipes
View of the risers for the breakers.	
dpesaven_t_20100906_161.jpg

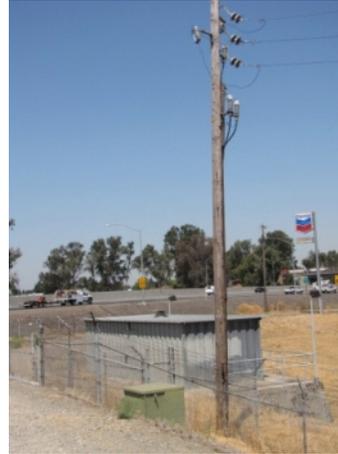
Levee Mile Report Line	3
Start Levee Mile	
End Levee Mile	
Location	
Category	Pump Stations
Item	Plant Building
View of the building from the crown of the levee to the north-east.	
dpesaven_t_20100906_145.jpg

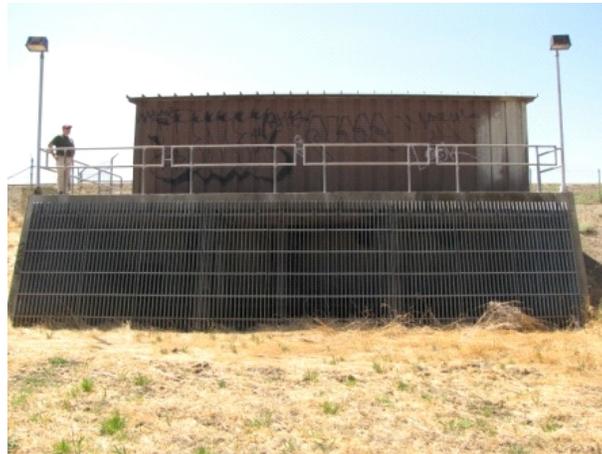
Levee Mile Report Line	3
Start Levee Mile	
End Levee Mile	
Location	
Category	Pump Stations
Item	Plant Building
View of the trash rack and building from the detention basin.	
dpesaven_t_20100906_146.jpg

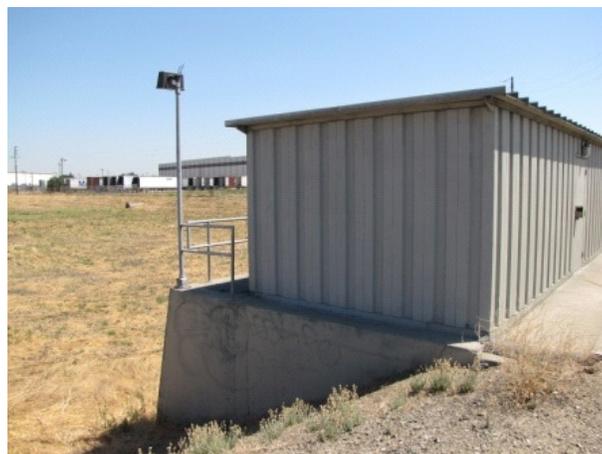
Levee Mile Report Line	3
Start Levee Mile	
End Levee Mile	
Location	
Category	Pump Stations
Item	Plant Building
View of the building from the south-west.	
dpesaven_t_20100906_147.jpg

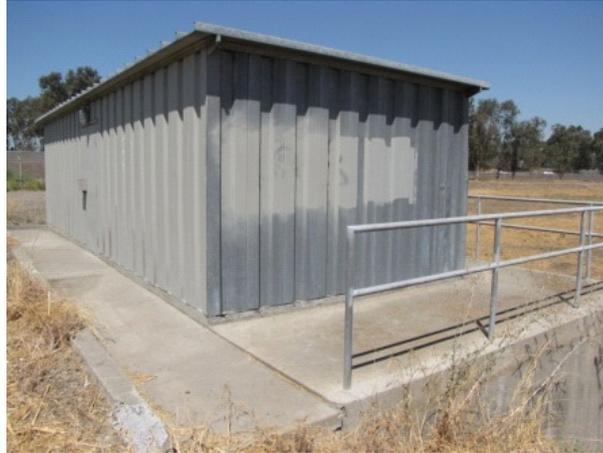
Levee Mile Report Line	3
Start Levee Mile	
End Levee Mile	
Location	
Category	Pump Stations
Item	Plant Building
View of the building from the north-east.	
dpesaven_t_20100906_148.jpg

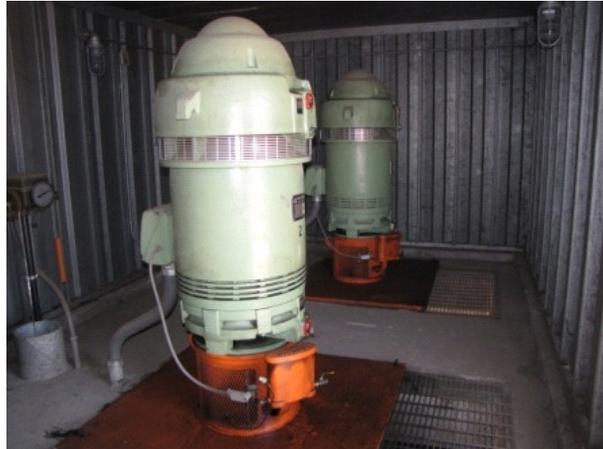
Levee Mile Report Line	7
Start Levee Mile	0.00
End Levee Mile	0.00
Location	
Category	Pump Stations
Item	Pumps
View of the pumps.	
dpesaven_t_20100906_152.jpg

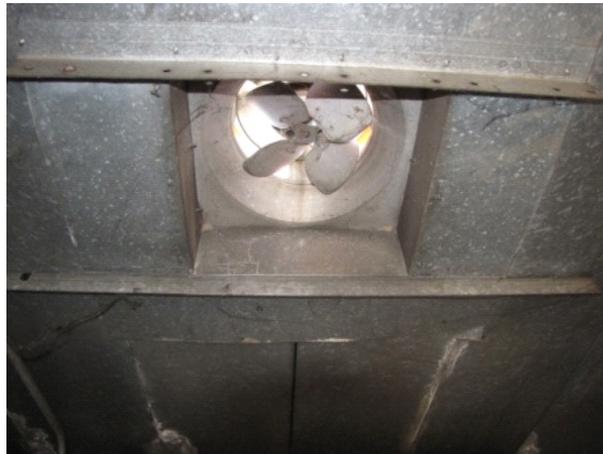
Levee Mile Report Line	9
Start Levee Mile	0.00
End Levee Mile	0.00
Location	
Category	Pump Stations
Item	Motors, Engines, Fans & Gear Reducers
View of the ventilation fan in the ceiling.	
dpesaven_t_20100906_154.jpg

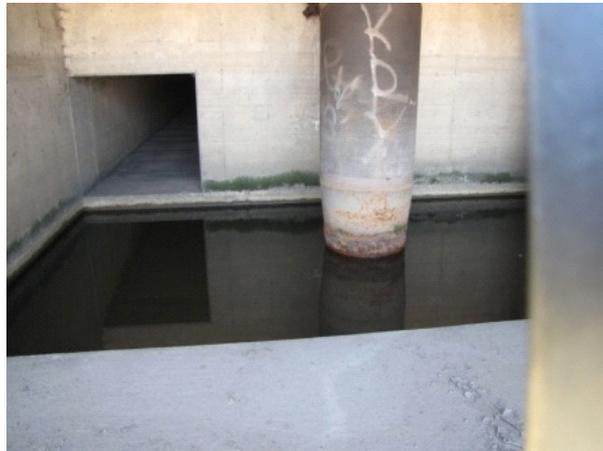
Levee Mile Report Line	11
Start Levee Mile	0.00
End Levee Mile	0.00
Location	
Category	Pump Stations
Item	Sumps/Wet Well

View of the sump under the station.

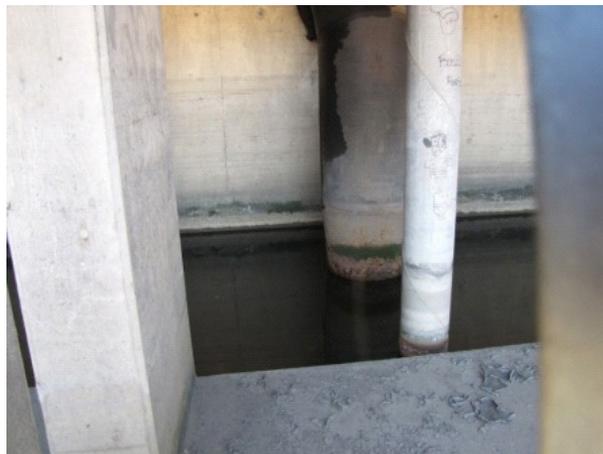
Levee Mile Report Line	11
Start Levee Mile	0.00
End Levee Mile	0.00
Location	
Category	Pump Stations
Item	Sumps/Wet Well

Additional view of the sump under the station.

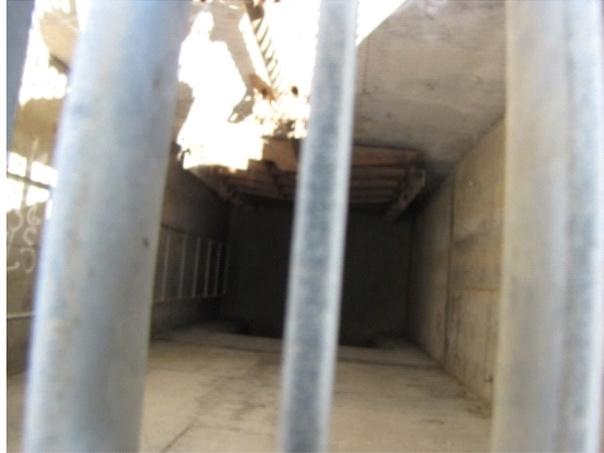
Levee Mile Report Line	14
Start Levee Mile	0.00
End Levee Mile	0.00
Location	
Category	Pump Stations
Item	Sluice / Slide Gates
View of the sluice gate.	
dpesaven_t_20100906_149.jpg

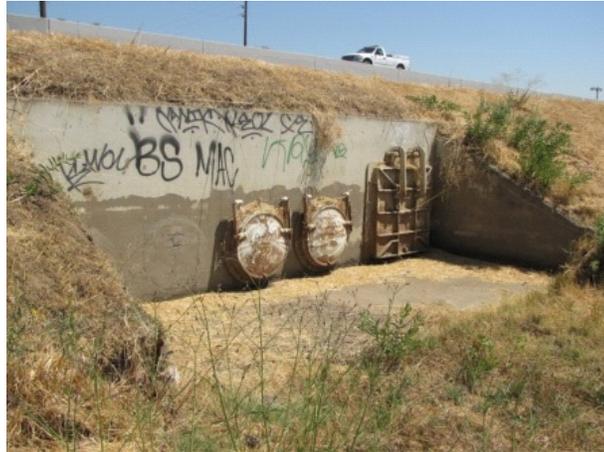
Levee Mile Report Line	18
Start Levee Mile	0.00
End Levee Mile	0.00
Location	
Category	Pump Stations
Item	Flap Gates
View of the flap gates.	
dpesaven_t_20100906_150.jpg

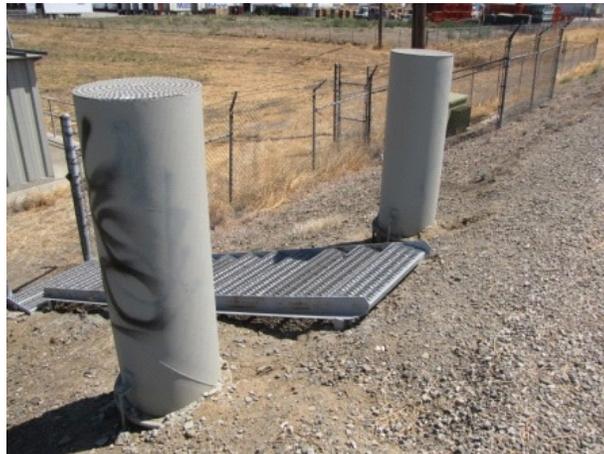
Levee Mile Report Line	21
Start Levee Mile	0.00
End Levee Mile	0.00
Location	
Category	Pump Stations
Item	Intake and Discharge Pipes
View of the risers for the vacuum breakers.	
dpesaven_t_20100906_151.jpg

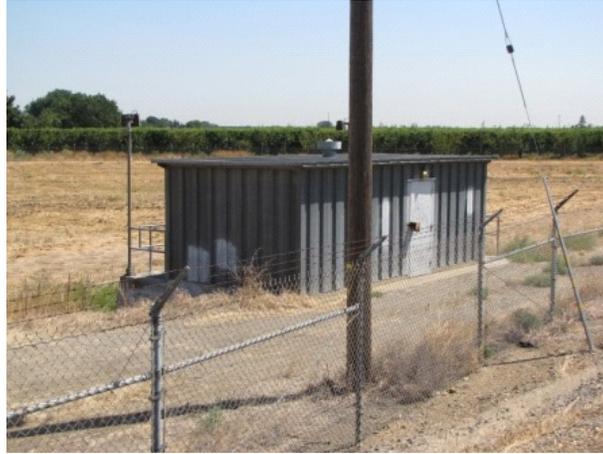
Levee Mile Report Line	3
Start Levee Mile	
End Levee Mile	
Location	
Category	Pump Stations
Item	Plant Building
View of the station from the crown of the levee to the south-west of the station.	
dpesaven_t_20100906_136.jpg

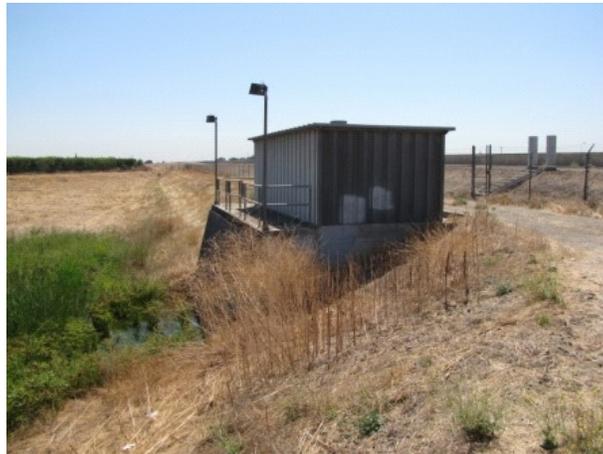
Levee Mile Report Line	3
Start Levee Mile	
End Levee Mile	
Location	
Category	Pump Stations
Item	Plant Building
View of the station from the west.	
dpesaven_t_20100906_137.jpg

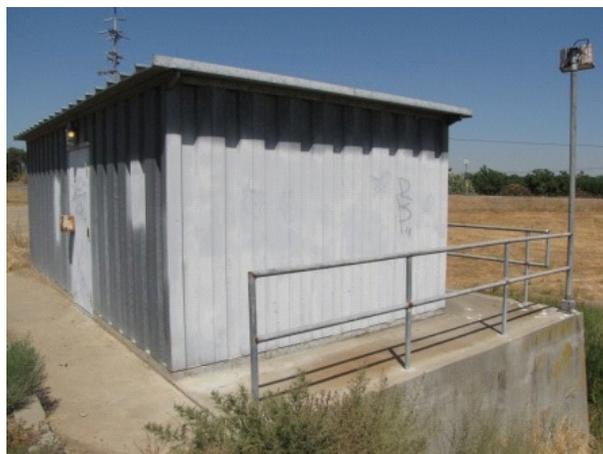
Levee Mile Report Line	3
Start Levee Mile	
End Levee Mile	
Location	
Category	Pump Stations
Item	Plant Building
View of the station from the north-east.	
dpesaven_t_20100906_138.jpg

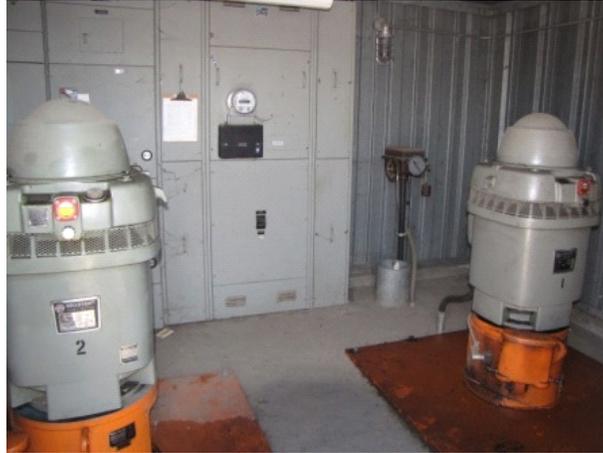
Levee Mile Report Line	7
Start Levee Mile	0.00
End Levee Mile	0.00
Location	
Category	Pump Stations
Item	Pumps
View of the pumps.	
dpesaven_t_20100906_144.jpg

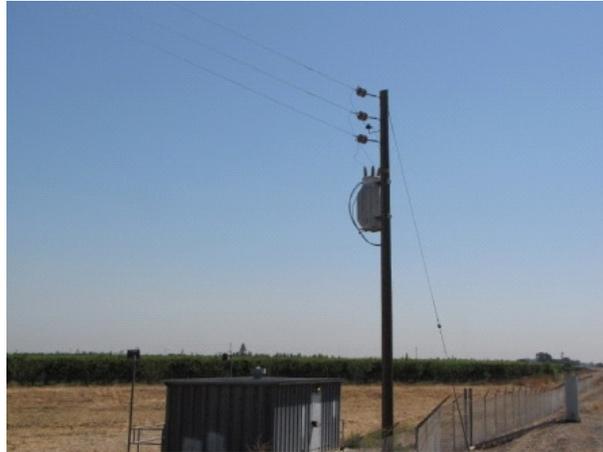
Levee Mile Report Line	8
Start Levee Mile	0.00
End Levee Mile	0.00
Location	
Category	Pump Stations
Item	Power
View of the power supply and transformer supplying power to the station.	
dpesaven_t_20100906_135.jpg

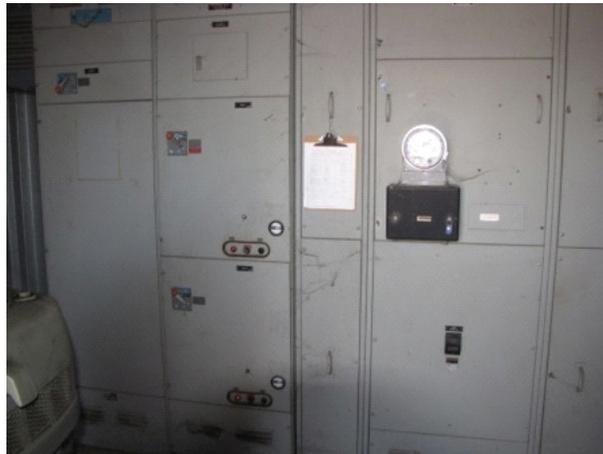
Levee Mile Report Line	10
Start Levee Mile	0.00
End Levee Mile	0.00
Location	
Category	Pump Stations
Item	Pump Control Systems
View of the power and pump control cabinets.	
dpesaven_t_20100906_142.jpg

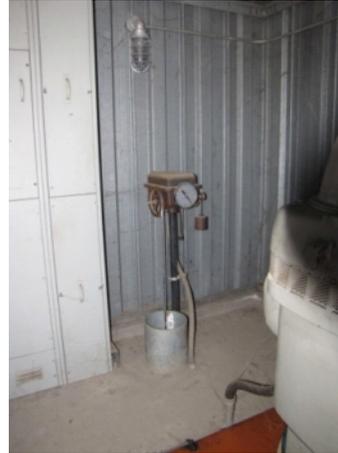
Levee Mile Report Line	10
Start Levee Mile	0.00
End Levee Mile	0.00
Location	
Category	Pump Stations
Item	Pump Control Systems
View of the level sensing equipment.	
dpesaven_t_20100906_143.jpg

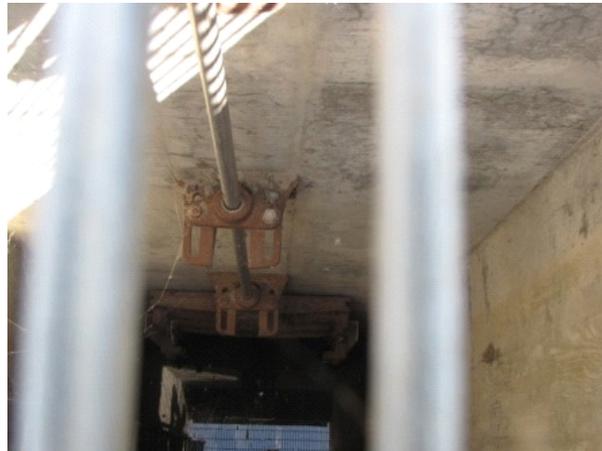
Levee Mile Report Line	14
Start Levee Mile	0.00
End Levee Mile	0.00
Location	
Category	Pump Stations
Item	Sluice / Slide Gates
View of the sluice gate.	
dpesaven_t_20100906_139.jpg

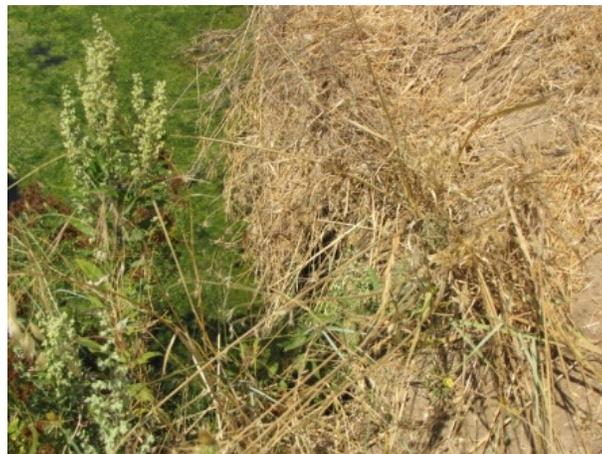
Levee Mile Report Line	18
Start Levee Mile	0.00
End Levee Mile	0.00
Location	
Category	Pump Stations
Item	Flap Gates
View of the headwall where the flap gates are located. Vegetation and water obstructed the view of the flap gates.	
dpesaven_t_20100906_140.jpg

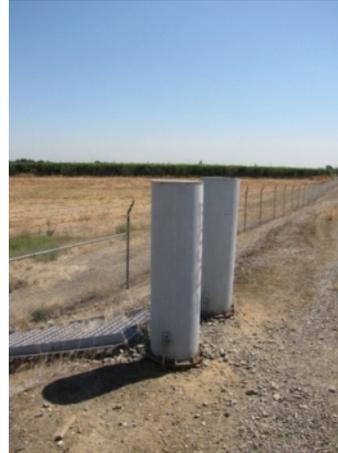
Levee Mile Report Line	21
Start Levee Mile	0.00
End Levee Mile	0.00
Location	
Category	Pump Stations
Item	Intake and Discharge Pipes
View of the risers for the vacuum breakers.	
dpesaven_t_20100906_141.jpg
