Flood Control Project Maintenance

2011 Structure Summary Report

San Joaquin County Flood Control and Water Conservation District

Duck Creek Diversion Weir And Control Structure

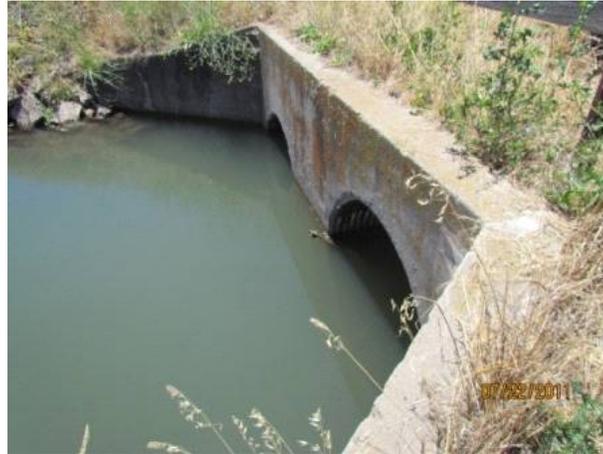
| LNI/R No. | Levee Mile | | Category | Item | Location | Rating | Action/Comment | GPS Latitude/Longitude | | Issue No. |
|---|---|---|---|---|---|---|--|---|---|---|
| 6 | 0.00 | 0.00 | Structures | Culverts: Inlets / Outlets | | A | Inspector Comments: Little debris was found around the culvert's inlet, but it didn't restrict the flow through the culvert. | 37.938383 ° -120.990133 ° | 37.938383 ° -120.990133 ° | 7 Y |

| View of the culvert inlet. | |

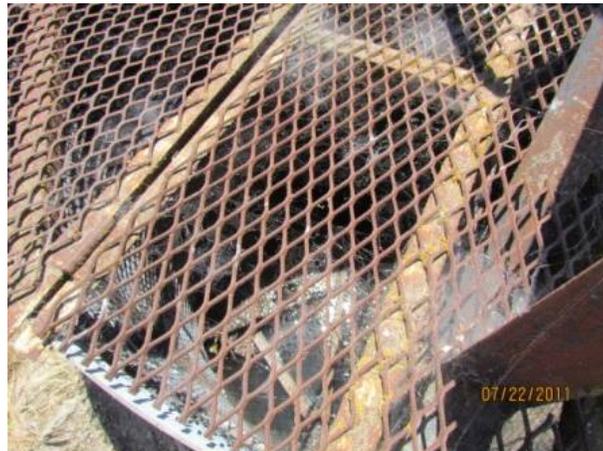
| LNI/R No. | Levee Mile | | Category | Item | Location | Rating | Action/Comment | GPS Latitude/Longitude | | Issue No. |
|---|---|---|---|---|---|---|--|---|---|---|
| 11 | 0.00 | 0.00 | Structures | Sluice/Slide Gates | | M | Inspector Comments: The gates appeared to be in good working condition with minor debris inside the gate structure. | 37.938383 ° -120.990133 ° | 37.938383 ° -120.990133 ° | 12 Y |

| View of the debris inside the slide gate. | |

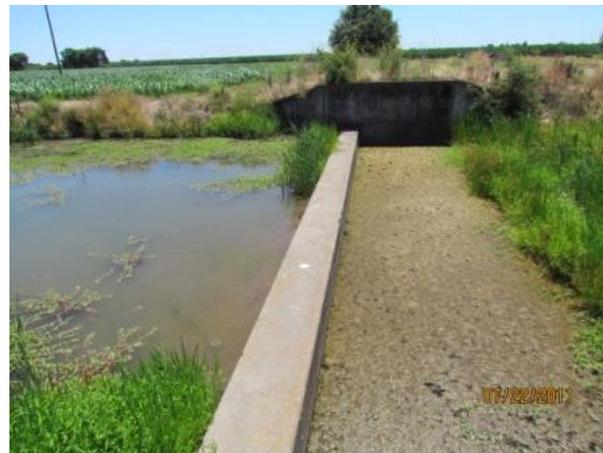
| LNI/R No. | Levee Mile | | Category | Item | Location * | Rating ** | Action/Comment | GPS Latitude/Longitude | | Issue No. Photo |
|---|---|---|---|---|---|---|--|---|---|---|
| 14 | 0.00 | 0.00 | Structures | Concrete Surfaces | | A | Inspector Comments: The concrete surfaces had minor cracking and the surface was weathered but they didn't pose any threats to the integrity of the structure. | 37.938383 ° -120.990133 ° | 37.938383 ° -120.990133 ° | 15 Y |

| View of the weir. | |

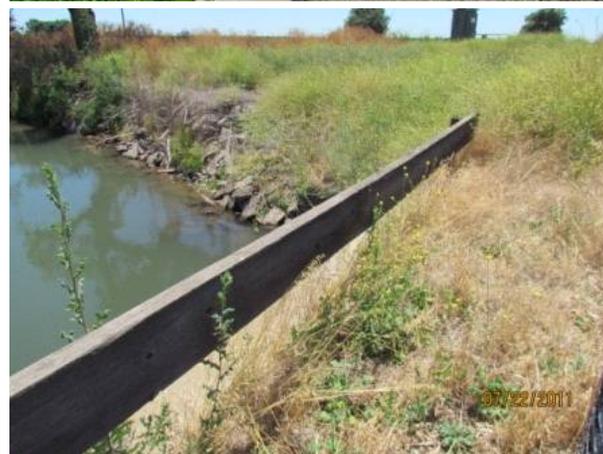
| LNI/R No. | Levee Mile | | Category | Item | Location * | Rating ** | Action/Comment | GPS Latitude/Longitude | | Issue No. Photo |
|---|---|---|---|---|---|---|--|---|---|---|
| 22 | 0.00 | 0.00 | Structures | Safety | | A | Inspector Comments: The wood railing top of the culvert appeared to provide adequate protection against fall hazards. | 37.938383 ° -120.990133 ° | 37.938383 ° -120.990133 ° | 23 Y |

| view of the railing top of the culvert. | |

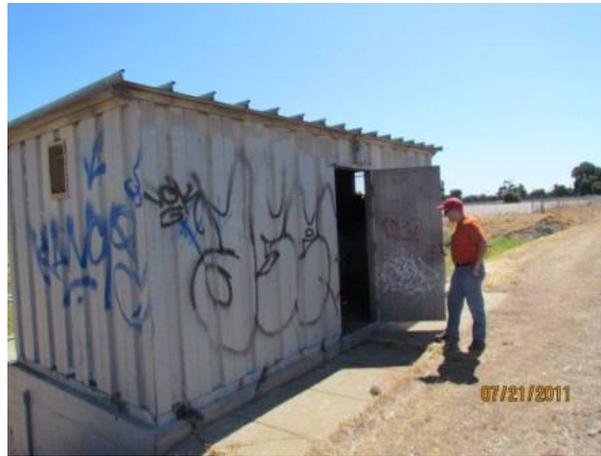
| LMR No. | Levee Mile | | Category | Item | Location * | Rating ** | Action/Comment | GPS Latitude/Longitude | | Issue No. Photo |
|---|---|---|---|---|---|---|---|---|---|---|
| 3 | 0.00 | 0.00 | Pump Stations | Plant Building | | A | Item inspected visually only. Item was not operated during the inspection. Inspector Comments: The plant building was in good structural condition but there were lot of graffiti markings around the building. | 37.989633 ° -121.266933 ° | 37.989633 ° -121.266933 ° | 3 Y |

View of the pumping plant.

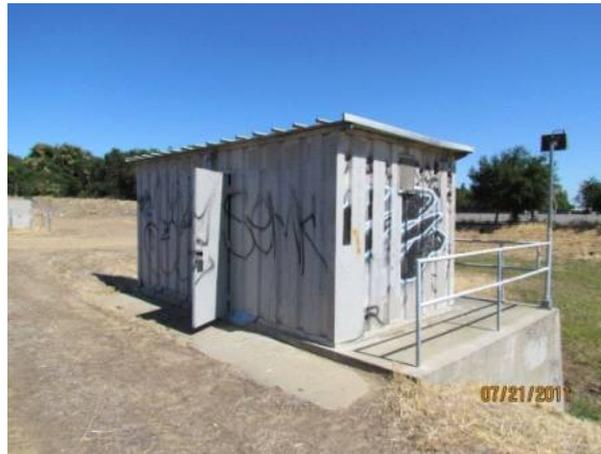
| LMR No. | Levee Mile | | Category | Item | Location * | Rating ** | Action/Comment | GPS Latitude/Longitude | | Issue No. Photo |
|---|---|---|---|---|---|---|---|---|---|---|
| 5 | 0.00 | 0.00 | Pump Stations | Safety | | A | Item inspected visually only. Item was not operated during the inspection. Inspector Comments: There were no safety hazards found around the structure and the guard rails around the structure were in good condition. | 37.989633 ° -121.266933 ° | 37.989633 ° -121.266933 ° | 5 Y |

View of the guard rails around the plant.

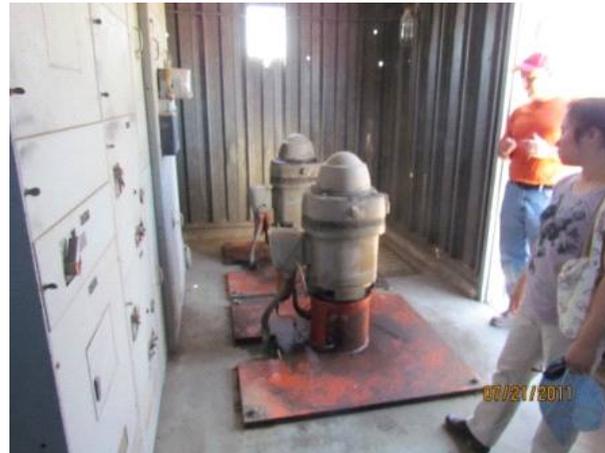
| LMR No. | Levee Mile | | Category | Item | Location * | Rating ** | Action/Comment | GPS Latitude/Longitude | | Issue No. Photo |
|---|---|---|---|---|---|---|---|---|---|---|
| 7 | 0.00 | 0.00 | Pump Stations | Pumps | | A | Item inspected visually only. Item was not operated during the inspection. Inspector Comments: All pumps were appeared to be in working condition and they were maintained, lubricated and tested periodically. | 37.989633 ° -121.266933 ° | 37.989633 ° -121.266933 ° | 7 Y |

View of the pumps in the plant.

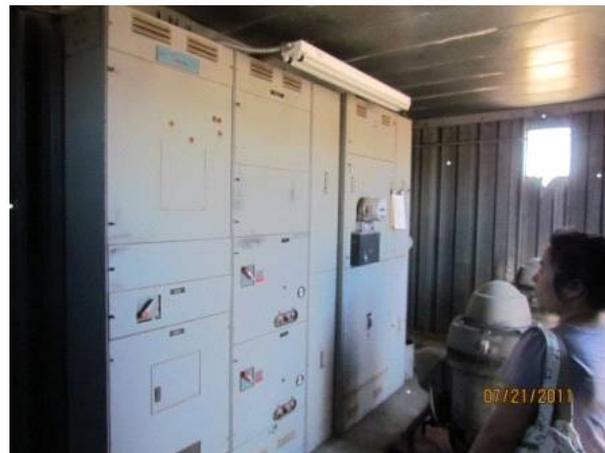
| LMR No. | Levee Mile | | Category | Item | Location * | Rating ** | Action/Comment | GPS Latitude/Longitude | | Issue No. Photo |
|---|---|---|---|---|---|---|---|---|---|---|
| 10 | 0.00 | 0.00 | Pump Stations | Pump Control Systems | | A | Item inspected visually only. Item was not operated during the inspection. Inspector Comments: The pump control systems were maintained properly and it appeared to be free of damage. | 37.989633 ° -121.266933 ° | 37.989633 ° -121.266933 ° | 11 Y |

View of the power control systems inside the plant.

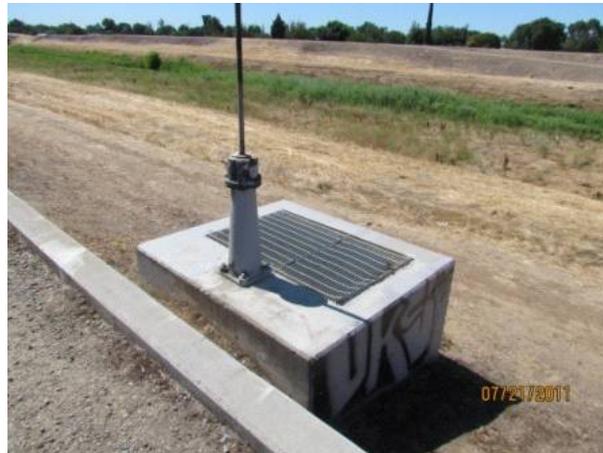
| LMR No. | Levee Mile | | Category | Item | Location | Rating | Action/Comment | GPS Latitude/Longitude | | Issue No. Photo |
|---|---|---|---|---|---|---|---|---|---|---|
| 14 | 0.00 | 0.00 | Pump Stations | Sluice / Slide Gates | | A | Item inspected visually only. Item was not operated during the inspection. Inspector Comments: The slide gate appeared to be in good condition. | 37.989633 ° -121.266933 ° | 37.989633 ° -121.266933 ° | 15 Y |

View of the slide gate next to the plant.

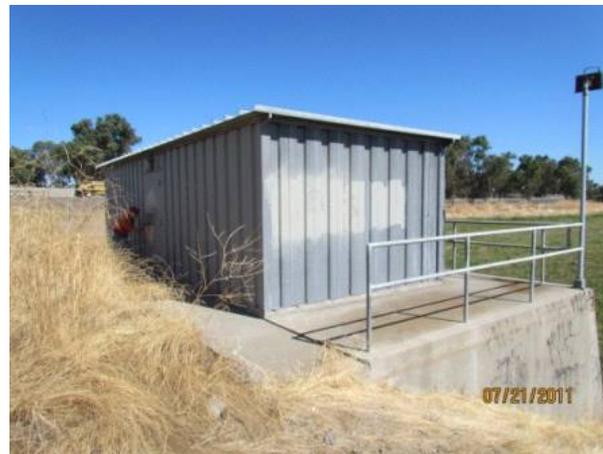
| LMR No. | Levee Mile | | Category | Item | Location | Rating | Action/Comment | GPS Latitude/Longitude | | Issue No. |
|---|---|---|---|---|---|--|---|---|---|---|
| 3 | 0.00 | 0.00 | Pump Stations | Plant Building | A | Item inspected visually only. Item was not operated during the inspection. Inspector Comments: The plant building was in good structural condition without any major cracks in the concrete. | 37.982317 ° -121.249433 ° | 37.982317 ° -121.249433 ° | 3 Y | |

View of the pumping plant.

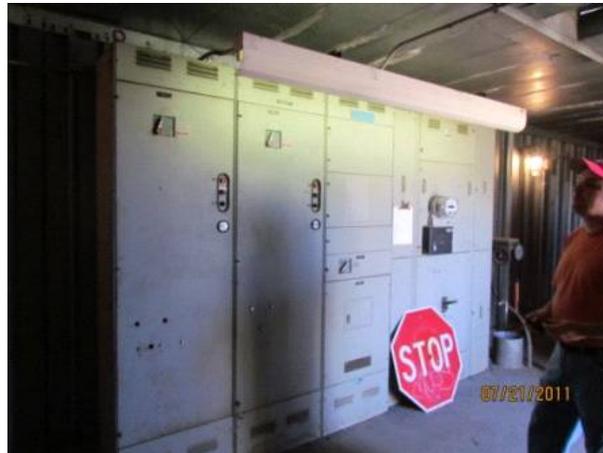
| LMR No. | Levee Mile | | Category | Item | Location | Rating | Action/Comment | GPS Latitude/Longitude | | Issue No. |
|---|---|---|---|---|---|--|---|---|---|---|
| 10 | 0.00 | 0.00 | Pump Stations | Pump Control Systems | A | Item inspected visually only. Item was not operated during the inspection. Inspector Comments: The pump control system was maintained to be free of corrosion or any damage. | 37.982317 ° -121.249433 ° | 37.982317 ° -121.249433 ° | 11 Y | |

| View of the power control system. | |

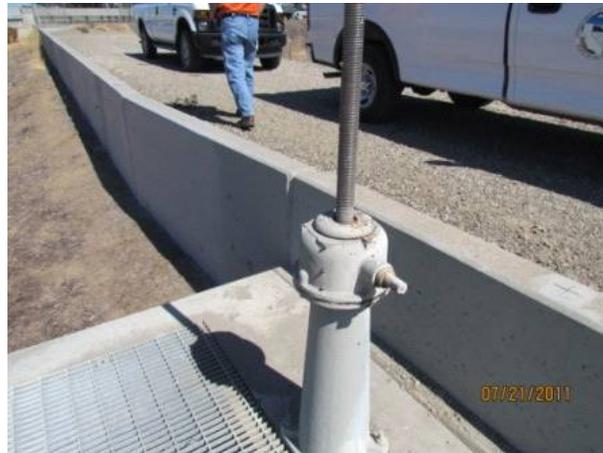
| LNI# No. | Levee Mile | | Category | Item | Location | Rating | Action/Comment | GPS Latitude/Longitude | | Issue No. |
|---|---|---|---|---|---|---|---|---|---|---|
| 16 | 0.00 | 0.00 | Pump Stations | Manual Gate Operators | | A | Item inspected visually only. Item was not operated during the inspection. Inspector Comments: Manual gate operator appeared to be in good condition. | 37.982317 ° -121.249433 ° | 37.982317 ° -121.249433 ° | 17 Y |

| View of the manual gate. | |

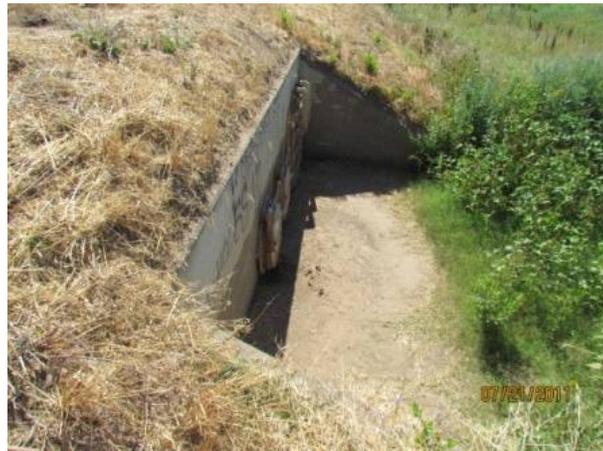
| LNI# No. | Levee Mile | | Category | Item | Location | Rating | Action/Comment | GPS Latitude/Longitude | | Issue No. |
|---|---|---|---|---|---|---|---|---|---|---|
| 18 | 0.00 | 0.00 | Pump Stations | Flap Gates | | A | Item inspected visually only. Item was not operated during the inspection. Inspector Comments: Flap gates were in good condition and showed no damage. | 37.982317 ° -121.249433 ° | 37.982317 ° -121.249433 ° | 19 Y |

| View of the flap gates on the waterside. | |

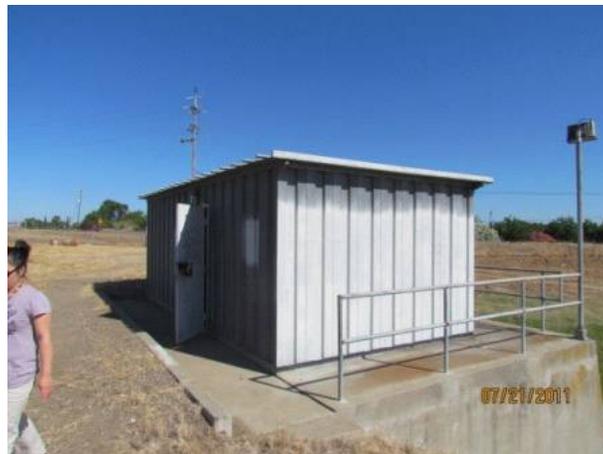
| LNI# No. | Levee Mile | | Category | Item | Location * | Rating ** | Action/Comment | GPS Latitude/Longitude | | Issue No. Photo |
|---|---|---|---|---|---|---|---|---|---|---|
| 3 | 0.00 | 0.00 | Pump Stations | Plant Building | | A | Item inspected visually only. Item was not operated during the inspection. Inspector Comments: The plant building appeared to be in good structural condition. | 37.973983 ° -121.229967 ° | 37.973983 ° -121.229967 ° | 3 Y |

| View of the pumping plant. | |

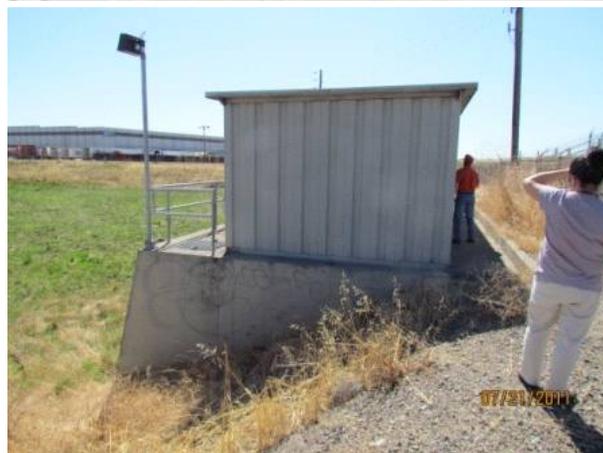
| LNI# No. | Levee Mile | | Category | Item | Location * | Rating ** | Action/Comment | GPS Latitude/Longitude | | Issue No. Photo |
|---|---|---|---|---|---|---|---|---|---|---|
| 5 | 0.00 | 0.00 | Pump Stations | Safety | | A | Item inspected visually only. Item was not operated during the inspection. Inspector Comments: No safety hazard was found around the pumping plant and guard rails around the plant were in a good condition. | 37.973983 ° -121.229967 ° | 37.973983 ° -121.229967 ° | 5 Y |

| View of the guard rails around the plant. | |

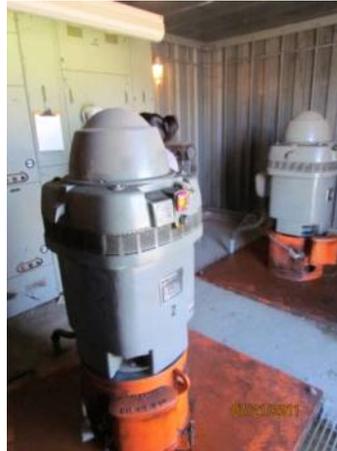
| LNI# No. | Levee Mile | | Category | Item | Location * | Rating ** | Action/Comment | GPS Latitude/Longitude | | Issue No. Photo |
|---|---|---|---|---|---|---|---|---|---|---|
| 7 | 0.00 | 0.00 | Pump Stations | Pumps | | A | Item inspected visually only. Item was not operated during the inspection. Inspector Comments: All pumps were appeared to be in good condition and maintained properly. | 37.973983 ° -121.229967 ° | 37.973983 ° -121.229967 ° | 7 Y |

| View of the pumps inside the structure. | |

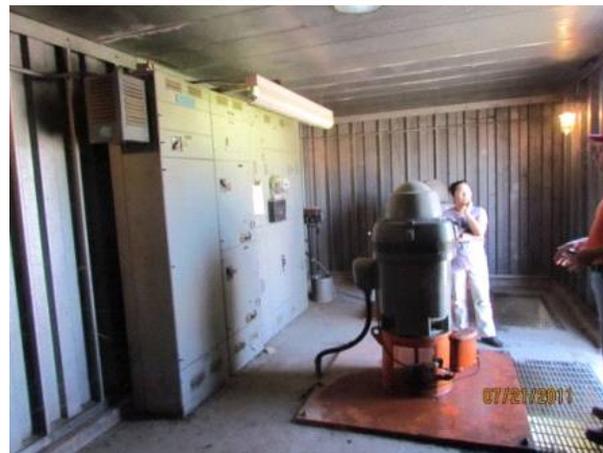
| LNI# No. | Levee Mile | | Category | Item | Location * | Rating ** | Action/Comment | GPS Latitude/Longitude | | Issue No. Photo |
|---|---|---|---|---|---|---|---|---|---|---|
| 10 | 0.00 | 0.00 | Pump Stations | Pump Control Systems | | A | Item inspected visually only. Item was not operated during the inspection. Inspector Comments: The pump control system appeared to be operational and free of damage. | 37.973983 ° -121.229967 ° | 37.973983 ° -121.229967 ° | 11 Y |

| View of the power control systems inside the plant. | |
