**Flood Control Project Maintenance**  
**2016 Structure Summary Report**  
**Overall Unit and Item Ratings**

**San Joaquin County Flood Control and Water Conservation District**

**Duck Creek Diversion Weir And Control Structure**

**2016 Structure Inspection Results**

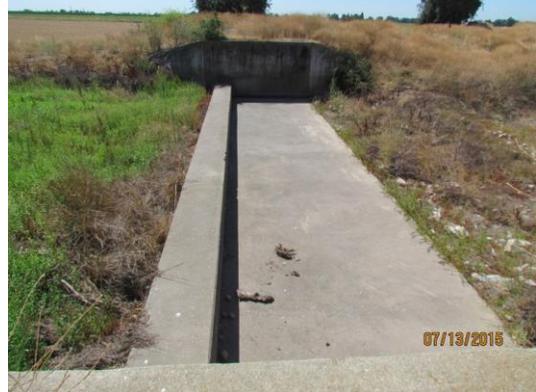
Photo 1 of 1 : ST\_2016\_NA0017\_5\_24\_20160613\_00011.jpg

View of the weir.

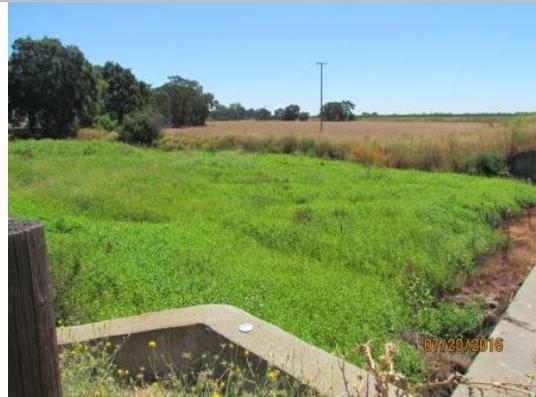
Photo 1 of 1 : ST\_2016\_NA0017\_5\_2\_20160728\_00012.jpg

LM Start	<b>0.00</b>	Rating **	A	Issue No.	<b>2</b>
LM End	<b>0.00</b>	Issue Type +	Ma	Location *	
Category	Structures & Concrete Lined Channels		GPS Latitude/Longitude		
			Start	End	
Item	Vegetation & Obstructions		37.938383 °	37.938383 °	
			-120.990133 °	-120.990133 °	
DWR ID	DWR_NA0017_5_t_2012_2				
Action/Comments					
Inspector Comments: There was minimal vegetation around the structure. The flow was not impeded.

View of the vegetation looking upstream of the weir.

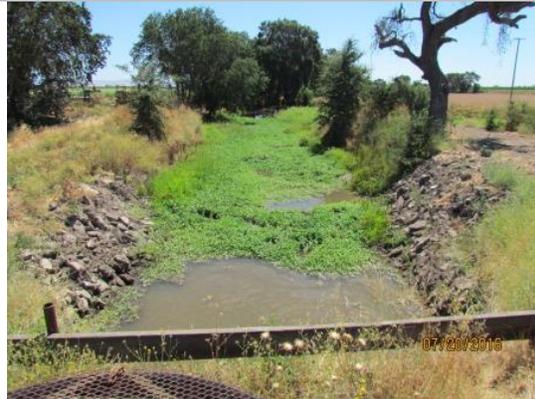
Photo 1 of 2 : ST\_2016\_NA0017\_5\_5\_20160728\_00013.jpg

View of the revetments looking upstream of the weir.

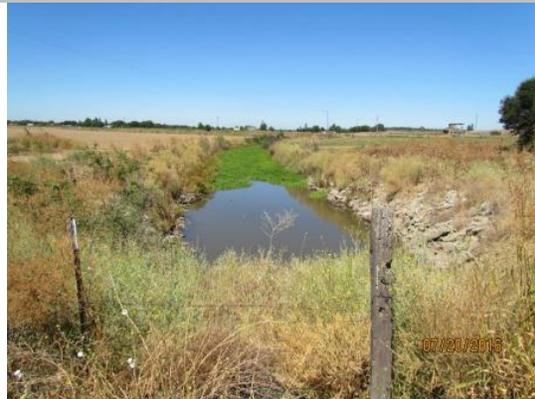
Photo 2 of 2 : ST\_2016\_NA0017\_5\_5\_20160728\_00014.jpg

View of the revetments looking downstream of the weir.

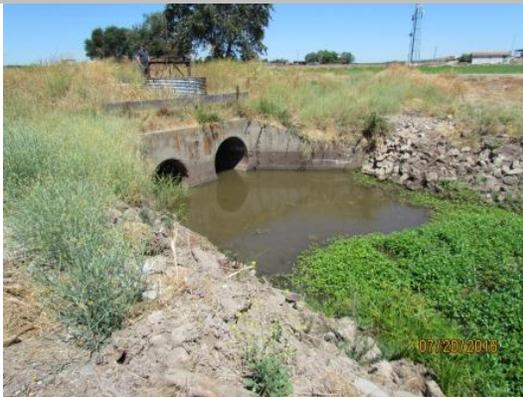
Photo 1 of 2 : ST\_2016\_NA0017\_5\_7\_20160728\_00015.jpg

View of the inlet of the culvert.

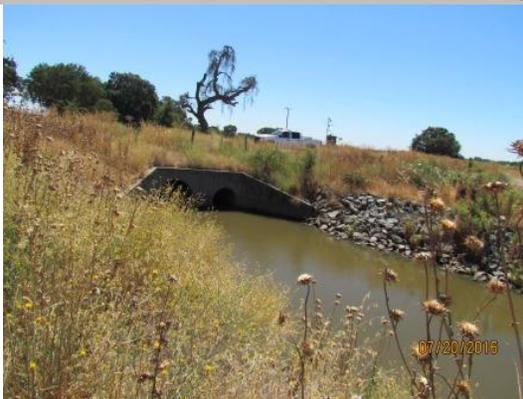
Photo 2 of 2 : ST\_2016\_NA0017\_5\_7\_20160728\_00016.jpg

View of the outlet of the culvert.

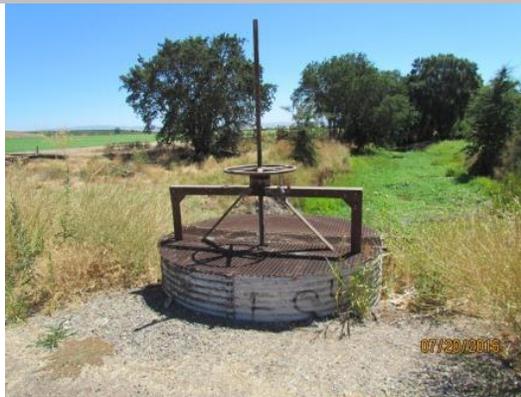
Photo 1 of 1 : ST\_2016\_NA0017\_5\_12\_20160801\_00018.jpg

LM Start	<b>0.00</b>	Rating **	M	Issue No.	<b>12</b>
LM End	<b>0.00</b>	Issue Type +	Ma	Location *	
Category	Structures & Concrete Lined Channels		GPS Latitude/Longitude		
			Start	End	
Item	Sluice/Slide Gates		37.938383 °	37.938383 °	
			-120.990133 °	-120.990133 °	
DWR ID	DWR_NA0017_5_t_2012_12				
Action/Comments					
Inspector Comments: The gates appeared to be in good working condition. The screw gate needs to be maintained properly so that it can be turned with ease.

View of the slide gate.

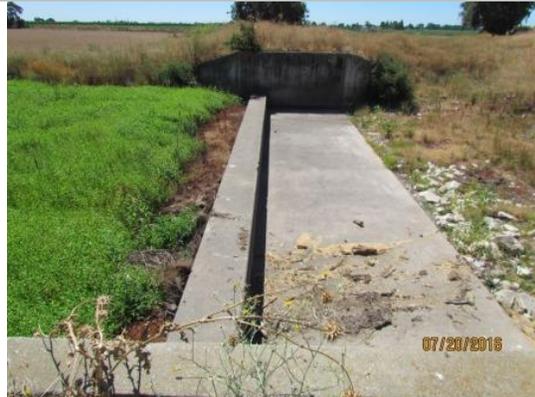
Photo 1 of 2 : ST\_2016\_NA0017\_5\_15\_20160801\_00019.jpg

LM Start	<b>0.00</b>	Rating **	A	Issue No.	<b>15</b>
LM End	<b>0.00</b>	Issue Type +	Ma	Location *	
Category	Structures & Concrete Lined Channels		GPS Latitude/Longitude		
			Start	End	
Item	Concrete Surfaces		37.938383 °	37.938383 °	
			-120.990133 °	-120.990133 °	
DWR ID	DWR_NA0017_5_t_2012_15				
Action/Comments					
Inspector Comments: The concrete surfaces had minor cracking and the surface was weathered but they didn't pose any threats to the integrity of the structure.

View of the weir and the concrete surface during 2016 inspection.

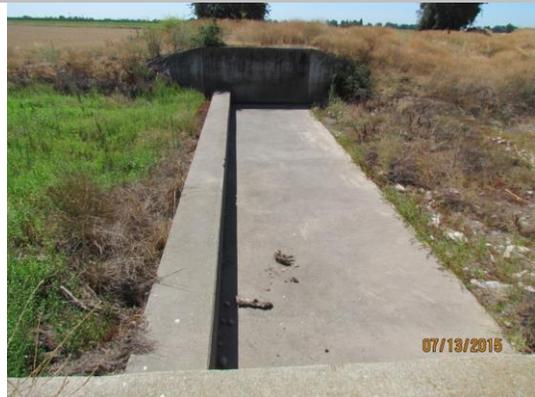
Photo 2 of 2 : ST\_2016\_NA0017\_5\_15\_20160613\_00008.jpg

View of the weir and the concrete surface during 2015 inspection.

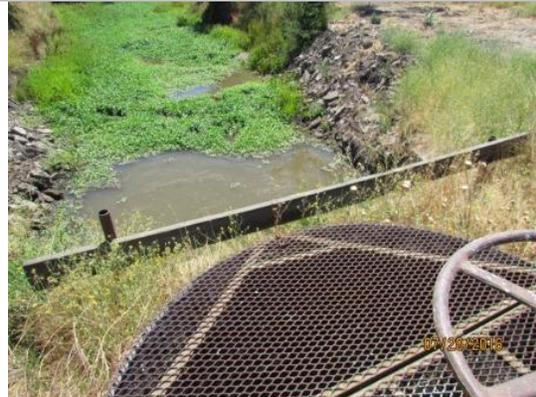
Photo 1 of 1 : ST\_2016\_NA0017\_5\_23\_20160801\_00020.jpg

LM Start	<b>0.00</b>	Rating **	A	Issue No.	<b>23</b>
LM End	<b>0.00</b>	Issue Type +	Ma	Location *	
Category	Structures & Concrete Lined Channels		GPS Latitude/Longitude		
			Start	End	
Item	Safety		37.938383 °	37.938383 °	
			-120.990133 °	-120.990133 °	
DWR ID	DWR_NA0017_5_t_2012_23				
Action/Comments					
Inspector Comments: The wood railing top of the culvert appeared to provide adequate protection against fall hazards.

View of the railing top of the culvert.

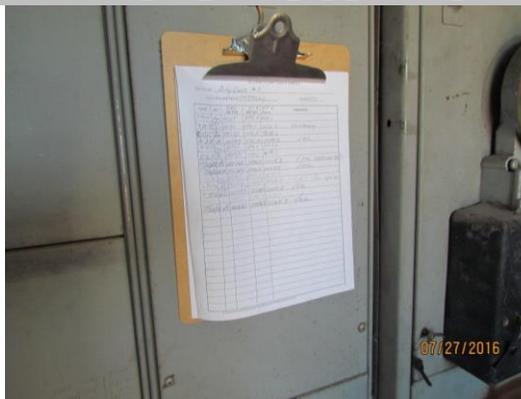
Photo 1 of 1 : ST\_2016\_NA0017\_18\_1\_20160805\_00013.jpg

View of the operation log in the plant.

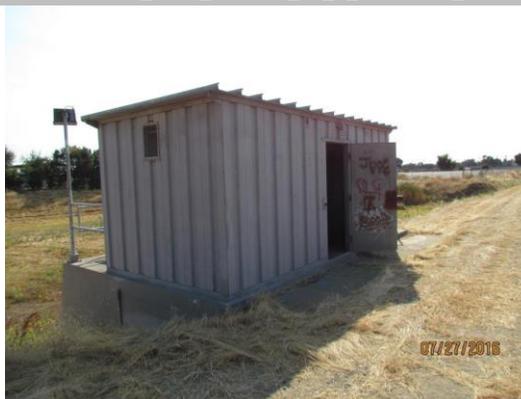
Photo 1 of 1 : ST\_2016\_NA0017\_18\_3\_20160805\_00014.jpg

LM Start	<b>0.00</b>	Rating **	A	Issue No.	<b>3</b>
LM End	<b>0.00</b>	Issue Type +	Ma	Location *	
Category	Pump Stations		GPS Latitude/Longitude		
			Start	End	
Item	Plant Building		37.989633 °	37.989633 °	
			-121.266933 °	-121.266933 °	
DWR ID	DWR_NA0017_18_t_2012_3				
Action/Comments					
Inspector Comments: The plant building was in good structural condition.

View of the pumping plant during 2016 inspection.

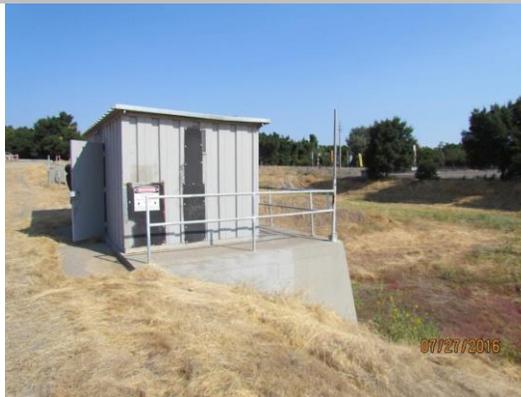
Photo 1 of 1 : ST\_2016\_NA0017\_18\_5\_20160805\_00015.jpg

LM Start	<b>0.00</b>	Rating **	A	Issue No.	<b>5</b>
LM End	<b>0.00</b>	Issue Type +	Ma	Location *	
Category	Pump Stations		GPS Latitude/Longitude		
			Start	End	
Item	Safety		37.989633 °	37.989633 °	
			-121.266933 °	-121.266933 °	
DWR ID	DWR_NA0017_18_t_2012_5				
Action/Comments					
Inspector Comments: There were no safety hazards found around the structure and the guard rails around the structure were in good condition.

View of the guard rails around the plant.

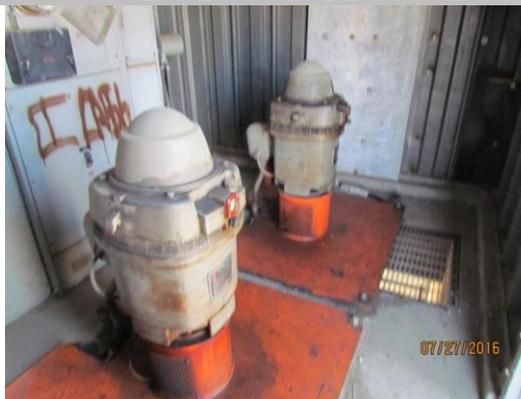
Photo 1 of 2 : ST\_2016\_NA0017\_18\_7\_20160805\_00016.jpg

LM Start	<b>0.00</b>	Rating **	A	Issue No.	<b>7</b>
LM End	<b>0.00</b>	Issue Type +	Ma	Location *	
Category	Pump Stations		GPS Latitude/Longitude		
			Start	End	
Item	Pumps		37.989633 °	37.989633 °	
			-121.266933 °	-121.266933 °	
DWR ID	DWR_NA0017_18_t_2012_7				
Action/Comments					
Inspector Comments: All pumps appeared to be in working condition and they were maintained, lubricated and tested periodically.

View of the pumps inside the plant.

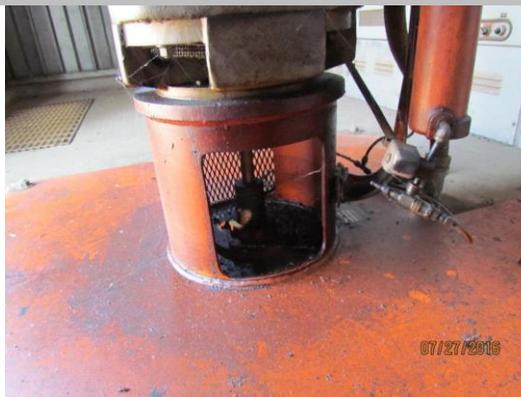
Photo 2 of 2 : ST\_2016\_NA0017\_18\_7\_20160805\_00017.jpg

View of the metallic shaft below a pump inside the plant.

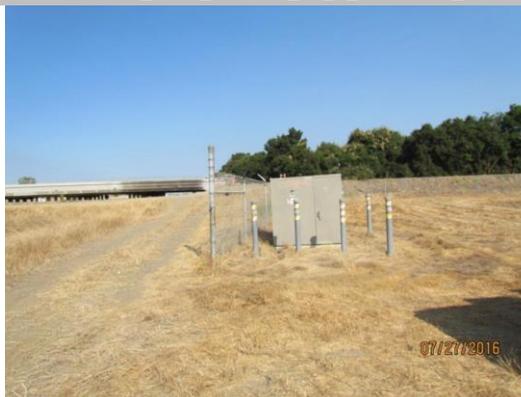
Photo 1 of 1 : ST\_2016\_NA0017\_18\_8\_20160805\_00018.jpg

LM Start	<b>0.00</b>	Rating **	A	Issue No.	<b>8</b>
LM End	<b>0.00</b>	Issue Type +	Ma	Location *	
Category	Pump Stations		GPS Latitude/Longitude		
			Start	End	
Item	Power		37.989633 °	37.989633 °	
			-121.266933 °	-121.266933 °	
DWR ID	DWR_NA0017_18_t_2012_8				
Action/Comments					
Inspector Comments: The power source appeared to be safe and reliable.

View of the power source next to the pumping plant.

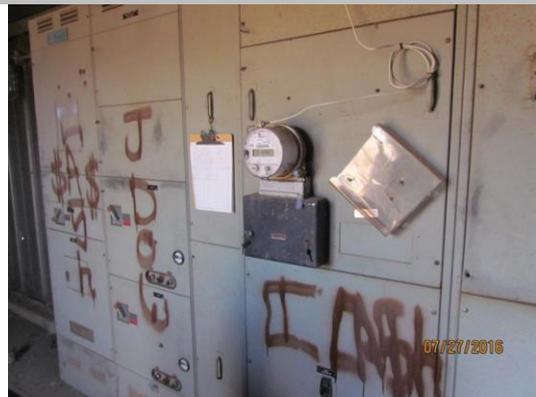
Photo 1 of 1 : ST\_2016\_NA0017\_18\_11\_20160805\_00020.jpg

LM Start	<b>0.00</b>	Rating **	A	Issue No.	<b>11</b>
LM End	<b>0.00</b>	Issue Type +	Ma	Location *	
Category	Pump Stations			GPS Latitude/Longitude	
				Start	End
Item	Pump Control Systems			37.989633 °	37.989633 °
				-121.266933 °	-121.266933 °
DWR ID	DWR_NA0017_18_t_2012_11				
Action/Comments					
Inspector Comments: The pump control systems were maintained properly and appeared to be free of damage eventhough vandalism occurred a last year.

View of the pump control system inside the plant.

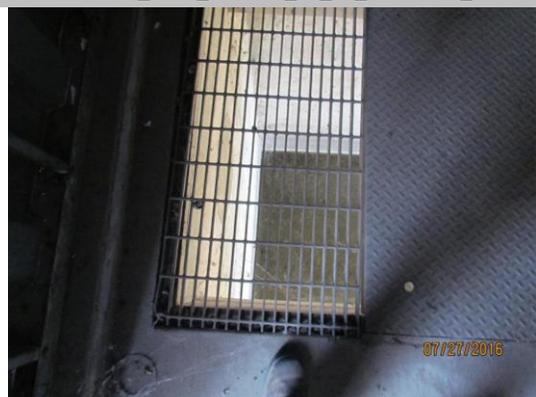
Photo 1 of 1 : ST\_2016\_NA0017\_18\_12\_20160805\_00021.jpg

LM Start	<b>0.00</b>	Rating **	A	Issue No.	<b>12</b>
LM End	<b>0.00</b>	Issue Type +	Ma	Location *	
Category	Pump Stations			GPS Latitude/Longitude	
				Start	End
Item	Sumps/Wet Well			37.989633 °	37.989633 °
				-121.266933 °	-121.266933 °
DWR ID	DWR_NA0017_18_t_2012_12				
Action/Comments					
Inspector Comments: The wet well was completely dry and very little debris was present during inspection.

View of the wet well.

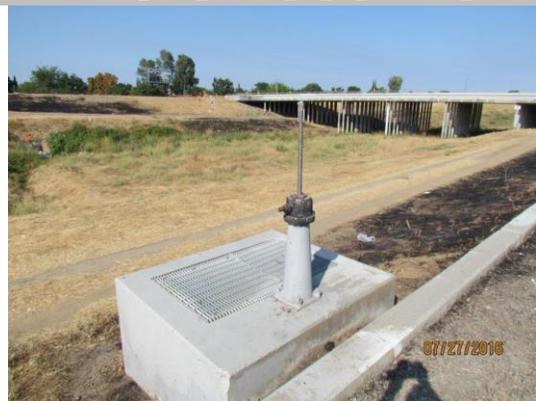
Photo 1 of 1 : ST\_2016\_NA0017\_18\_15\_20160805\_00023.jpg

LM Start	<b>0.00</b>	Rating **	A	Issue No.	<b>15</b>
LM End	<b>0.00</b>	Issue Type +	Ma	Location *	
Category	Pump Stations		GPS Latitude/Longitude		
			Start	End	
Item	Sluice / Slide Gates		37.989633 °	37.989633 °	
			-121.266933 °	-121.266933 °	
DWR ID	DWR_NA0017_18_t_2012_15				
Action/Comments					
Inspector Comments: The slide gate appeared to be in good condition.

View of the slide gate.

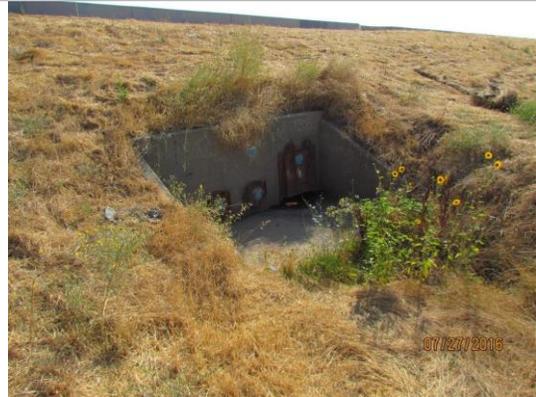
Photo 1 of 2 : ST\_2016\_NA0017\_18\_19\_20160805\_00024.jpg

LM Start	<b>0.00</b>	Rating **	A	Issue No.	<b>19</b>
LM End	<b>0.00</b>	Issue Type +	Ma	Location *	
Category	Pump Stations		GPS Latitude/Longitude		
			Start	End	
Item	Flap Gates		37.989633 °	37.989633 °	
			-121.266933 °	-121.266933 °	
DWR ID	DWR_NA0017_18_t_2012_19				
Action/Comments					
Inspector Comments: The flap gates appeared to be in good working condition.

View of the flap gates during 2016 inspection.

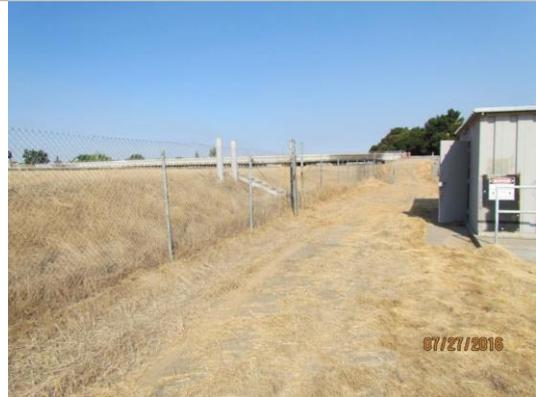
Photo 1 of 1 : ST\_2016\_NA0017\_18\_21\_20160805\_00025.jpg

LM Start	<b>0.00</b>	Rating **	A	Issue No.	<b>21</b>
LM End	<b>0.00</b>	Issue Type +	Ma	Location *	
Category	Pump Stations		GPS Latitude/Longitude		
			Start	End	
Item	Security Fencing		37.989633 °	37.989633 °	
			-121.266933 °	-121.266933 °	
DWR ID	DWR_NA0017_18_t_2012_21				
Action/Comments					
Inspector Comments: Security fencing appeared to be in good condition.

View of the security fence around the pumping plant.

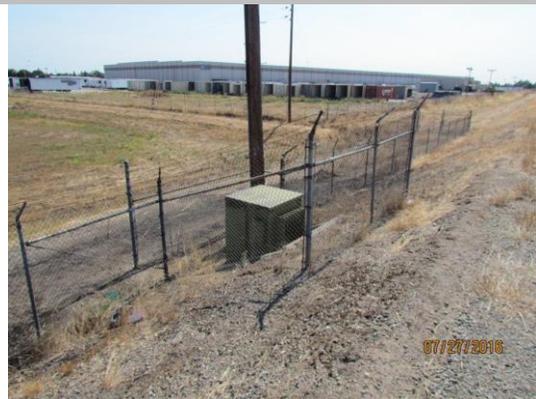
Photo 1 of 1 : ST\_2016\_NA0017\_19\_8\_20160808\_00033.jpg

LM Start	<b>0.00</b>	Rating **	A	Issue No.	<b>8</b>
LM End	<b>0.00</b>	Issue Type +	Ma	Location *	
Category	Pump Stations		GPS Latitude/Longitude		
			Start	End	
Item	Power		37.982317 °	37.982317 °	
			-121.249433 °	-121.249433 °	
DWR ID	DWR_NA0017_19_t_2012_8				
Action/Comments					
Inspector Comments: The power source appeared to be safe and reliable.

View of the power source outside the plant.
