**Flood Control Project Maintenance
Levee Inspections**

Fall 2014 Levee Maintenance Deficiency Summary Report

Sacramento River Basin

California Department of Fish and Game Shea Levee

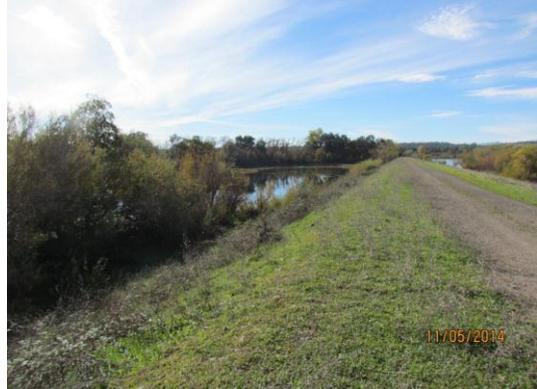
Photo 1 of 1 : FA_2014_NA0018_269_1_20141112_00007.jpg

LM Start	0.02	Rating **	M	Issue No.	1
LM End	0.06	Issue Type +	Ma	Location *	LS
Category	Earthen Levee		GPS Latitude/Longitude		
			Start	End	
Item	Vegetation		40.511185 °	40.510670 °	
			-122.360553 °	-122.361203 °	
DWR ID	DWR_NA0018_01_s_2012_1				
Action/Comments					
Remove the wild growth other than native grasses from the levee slopes. Inspector Comments: Fish and Wildlife Service has not completed any maintenance.

View of the blackberries and other vegetation along the landside slope.

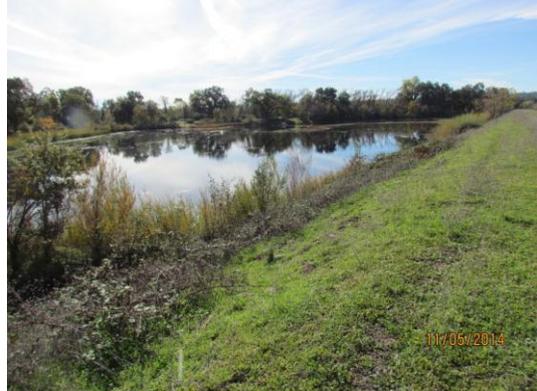
Photo 1 of 1 : FA_2014_NA0018_269_6_20141112_00008.jpg

LM Start	0.02	Rating **	M	Issue No.	6
LM End	0.08	Issue Type +	Ma	Location *	LS
Category	Earthen Levee		GPS Latitude/Longitude		
			Start	End	
Item	Animal Control		40.511185 °	40.510671 °	
			122.360553 °	122.360944 °	
DWR ID	DWR_NA0018_01_s_2013_6				
Action/Comments					
Repair the levee slope damaged by livestock and prevent large animal access. Inspector Comments: The livestock damaged the L/S slope.

View of the livestock erosion along the land side slope.

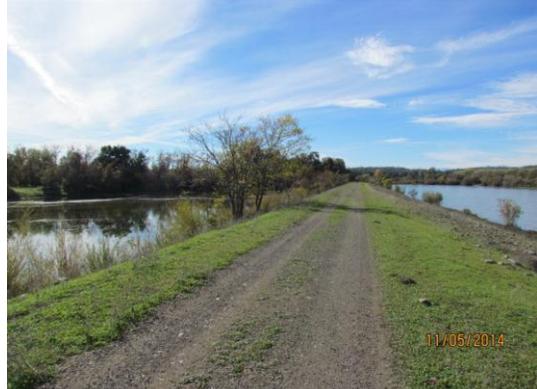
Photo 1 of 1 : FA_2014_NA0018_269_9_20141112_00009.jpg

LM Start	0.06	Rating **	M	Issue No.	9
LM End	0.20	Issue Type +	Ma	Location *	LS
Category	Earthen Levee		GPS Latitude/Longitude		
			Start	End	
Item	Trim / Thin Trees		40.510649 °	40.509012 °	
			-122.360945 °	-122.362609 °	
DWR ID	DWR_NA0018_01_f_2012_9				
Action/Comments					
Thin trees to allow visibility of the ground and room to flood fight. Inspector Comments: Fish and Wildlife Service has not completed any maintenance.

Remove the small trees along the landside slope.

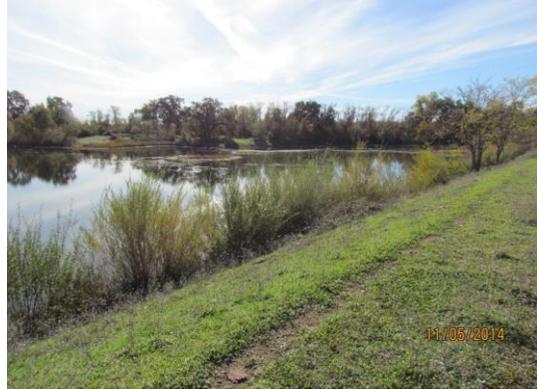
Photo 1 of 1 : FA_2014_NA0018_269_5_20141112_00010.jpg

LM Start	0.08	Rating **	M	Issue No.	5
LM End	0.21	Issue Type +	Ma	Location *	LS
Category	Earthen Levee		GPS Latitude/Longitude		
			Start	End	
Item	Vegetation		40.510671 °	40.509146 °	
			-122.360944 °	-122.362499 °	
DWR ID	DWR_NA0018_01_s_2012_5				
Action/Comments					
Remove the wild growth other than native grasses from the levee slopes.

The Dept. of Fish and wildlife services has done no maintenance this year.

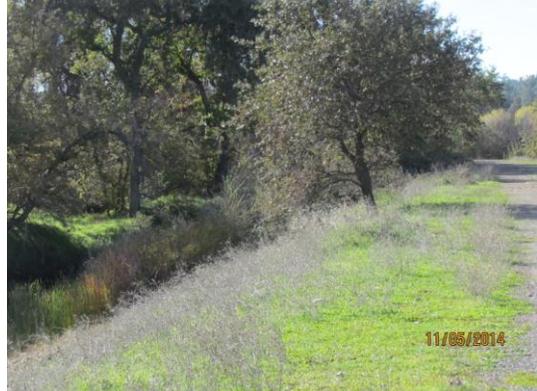
Photo 1 of 1 : FA_2014_NA0018_269_2_20141112_00011.jpg

LM Start	0.25	Rating **	M	Issue No.	2
LM End	0.30	Issue Type +	Ma	Location *	LS
Category	Earthen Levee		GPS Latitude/Longitude		
			Start	End	
Item	Vegetation		40.508138 °	40.508138 °	
			-122.363480 °	-122.363480 °	
DWR ID	DWR_NA0018_01_s_2012_2				
Action/Comments					
Remove the wild growth other than native grasses from the levee slopes.

View of the levee with no maintenance done.
