**Flood Control Project Maintenance  
Levee Inspections**  
**LMA District Cover Sheet**  
**Spring 2014 Levee Inspection Results**

**California Department of Fish and Game Shea Levee**

**Levee Inspection Report By Mile - Spring 2014**

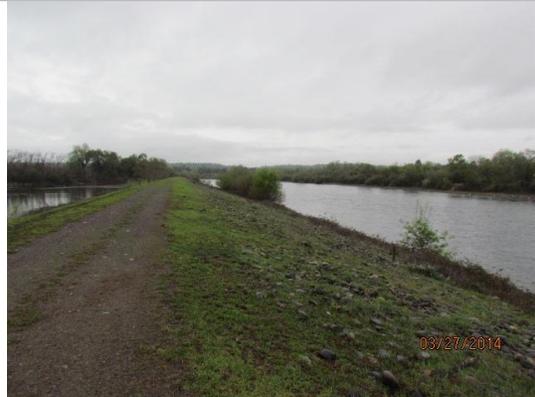
Photo 1 of 1 : rduffey\_s\_20140428\_230.jpg

LM Start	<b>0.00</b>	Rating **	M	Issue No.	<b>11</b>
LM End	<b>0.28</b>	Issue Type +	Ma	Location *	WS
Category	Earthen Levee		GPS Latitude/Longitude		
			Start	End	
Item	Vegetation		40.511276 °	40.507907 °	
			-122.360355 °	-122.363620 °	
DWR ID	DWR_NA0018_01_f_2013_11				
Action/Comments					
Control annual grass and weeds on the levee slopes and easements.

The Dept. of Fish and wildlife services has not done any maintenance.

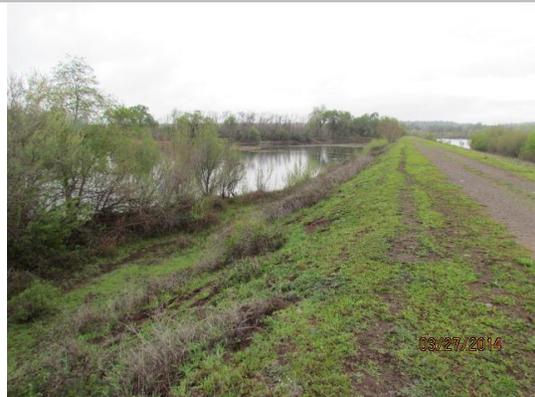
Photo 1 of 1 : rduffey\_s\_20140428\_231.jpg

LM Start	<b>0.02</b>	Rating **	M	Issue No.	<b>1</b>
LM End	<b>0.06</b>	Issue Type +	Ma	Location *	LS
Category	Earthen Levee		GPS Latitude/Longitude		
			Start	End	
Item	Vegetation		40.511185 °	40.510670 °	
			-122.360553 °	-122.361203 °	
DWR ID	DWR_NA0018_01_s_2012_1				
Action/Comments					
Remove the wild growth other than native grasses from the levee slopes.

View of the blackberry and other vegetation along the landside slope.

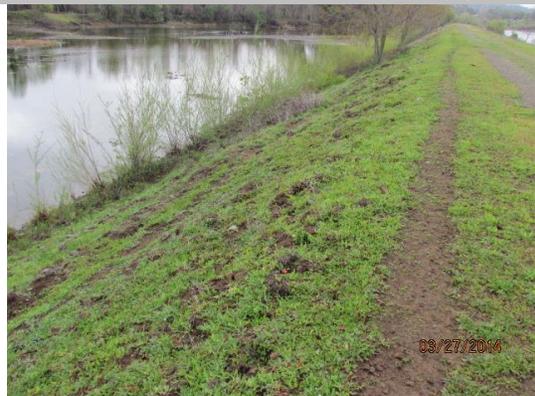
Photo 1 of 1 : rduffey\_s\_20140428\_232.jpg

LM Start	<b>0.02</b>	Rating **	M	Issue No.	<b>6</b>
LM End	<b>0.08</b>	Issue Type +	Ma	Location *	LS
Category	Earthen Levee		GPS Latitude/Longitude		
			Start	End	
Item	Animal Control		40.511185 °	40.510671 °	
			122.360553 °	122.360944 °	
DWR ID	DWR_NA0018_01_s_2013_6				
Action/Comments					
Repair the levee slope damaged by livestock and prevent large animal access. Inspector Comments: The livestock damaged the L/S slope.

View of the livestock erosion along the landside slope.

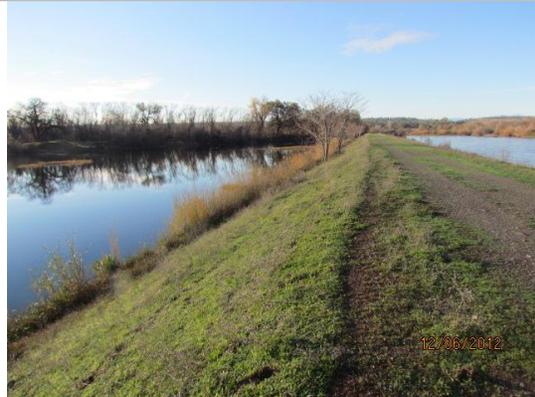
Photo 1 of 2 : rduffey\_s\_20140304\_593.jpg

LM Start	<b>0.06</b>	Rating **	M	Issue No.	<b>9</b>
LM End	<b>0.20</b>	Issue Type +	Ma	Location *	LS
Category	Earthen Levee		GPS Latitude/Longitude		
			Start	End	
Item	Trim / Thin Trees		40.510649 °	40.509012 °	
			-122.360945 °	-122.362609 °	
DWR ID	DWR_NA0018_01_f_2012_9				
Action/Comments					
Thin trees to allow visibility of the ground and room to flood fight.

Remove the small trees along the landside slope.

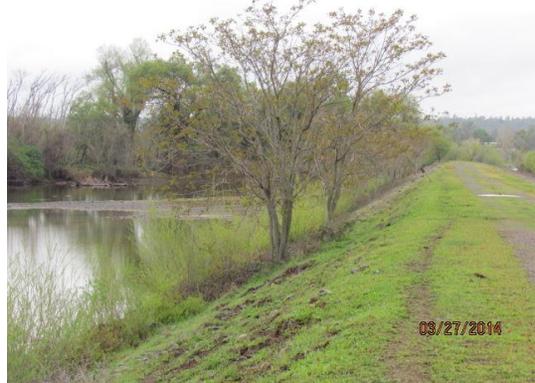
Photo 2 of 2 : rduffey\_s\_20140428\_233.jpg

LM Start	<b>0.06</b>	Rating **	M	Issue No.	<b>9 (cont)</b>
LM End	<b>0.20</b>	Issue Type +	Ma	Location *	LS

Remove the small trees along the landside slope.

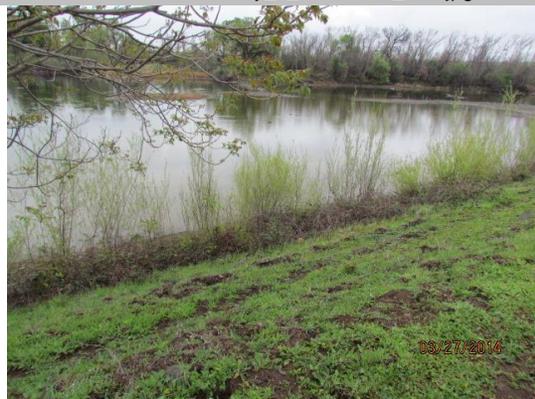
Photo 1 of 1 : rduffey\_s\_20140428\_234.jpg

LM Start	<b>0.08</b>	Rating **	M	Issue No.	<b>5</b>
LM End	<b>0.21</b>	Issue Type +	Ma	Location *	LS
Category	Earthen Levee		GPS Latitude/Longitude		
			Start	End	
Item	Vegetation		40.510671 °	40.509146 °	
			-122.360944 °	-122.362499 °	
DWR ID	DWR_NA0018_01_s_2012_5				
Action/Comments					
Remove the wild growth other than native grasses from the levee

The Dept. of Fish and wildlife service has done no maintenance this

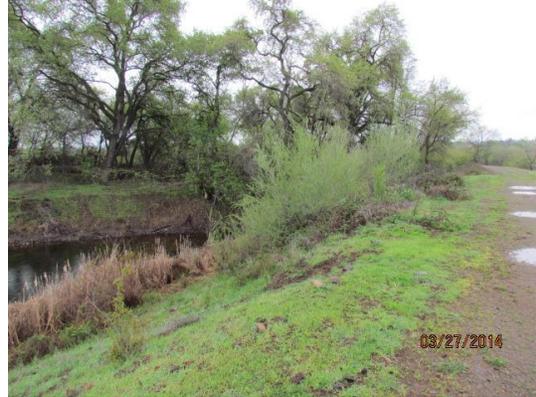
Photo 1 of 1 : rduffey\_s\_20140428\_235.jpg

LM Start	<b>0.25</b>	Rating **	M	Issue No.	<b>2</b>
LM End	<b>0.30</b>	Issue Type +	Ma	Location *	LS
Category	Earthen Levee			GPS Latitude/Longitude	
				Start	End
Item	Vegetation			40.508138 °	40.508138 °
				-122.363480 °	-122.363480 °
DWR ID	DWR_NA0018_01_s_2012_2				
Action/Comments					
Remove the wild growth other than native grasses from the levee slopes.

View of the vegetation along the landside slope.
