**Flood Control Project Maintenance
Levee Inspections**

Maintenance Issue Types Only, Levee Inspection Report By Mile - Fall 2015

California Department of Fish and Game Shea Levee

Waterway	Bank	Unit Miles	Inspection Start/End	Inspector
Unit No. 01 Sacramento River	Left	0.30	09/25/2015 09/25/2015	Bob Duffey

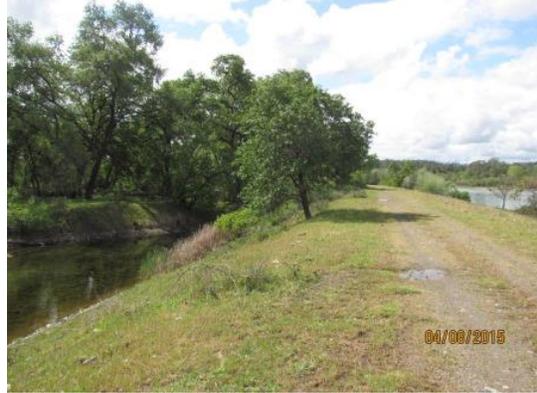
Photo 1 of 2 : FA_2015_NA0018_269_2_20150910_00002.jpg

LM Start	0.00	Rating **	M	Issue No.	2
LM End	0.07	Issue Type +	Ma	Location *	LS
Category	Earthen Levee		GPS Latitude/Longitude		
			Start	End	
Item	Vegetation		40.508138 °	40.508138 °	
			-122.363480 °	-122.363480 °	
DWR ID	DWR_NA0018_01_s_2012_2				
Action/Comments					
Remove the wild growth other than native grasses from the levee slopes. Inspector Comments: California Department of Fish and Wildlife has not completed any maintenance this year.

View of the levee with no maintenance done.

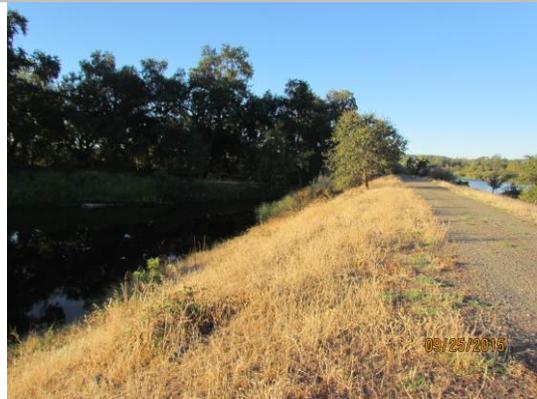
Photo 2 of 2 : FA_2015_NA0018_269_2_20151012_00006.jpg

LM Start	0.00	Rating **	M	Issue No.	2 (cont)
LM End	0.07	Issue Type +	Ma	Location *	LS

View of the levee with no maintenance done.

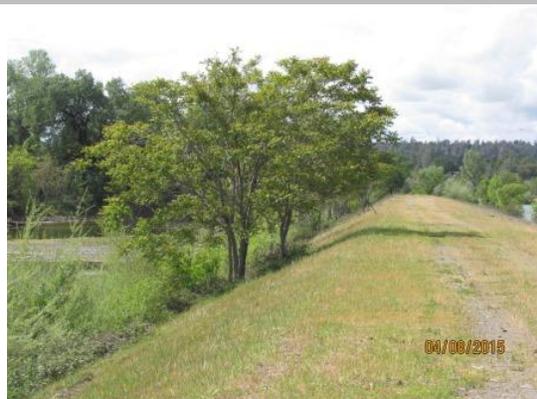
Photo 1 of 2 : FA_2015_NA0018_269_9_20150910_00005.jpg

LM Start	0.00	Rating **	M	Issue No.	9
LM End	0.21	Issue Type +	Ma	Location *	LS
Category	Earthen Levee		GPS Latitude/Longitude		
			Start	End	
Item	Trim / Thin Trees		40.509012 °	40.510649 °	
			-122.362609 °	-122.360945 °	
DWR ID	DWR_NA0018_01_f_2012_9				
Action/Comments					
Thin trees to allow visibility of the ground and room to flood fight. Inspector Comments: Fish and Wildlife Service has not completed any maintenance.

Remove the small trees along the landside slope.

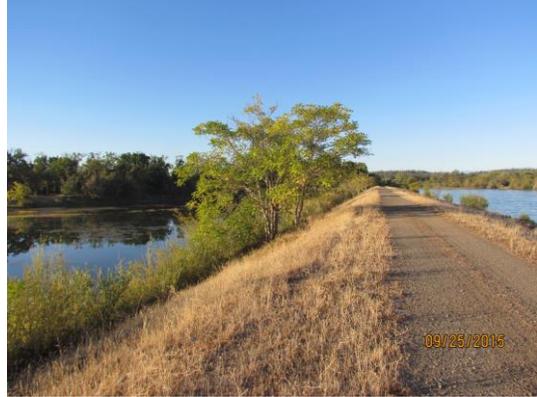
Photo 2 of 2 : FA_2015_NA0018_269_9_20151012_00007.jpg

LM Start	0.00	Rating **	M	Issue No.	9 (cont)
LM End	0.21	Issue Type +	Ma	Location *	LS
Category	Earthen Levee		GPS Latitude/Longitude		
			Start	End	
Item	Trim / Thin Trees		40.509012 °	40.510649 °	
			-122.362609 °	-122.360945 °	
DWR ID	DWR_NA0018_01_f_2012_9				
Action/Comments					
Thin trees to allow visibility of the ground and room to flood fight. Inspector Comments: Fish and Wildlife Service has not completed any maintenance.

Remove the small trees along the landside slope.

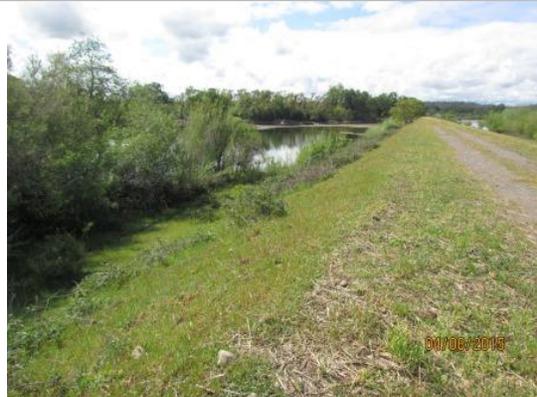
Photo 1 of 2 : FA_2015_NA0018_269_1_20150910_00001.jpg

LM Start	0.10	Rating **	M	Issue No.	1
LM End	0.30	Issue Type +	Ma	Location *	LS
Category	Earthen Levee		GPS Latitude/Longitude		
			Start	End	
Item	Vegetation		40.511185 °	40.510670 °	
			-122.360553 °	-122.361203 °	
DWR ID	DWR_NA0018_01_s_2012_1				
Action/Comments					
Remove the wild growth other than native grasses from the levee slopes. Inspector Comments: Fish and Wildlife Service has not completed any maintenance.

View of the blackberries and other vegetation along the landside slope.

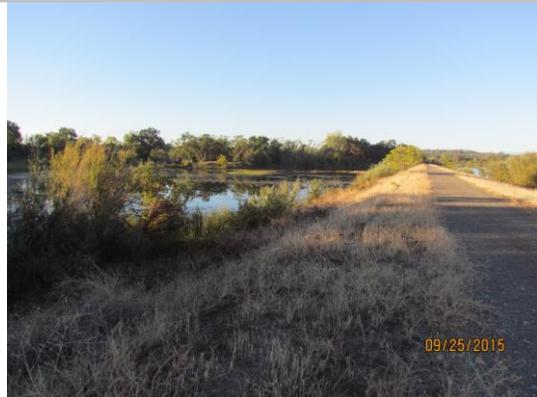
Photo 2 of 2 : FA_2015_NA0018_269_1_20151012_00008.jpg

LM Start	0.10	Rating **	M	Issue No.	1 (cont)
LM End	0.30	Issue Type +	Ma	Location *	LS

View of the blackberries and other vegetation along the landside slope.

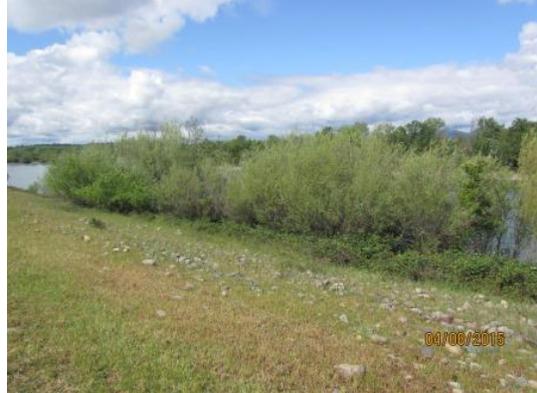
Photo 1 of 2 : FA_2015_NA0018_269_4_20150910_00003.jpg

LM Start	0.21	Rating **	M	Issue No.	4
LM End	0.26	Issue Type +	Ma	Location *	WS
Category	Earthen Levee		GPS Latitude/Longitude		
			Start	End	
Item	Trim / Thin Trees		40.511518 °	40.508234 °	
			-122.360100 °	-122.363430 °	
DWR ID	DWR_NA0018_01_s_2012_4				
Action/Comments					
Trim and thin trees to allow visibility of the ground and room to flood fight. Inspector Comments: Trim the trees along the waterside slope.

Trim the trees along the waterside slope.

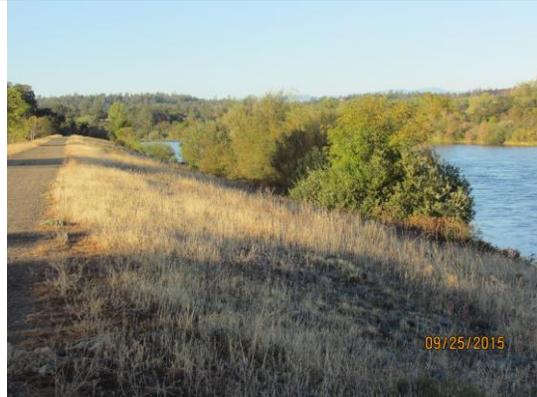
Photo 2 of 2 : FA_2015_NA0018_269_4_20151012_00009.jpg

LM Start	0.21	Rating **	M	Issue No.	4 (cont)
LM End	0.26	Issue Type +	Ma	Location *	WS

Trim the trees along the waterside slope.

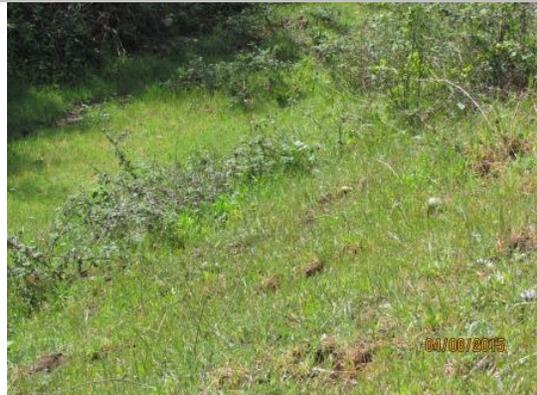
Photo 1 of 2 : FA_2015_NA0018_269_6_20150910_00004.jpg

LM Start	0.22	Rating **	M	Issue No.	6
LM End	0.30	Issue Type +	Ma	Location *	LS
Category	Earthen Levee		GPS Latitude/Longitude		
			Start	End	
Item	Animal Control		40.510671 °	40.511185 °	
			122.360944 °	122.360553 °	
DWR ID	DWR_NA0018_01_s_2013_6				
Action/Comments					
Repair the levee slope damaged by livestock and prevent large animal access. Inspector Comments: The livestock damaged the L/S slope.

View of the livestock erosion along the landside slope.

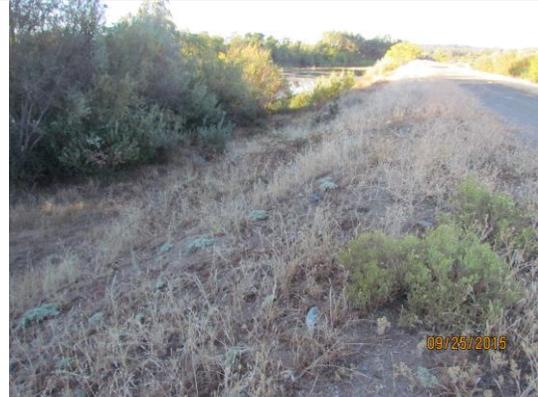
Photo 2 of 2 : FA_2015_NA0018_269_6_20151012_00010.jpg

LM Start	0.22	Rating **	M	Issue No.	6 (cont)
LM End	0.30	Issue Type +	Ma	Location *	LS
Category	Earthen Levee			GPS Latitude/Longitude	
				Start	End
Item	Animal Control			40.510671 °	40.511185 °
				122.360944 °	122.360553 °
DWR ID	DWR_NA0018_01_s_2013_6				
Action/Comments					
Repair the levee slope damaged by livestock and prevent large animal access. Inspector Comments: The livestock damaged the L/S slope.

View of the livestock erosion along the landside slope.
