**Flood Control Project Maintenance
Levee Inspections**

Maintenance Issue Types Only, Levee Inspection Report By Mile - Spring 2015

California Department of Fish and Game Shea Levee

Waterway	Bank	Unit Miles	Inspection Start/End	Inspector
Unit No. 01 Sacramento River	Left	0.30	04/08/2015 04/08/2015	Bob Duffey

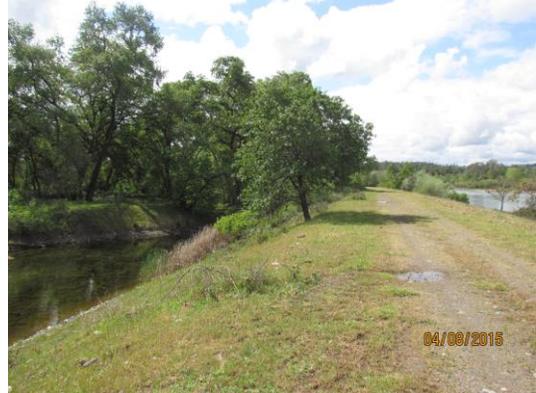
Photo 1 of 1 : SP_2015_NA0018_269_2_20150420_00006.jpg

LM Start	0.00	Rating **	M	Issue No.	2
LM End	0.07	Issue Type +	Ma	Location *	LS
Category	Earthen Levee		GPS Latitude/Longitude		
			Start	End	
Item	Vegetation		40.508138 °	40.508138 °	
			-122.363480 °	-122.363480 °	
DWR ID	DWR_NA0018_01_s_2012_2				
Action/Comments					
Remove the wild growth other than native grasses from the levee slopes.

View of the levee with no maintenance done.

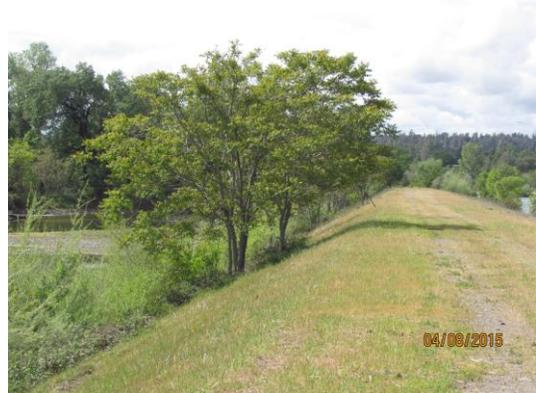
Photo 1 of 1 : SP_2015_NA0018_269_9_20150420_00007.jpg

LM Start	0.00	Rating **	M	Issue No.	9
LM End	0.21	Issue Type +	Ma	Location *	LS
Category	Earthen Levee		GPS Latitude/Longitude		
			Start	End	
Item	Trim / Thin Trees		40.509012 °	40.510649 °	
			-122.362609 °	-122.360945 °	
DWR ID	DWR_NA0018_01_f_2012_9				
Action/Comments					
Thin trees to allow visibility of the ground and room to flood fight. Inspector Comments: Fish and Wildlife Service has not completed any maintenance.

Remove the small trees along the landside slope.

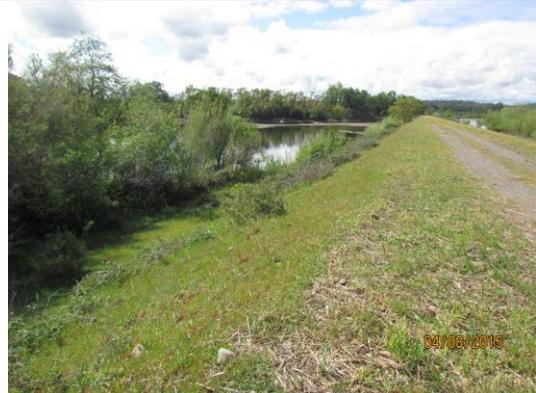
Photo 1 of 1 : SP_2015_NA0018_269_1_20150420_00008.jpg

LM Start	0.10	Rating **	M	Issue No.	1
LM End	0.30	Issue Type +	Ma	Location *	LS
Category	Earthen Levee		GPS Latitude/Longitude		
			Start	End	
Item	Vegetation		40.511185 °	40.510670 °	
			-122.360553 °	-122.361203 °	
DWR ID	DWR_NA0018_01_s_2012_1				
Action/Comments					
Remove the wild growth other than native grasses from the levee slopes. Inspector Comments: Fish and Wildlife Service has not completed any maintenance.

View of the blackberries and other vegetation along the landside slope.
