**Flood Control Project Maintenance  
Levee Inspections  
LMA District Cover Sheet  
Spring 2013 Levee Inspection Results**

**California Department of Fish and Game Shea Levee**

**Spring 2013 Levee Inspection Results**

Waterway	Bank	Unit Miles	Inspection Start/End	Inspector
Unit No. 01 Sacramento River	Left	0.30	03/04/2013 03/04/2013	Bob Duffey

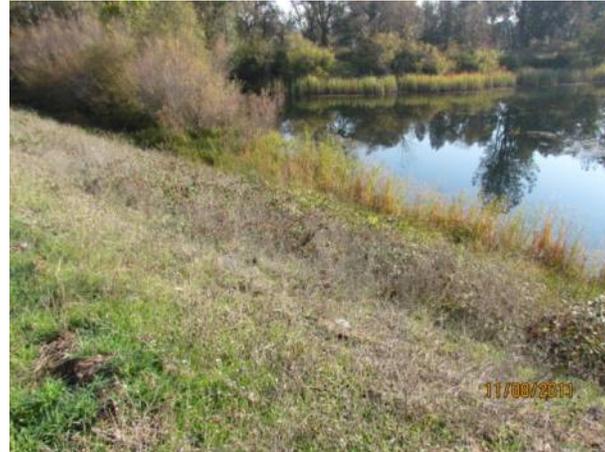
Levee Mile Report Line	4
Start Levee Mile	0.02
End Levee Mile	0.06
Location	Land Side
Category	
Item	Vegetation
View of the berrie vines along the L/S slope.	
rduffey_s_20130225_153.jpg

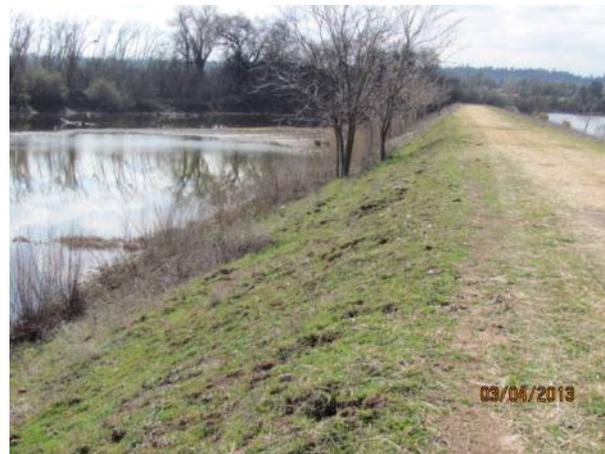
Levee Mile Report Line	5
Start Levee Mile	0.02
End Levee Mile	0.08
Location	Land Side
Category	
Item	Animal Control
View of the livestock erosion along the landside slope.	
rduffey_s_20130312_304.JPG

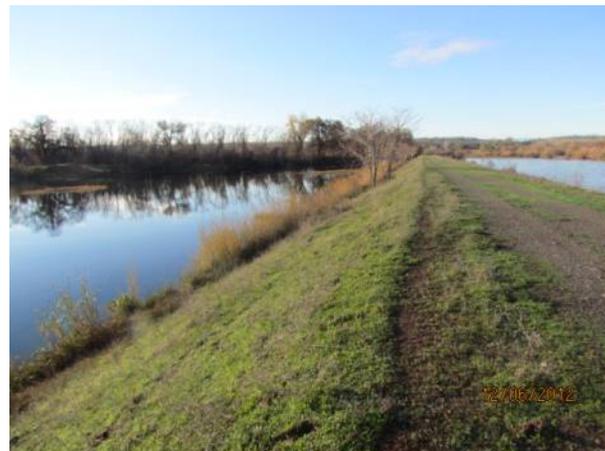
Levee Mile Report Line	6
Start Levee Mile	0.06
End Levee Mile	0.20
Location	Land Side
Category	
Item	Trim / Thin Trees
Remove the small trees along the landside slope.	
rduffey_s_20130225_156.JPG

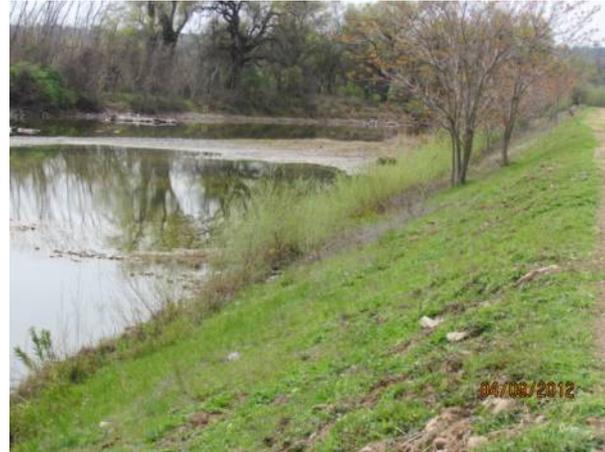
Levee Mile Report Line	7
Start Levee Mile	0.08
End Levee Mile	0.21
Location	Land Side
Category	
Item	Vegetation
View of the vegetation that needs to be removed from the slope of the levee.	
rduffey_s_20130225_155.jpg

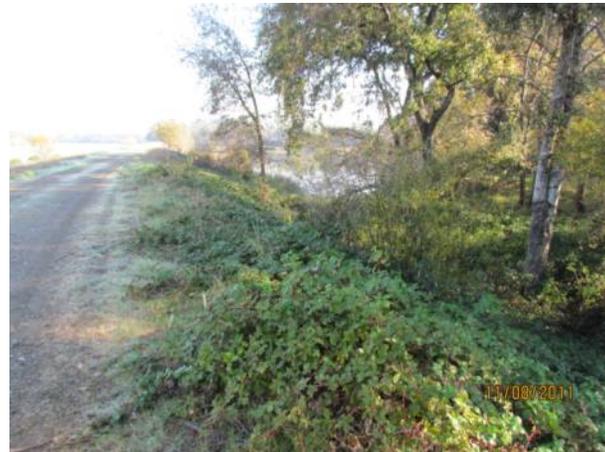
Levee Mile Report Line	8
Start Levee Mile	0.25
End Levee Mile	0.30
Location	Land Side
Category	
Item	Vegetation
View of the vegetation along the L/S slope.	
rduffey_s_20130225_154.jpg
