**Flood Control Project Maintenance
Levee Inspections**

2009 Channel Summary Report

Tehama County Flood Control and Water Conservation District

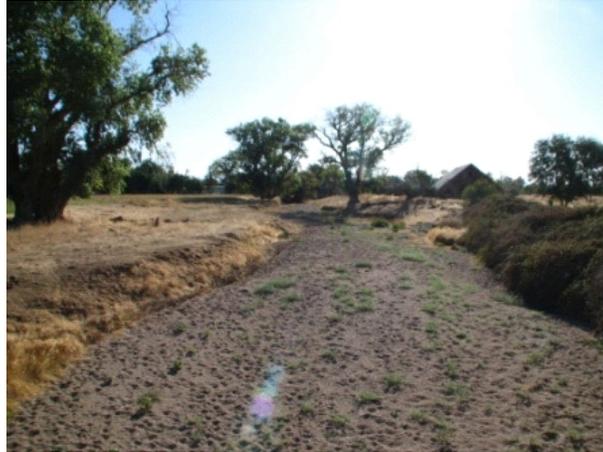
Levee Mile Report Line	5
Start Levee Mile	0.00
End Levee Mile	0.00
Location	
Category	Channels
Item	Encroachments
Downstream from extension of Truckee Avenue.	
rduffey_c_20090819_013.jpg

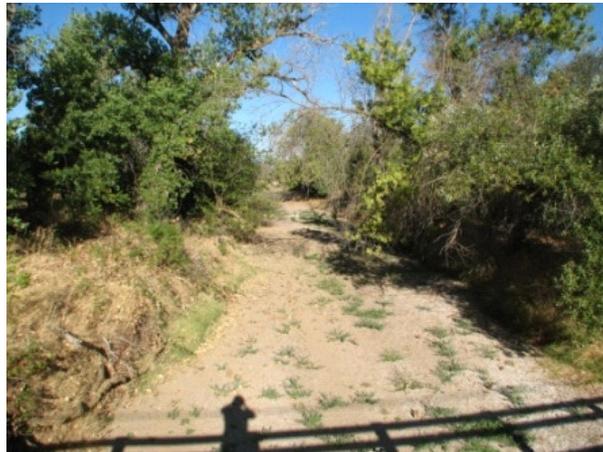
Levee Mile Report Line	8
Start Levee Mile	0.00
End Levee Mile	0.00
Location	
Category	Channels
Item	Erosion / Bank Caving
Upstream from extension of Truckee Avenue.	
rduffey_c_20090819_012.jpg

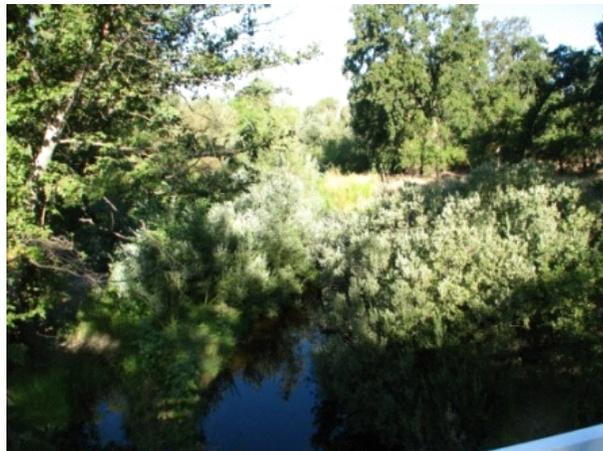
Levee Mile Report Line	11
Start Levee Mile	0.00
End Levee Mile	0.00
Location	
Category	Channels
Item	Vegetation & Obstructions
Upstream from Highway 99 bridge W vegetation in the channel.	
rduffey_c_20090819_014.jpg

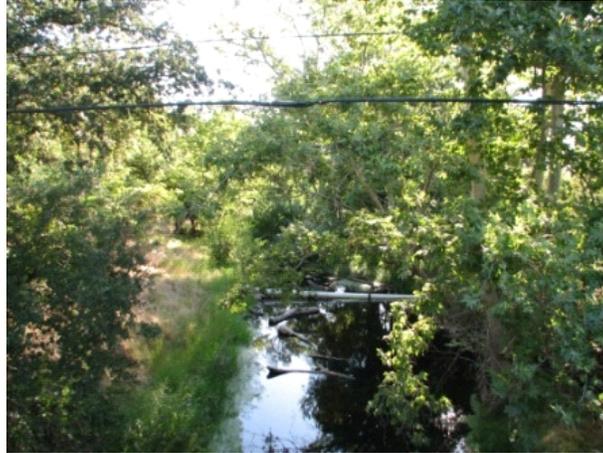
Levee Mile Report Line	12
Start Levee Mile	0.00
End Levee Mile	0.00
Location	
Category	Channels
Item	Shoaling / Sedimentation
Downstream from Highway 99 W bridge dense vegetation in channel.	
rduffey_c_20090819_015.jpg

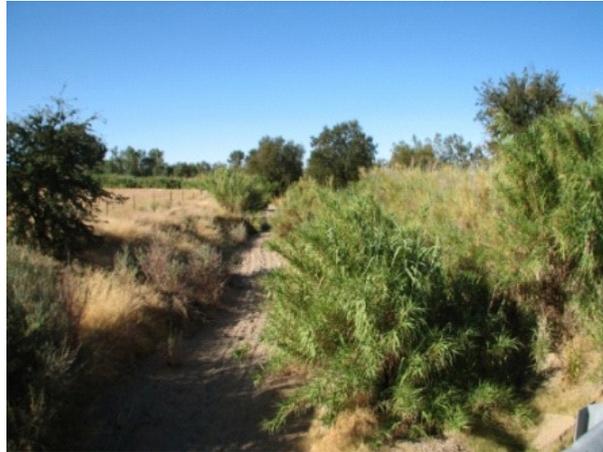
Levee Mile Report Line	21
Start Levee Mile	0.00
End Levee Mile	0.00
Location	
Category	Channels
Item	Vegetation & Obstructions
Upstream from Hamilton Road dense vegetation in the channel.	
rduffey_c_20090819_016.jpg

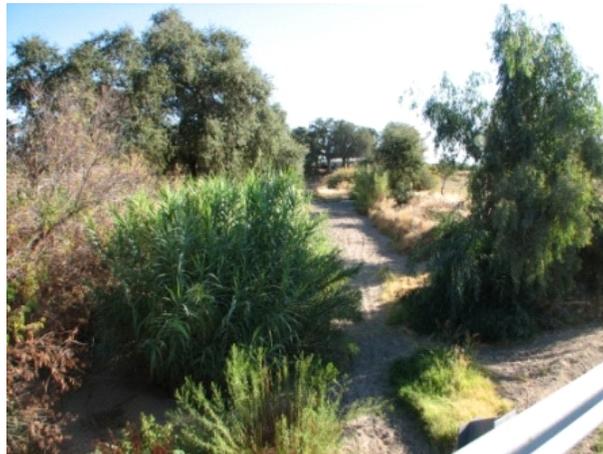
Levee Mile Report Line	28
Start Levee Mile	0.00
End Levee Mile	0.00
Location	
Category	Channels
Item	Erosion / Bank Caving
Downstream from Hamilton road vegetation in channel.	
rduffey_c_20090819_017.jpg

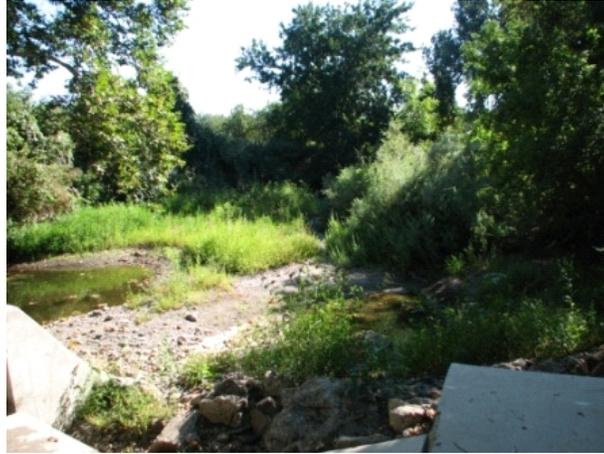
Levee Mile Report Line	8
Start Levee Mile	0.00
End Levee Mile	0.00
Location	
Category	Channels
Item	Erosion / Bank Caving
Downstream of low watercrossing vegetation in channel.	
rduffey_c_20090819_018.jpg

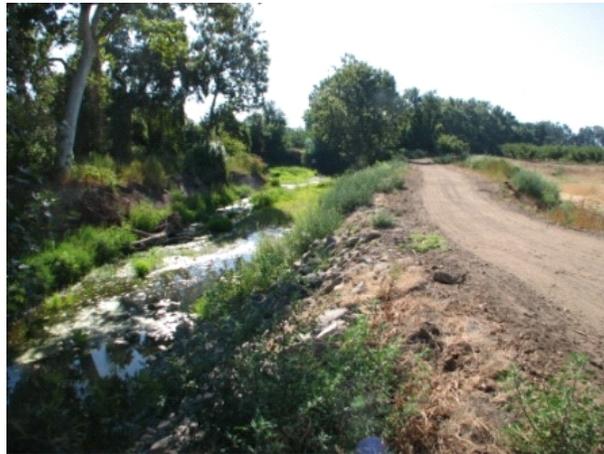
Levee Mile Report Line	19
Start Levee Mile	0.00
End Levee Mile	0.00
Location	
Category	Channels
Item	Revetments
Land owner repaired erosion sites.	
rduffey_c_20090819_019.jpg

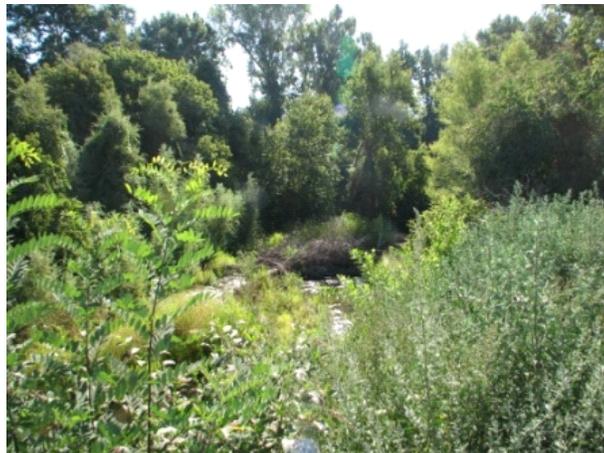
Levee Mile Report Line	26
Start Levee Mile	0.00
End Levee Mile	0.00
Location	
Category	Channels
Item	Vegetation & Obstructions
Logs & dense vegetation in channel.	
rduffey_c_20090819_020.jpg

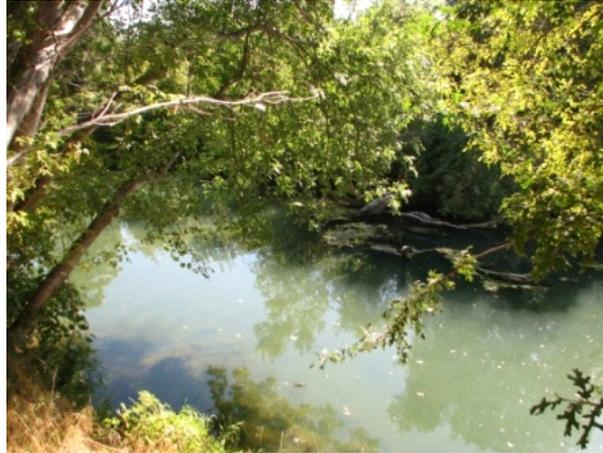
Levee Mile Report Line	31
Start Levee Mile	0.00
End Levee Mile	0.00
Location	
Category	Channels
Item	Vegetation & Obstructions
Downstream approximately 50 feet from the confluence of the Sacramento River.	
rduffey_c_20090819_021.jpg
