**Flood Control Project Maintenance
Levee Inspections**

2010 Channel Summary Report

Tehama County Flood Control and Water Conservation District

2010 Channel Inspection Results

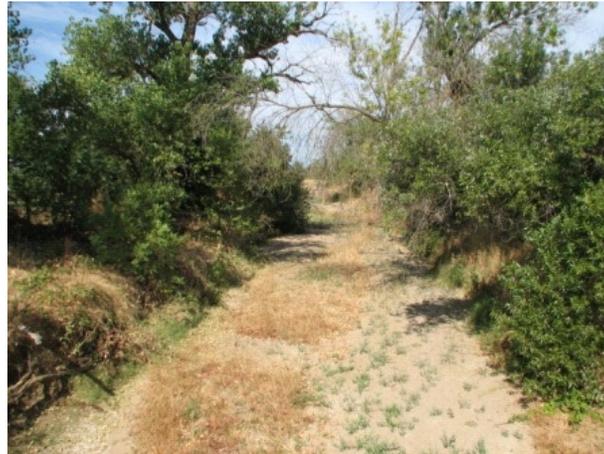
Levee Mile Report Line	3
Start Levee Mile	0.00
End Levee Mile	0.00
Location	
Category	Channels
Item	Erosion / Bank Caving
Upstream from extension of Truckee Avenue.	
rduffey_c_20100928_106.jpg

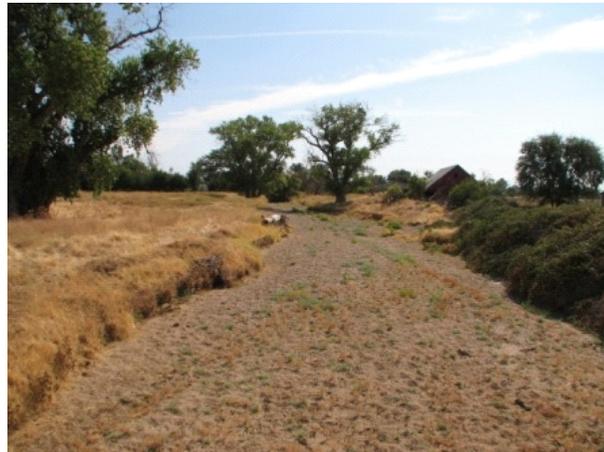
Levee Mile Report Line	10
Start Levee Mile	0.00
End Levee Mile	0.00
Location	
Category	Channels
Item	Encroachments
Downstream from extension of Truckee Avenue.	
rduffey_c_20100928_107.jpg

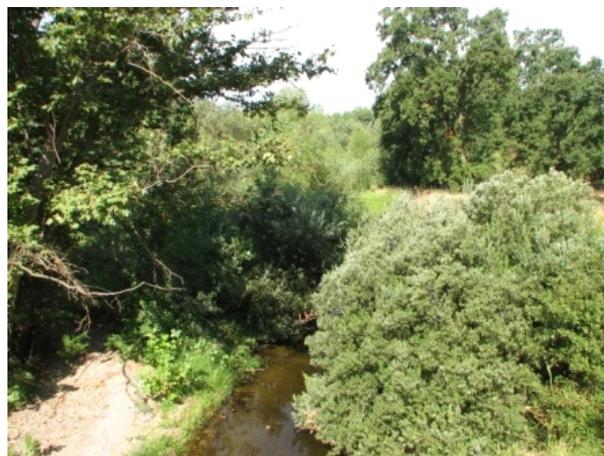
Levee Mile Report Line	11
Start Levee Mile	0.00
End Levee Mile	0.00
Location	
Category	Channels
Item	Vegetation & Obstructions
Upstream from Highway 99 W. Vegetation in the channel.	
rduffey_c_20100914_101.jpg

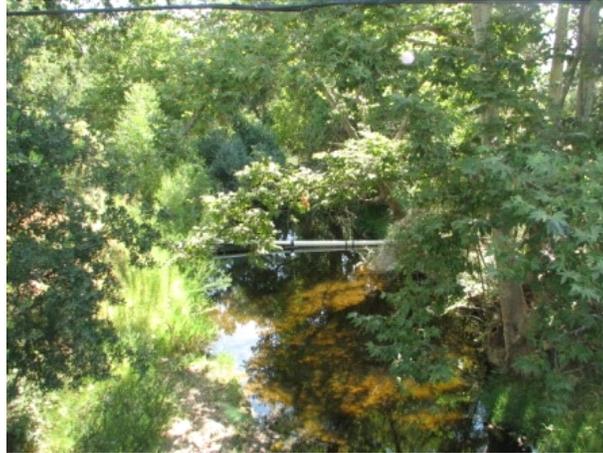
Levee Mile Report Line	16
Start Levee Mile	0.00
End Levee Mile	0.00
Location	
Category	Channels
Item	Vegetation & Obstructions
Downstream from Highway 99 W. Vegetation in the channel.	
rduffey_c_20100914_102.jpg

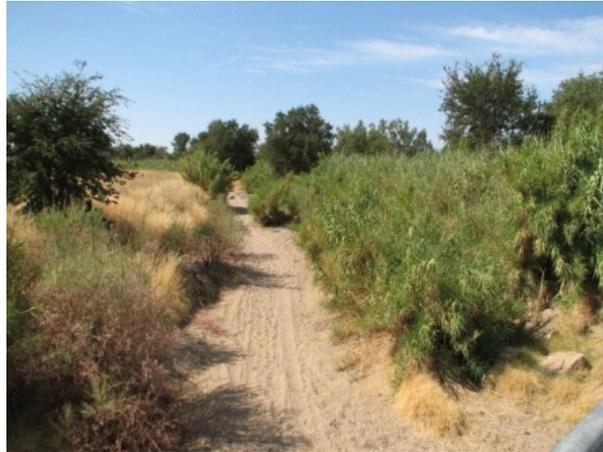
Levee Mile Report Line	21
Start Levee Mile	0.00
End Levee Mile	0.00
Location	
Category	Channels
Item	Vegetation & Obstructions
Upstream from Hamilton RD. Dense vegetation in the channel.	
rduffey_c_20100914_103.jpg

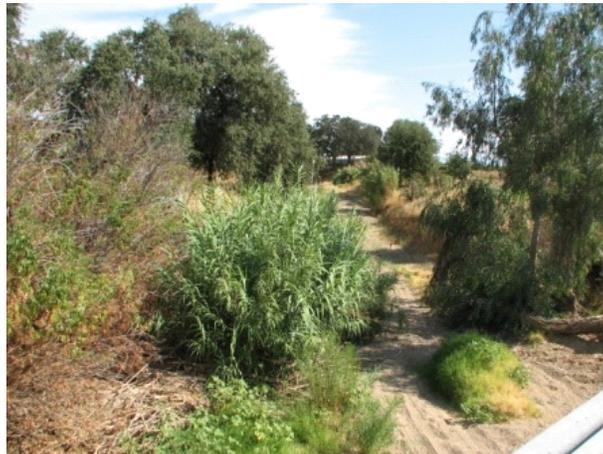
Levee Mile Report Line	26
Start Levee Mile	0.00
End Levee Mile	0.00
Location	
Category	Channels
Item	Vegetation & Obstructions
Downstream from Hamilton Rd. Vegetation in the channel.	
rduffey_c_20100914_104.jpg

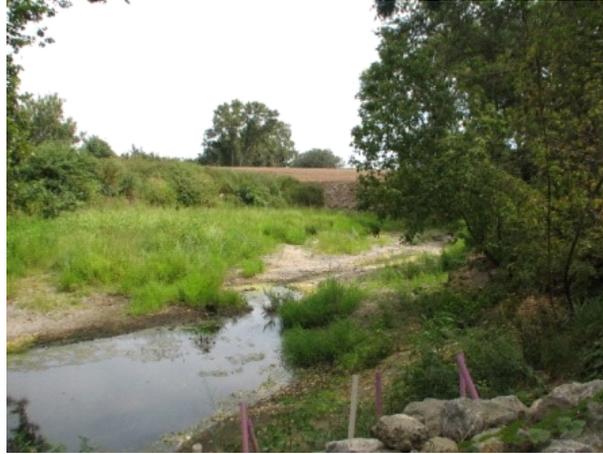
Levee Mile Report Line	1
Start Levee Mile	0.00
End Levee Mile	0.00
Location	
Category	Channels
Item	Vegetation & Obstructions
<p>Low water crossing has been removed and vegetation has been removed.</p>	
<p>rduffey_c_20100831_080.jpg</p>

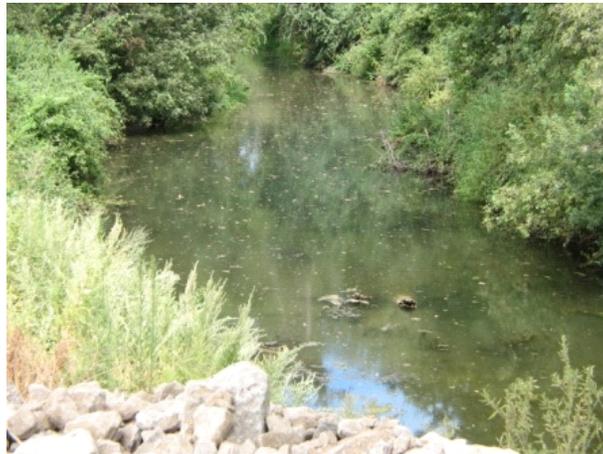
Levee Mile Report Line	6
Start Levee Mile	0.00
End Levee Mile	0.00
Location	
Category	Channels
Item	Vegetation & Obstructions
<p>Channel has been cleared of all logs and vegetation by the landowner.</p>	
<p>rduffey_c_20100831_081.jpg</p>

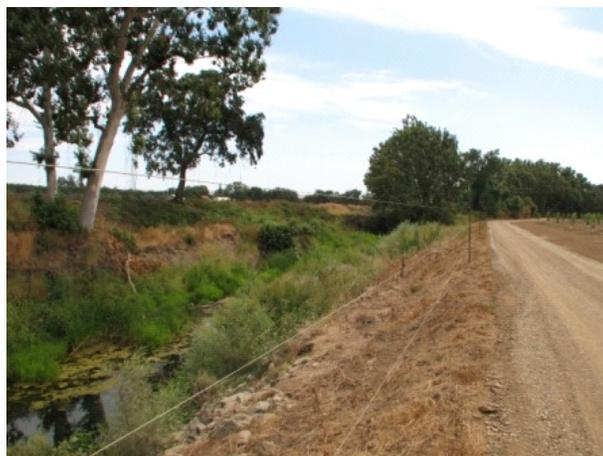
Levee Mile Report Line	9
Start Levee Mile	0.00
End Levee Mile	0.00
Location	
Category	Channels
Item	Revetments
<p>The landowner has placed concrete riprap along all erosion sites.</p>	
<p>rduffey_c_20100831_082.jpg</p>

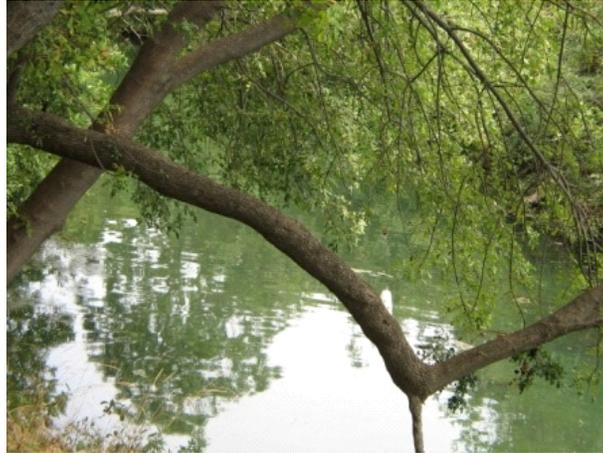
Levee Mile Report Line	16
Start Levee Mile	0.00
End Levee Mile	0.00
Location	
Category	Channels
Item	Vegetation & Obstructions
<p>Logs and vegetation has been removed from the channel at the confluence of the Sacramento River.</p>	
<p>rduffey_c_20100831_083.jpg</p>
