**Flood Control Project Maintenance
Levee Inspections
2012 Channel Summary Report
Overall Unit and Item Ratings**

Tehama County Flood Control and Water Conservation District

Flood Control Project Maintenance**Unit Cover Sheet****2012 Channel Inspection Results****Tehama County Flood Control and Water Conservation District**

Channel
McClure Creek

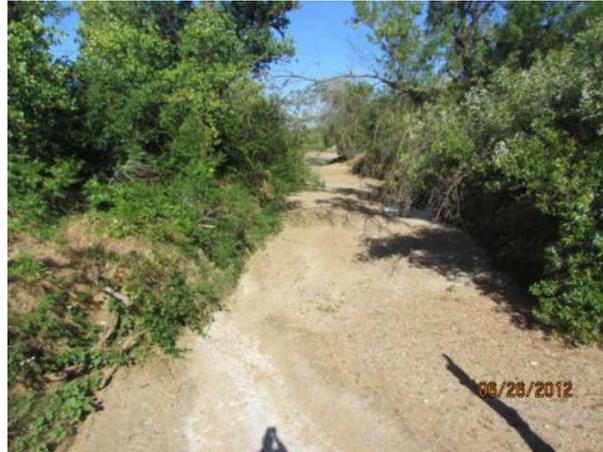
Levee Mile Report Line	4
Start Levee Mile	0.00
End Levee Mile	0.00
Location	
Category	Channels
Item	Encroachments
Upstream from extension of Truckee Avenue.	
rduffey_c_20120710_035.jpg

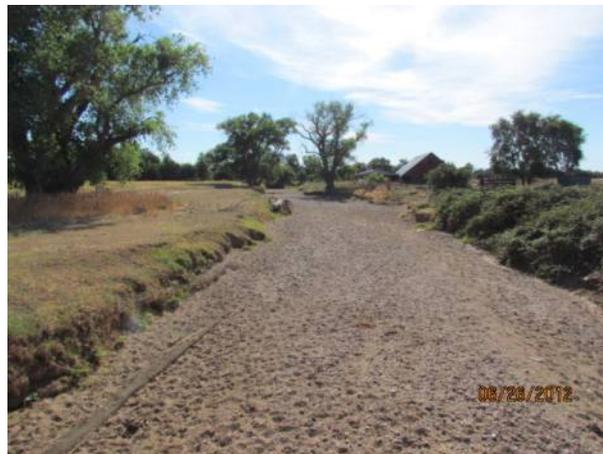
Levee Mile Report Line	10
Start Levee Mile	0.00
End Levee Mile	0.00
Location	
Category	Channels
Item	Encroachments
Downstream from extension of Truckee Avenue.	
rduffey_c_20120710_036.jpg

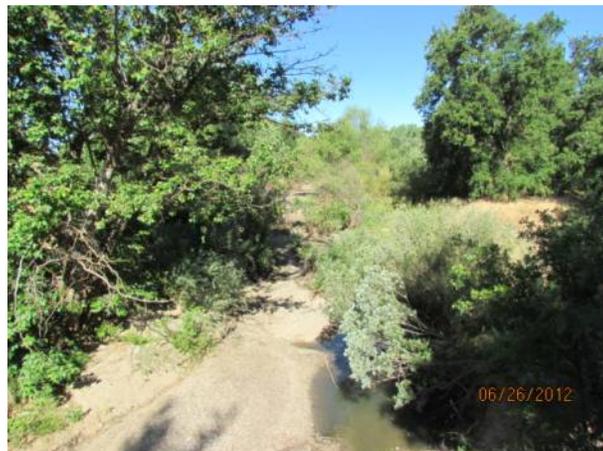
Levee Mile Report Line	11
Start Levee Mile	0.00
End Levee Mile	0.00
Location	
Category	Channels
Item	Vegetation & Obstructions
Upstream from Highway 99 W. Vegetation in the channel.	
rduffey_c_20120710_037.jpg

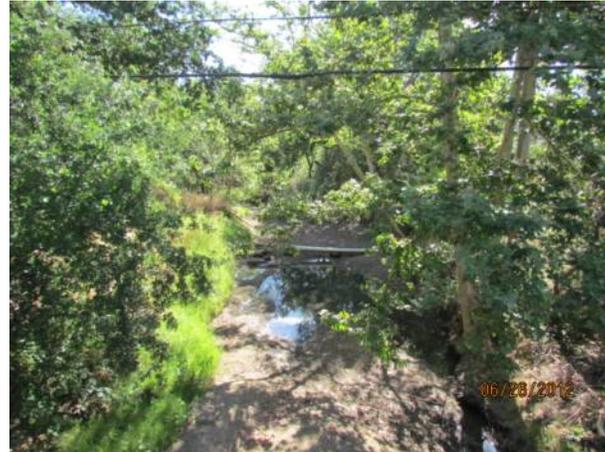
Levee Mile Report Line	16
Start Levee Mile	0.00
End Levee Mile	0.00
Location	
Category	Channels
Item	Vegetation & Obstructions
Downstream from Highway 99 W. Vegetation in the channel.	
rduffey_c_20120710_038.jpg

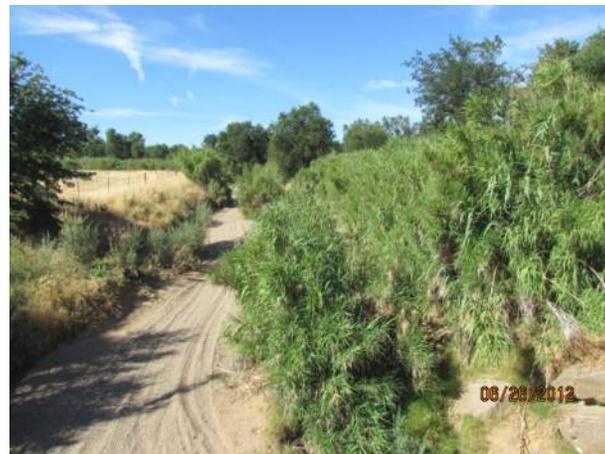
Levee Mile Report Line	21
Start Levee Mile	0.00
End Levee Mile	0.00
Location	
Category	Channels
Item	Vegetation & Obstructions
Upstream from Hamilton RD. Dense vegetation in the channel.	
rduffey_c_20120710_039.jpg

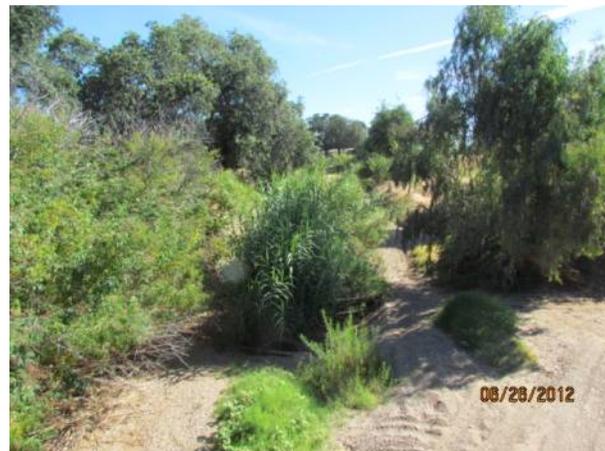
Levee Mile Report Line	26
Start Levee Mile	0.00
End Levee Mile	0.00
Location	
Category	Channels
Item	Vegetation & Obstructions
Downstream from Hamilton Rd. Vegetation in the channel.	
rduffey_c_20120710_040.jpg

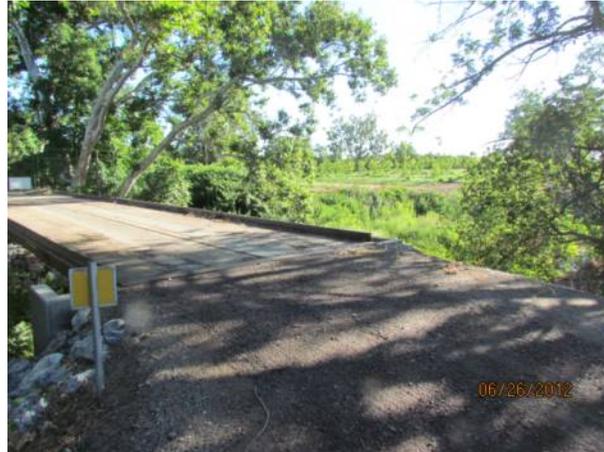
Levee Mile Report Line	1
Start Levee Mile	0.00
End Levee Mile	0.00
Location	
Category	Channels
Item	Vegetation & Obstructions

View of the new railroad car bridge crossing Salt Creek.

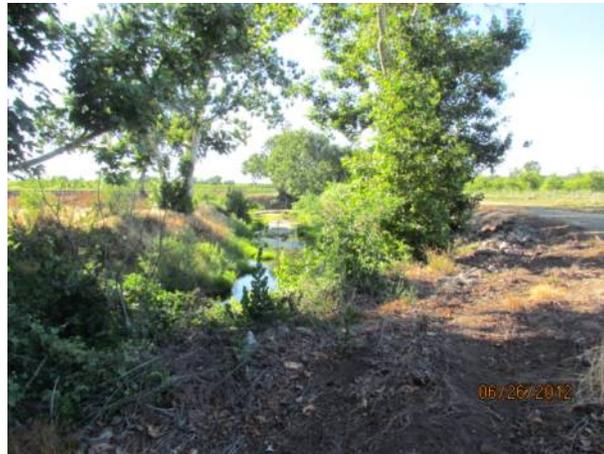
Levee Mile Report Line	14
Start Levee Mile	0.00
End Levee Mile	0.00
Location	
Category	Channels
Item	Revetments

The landowner has place concrete riprap along all erosion sites.

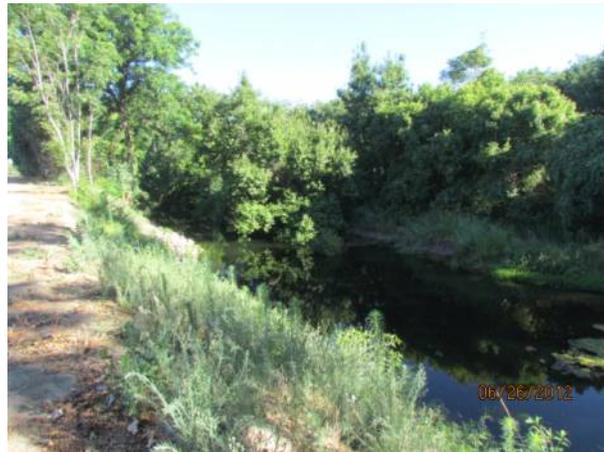
Levee Mile Report Line	21
Start Levee Mile	0.00
End Levee Mile	0.00
Location	
Category	Channels
Item	Vegetation & Obstructions

Channel has been cleared of all logs and vegetation by landowner.

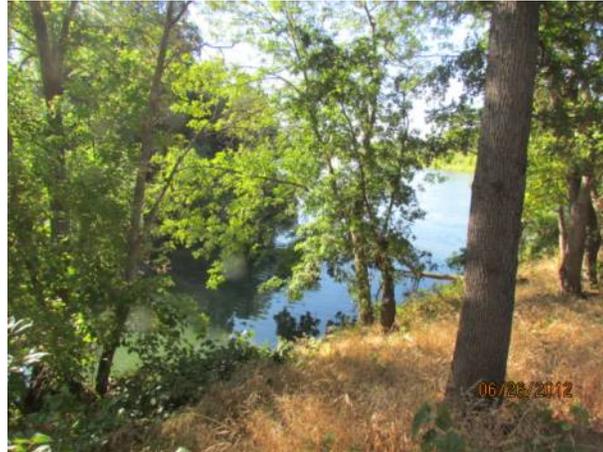
Levee Mile Report Line	31
Start Levee Mile	0.00
End Levee Mile	0.00
Location	
Category	Channels
Item	Vegetation & Obstructions
<p>Logs and vegetation has been removed from the channel at the confluence of the Sac. River.</p>	
<p>rduffey_c_20120710_034.jpg</p>
