**Flood Control Project Maintenance
Levee Inspections
2013 Channel Summary Report
Overall Unit and Item Ratings**

Tehama County Flood Control and Water Conservation District

Flood Control Project Maintenance**Unit Cover Sheet****2013 Channel Inspection Results****Tehama County Flood Control and Water Conservation District**

**Flood Control Project Maintenance
Channel Inspections**

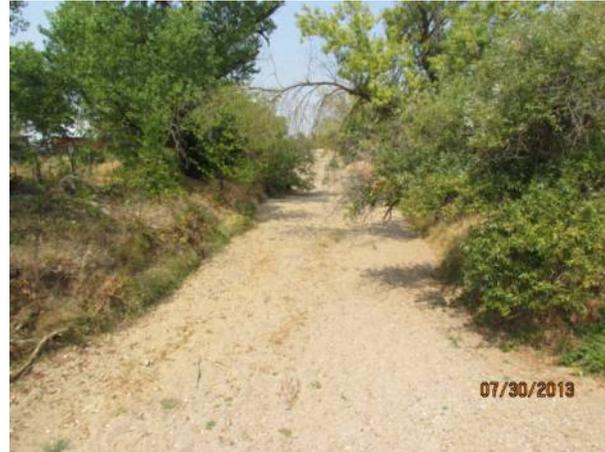
Levee Mile Report Line	5
Start Levee Mile	0.00
End Levee Mile	0.00
Location	
Category	Channels
Item	Encroachments
Upstream from extension of Truckee Avenue.	
rduffey_c_20130819_036.JPG

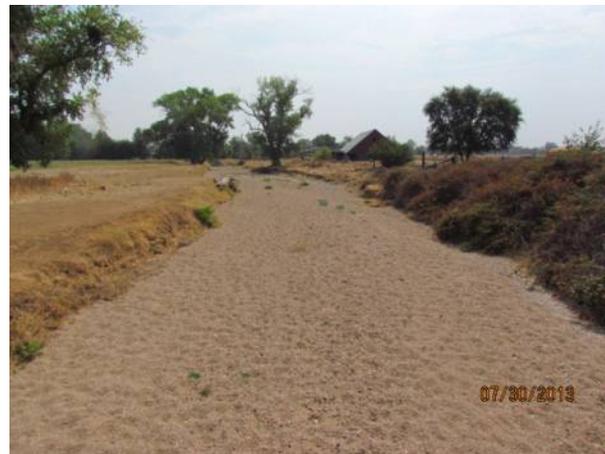
Levee Mile Report Line	10
Start Levee Mile	0.00
End Levee Mile	0.00
Location	
Category	Channels
Item	Encroachments
Downstream from extension of Truckee Avenue.	
rduffey_c_20130819_037.JPG

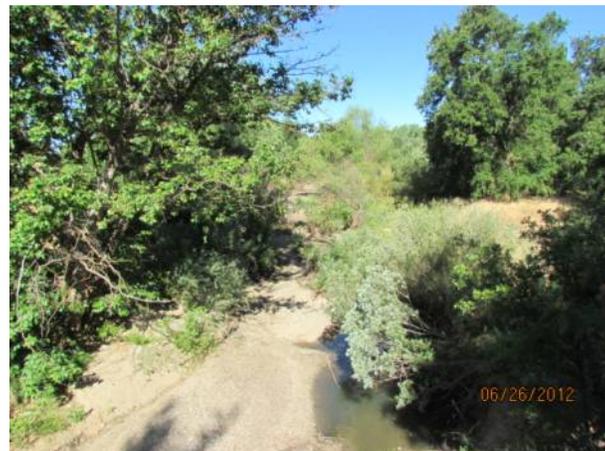
Levee Mile Report Line	11
Start Levee Mile	0.00
End Levee Mile	0.00
Location	
Category	Channels
Item	Vegetation & Obstructions
Upstream from Highway 99 W. Vegetation in the channel.	
rduffey_c_20130619_003.jpg

10		Down	Encroachments		A	Inspector Comments: No encroachments in the channel	40.009840 ° -122.200180 °	Y	10
11	Highway 99 W	Up	Vegetation & Obstructions		M	Inspector Comments: Remove all vegetation from channel before winter.	40.007430 ° -122.171780 °	Y	11
12		Up	Shoaling / Sedimentation		A		40.007430 ° -122.171780 °		12
13		Up	Erosion / Bank Caving		A		40.007430 ° -122.171780 °		13
14		Up	Revetments		N	Inspector Comments: No riprap along the bank of the channel.	40.007430 ° -122.171780 °		14
15		Up	Encroachments		A		40.007430 ° -122.171780 °		15
16		Down	Vegetation & Obstructions		M	Inspector Comments: Remove all vegetation from channel before winter.	40.007430 ° -122.171780 °	Y	16

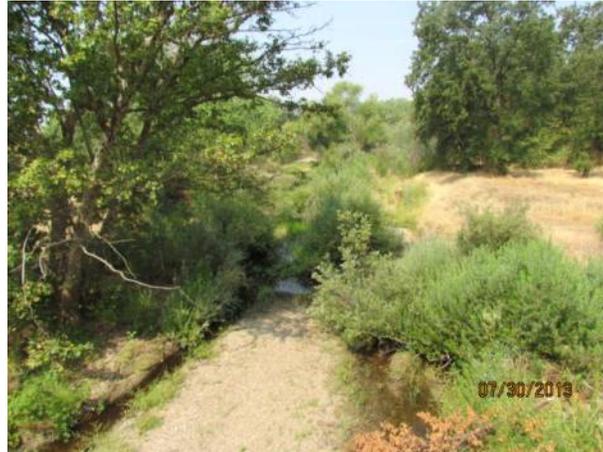
Levee Mile Report Line	11
Start Levee Mile	0.00
End Levee Mile	0.00
Location	
Category	Channels
Item	Vegetation & Obstructions
Upstream from Highway 99 W. Vegetation in the channel.	
rduffey_c_20130819_038.JPG

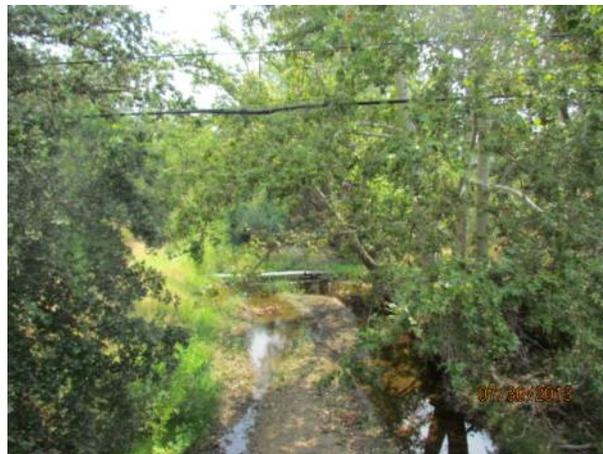
Levee Mile Report Line	16
Start Levee Mile	0.00
End Levee Mile	0.00
Location	
Category	Channels
Item	Vegetation & Obstructions
Downstream from Highway 99 W. Vegetation in the channel.	
rduffey_c_20130819_039.JPG

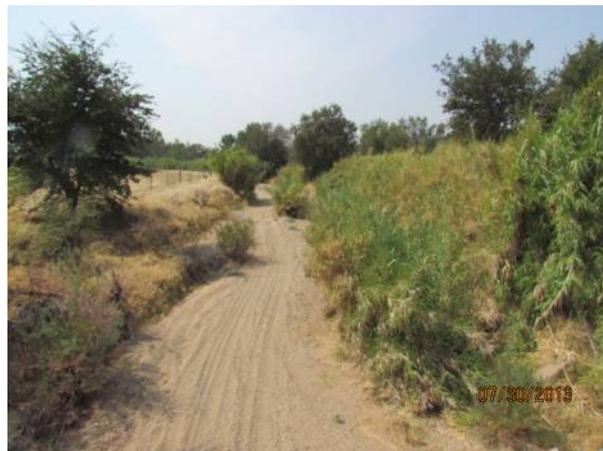
Levee Mile Report Line	21
Start Levee Mile	0.00
End Levee Mile	0.00
Location	
Category	Channels
Item	Vegetation & Obstructions
Upstream from Hamilton RD. Dense vegetation in the channel.	
rduffey_c_20130819_041.JPG

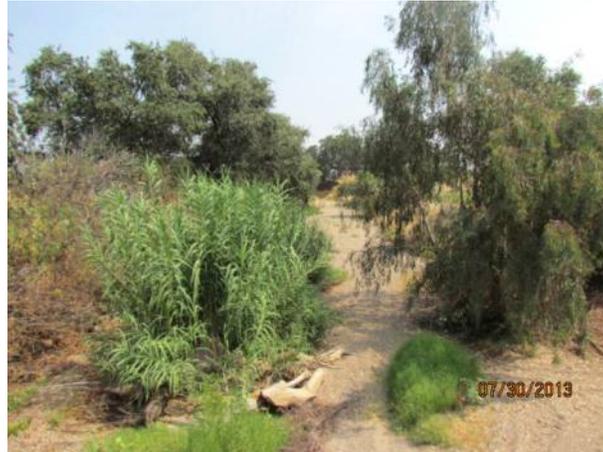
Levee Mile Report Line	26
Start Levee Mile	0.00
End Levee Mile	0.00
Location	
Category	Channels
Item	Vegetation & Obstructions
Downstream from Hamilton Rd. Vegetation in the channel.	
rduffey_c_20130819_040.JPG

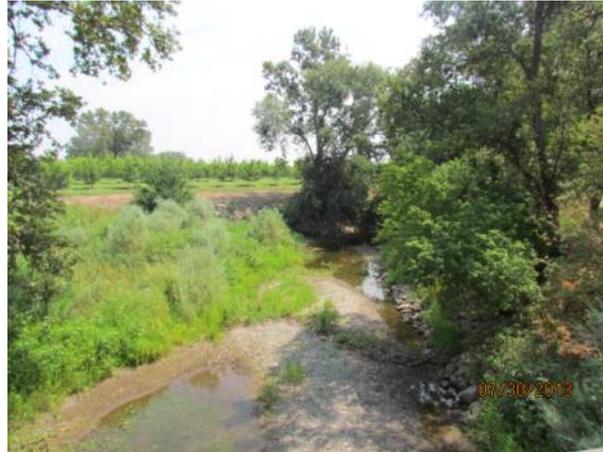
Levee Mile Report Line	1
Start Levee Mile	0.00
End Levee Mile	0.00
Location	
Category	Channels
Item	Vegetation & Obstructions

View of Salt Creek from the new railroad car bridge.

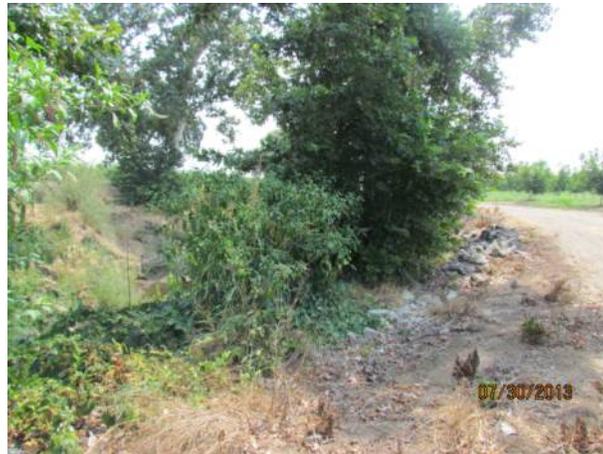
Levee Mile Report Line	14
Start Levee Mile	0.00
End Levee Mile	0.00
Location	
Category	Channels
Item	Revetments

The landowner has place concrete riprap along all erosion sites.

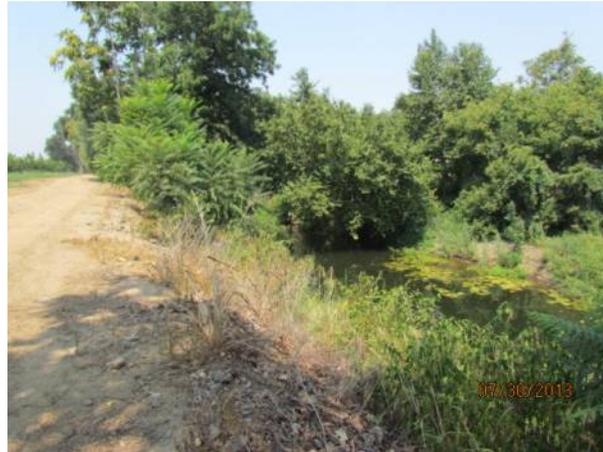
Levee Mile Report Line	21
Start Levee Mile	0.00
End Levee Mile	0.00
Location	
Category	Channels
Item	Vegetation & Obstructions

Channel has been cleared of all logs and vegetation by landowner.

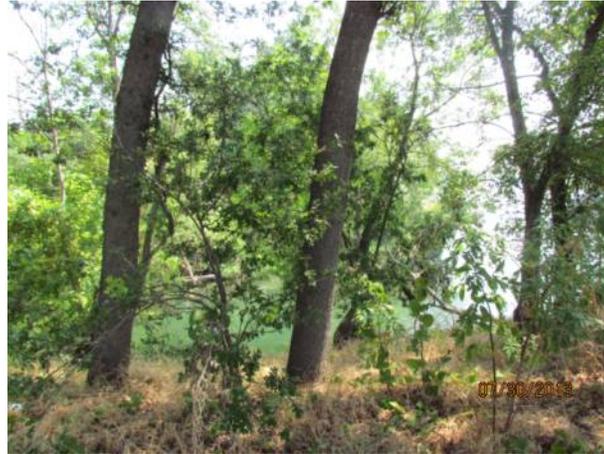
Levee Mile Report Line	31
Start Levee Mile	0.00
End Levee Mile	0.00
Location	
Category	Channels
Item	Vegetation & Obstructions
Logs and vegetation has been removed from the channel at the confluence of the Sac. River.	
rduffey_c_20130819_035.JPG
