**Flood Control Project Maintenance
Levee Inspections**
2014 Channel Summary Report
Overall Unit and Item Ratings

Tehama County Flood Control and Water Conservation District

Flood Control Project Maintenance**Unit Cover Sheet****2014 Channel Inspection Results****Tehama County Flood Control and Water Conservation District**

Levee Inspection Report By Mile - Channel 2014

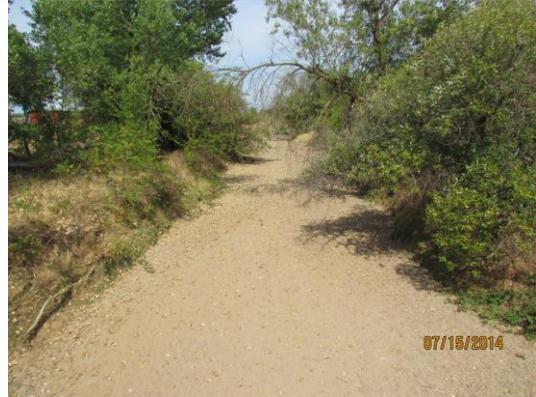
Photo 1 of 1 : CH_2014_NA0019_3_3_20140829_00008.jpg

Rating **	A	Issue No. 3	GPS Lat/Long
Issue Type +	Ma	Location *	40.009840 °
Category	Rivers, Channels & Designated Flood		-122.200180 °
Item	Encroachments		
DWR ID	DWR_NA0019_3_c_2012_3		
Action/Comments			
Inspector Comments: No erosion in the channel.

Upstream from extension of Truckee Avenue.

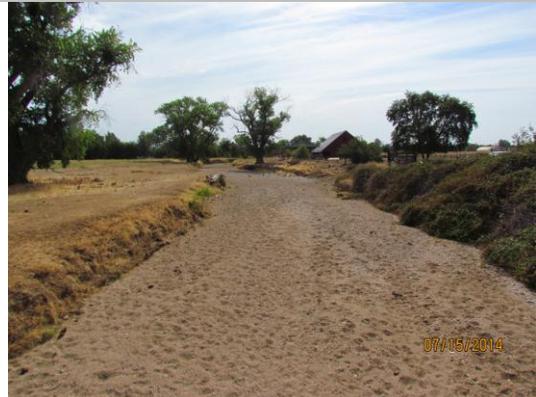
Photo 1 of 1 : CH_2014_NA0019_3_10_20140829_00009.jpg

Check Point / View			
Truckee Avenue / Down (cont)			
Rating **	A	Issue No.	10
Issue Type +	Ma	Location *	GPS Lat/Long
Category	Rivers, Channels & Designated Flood		40.009840 °
Item	Encroachments		-122.200180 °
DWR ID	DWR_NA0019_3_c_2012_10		
Action/Comments			
Inspector Comments: No encroachments in the channel

Downstream of the extension of Truckee Avenue.

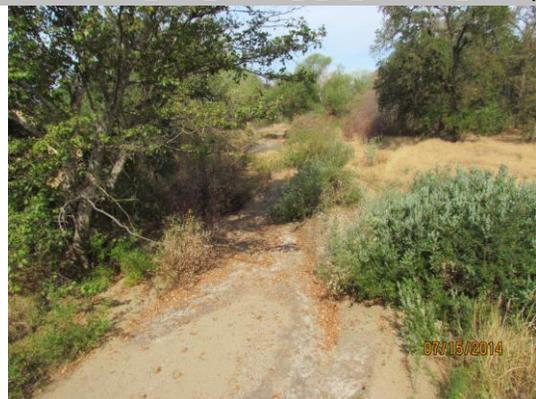
Photo 1 of 1 : CH_2014_NA0019_3_11_20140829_00010.jpg

Upstream from Highway 99 W. vegetation in the channel.

Check Point / View			
Highway 99 W / Up			
Rating **	M	Issue No.	11
Issue Type +	Ma	Location *	GPS Lat/Long
Category	Rivers, Channels & Designated Flood		40.007430 °
Item	Vegetation & Obstructions		-122.171780 °
DWR ID	DWR_NA0019_3_c_2012_11		
Action/Comments			
Inspector Comments: Remove all vegetation from channel before winter.

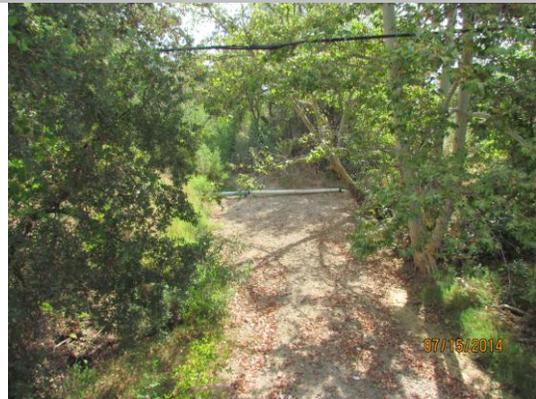
Photo 1 of 1 : CH_2014_NA0019_3_16_20140829_00011.jpg

Downstream from Highway 99 W. Vegetation in the channel.

Check Point / View			
Highway 99 W / Down			
Rating **	M	Issue No. 16	GPS Lat/Long
Issue Type +	Ma	Location *	40.007430 °
Category	Rivers, Channels & Designated Flood		-122.171780 °
Item	Vegetation & Obstructions		
DWR ID	DWR_NA0019_3_c_2012_16		
Action/Comments			
Inspector Comments: Remove all vegetation from channel before winter.

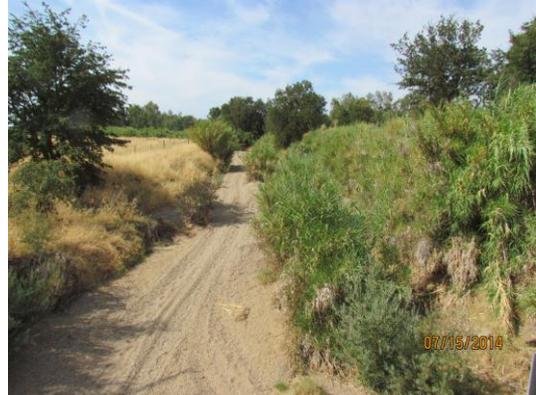
Photo 1 of 1 : CH_2014_NA0019_3_41_20140829_00012.jpg

Upstream From Hamilton Rd. Dense vegetation in the channel.

Check Point / View				
Hamilton Road / Up				
Rating **	M	Issue No.	41	GPS Lat/Long
Issue Type +	Ma	Location *		40.017400 °
Category	Rivers, Channels & Designated Flood			-122.146540 °
Item	Vegetation & Obstructions			
DWR ID	DWR_NA0019_3_c_2012_41			
Action/Comments				
Inspector Comments: Remove all vegetation from the channel before winter.

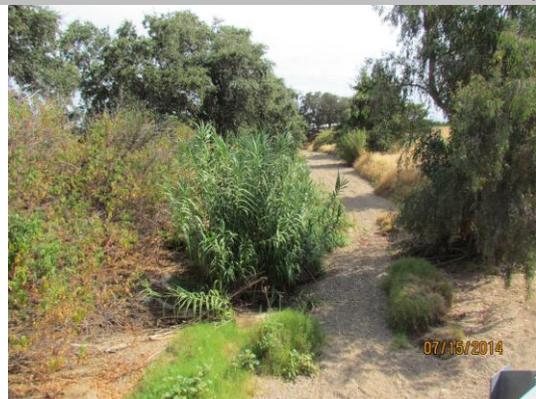
Photo 1 of 1 : CH_2014_NA0019_3_46_20140829_00013.jpg

Downstream from Hamilton RD. Vegetation in the channel.

Check Point / View			
Hamilton Road / Down			
Rating **	M	Issue No. 46	GPS Lat/Long
Issue Type +	Ma	Location *	40.017400 °
Category	Rivers, Channels & Designated Flood		-122.146540 °
Item	Vegetation & Obstructions		
DWR ID	DWR_NA0019_3_c_2012_46		
Action/Comments			
Inspector Comments: Remove all vegetation from the channel before winter.

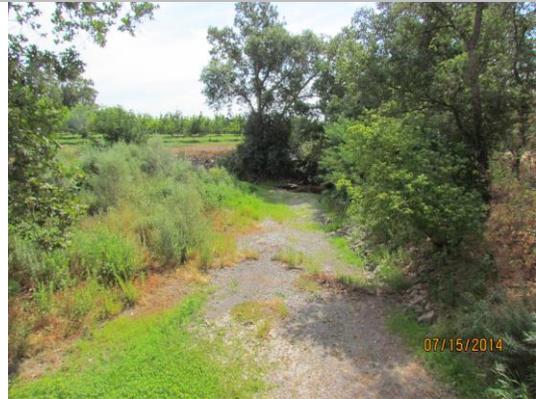
Photo 1 of 1 : CH_2014_NA0019_4_1_20140829_00005.jpg

Check Point / View				
Upstream Limit / Up				
Rating **	A	Issue No.	1	GPS Lat/Long
Issue Type +	Ma	Location *		40.157120 °
Category	Rivers, Channels & Designated Flood			-122.164250 °
Item	Vegetation & Obstructions			
DWR ID	DWR_NA0019_4_c_2012_1			
Action/Comments				
Inspector Comments: Minimal, scattered obstructions or vegetation. The flow is not impeded.

View of Salt Creek from the new railroad car bridge.

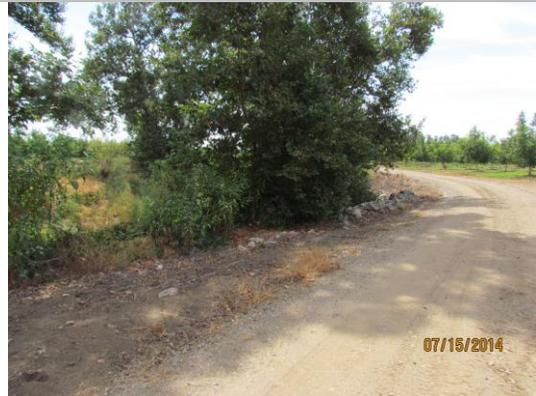
Photo 1 of 1 : CH_2014_NA0019_4_14_20140829_00006.jpg

Rating **	A	Issue No.	14	GPS Lat/Long
Issue Type +	Ma	Location *		40.156770 °
Category	Rivers, Channels & Designated Flood			-122.163670 °
Item	Revetments			
DWR ID	DWR_NA0019_4_c_2012_14			
Action/Comments				
Inspector Comments: Existing riprap protection is properly maintained and is undamaged. Riprap clearly visible.

The landowner has placed rip rap along all erosion sites.

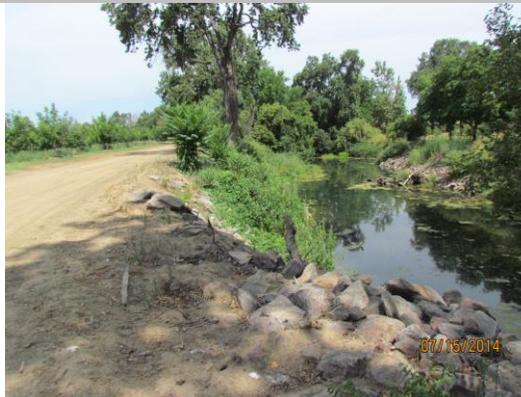
Photo 1 of 1 : CH_2014_NA0019_4_21_20140829_00007.jpg

Check Point / View			
2,800' upstream of downstream limit / Up			
Rating **	A	Issue No.	21
Issue Type +	Ma	Location *	GPS Lat/Long
Category	Rivers, Channels & Designated Flood		40.151480 °
Item	Vegetation & Obstructions		-122.157590 °
DWR ID	DWR_NA0019_4_c_2012_21		
Action/Comments			
Inspector Comments: The property owner has removed the debris from the channel.

Channel has been cleared of logs and vegetation by landowner.

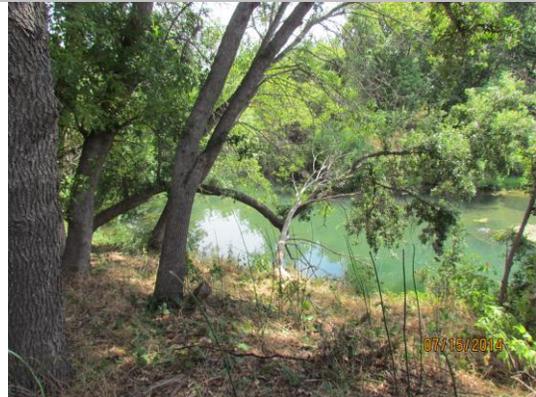
Photo 1 of 1 : CH_2014_NA0019_4_31_20140829_00008.jpg

Check Point / View			
100' upstream of confluence with Sac. R. / Up			
Rating **	A	Issue No.	31
Issue Type +	Ma	Location *	GPS Lat/Long
Category	Rivers, Channels & Designated Flood		40.147230 °
Item	Vegetation & Obstructions		122.154420 °
DWR ID	DWR_NA0019_4_c_2012_31		
Action/Comments			
Inspector Comments: Logs and vegetation have been removed from the channel.

Logs and vegetation has been removed from the channel at the confluence of the Sacramento River.
