**Flood Control Project Maintenance
Levee Inspections**
2015 Channel Summary Report
Overall Unit and Item Ratings

Tehama County Flood Control and Water Conservation District

Flood Control Project Maintenance**Unit Cover Sheet****2015 Channel Inspection Results****Tehama County Flood Control and Water Conservation District**

Levee Inspection Report By Mile - Channel 2015

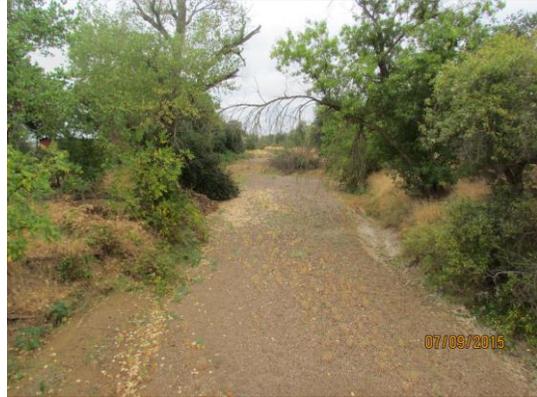
Photo 1 of 1 : CH_2015_NA0019_3_3_20150729_00007.jpg

Rating **	A	Issue No.	3	GPS Lat/Long
Issue Type +	Ma	Location *		40.009840 °
Category	Rivers, Channels & Designated Flood			-122.200180 °
Item	Encroachments			
DWR ID	DWR_NA0019_3_c_2012_3			
Action/Comments				
Inspector Comments: No erosion in the channel.

Upstream extension of Truckee Avenue.

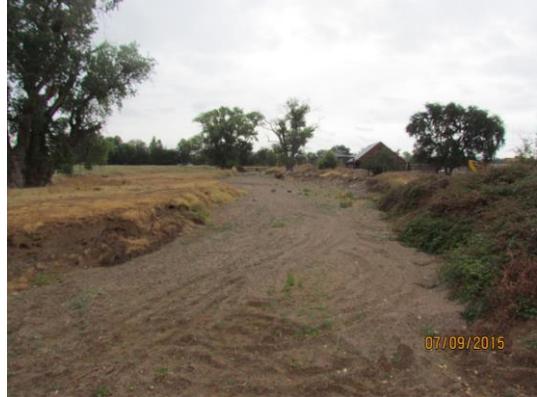
Photo 1 of 1 : CH_2015_NA0019_3_10_20150729_00008.jpg

Check Point / View			
Truckee Avenue / Down (cont)			
Rating **	A	Issue No.	10
Issue Type +	Ma	Location *	GPS Lat/Long
Category	Rivers, Channels & Designated Flood		40.009840 °
Item	Encroachments		-122.200180 °
DWR ID	DWR_NA0019_3_c_2012_10		
Action/Comments			
Inspector Comments: No encroachments in the channel

Downstream extension of Truckee Avenue.

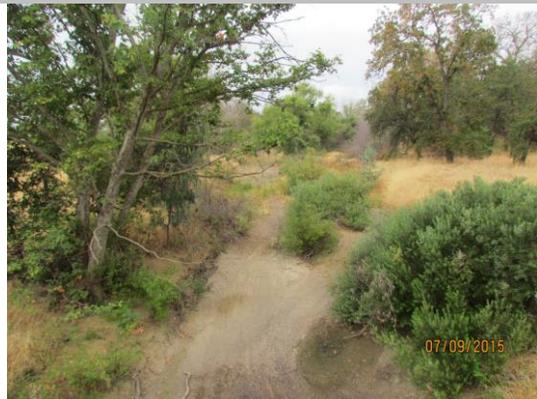
Photo 1 of 1 : CH_2015_NA0019_3_11_20150729_00009.jpg

Upstream from Highway 99 W. vegetation in the channel.

Check Point / View			
Highway 99 W / Up			
Rating **	M	Issue No.	11
Issue Type +	Ma	Location *	GPS Lat/Long
Category	Rivers, Channels & Designated Flood		40.007430 °
Item	Vegetation & Obstructions		-122.171780 °
DWR ID	DWR_NA0019_3_c_2012_11		
Action/Comments			
Inspector Comments: Remove all vegetation from channel before winter.

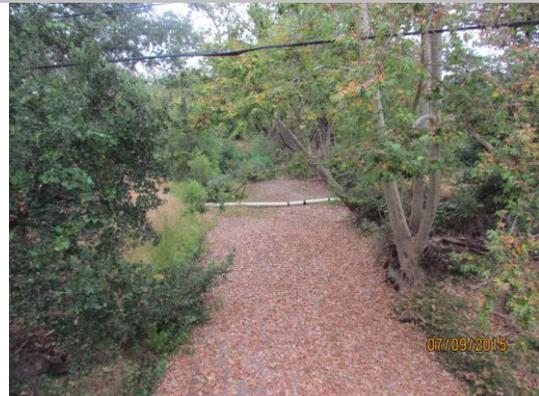
Photo 1 of 1 : CH_2015_NA0019_3_16_20150729_00010.jpg

Downstream view from Highway 99 W. There is an irrigation pipe going across the channel.

Check Point / View				
Highway 99 W / Down				
Rating **	M	Issue No.	16	GPS Lat/Long
Issue Type +	Ma	Location *		40.007430 °
Category	Rivers, Channels & Designated Flood			-122.171780 °
Item	Vegetation & Obstructions			
DWR ID	DWR_NA0019_3_c_2012_16			
Action/Comments				
Inspector Comments: Remove all vegetation from channel before winter.

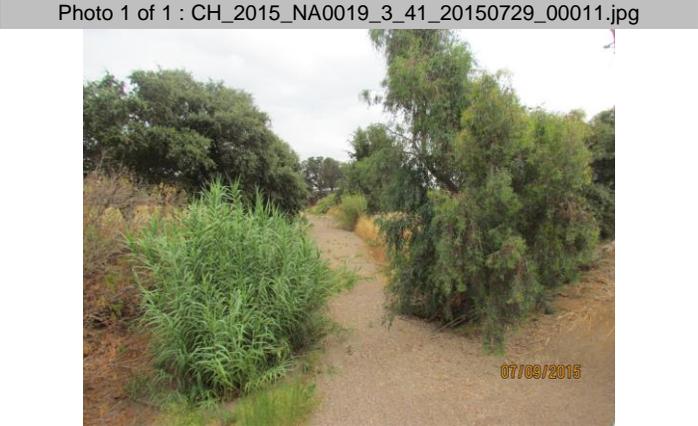
Upstream from Hamilton Rd. Dense vegetation in the channel.

Check Point / View				
Hamilton Road / Up				
Rating **	M	Issue No.	41	GPS Lat/Long
Issue Type +	Ma	Location *		40.017400 °
Category	Rivers, Channels & Designated Flood			-122.146540 °
Item	Vegetation & Obstructions			
DWR ID	DWR_NA0019_3_c_2012_41			
Action/Comments				
Inspector Comments: Remove all vegetation from the channel before winter.

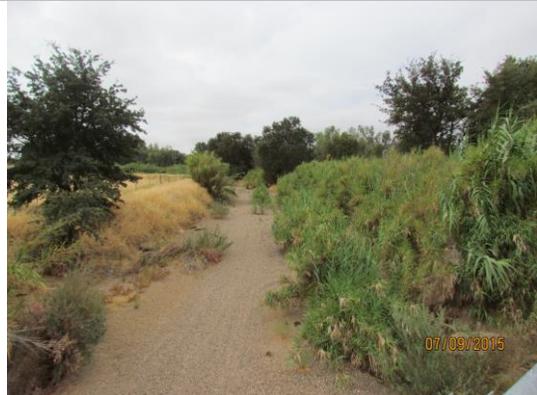
Photo 1 of 1 : CH_2015_NA0019_3_46_20150729_00012.jpg

Downstream from Hamilton Rd. Dense vegetation in the channel.

Check Point / View				
Hamilton Road / Down				
Rating **	M	Issue No.	46	GPS Lat/Long
Issue Type +	Ma	Location *		40.017400 °
Category	Rivers, Channels & Designated Flood			-122.146540 °
Item	Vegetation & Obstructions			
DWR ID	DWR_NA0019_3_c_2012_46			
Action/Comments				
Inspector Comments: Remove all vegetation from the channel before winter.

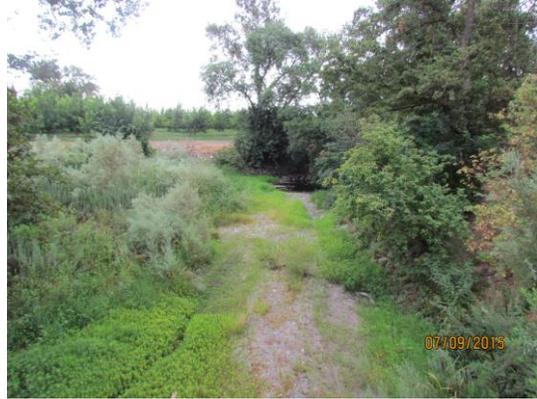
Photo 1 of 1 : CH_2015_NA0019_4_1_20150805_00005.jpg

Check Point / View				
Upstream Limit / Up				
Rating **	A	Issue No.	1	GPS Lat/Long
Issue Type +	Ma	Location *		40.157120 °
Category	Rivers, Channels & Designated Flood			-122.164250 °
Item	Vegetation & Obstructions			
DWR ID	DWR_NA0019_4_c_2012_1			
Action/Comments				
Inspector Comments: Minimal, scattered obstructions or vegetation. The flow is not impeded.

View of Salt Creek from the railroad car bridge.

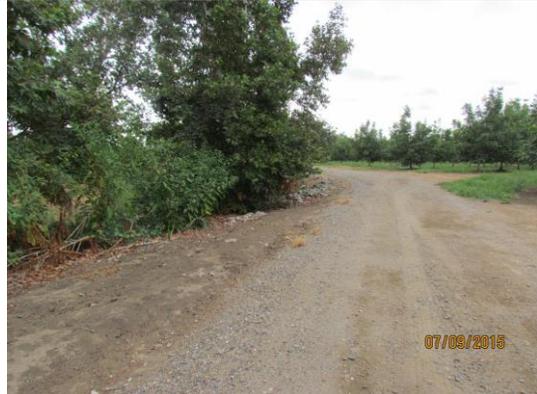
Photo 1 of 1 : CH_2015_NA0019_4_14_20150805_00006.jpg

Rating **	A	Issue No.	14	GPS Lat/Long
Issue Type +	Ma	Location *		40.156770 °
Category	Rivers, Channels & Designated Flood			-122.163670 °
Item	Revetments			
DWR ID	DWR_NA0019_4_c_2012_14			
Action/Comments				
Inspector Comments: Existing riprap protection is properly maintained and is undamaged. Riprap clearly visible.

The landowner has placed rip rap along all erosion sites.

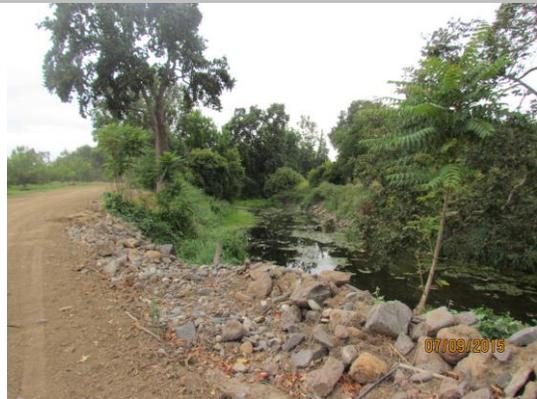
Photo 1 of 1 : CH_2015_NA0019_4_21_20150805_00007.jpg

Check Point / View				
2,800' upstream of downstream limit / Up				
Rating **	A	Issue No.	21	GPS Lat/Long
Issue Type +	Ma	Location *		40.151480 °
Category	Rivers, Channels & Designated Flood			-122.157590 °
Item	Vegetation & Obstructions			
DWR ID	DWR_NA0019_4_c_2012_21			
Action/Comments				
Inspector Comments: The property owner has removed the debris from the channel.

Channel has been cleared of logs and vegetation by landowner.

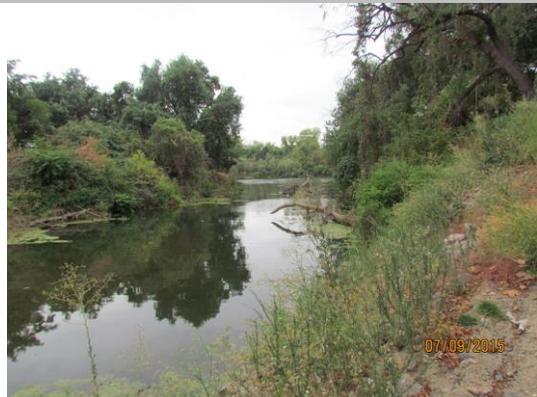
Photo 1 of 1 : CH_2015_NA0019_4_36_20150827_00008.jpg

Check Point / View				
100' upstream of confluence with Sac. R. / Down				
Rating **	A	Issue No.	36	GPS Lat/Long
Issue Type +	Ma	Location *		40.147230 °
Category	Rivers, Channels & Designated Flood			-122.154420 °
Item	Vegetation & Obstructions			
DWR ID	DWR_NA0019_4_c_2012_36			
Action/Comments				
Inspector Comments: Minimal, scattered obstructions or vegetation. The flow is not impacted.

View of the confluence of the Sacramento River.
