**Flood Control Project Maintenance
Levee Inspections**
2016 Channel Summary Report
Overall Unit and Item Ratings

Tehama County Flood Control and Water Conservation District

Flood Control Project Maintenance**Unit Cover Sheet****2016 Channel Inspection Results****Tehama County Flood Control and Water Conservation District**

Levee Inspection Report By Mile - Channel 2016

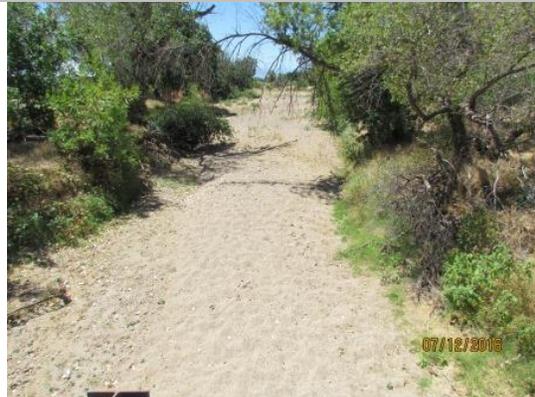
Photo 1 of 1 : CH_2016_NA0019_3_1_20160726_00007.jpg

Check Point / View			
Truckee Avenue / Up			
Rating **	A	Issue No. 1	GPS Lat/Long
Issue Type +	Ma	Location *	40.009840 °
Category	Rivers, Channels & Designated Flood		-122.200180 °
Item	Vegetation & Obstructions		
DWR ID	DWR_NA0019_3_c_2012_1		
Action/Comments			
Inspector Comments: No vegetation in the channel.

View of the upstream extension of McClure Creek at Truckee Avenue.

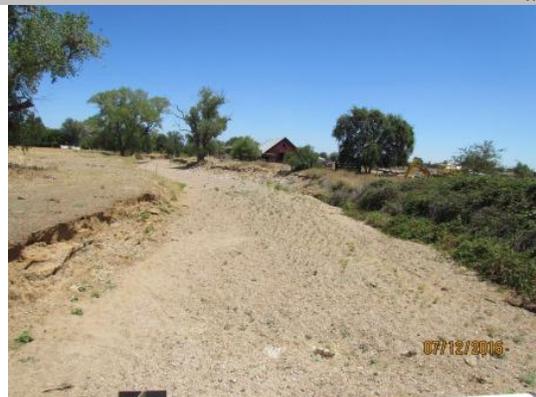
Photo 1 of 1 : CH_2016_NA0019_3_6_20160726_00008.jpg

Check Point / View			
Truckee Avenue / Down			
Rating **	A	Issue No. 6	GPS Lat/Long
Issue Type +	Ma	Location *	40.009840 °
Category	Rivers, Channels & Designated Flood		-122.200180 °
Item	Vegetation & Obstructions		
DWR ID	DWR_NA0019_3_c_2012_6		
Action/Comments			
Inspector Comments: No vegetation in the channel.

View of the downstream extension of McClure Creek at Truckee Avenue.

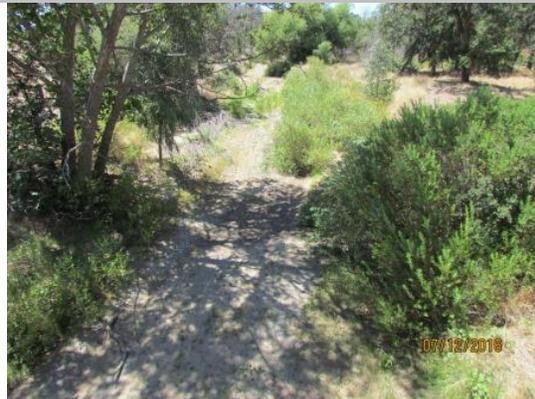
Photo 1 of 1 : CH_2016_NA0019_3_11_20160726_00009.jpg

Check Point / View			
Highway 99 W / Up			
Rating **	M	Issue No.	11
Issue Type +	Ma	Location *	GPS Lat/Long
Category	Rivers, Channels & Designated Flood		40.007430 °
Item	Vegetation & Obstructions		-122.171780 °
DWR ID	DWR_NA0019_3_c_2012_11		
Action/Comments			
Inspector Comments: Remove all vegetation from channel before winter.

Upstream view from HWY 99W. Note the vegetation in the channel.

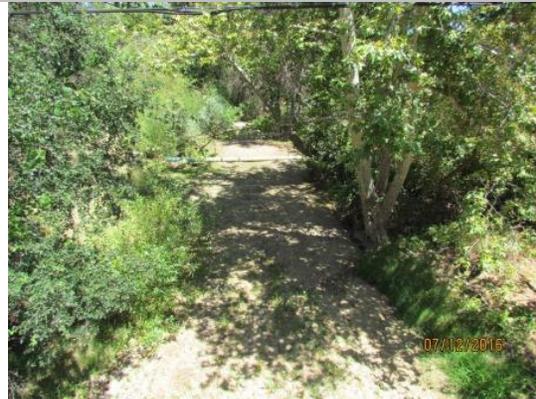
Photo 1 of 1 : CH_2016_NA0019_3_16_20160726_00010.jpg

Check Point / View				
Highway 99 W / Down				
Rating **	M	Issue No.	16	GPS Lat/Long
Issue Type +	Ma	Location *		40.007430 °
Category	Rivers, Channels & Designated Flood			-122.171780 °
Item	Vegetation & Obstructions			
DWR ID	DWR_NA0019_3_c_2012_16			
Action/Comments				
Inspector Comments: Remove all vegetation from channel before winter.

Downstream view from HWY 99 W. There is an irrigation pipe going across the channel.

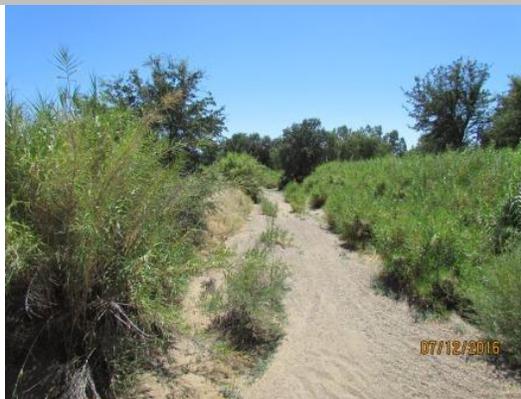
Photo 1 of 1 : CH_2016_NA0019_3_41_20160726_00011.jpg

Check Point / View			
Hamilton Road / Up			
Rating **	M	Issue No.	41
Issue Type +	Ma	Location *	GPS Lat/Long
Category	Rivers, Channels & Designated Flood		40.017400 °
Item	Vegetation & Obstructions		-122.146540 °
DWR ID	DWR_NA0019_3_c_2012_41		
Action/Comments			
Inspector Comments: Remove all vegetation from the channel before winter.

Upstream from Hamilton Rd. Dense vegetation in the channel.

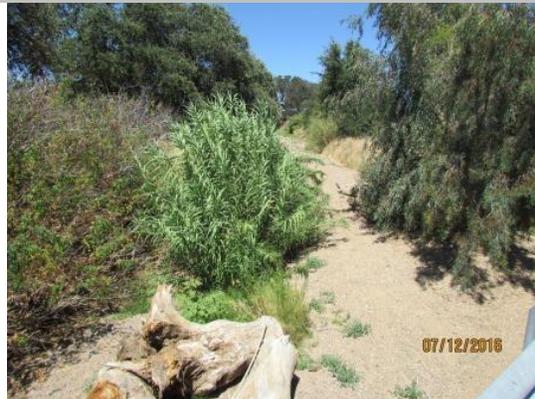
Photo 1 of 1 : CH_2016_NA0019_3_46_20160726_00012.jpg

Check Point / View				
Hamilton Road / Down				
Rating **	M	Issue No.	46	GPS Lat/Long
Issue Type +	Ma	Location *		40.017400 °
Category	Rivers, Channels & Designated Flood			-122.146540 °
Item	Vegetation & Obstructions			
DWR ID	DWR_NA0019_3_c_2012_46			
Action/Comments				
Inspector Comments: Remove all vegetation from the channel before winter.

Downstream from Hamilton Rd. Dense vegetation in the channel.

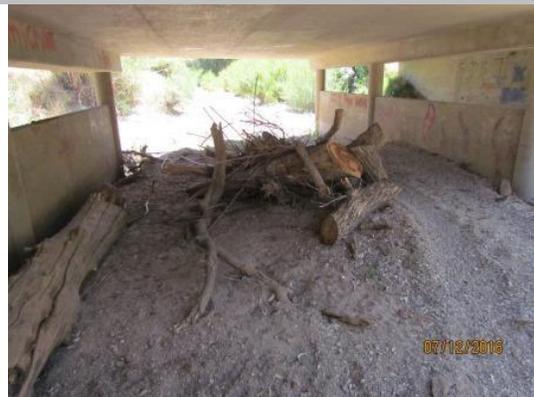
Photo 1 of 1 : CH_2016_NA0019_3_50_20160726_00013.jpg

Rating **	M	Issue No.	50
Issue Type +	Ma	Location *	GPS Lat/Long
Category	Rivers, Channels & Designated Flood		40.017400 °
Item	Encroachments		-122.146540 °
DWR ID	DWR_NA0019_3_c_2012_50		
Action/Comments			
Inspector Comments: There is debris in the channel.

View of the debris and sedimentation in the channel.

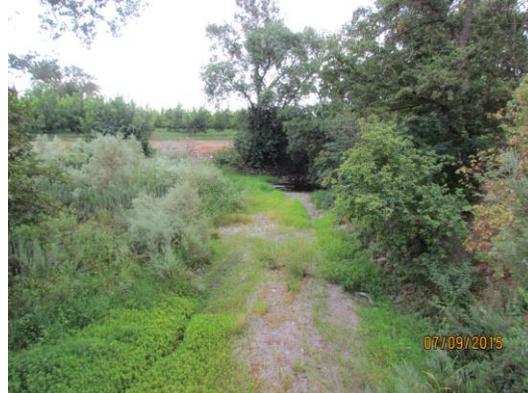
Photo 1 of 1 : CH_2016_NA0019_4_1_20160615_00001.jpg

Check Point / View				
Upstream Limit / Up				
Rating **	A	Issue No.	1	GPS Lat/Long
Issue Type +	Ma	Location *		40.157120 °
Category	Rivers, Channels & Designated Flood			-122.164250 °
Item	Vegetation & Obstructions			
DWR ID	DWR_NA0019_4_c_2012_1			
Action/Comments				
Inspector Comments: Minimal, scattered obstructions or vegetation. The flow is not impeded.

View of Salt Creek from the railroad car bridge.

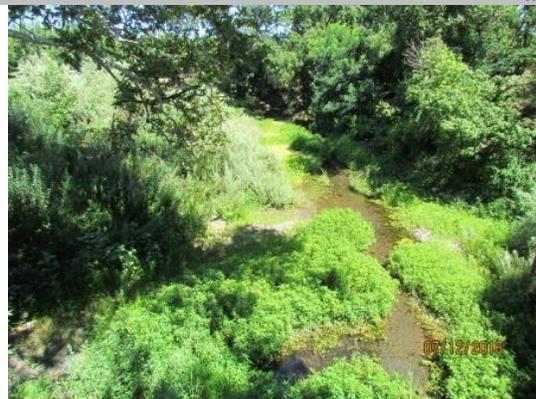
Photo 1 of 1 : CH_2016_NA0019_4_6_20160718_00005.jpg

Check Point / View			
Upstream Limit / Down			
Rating **	A	Issue No. 6	GPS Lat/Long
Issue Type +	Ma	Location *	40.157120 °
Category	Rivers, Channels & Designated Flood		-122.164250 °
Item	Vegetation & Obstructions		
DWR ID	DWR_NA0019_4_c_2012_6		
Action/Comments			
Inspector Comments: Minimal scattered obstructions or vegetation. The flow is not impeded.

Downstream view of Salt Creek from the railroad car bridge.

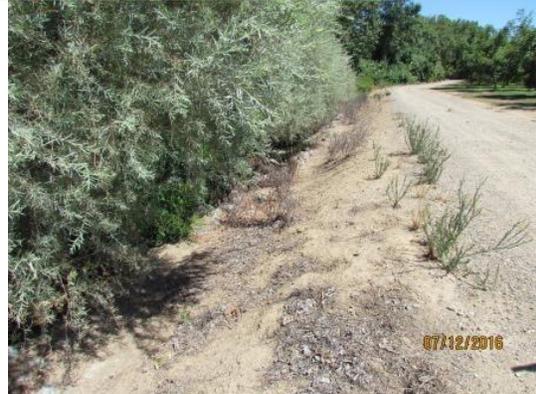
Photo 1 of 1 : CH_2016_NA0019_4_14_20160718_00006.jpg

Rating **	A	Issue No.	14	GPS Lat/Long
Issue Type +	Ma	Location *		40.156770 °
Category	Rivers, Channels & Designated Flood			-122.163670 °
Item	Revetments			
DWR ID	DWR_NA0019_4_c_2012_14			
Action/Comments				
Inspector Comments: Existing riprap protection is properly maintained and is undamaged. Riprap clearly visible.

The landowner has placed rip rap along all erosion sites.

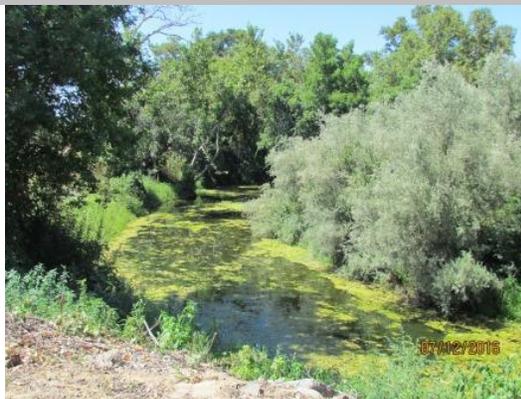
Photo 1 of 1 : CH_2016_NA0019_4_21_20160718_00007.jpg

Check Point / View			
2,800' upstream of downstream limit / Up			
Rating **	A	Issue No.	21
Issue Type +	Ma	Location *	
Category	Rivers, Channels & Designated Flood		GPS Lat/Long
Item	Vegetation & Obstructions		
DWR ID	DWR_NA0019_4_c_2012_21		
Action/Comments			
Inspector Comments: The property owner has removed the debris from the channel.

Channel has been cleared of logs and vegetation by landowner.

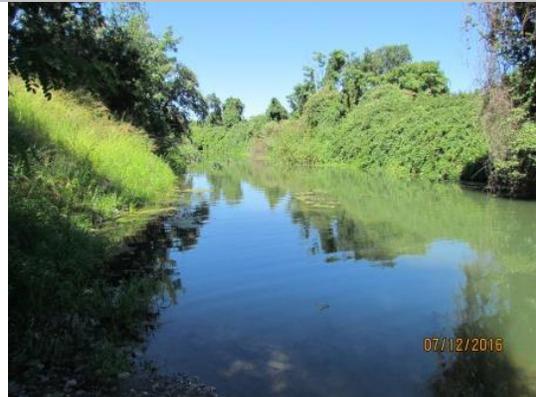
Photo 1 of 1 : CH_2016_NA0019_4_31_20160718_00009.jpg

Check Point / View			
100' upstream of confluence with Sac. R. / Up			
Rating **	A	Issue No. 31	GPS Lat/Long
Issue Type +	Ma	Location *	40.147230 °
Category	Rivers, Channels & Designated Flood		-122.154420 °
Item	Vegetation & Obstructions		
DWR ID	DWR_NA0019_4_c_2012_31		
Action/Comments			
Inspector Comments: Logs and vegetation have been removed from the channel.

Upstream view of the confluence at the Sacramento River.

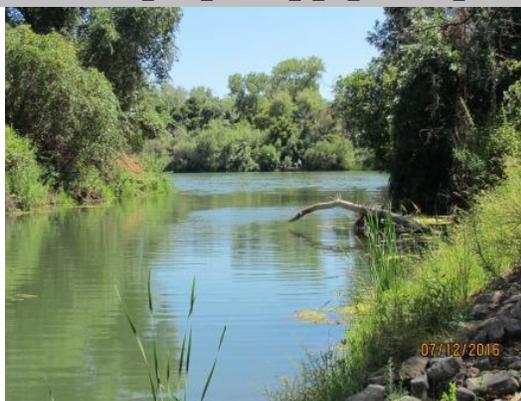
Photo 1 of 1 : CH_2016_NA0019_4_36_20160718_00008.jpg

Check Point / View			
100' upstream of confluence with Sac. R. / Down			
Rating **	A	Issue No.	36
Issue Type +	Ma	Location *	GPS Lat/Long
Category	Rivers, Channels & Designated Flood		40.147230 °
Item	Vegetation & Obstructions		-122.154420 °
DWR ID	DWR_NA0019_4_c_2012_36		
Action/Comments			
Inspector Comments: Minimal, scattered obstructions or vegetation. The flow is not impacted.

Downstream view of the confluence of the Sacramento River.
