**Flood Control Project Maintenance
Levee Inspections**

Fall 2015 Levee Maintenance Deficiency Summary Report

Tehama County Flood Control and Water Conservation District

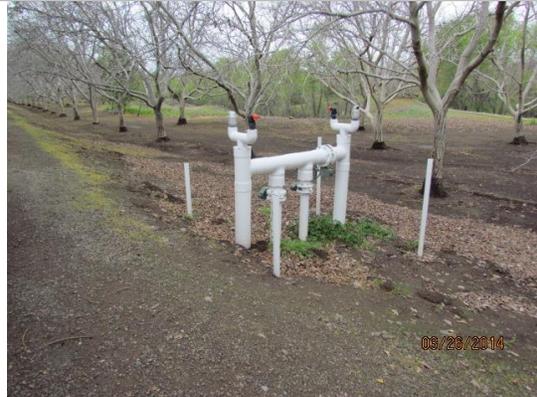
Photo 1 of 1 : FA_2015_NA0019_78_275_20150910_00016.jpg

View of the irrigation pipe along the waterside slope.

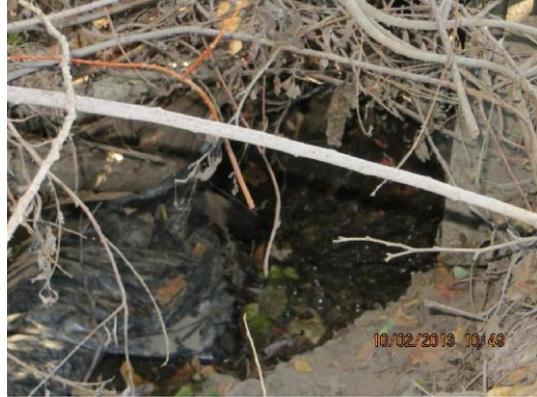
Photo 1 of 2 : UCIP_FA_2015_1919.jpg

LM Start	0.17	Rating **	M	Issue No.	278
LM End	0.17	Issue Type +	En	Location *	WS
Category	Supplemental			GPS Latitude/Longitude	
				Start	End
Item	DWR UCIP Field Study			39.973302 °	39.973302 °
				-121.983538 °	-121.983538 °
DWR ID					
Action/Comments					
Inspector Comments: FS_ID:39840 DS_ID:24684 EP_NO: N/A FS_HLM: 0.182 Repair Type: Non-Urgent Crossing Status: Found UCIP Comments: No permit identified for this crossing. FIELD_STRUCT_DESC: 36-inch concrete irrigation pipe through the levee 0.5-feet below the crown. Concrete canal and distribution structure on LS shoulder. FS Date: 10/02/2013

Pipe visible at WS outlet.

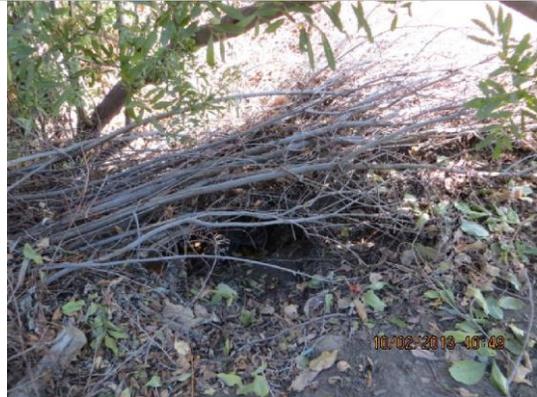
Photo 2 of 2 : UCIP_FA_2015_1920.jpg

Outlet covered by tree trimmings.

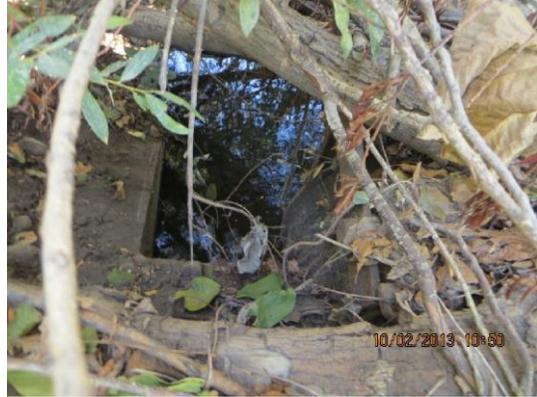
Photo 1 of 1 : UCIP_FA_2015_1918.jpg

LM Start	0.17	Rating **	M	Issue No.	279
LM End	0.17	Issue Type +	En	Location *	WS
Category	Supplemental			GPS Latitude/Longitude	
				Start	End
Item	DWR UCIP Field Study			39.973285 °	39.973285 °
				-121.983531 °	-121.983531 °
DWR ID					
Action/Comments					
Inspector Comments: FS_ID:39838 DS_ID:24685 EP_NO: N/A FS_HLM: 0.182 Repair Type: Non-Urgent Crossing Status: Found

Concrete U-shaped headwall and flaggate at WS toe.

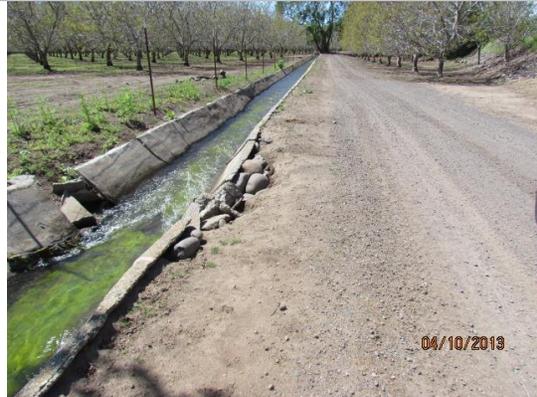
Photo 1 of 1 : FA_2015_NA0019_78_18_20150910_00010.jpg

LM Start	0.41	Rating **	M	Issue No.	18
LM End	0.41	Issue Type +	Ma	Location *	LS
Category	Earthen Levee			GPS Latitude/Longitude	
				Start	End
Item	Erosion / Bank Caving			39.972560 °	39.972560 °
				-121.987759 °	-121.987759 °
DWR ID	DWR_NA0019_01_s_2013_18				
Action/Comments					
Note and monitor erosion site.

View of the erosion along the landside slope.

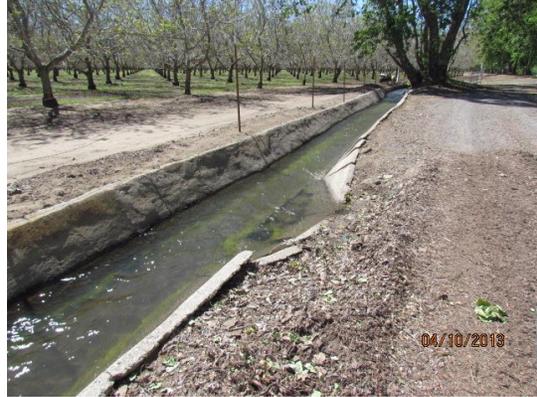
Photo 1 of 1 : FA_2015_NA0019_78_19_20150910_00011.jpg

View of the erosion along the landside slope.

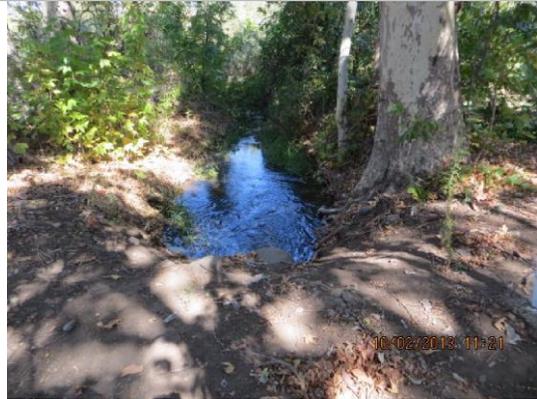
Photo 1 of 3 : UCIP_FA_2015_1921.jpg

LM Start	0.49	Rating **	M	Issue No.	280
LM End	0.49	Issue Type +	En	Location *	LS
Category	Supplemental		GPS Latitude/Longitude		
			Start	End	
Item	DWR UCIP Field Study		39.972280 °	39.972280 °	
			-121.989227 °	-121.989227 °	
DWR ID					
Action/Comments					
Inspector Comments: FS_ID:39839 DS_ID:24686 EP_NO: N/A FS_HLM: 0.5 Repair Type: Non-Urgent Crossing Status: Found UCIP Comments: No permit identified for crossing. FIELD_STRUCT_DESC: 20-inch concrete irrigation pipe through the levee 2-feet below the crown. Concrete canal and distribution structure with slat boards on LS shoulder. FS Date: 10/02/2013

Pipe visible at outlet on WS toe.

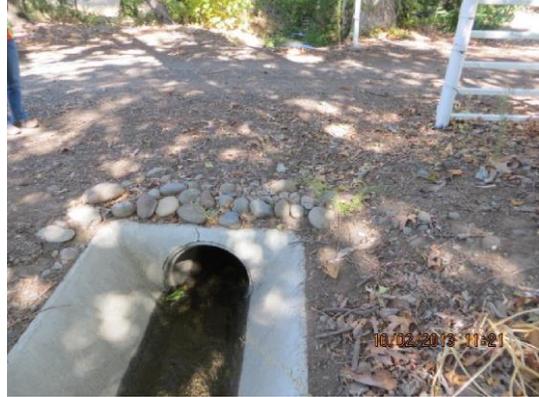
Photo 2 of 3 : UCIP_FA_2015_1922.jpg

Concrete headwall at canal on LS shoulder.

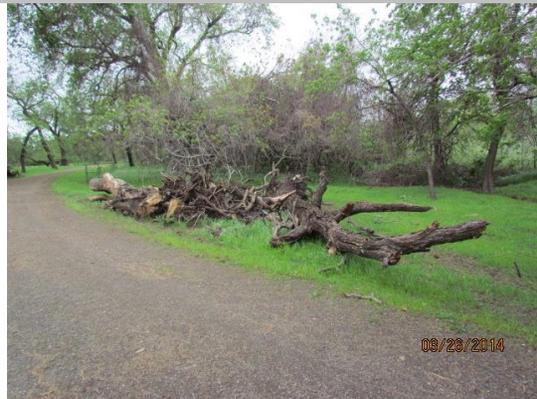
Photo 1 of 1 : FA_2015_NA0019_78_277_20150910_00018.jpg

View of the trees limbs along the waterside toe.

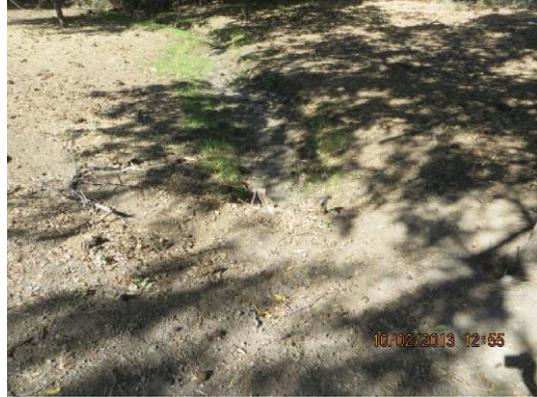
Photo 1 of 3 : UCIP_FA_2015_0734.jpg

LM Start	1.67	Rating **	U	Issue No.	281
LM End	1.67	Issue Type +	En	Location *	WS
Category	Supplemental			GPS Latitude/Longitude	
				Start	End
Item	DWR UCIP Field Study			39.968642 °	39.968642 °
				-122.010494 °	-122.010494 °
DWR ID					
Action/Comments					
Inspector Comments: FS_ID:21729 DS_ID:20770 EP_NO: N/A FS_HLM: 1.685 Repair Type: Urgent Crossing Status: Found UCIP Comments: Flapgate blocked by soil buildup. FIELD_STRUCT_DESC: 24-inch pipe through the levee 1.5-feet below the crown. Flap gate on the WS toe. Originally included in O+M manual (1957). As-built drawings available 50-4-2394. FS Date: 10/02/2013

Outlet on WS toe.

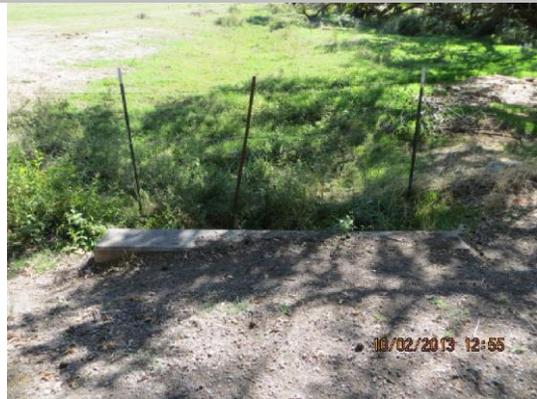
Photo 2 of 3 : UCIP_FA_2015_0735.jpg

Concrete headwall on LS toe.

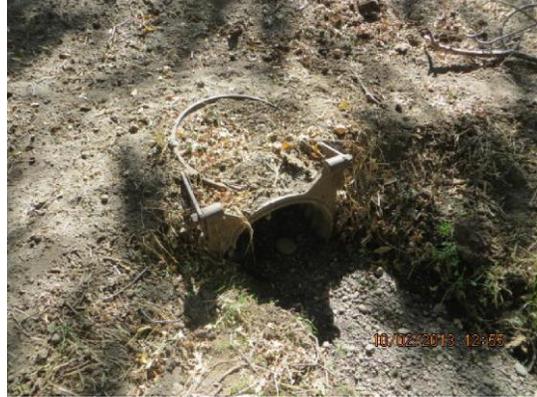
Photo 3 of 3 : UCIP_FA_2015_0736.jpg

LM Start	1.67	Rating **	U	Issue No.	281 (cont)
LM End	1.67	Issue Type +	En	Location *	WS
Category	Supplemental			GPS Latitude/Longitude	
				Start	End
Item	DWR UCIP Field Study			39.968642 °	39.968642 °
				-122.010494 °	-122.010494 °
DWR ID					
Action/Comments					
Inspector Comments: FS_ID:21729 DS_ID:20770 EP_NO: N/A FS_HLM: 1.685 Repair Type: Urgent Crossing Status: Found

Flapgate on WS toe.

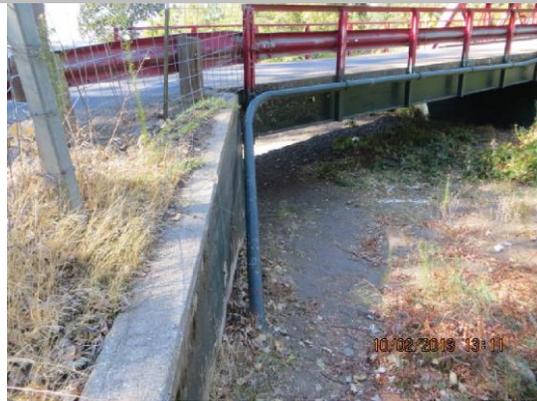
Photo 1 of 3 : UCIP_FA_2015_1924.jpg

LM Start	1.87	Rating **	M	Issue No.	282
LM End	1.87	Issue Type +	En	Location *	WS
Category	Supplemental			GPS Latitude/Longitude	
				Start	End
Item	DWR UCIP Field Study			39.969156 °	39.969156 °
				-122.013809 °	-122.013809 °
DWR ID					
Action/Comments					
Inspector Comments: FS_ID:39837 DS_ID:24690 EP_NO: N/A FS_HLM: 1.891 Repair Type: Non-Urgent Crossing Status: Found UCIP Comments: No permit identified for this crossing. FIELD_STRUCT_DESC: 4-inch steel conduit through the levee at an unknown depth. Junction box off LS toe next to JP and roadway. Conduit visible on upstream side of bridge at Deer Creek crossing. FS Date: 10/02/2013

Conduit visible on WS slope and at upstream side of bridge.

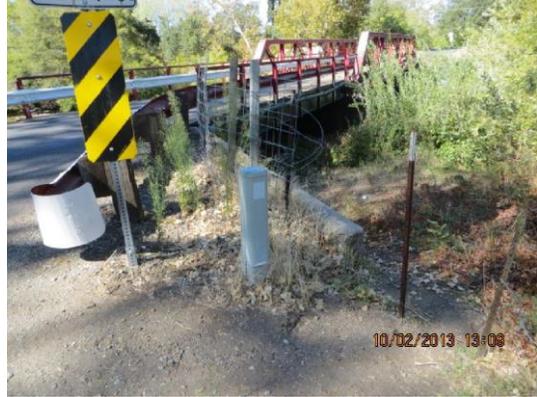
Photo 2 of 3 : UCIP_FA_2015_1925.jpg

Communication box on WS shoulder.

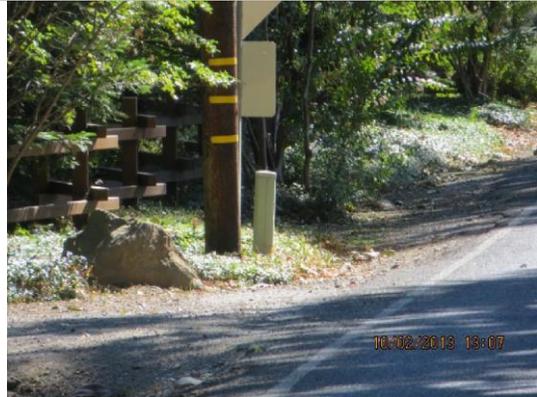
Photo 3 of 3 : UCIP_FA_2015_1926.jpg

Communication box off LS shoulder next to roadway.

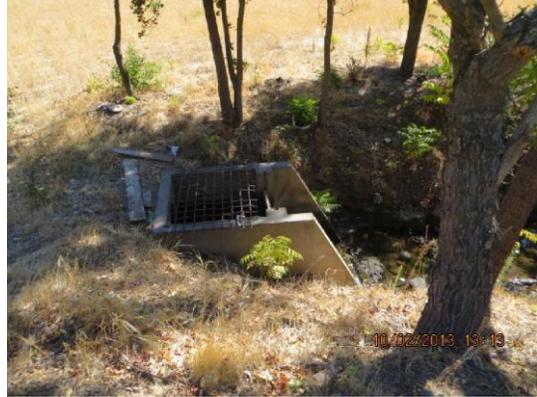
Photo 1 of 3 : UCIP_FA_2015_0737.jpg

LM Start	1.89	Rating **	U	Issue No.	283
LM End	1.89	Issue Type +	En	Location *	WS
Category	Supplemental			GPS Latitude/Longitude	
				Start	End
Item	DWR UCIP Field Study			39.969105 °	39.969105 °
				-122.014028 °	-122.014028 °
DWR ID					
Action/Comments					
Inspector Comments: FS_ID:21730 DS_ID:20769 EP_NO: N/A FS_HLM: 1.903 Repair Type: Urgent Crossing Status: Found

Concrete control structure on LS toe.

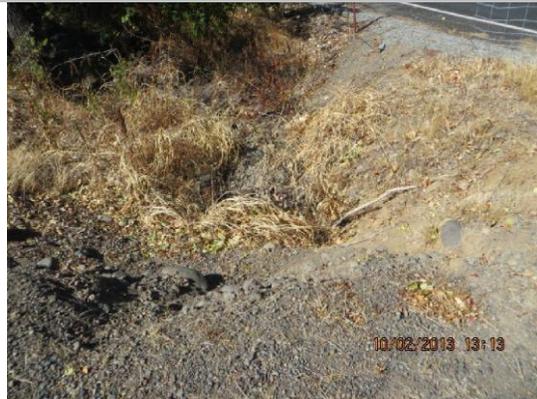
Photo 2 of 3 : UCIP_FA_2015_0738.jpg

Outlet on WS toe.

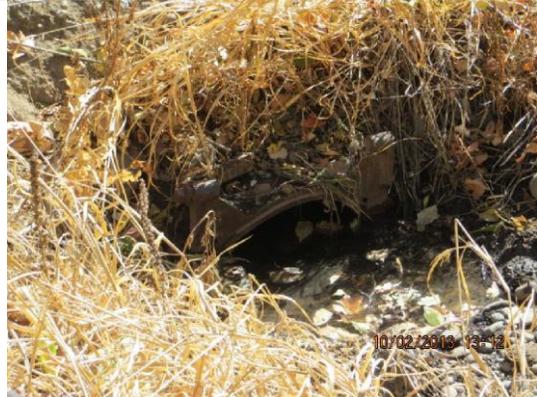
Photo 3 of 3 : UCIP_FA_2015_0739.jpg

Pipe on WS toe with flapgate hinges.

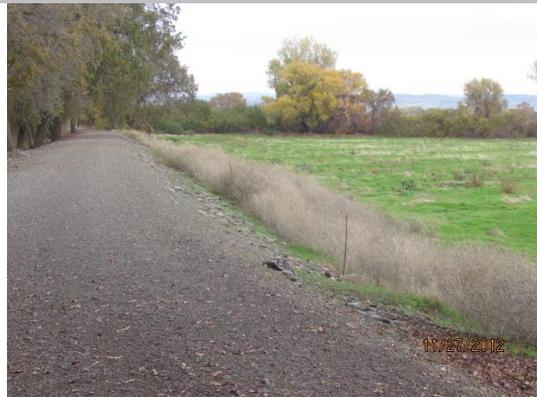
Photo 1 of 1 : FA_2015_NA0019_78_3_20150910_00002.jpg

View of the vegetation along the landside slope.

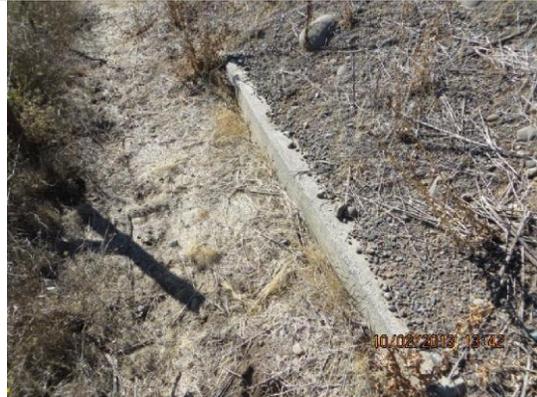
Photo 1 of 1 : UCIP_FA_2015_2099.jpg

LM Start	2.57	Rating **	M	Issue No.	284
LM End	2.57	Issue Type +	En	Location *	CR
Category	Supplemental			GPS Latitude/Longitude	
				Start	End
Item	DWR UCIP Field Study			39.966363 °	39.966363 °
				-122.025755 °	-122.025755 °
DWR ID					
Action/Comments					
Inspector Comments: FS_ID:22823 DS_ID:20877 EP_NO: N/A FS_HLM: 2.593 Repair Type: Non-Urgent Crossing Status: Found UCIP Comments: Headwall covered with soil. Needs to be cleared at both ends. FIELD_STRUCT_DESC: 24-inch Corrugated mtl pipe through the levee 5-feet below the crown. Calco automatic drainage gate. Originally included in O+M manual (1957). As-built drawings available 50-4-2394. FS Date: 10/02/2013

Concrete headwall on LS toe.

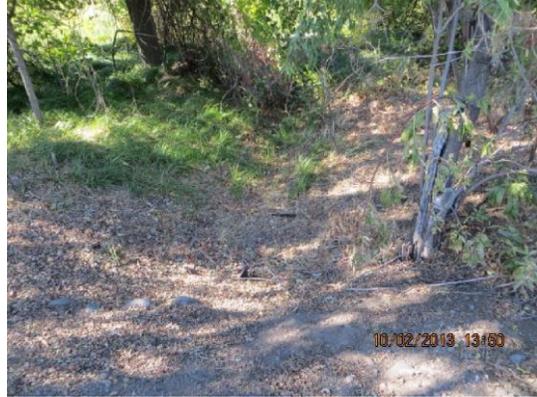
Photo 1 of 2 : UCIP_FA_2015_0677.jpg

LM Start	2.86	Rating **	M	Issue No.	285
LM End	2.86	Issue Type +	En	Location *	WS
Category	Supplemental			GPS Latitude/Longitude	
				Start	End
Item	DWR UCIP Field Study			39.963938 °	39.963938 °
				-122.030128 °	-122.030128 °
DWR ID					
Action/Comments					
Inspector Comments: FS_ID:22824 DS_ID:20767 EP_NO: N/A FS_HLM: 2.882 Repair Type: Non-Urgent Crossing Status: Found UCIP Comments: Pipe blocked by soil. FIELD_STRUCT_DESC: 24-inch pipe through the levee 6-feet below the crown. Flap gate on the waterward end. Originally included in O+M manual (1957). As-built drawings available 50-4-2394. FS Date: 10/02/2013

Flapgate blocked by soil and debris.

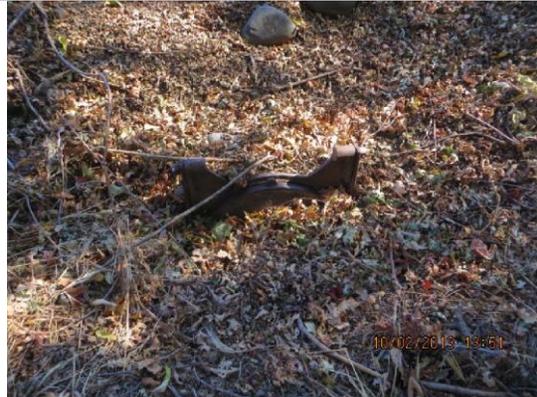
Photo 2 of 2 : UCIP_FA_2015_2100.jpg

Flapgate blocked by soil and debris.

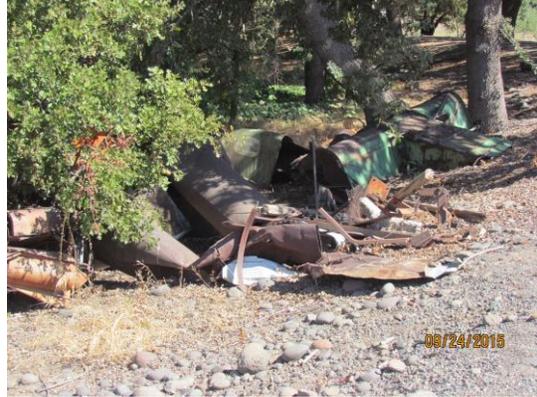
Photo 1 of 1 : FA_2015_NA0019_78_37_20151012_00028.jpg

View of the scrap equipment along the waterside toe.

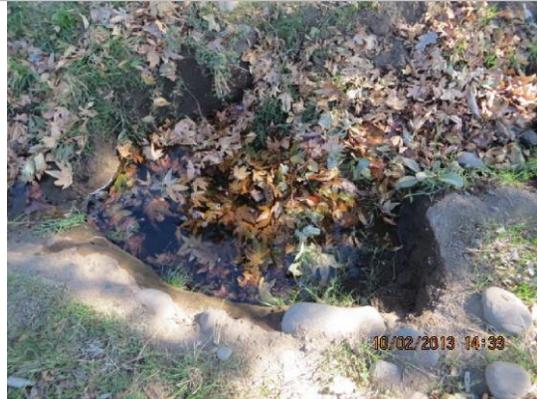
Photo 1 of 2 : UCIP_FA_2015_0678.jpg

LM Start	3.29	Rating **	M	Issue No.	286
LM End	3.29	Issue Type +	En	Location *	WS
Category	Supplemental		GPS Latitude/Longitude		
			Start	End	
Item	DWR UCIP Field Study		39.947484 °	39.947484 °	
			-122.049011 °	-122.049011 °	
DWR ID					
Action/Comments					
Inspector Comments: FS_ID:22825 DS_ID:20766 EP_NO: N/A FS_HLM: 3.309 Repair Type: Non-Urgent Crossing Status: Indicator Found UCIP Comments: Pipe buried. Water flows to low spot and dissapears, but pipe not visible. FIELD_STRUCT_DESC: 24-inch pipe through the levee 8-feet below the crown, flap gate on waterward end. Originally included in O+M manual (1957). As-built drawing No. 50-4-2394. FS Date: 10/02/2013

Low spot with water on LS toe.

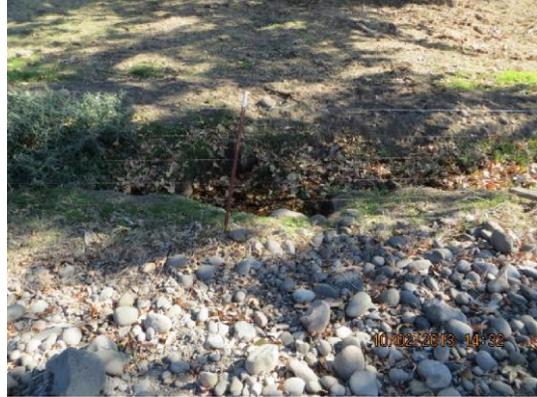
Photo 2 of 2 : UCIP_FA_2015_0679.jpg

Low spot with water on LS toe.

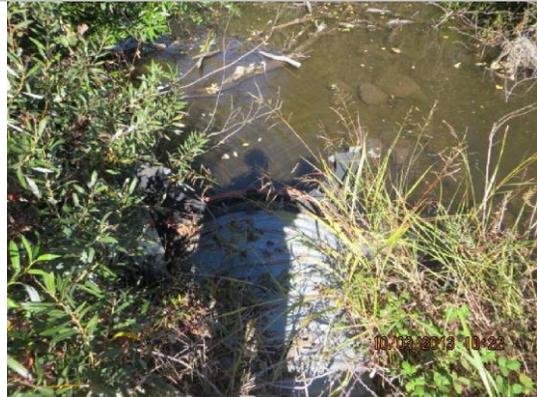
Photo 1 of 3 : UCIP_FA_2015_1927.jpg

LM Start	3.59	Rating **	M	Issue No.	287
LM End	3.59	Issue Type +	En	Location *	WS
Category	Supplemental			GPS Latitude/Longitude	
				Start	End
Item	DWR UCIP Field Study			39.945964 °	39.945964 °
				-122.054229 °	-122.054229 °
DWR ID					
Action/Comments					
Inspector Comments: FS_ID:23007 DS_ID:24687 EP_NO: N/A FS_HLM: 3.604 Repair Type: Non-Urgent Crossing Status: Found UCIP Comments: No permit identified for this crossing. FIELD_STRUCT_DESC: 48-inch corrugated metal drainpipe through the levee, 6-feet below the crown. Flap gate on the waterward end. FS Date: 10/03/2013

Flapgate visible on WS toe.

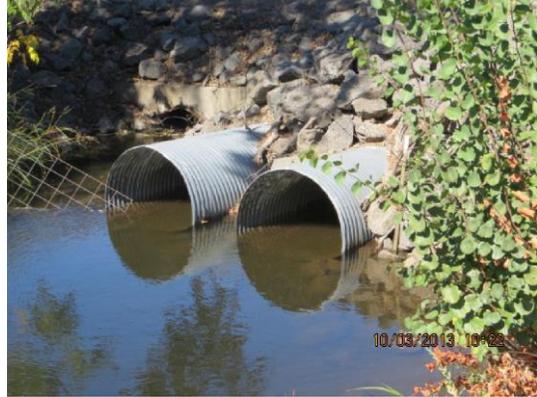
Photo 2 of 3 : UCIP_FA_2015_1928.jpg

Pipe visible on LS toe.

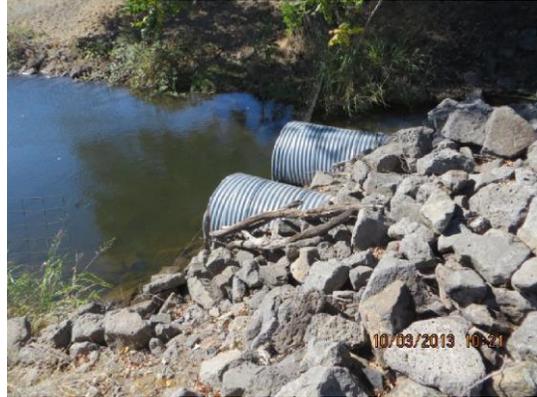
Photo 3 of 3 : UCIP_FA_2015_1929.jpg

Pipe visible on LS toe.

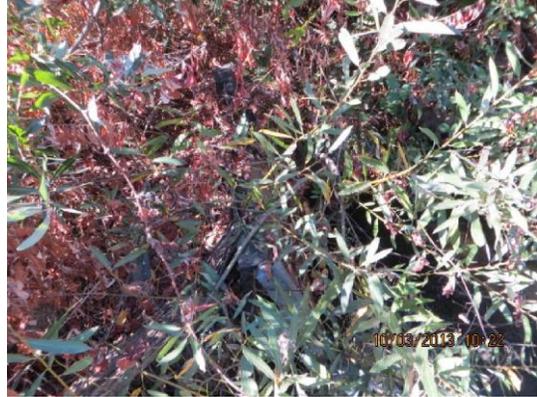
Photo 1 of 3 : UCIP_FA_2015_1930.jpg

LM Start	3.60	Rating **	M	Issue No.	288
LM End	3.60	Issue Type +	En	Location *	WS
Category	Supplemental			GPS Latitude/Longitude	
				Start	End
Item	DWR UCIP Field Study			39.945952 °	39.945952 °
				-122.054259 °	-122.054259 °
DWR ID					
Action/Comments					
Inspector Comments: FS_ID:39836 DS_ID:24688 EP_NO: N/A FS_HLM: 3.606 Repair Type: Non-Urgent Crossing Status: Found

Flapgate visible on WS toe covered in brush.

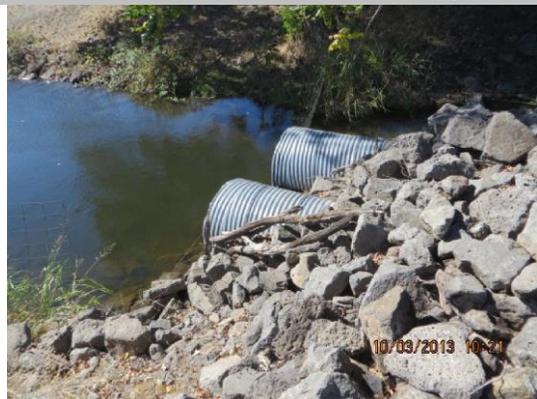
Photo 3 of 3 : UCIP_FA_2015_1932.jpg

Pipe visible on LS toe.

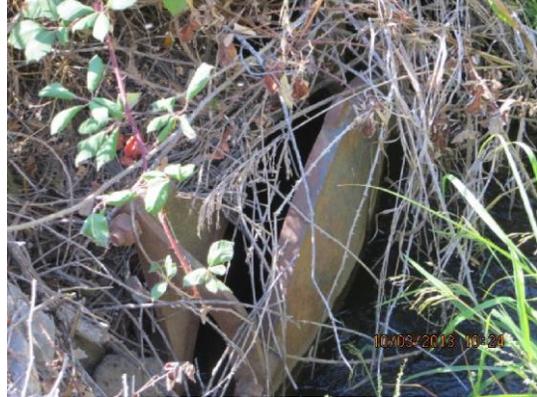
Photo 1 of 3 : UCIP_FA_2015_1933.jpg

LM Start	3.60	Rating **	U	Issue No.	289
LM End	3.60	Issue Type +	En	Location *	WS
Category	Supplemental			GPS Latitude/Longitude	
				Start	End
Item	DWR UCIP Field Study			39.945928 °	39.945928 °
				-122.054305 °	-122.054305 °
DWR ID					
Action/Comments					
Inspector Comments: FS_ID:41126 DS_ID:24689 EP_NO: N/A FS_HLM: 3.609 Repair Type: Urgent Crossing Status: Found

Flapgate visible on WS toe.

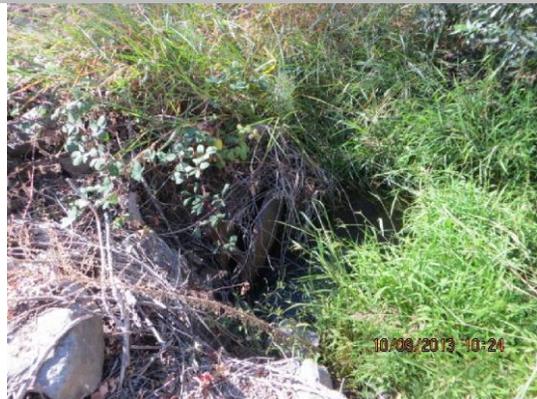
Photo 2 of 3 : UCIP_FA_2015_1934.jpg

Flapgate visible on WS toe.

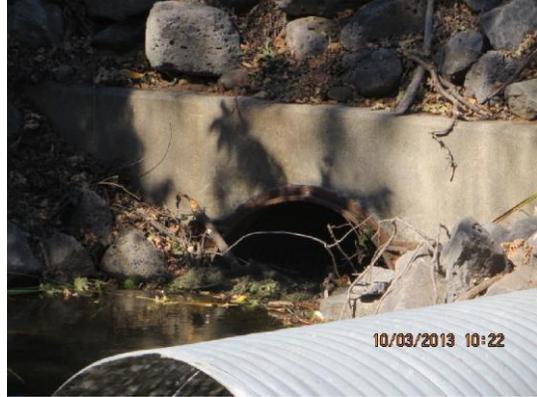
Photo 3 of 3 : UCIP_FA_2015_2022.jpg

Pipe visible at headwall on LS toe.

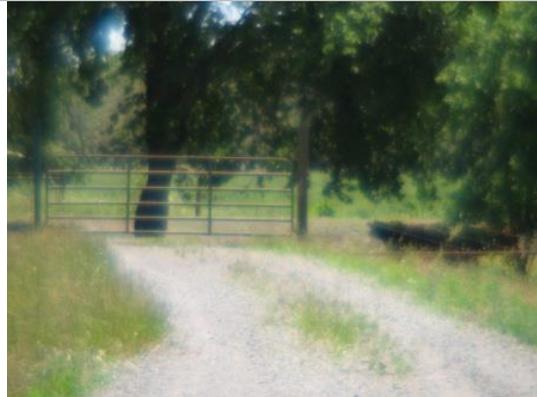
Photo 1 of 1 : FA_2015_NA0019_78_9_20150910_00004.jpg

View of the non-permitted gate on the crown of the levee.

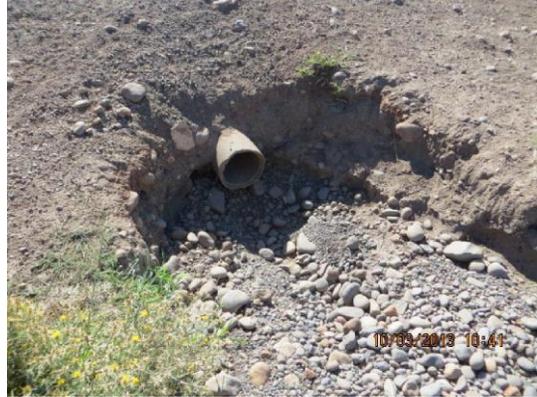
Photo 1 of 3 : UCIP_FA_2015_2206.jpg

Concrete pipe at outlet on WS toe.

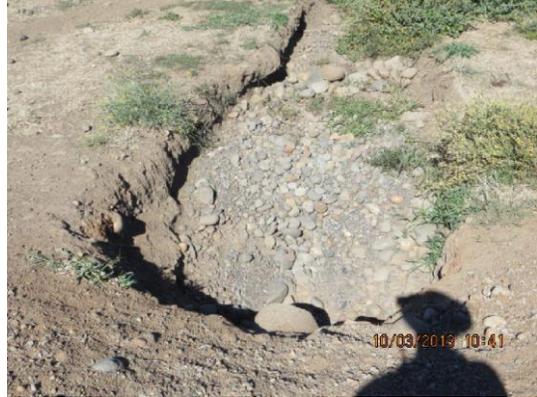
Photo 2 of 3 : UCIP_FA_2015_2207.jpg

Concrete pipe at outlet on WS toe.

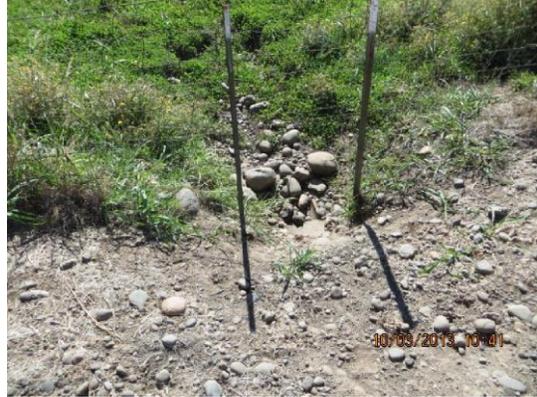
Photo 3 of 3 : UCIP_FA_2015_2208.jpg

Concrete pipe at inlet on LS toe.

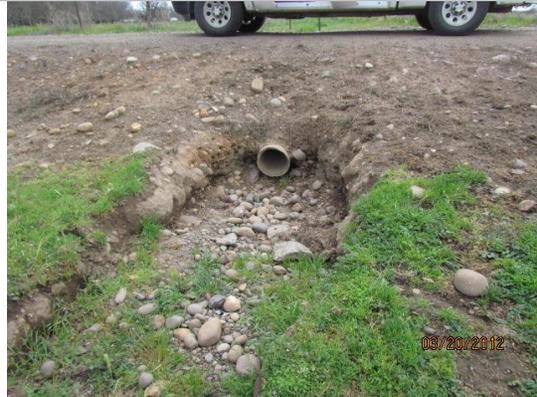
Photo 1 of 1 : FA_2015_NA0019_78_11_20150910_00006.jpg

No flap gate on 18 inch pipe going through the levee.

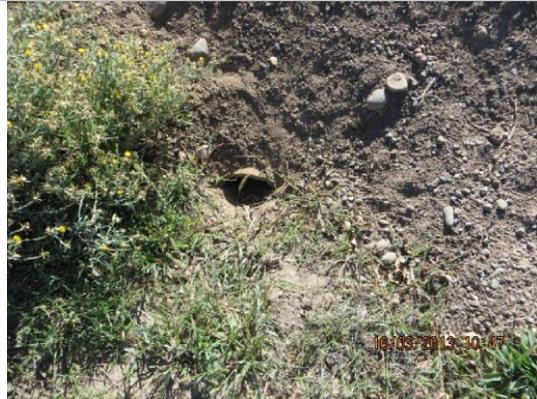
Photo 1 of 3 : UCIP_FA_2015_2203.jpg

Pipe outlet on WS toe.

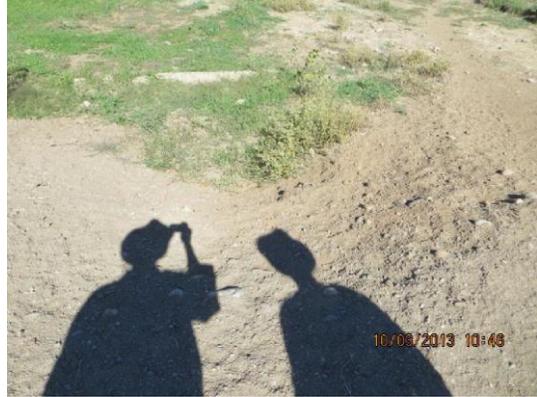
Photo 2 of 3 : UCIP_FA_2015_2204.jpg

Pipe outlet on WS toe.

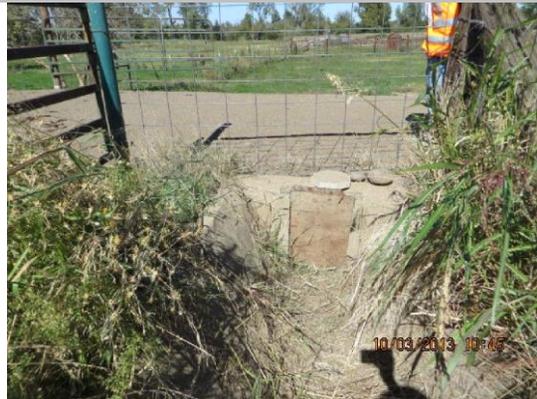
Photo 3 of 3 : UCIP_FA_2015_2205.jpg

Slide panel at inlet on LS shoulder.

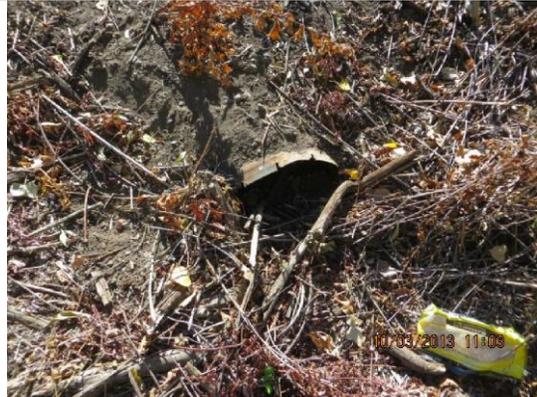
Photo 1 of 3 : UCIP_FA_2015_2422.jpg

Flap gate missing from pipe at WS toe.

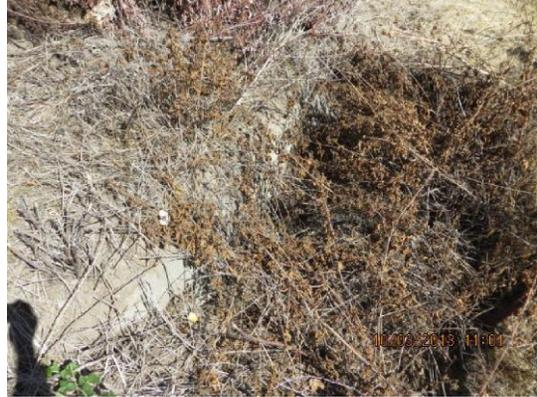
Photo 2 of 3 : UCIP_FA_2015_2423.jpg

Concrete headwall at inlet on LS toe.

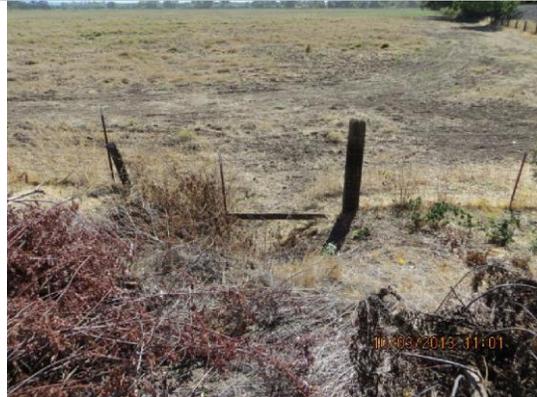
Photo 3 of 3 : UCIP_FA_2015_2424.jpg

Inlet on LS toe.

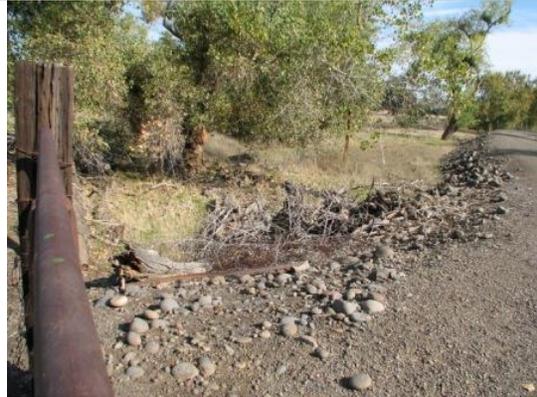
Photo 1 of 1 : FA_2015_NA0019_79_2_20150910_00001.jpg

View of debris & wire at toe of levee.

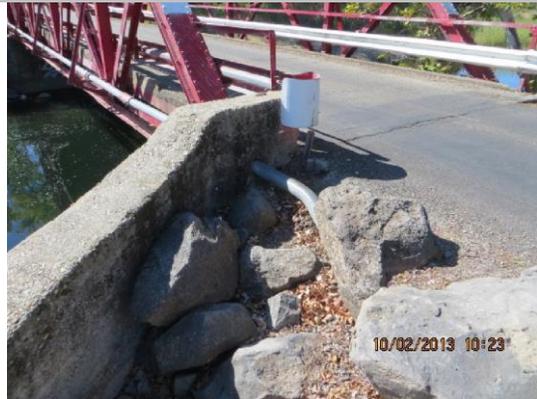
Photo 1 of 3 : UCIP_FA_2015_1915.jpg

Communication line conduit visible on upstream side of bridge at WS.

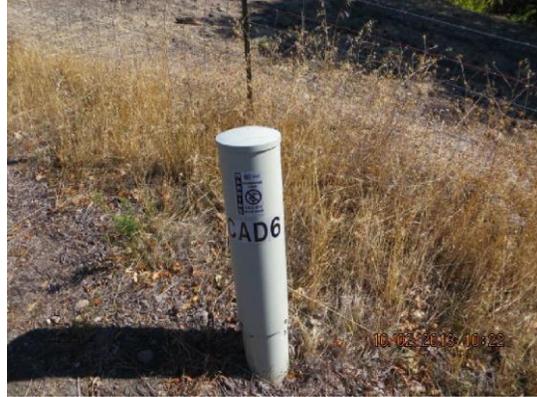
Photo 2 of 3 : UCIP_FA_2015_1916.jpg

Communication line access box on WS shoulder.

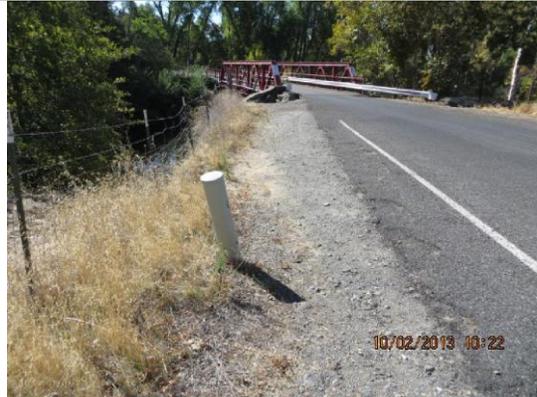
Photo 3 of 3 : UCIP_FA_2015_1917.jpg

Communication line access box on WS shoulder.

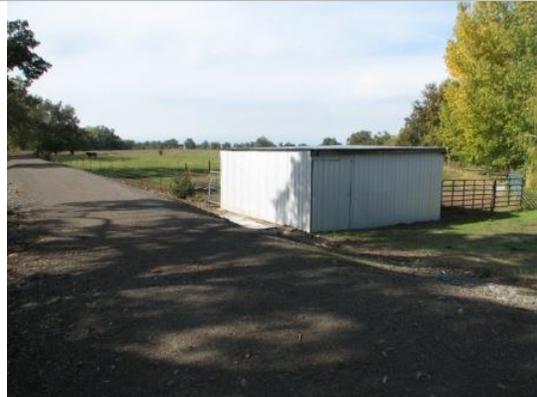
Photo 1 of 1 : FA_2015_NA0019_79_7_20150910_00005.jpg

View of building at toe of levee.

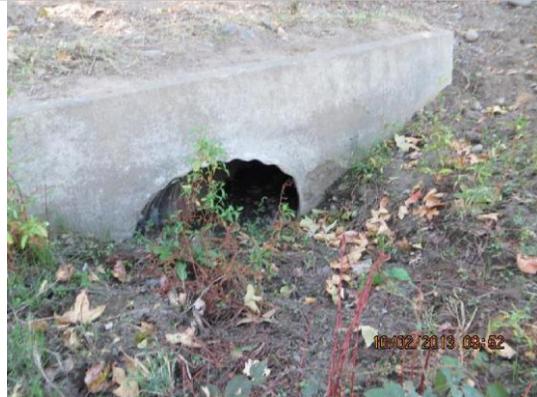
Photo 2 of 3 : UCIP_FA_2015_0732.jpg

Concrete headwall at LS toe.

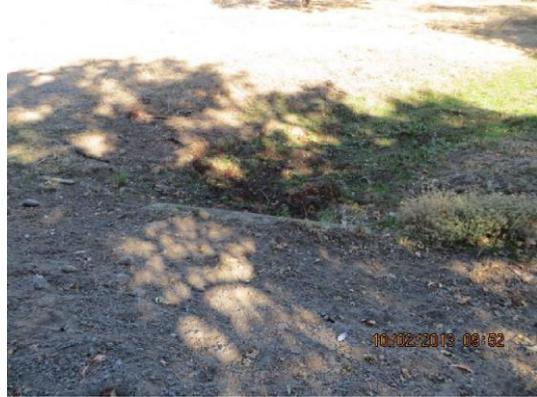
Photo 3 of 3 : UCIP_FA_2015_0733.jpg

Concrete headwall at LS toe.

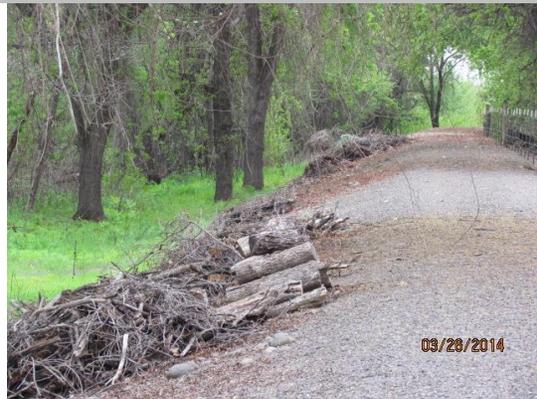
Photo 1 of 1 : FA_2015_NA0019_79_3_20150910_00002.jpg

View of the debris along the waterside slope.

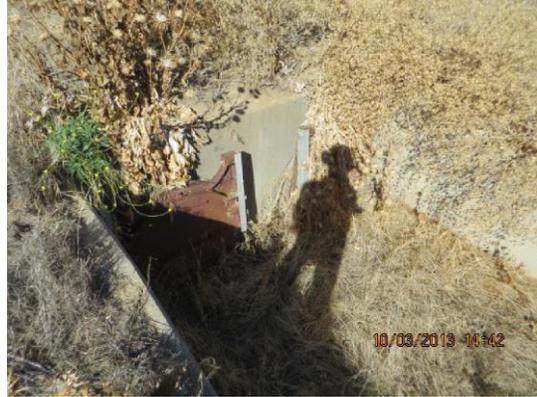
Photo 1 of 3 : UCIP_FA_2015_1880.jpg

Concrete U-shaped headwall and flapgate on WS toe.

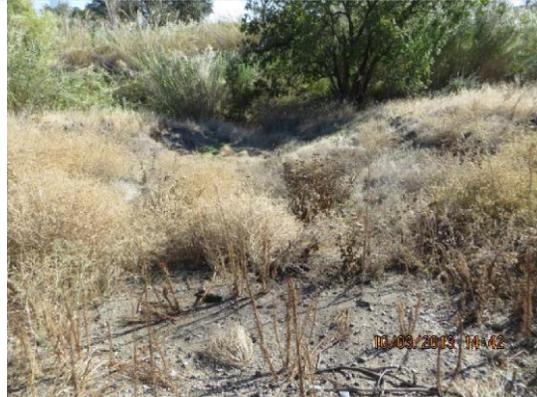
Photo 2 of 3 : UCIP_FA_2015_1881.jpg

Concrete U-shaped headwall on WS toe.

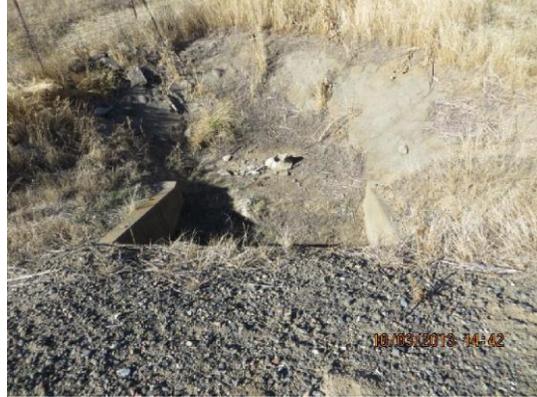
Photo 3 of 3 : UCIP_FA_2015_1882.jpg

Concrete U-shaped headwall on LS toe.

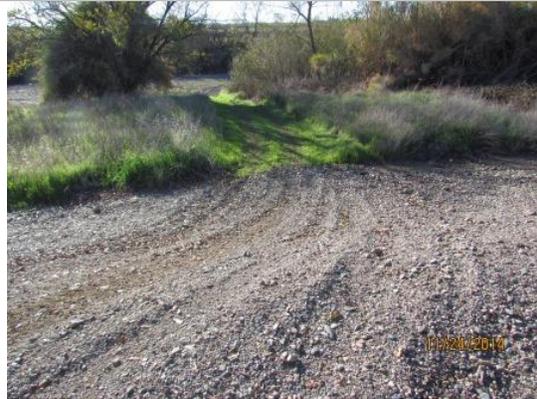
Photo 1 of 1 : FA_2015_NA0019_81_16_20150910_00009.jpg

View of the vehicle erosion along the waterside slope.

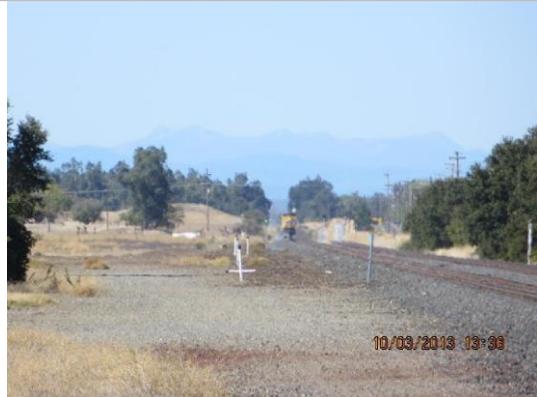
Photo 1 of 1 : UCIP_FA_2015_1674.jpg

Fiber optic line markers off LS shoulder.

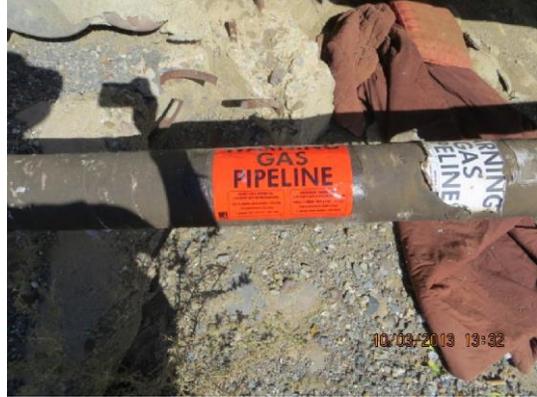
Photo 1 of 2 : UCIP_FA_2015_2061.jpg

Gasline on upstream side of bridge.

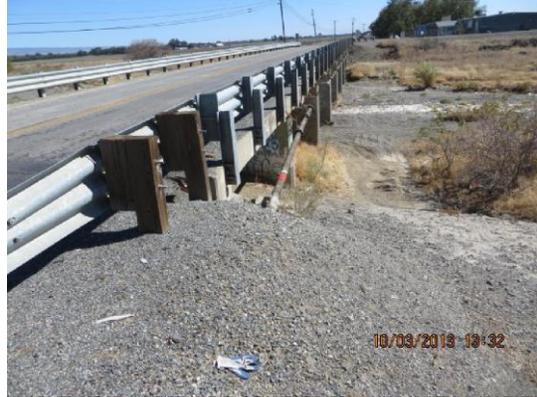
Photo 2 of 2 : UCIP_FA_2015_2062.jpg

Gasline on upstream side of bridge.

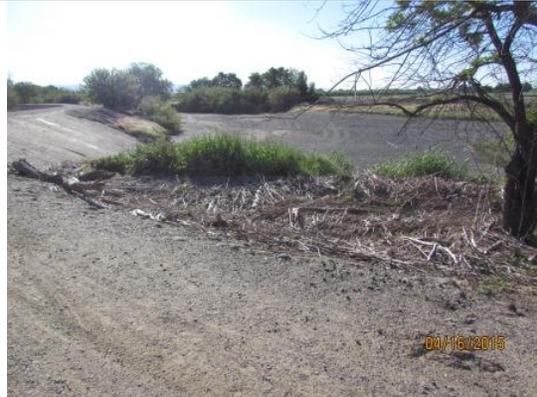
Photo 1 of 1 : FA_2015_NA0019_81_19_20150910_00012.jpg

View of the debris along the waterside slope.

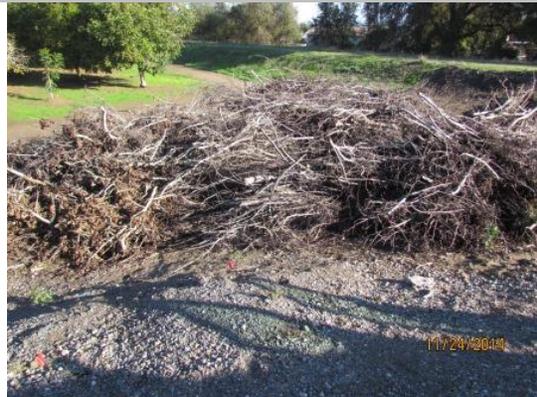
Photo 1 of 1 : FA_2015_NA0019_81_17_20150910_00010.jpg

View of the prunings along the landside slope.

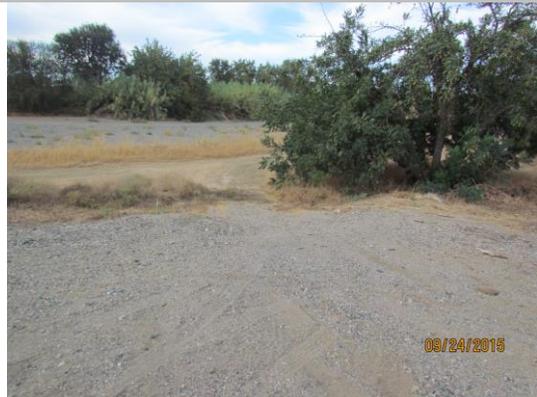
Photo 1 of 1 : FA_2015_NA0019_81_10_20151012_00022.jpg

View of the vehicle erosion along the waterside slope.

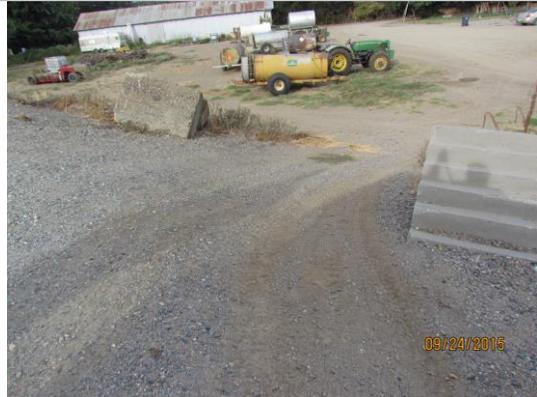
Photo 1 of 1 : FA_2015_NA0019_81_25_20151012_00023.jpg

View of the vehicle erosion along the landside slope.

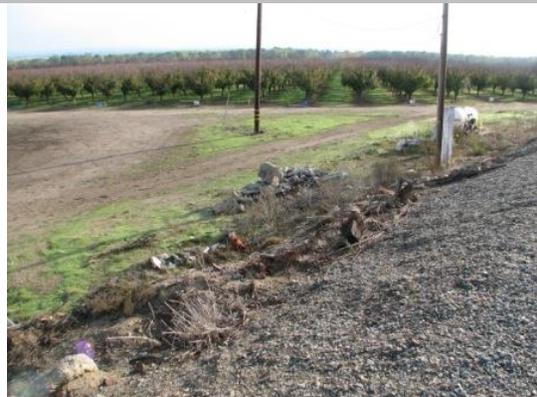
Photo 1 of 1 : FA_2015_NA0019_81_6_20150910_00004.jpg

View of the garbage and metal along the landside slope and toe of the levee.

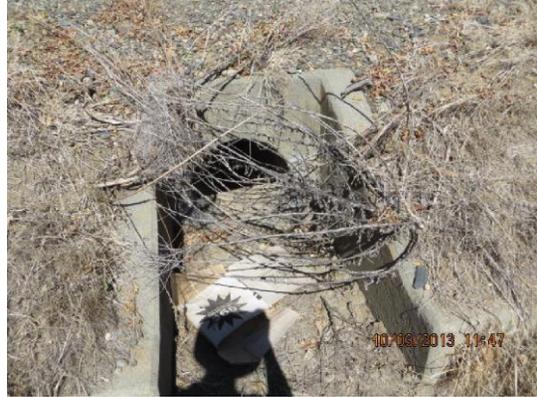
Photo 1 of 3 : UCIP_FA_2015_2425.jpg

Concrete headwall at LS toe.

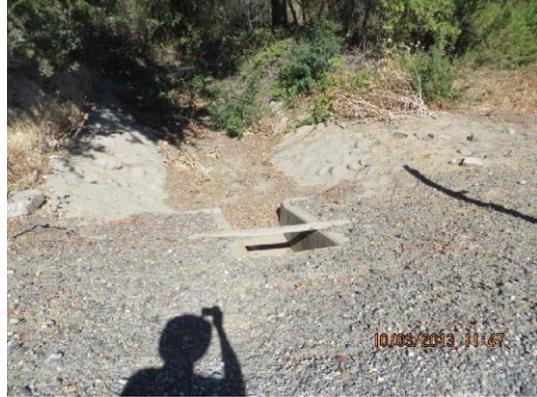
Photo 3 of 3 : UCIP_FA_2015_2505.jpg

Concrete headwall on WS toe.

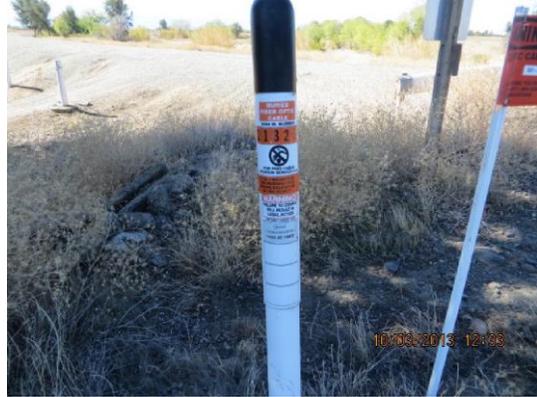
Photo 1 of 2 : UCIP_FA_2015_1675.jpg

Fiber optic line markers on LS shoulder.

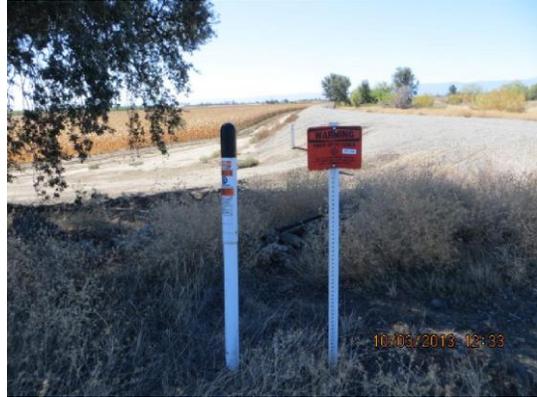
Photo 2 of 2 : UCIP_FA_2015_1676.jpg

Fiber optic line markers on LS shoulder.

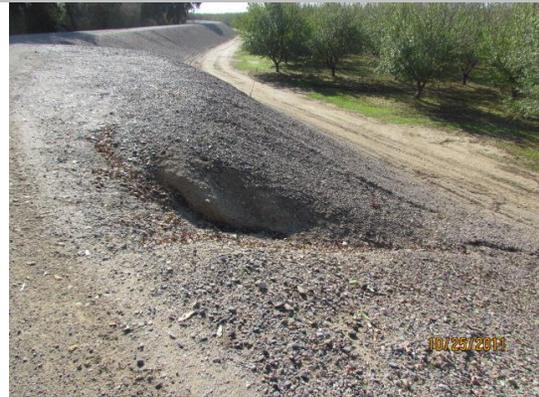
Photo 1 of 1 : FA_2015_NA0019_82_7_20150910_00002.jpg

View of the erosion along the L/S slope.
