**Flood Control Project Maintenance
Levee Inspections**
LMA District Cover Sheet
Spring 2015 Levee Inspection Results

Tehama County Flood Control and Water Conservation District

Waterway		Bank	Unit Miles
Unit No. 01 Deer Creek		Left	4.22

Levee Inspection Report By Mile - Spring 2015

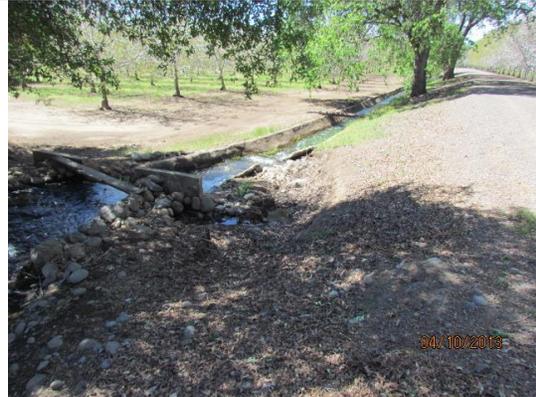
Photo 1 of 1 : SP_2015_NA0019_78_17_20150310_00009.jpg

View of the erosion along the landside slope.

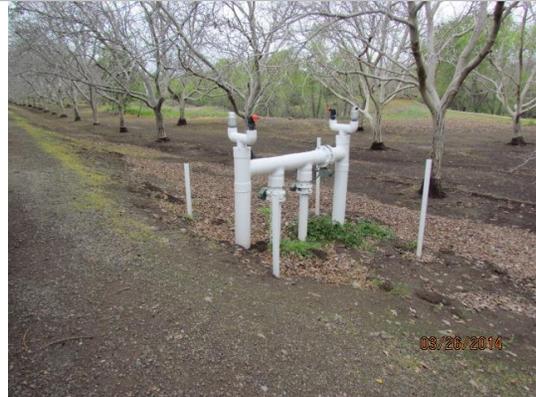
Photo 1 of 1 : SP_2015_NA0019_78_275_20150310_00015.jpg

LM Start	0.02	Rating **	U	Issue No.	275
LM End	0.02	Issue Type +	En	Location *	WS
Category	Earthen Levee			GPS Latitude/Longitude	
				Start	End
Item	Encroachments			39.973128 °	39.973128 °
				-121.980734 °	-121.980734 °
DWR ID	DWR_NA0019_01_s_2014_275				
Action/Comments					
Pipe

View of the irrigation pipe along the waterside slope.

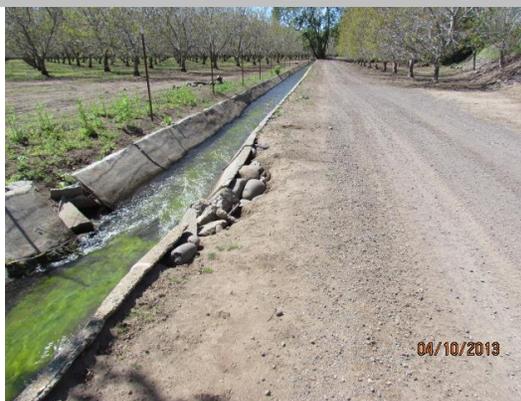
Photo 1 of 1 : SP_2015_NA0019_78_18_20150310_00010.jpg

View of the erosion along the landside slope.

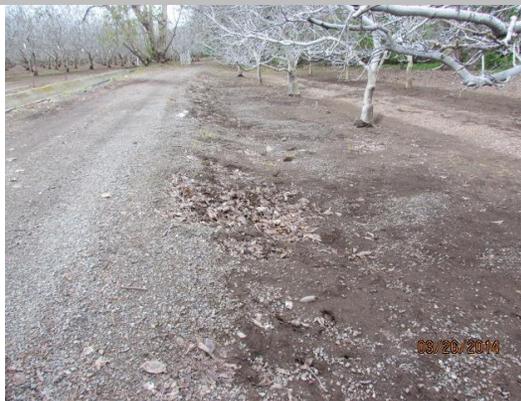
Photo 1 of 1 : SP_2015_NA0019_78_276_20150310_00016.jpg

LM Start	0.45	Rating **	M	Issue No.	276
LM End	0.45	Issue Type +	Ma	Location *	WS
Category	Earthen Levee			GPS Latitude/Longitude	
				Start	End
Item	Slope Stability			39.972377 °	39.972377 °
				-121.988559 °	-121.988559 °
DWR ID	DWR_NA0019_01_s_2014_276				
Action/Comments					
Repair slope instability.

View of the erosion along the waterside slope.

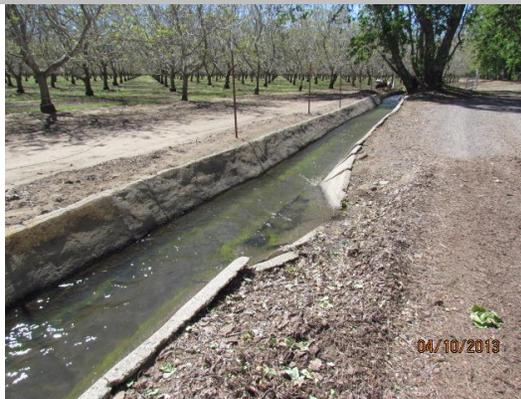
Photo 1 of 1 : SP_2015_NA0019_78_19_20150310_00011.jpg

View of the erosion along the landside slope.

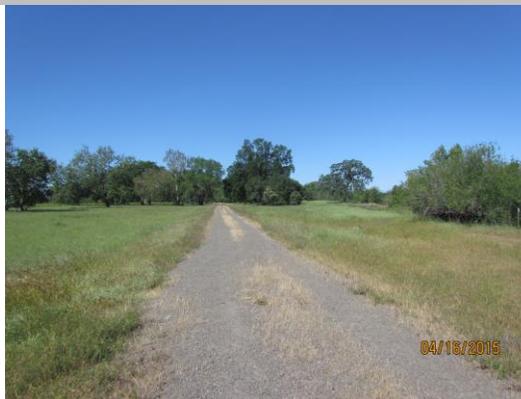
Photo 1 of 1 : SP_2015_NA0019_78_37_20150428_00029.jpg

View of the native grasses on both slopes.

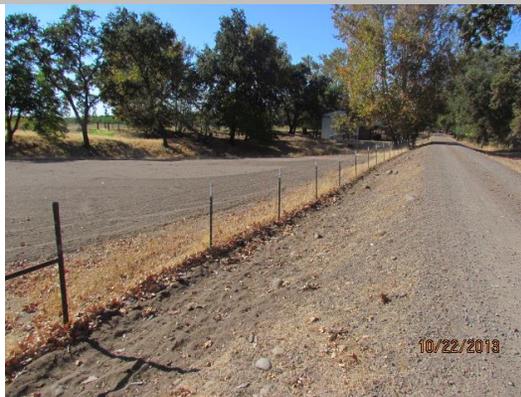
Photo 1 of 1 : SP_2015_NA0019_78_21_20150310_00013.jpg

LM Start	1.52	Rating **	M	Issue No.	21
LM End	1.52	Issue Type +	Ma	Location *	LS
Category	Earthen Levee		GPS Latitude/Longitude		
			Start	End	
Item	Animal Control		39.969419 °	39.969419 °	
			-122.007850 °	-122.007850 °	
DWR ID	DWR_NA0019_01_f_2013_21				
Action/Comments					
Repair the levee slope damaged by livestock and prevent large animal access.

View of the erosion caused by livestock on both slope of the levee.

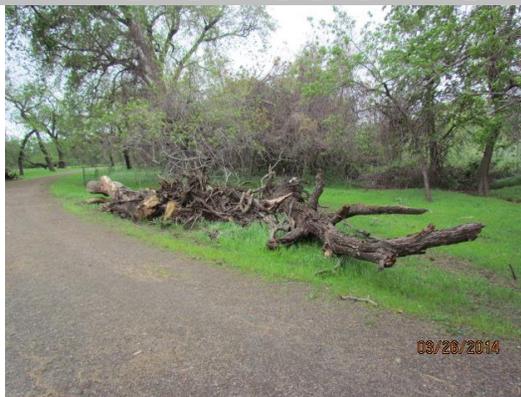
Photo 1 of 1 : SP_2015_NA0019_78_277_20150310_00017.jpg

LM Start	1.65	Rating **	M	Issue No.	277
LM End	1.65	Issue Type +	En	Location *	WS
Category	Earthen Levee		GPS Latitude/Longitude		
			Start	End	
Item	Encroachments		39.968654 °	39.968654 °	
			-122.010207 °	-122.010207 °	
DWR ID	DWR_NA0019_01_s_2014_277				
Action/Comments					
Tree or limb

View of the trees limbs along the waterside toe.

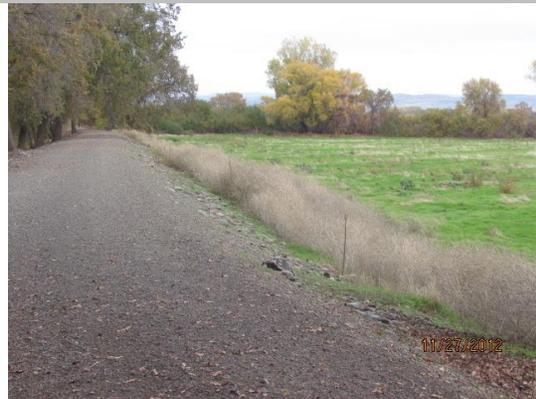
Photo 1 of 1 : SP_2015_NA0019_78_3_20150310_00002.jpg

LM Start	2.29	Rating **	M	Issue No.	3
LM End	3.04	Issue Type +	Ma	Location *	LS
Category	Earthen Levee		GPS Latitude/Longitude		
			Start	End	
Item	Vegetation		39.967015 °	°	
			-122.020781 °	°	
DWR ID	DWR_NA0019_01_f_2012_3				
Action/Comments					
Remove the wild growth other than native grasses from the levee slopes.

View of the vegetation along the landside slope.

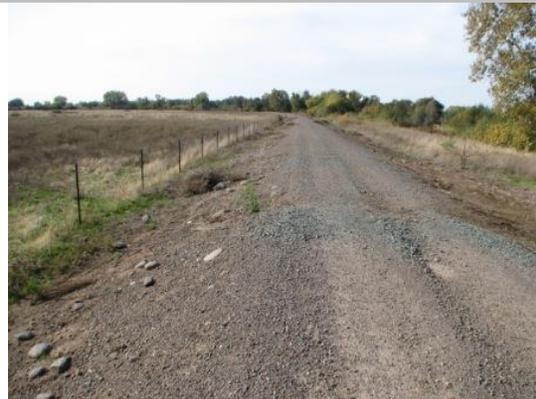
Photo 1 of 1 : SP_2015_NA0019_78_8_20150310_00003.jpg

LM Start	2.70	Rating **	M	Issue No.	8
LM End	2.73	Issue Type +	Ma	Location *	CR
Category	Earthen Levee			GPS Latitude/Longitude	
				Start	End
Item	Slope Stability			39.965434 °	39.965180 °
				-122.027776 °	-122.028331 °
DWR ID	DWR_NA0019_01_s_2012_8				
Action/Comments					
Repair the levee slope damaged by foot traffic and prevent access where possible.

Erosion on crown and both slopes.

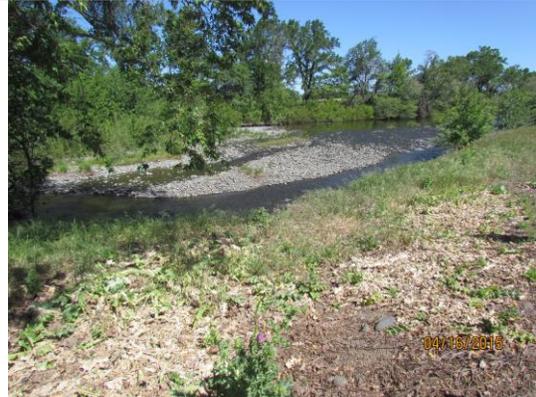
Photo 1 of 1 : SP_2015_NA0019_78_39_20150428_00028.jpg

View of the erosion along the waterside toe.

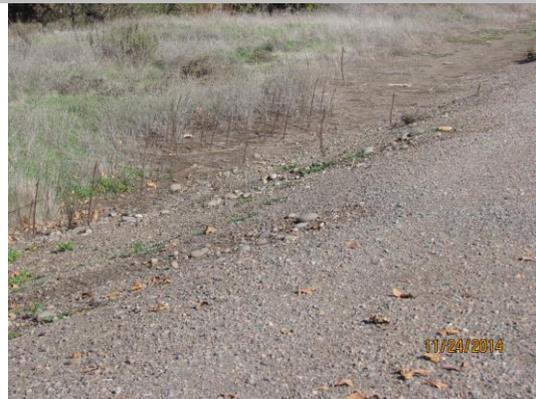
Photo 1 of 1 : SP_2015_NA0019_78_38_20150310_00014.jpg

LM Start	2.86	Rating **	M	Issue No.	38
LM End	2.86	Issue Type +	Ma	Location *	LS
Category	Earthen Levee		GPS Latitude/Longitude		
			Start	End	
Item	Slope Stability		39.963928 °	39.963928 °	
			-122.030120 °	-122.030120 °	
DWR ID	DWR_NA0019_01_f_2014_38				
Action/Comments					
Repair slope instability.

View of erosion from the cattle on both slopes.

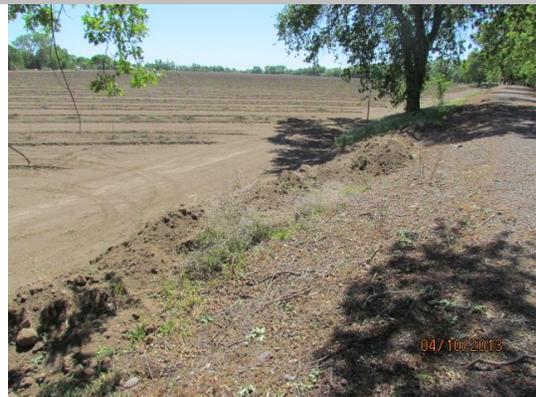
Photo 1 of 1 : SP_2015_NA0019_78_20_20150310_00012.jpg

LM Start	2.88	Rating **	M	Issue No.	20
LM End	2.88	Issue Type +	Ma	Location *	LS
Category	Earthen Levee		GPS Latitude/Longitude		
			Start	End	
Item	Slope Stability		39.963709 °	39.963709 °	
			-122.030384 °	-122.030384 °	
DWR ID	DWR_NA0019_01_s_2013_20				
Action/Comments					
Repair slope instability.

View of the erosion along the landside slope.

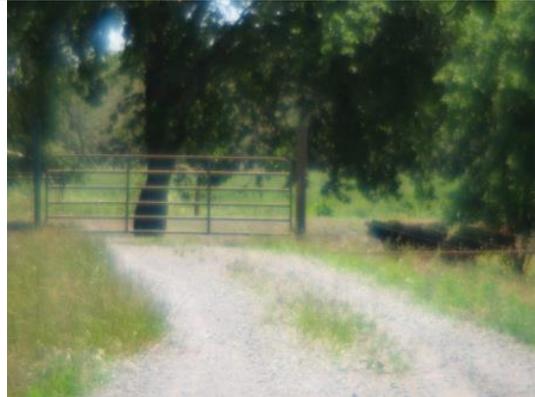
Photo 1 of 1 : SP_2015_NA0019_78_9_20150310_00004.jpg

View of the non-permitted gate on the crown of the levee.

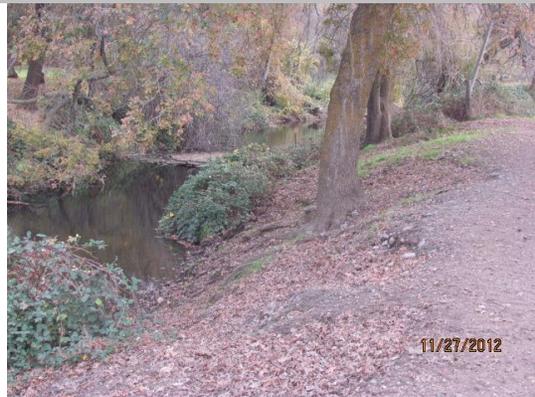
Photo 1 of 1 : SP_2015_NA0019_78_15_20150310_00007.jpg

LM Start	3.68	Rating **	M	Issue No.	15
LM End	3.68	Issue Type +	Ma	Location *	WS
Category	Earthen Levee		GPS Latitude/Longitude		
			Start	End	
Item	Slope Stability		39.945045 °	39.945045 °	
			-122.053469 °	-122.053469 °	
DWR ID	DWR_NA0019_01_f_2012_15				
Action/Comments					
Repair slope instability.

View of the erosion caused by livestock along the landside slope.

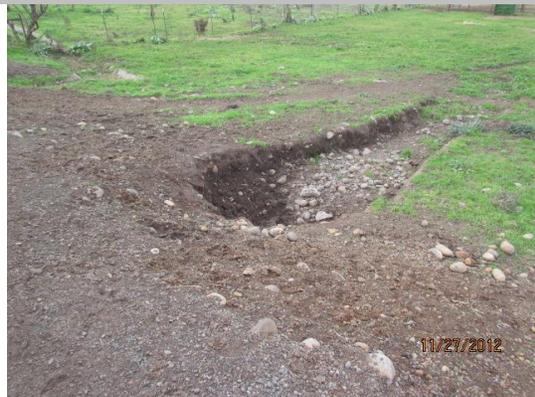
Photo 1 of 1 : SP_2015_NA0019_78_16_20150310_00008.jpg

LM Start	3.74	Rating **	M	Issue No.	16
LM End	3.74	Issue Type +	En	Location *	LS
Category	Earthen Levee		GPS Latitude/Longitude		
			Start	End	
Item	Encroachments		39.944456 °	39.944456 °	
			-122.053932 °	-122.053932 °	
DWR ID	DWR_NA0019_01_f_2012_16				
Action/Comments					
Ditch

View of the ditch along the waterside toe.

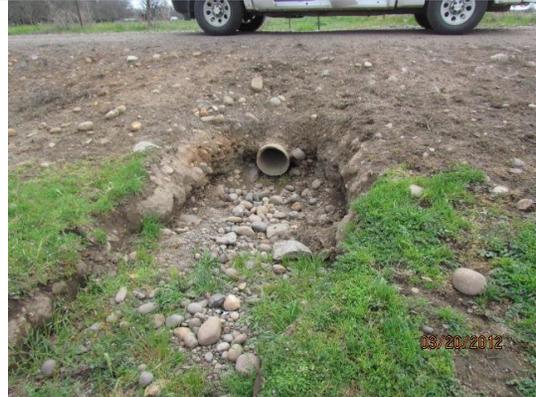
Photo 1 of 1 : SP_2015_NA0019_78_11_20150310_00006.jpg

No flap gate on 18 inch pipe going through the levee.

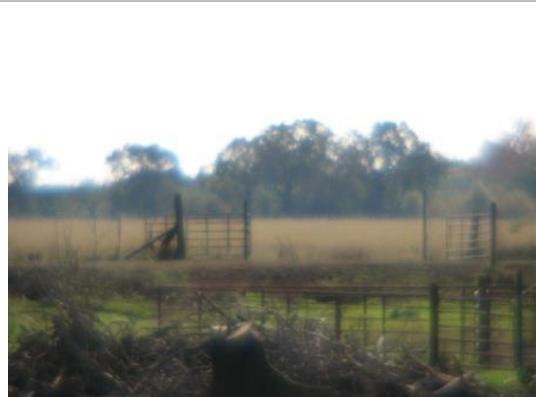
Photo 1 of 1 : SP_2015_NA0019_78_10_20150310_00005.jpg

View of the non-permitted gate on the crown roadway.

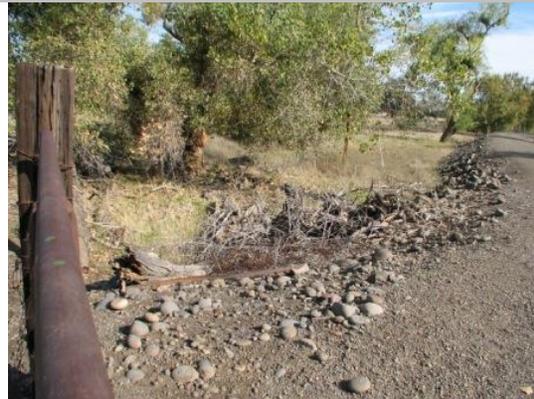
Photo 1 of 1 : SP_2015_NA0019_79_2_20150310_00001.jpg

View of debris & wire at toe of levee.

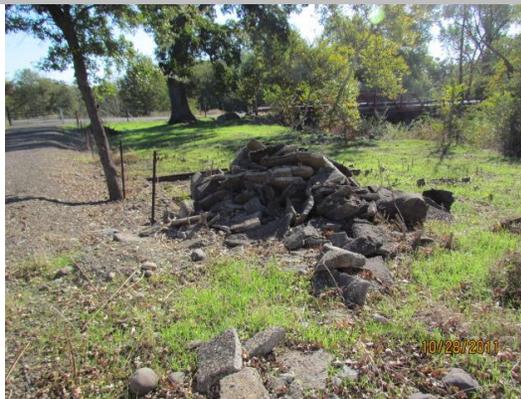
Photo 1 of 1 : SP_2015_NA0019_79_4_20150310_00003.jpg

View of the concrete pile along the W/S toe.

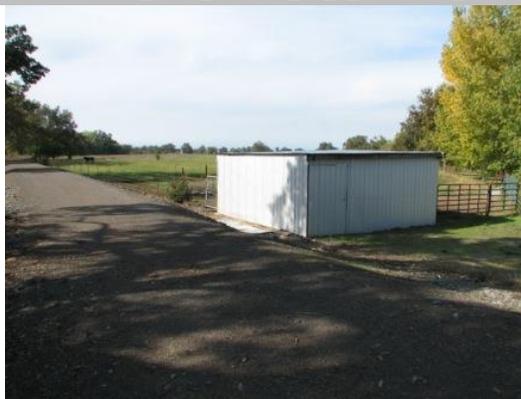
Photo 1 of 1 : SP_2015_NA0019_79_7_20150310_00005.jpg

LM Start	0.35	Rating **	M	Issue No.	7
LM End	0.35	Issue Type +	En	Location *	LS
Category	Earthen Levee		GPS Latitude/Longitude		
			Start	End	
Item	Encroachments		39.970117 °	39.970117 °	
			-122.015365 °	-122.015365 °	
DWR ID	DWR_NA0019_02_s_2012_7				
Action/Comments					
Building

View of building at toe of levee.

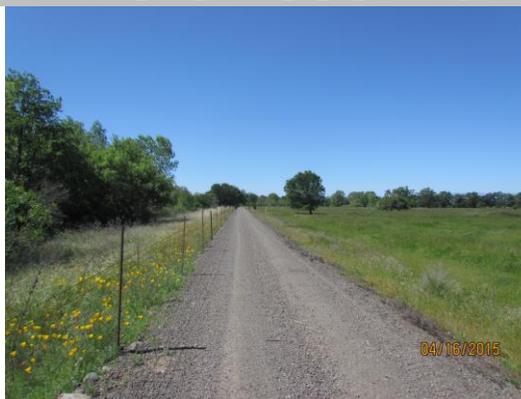
Photo 1 of 1 : SP_2015_NA0019_79_11_20150428_00007.jpg

View of the native grasses on both slopes.

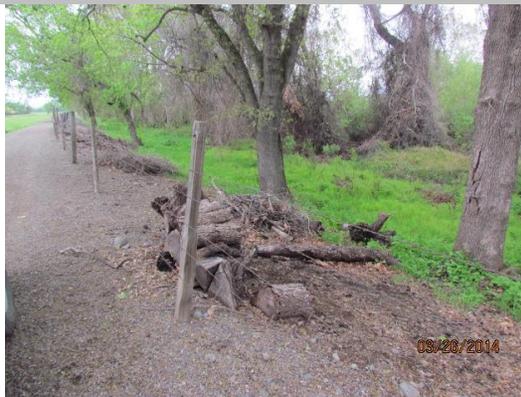
Photo 1 of 1 : SP_2015_NA0019_79_6_20150310_00004.jpg

LM Start	1.28	Rating **	M	Issue No.	6
LM End	1.28	Issue Type +	Ma	Location *	WS
Category	Earthen Levee		GPS Latitude/Longitude		
			Start	End	
Item	Encroachments		39.964883 °	39.964883 °	
			-122.030655 °	-122.030655 °	
DWR ID	DWR_NA0019_02_s_2012_6				
Action/Comments					
Firewood

Remove all firewood from the waterside slope.

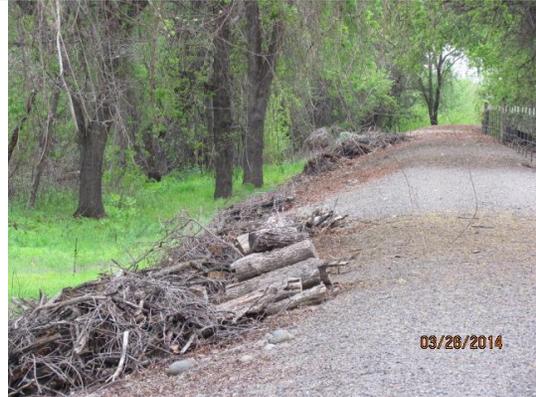
Photo 1 of 1 : SP_2015_NA0019_79_3_20150310_00002.jpg

View of the debris along the waterside slope.

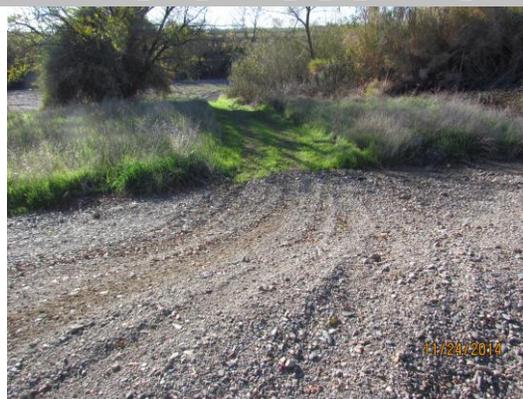
Photo 1 of 1 : SP_2015_NA0019_81_16_20150310_00007.jpg

LM Start	1.39	Rating **	M	Issue No.	16
LM End	1.39	Issue Type +	Ma	Location *	WS
Category	Earthen Levee			GPS Latitude/Longitude	
				Start	End
Item	Slope Stability			40.051493 °	40.051493 °
				-122.164935 °	-122.164935 °
DWR ID	DWR_NA0019_04_f_2014_16				
Action/Comments					
Repair the levee slope damaged by vehicle traffic and prevent access where possible.

View of the vehicle erosion along the waterside slope.

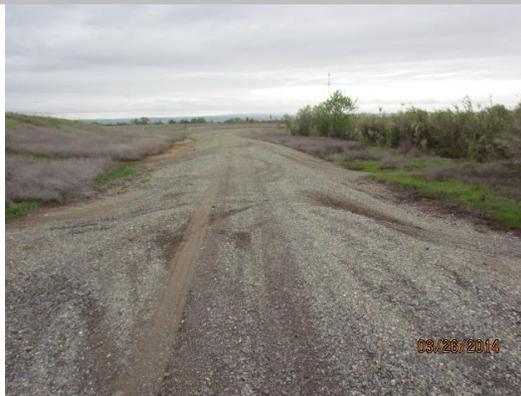
Photo 1 of 1 : SP_2015_NA0019_81_3_20150310_00003.jpg

LM Start	1.59	Rating **	M	Issue No.	3
LM End	1.69	Issue Type +	Ma	Location *	WS
Category	Earthen Levee			GPS Latitude/Longitude	
				Start	End
Item	Slope Stability			40.052607 °	40.053558 °
				-122.161418 °	-122.159903 °
DWR ID	DWR_04_s_2012_3				
Action/Comments					
Repair the levee slope damaged by vehicle traffic and prevent access where possible. Inspector Comments: Tehama Co. repaired the slope that was damaged by vehicle traffic, but the damage has returned.

View of the levee slope damaged by vehicle traffic.

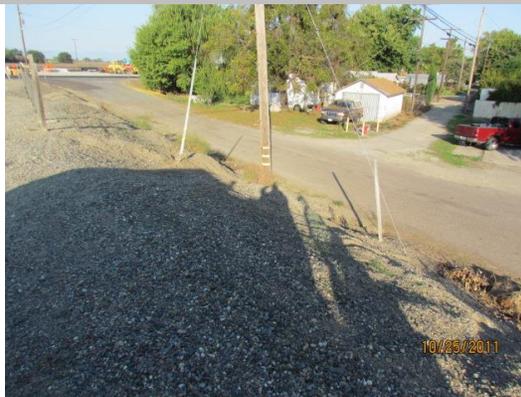
Photo 1 of 1 : SP_2015_NA0019_81_18_20150310_00009.jpg

View of the vehicle erosion along the L/S slope.

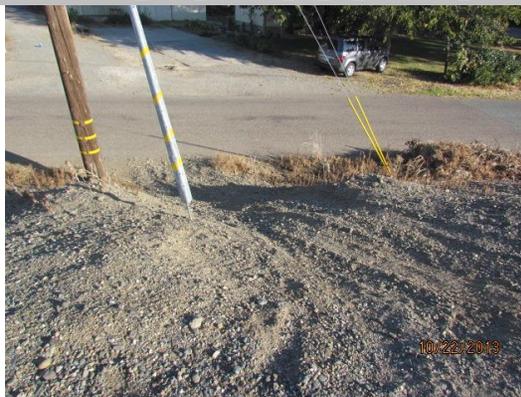
Photo 1 of 1 : SP_2015_NA0019_81_12_20150310_00006.jpg

View of the vehicle erosion along the landside slope.

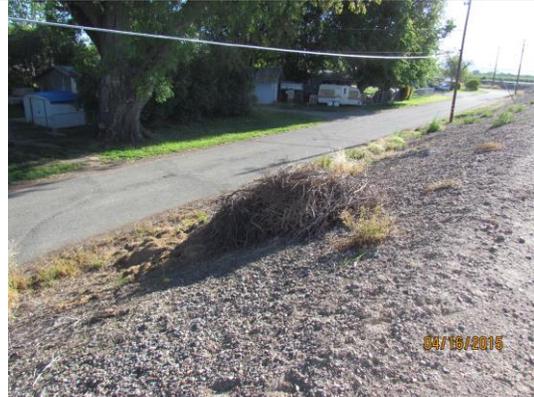
Photo 1 of 1 : SP_2015_NA0019_81_14_20150428_00014.jpg

View of the prunings along the landside slope.

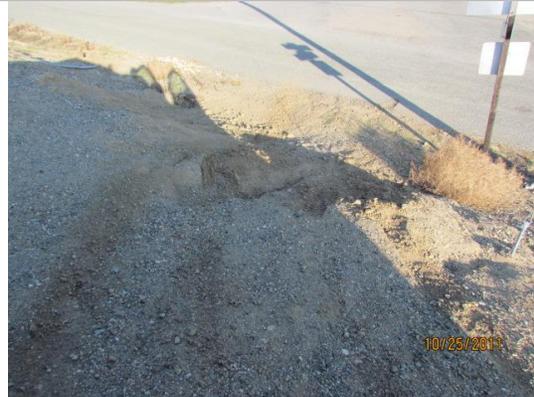
Photo 1 of 1 : SP_2015_NA0019_81_20_20150310_00010.jpg

View of the vehicle erosion along the L/S slope.

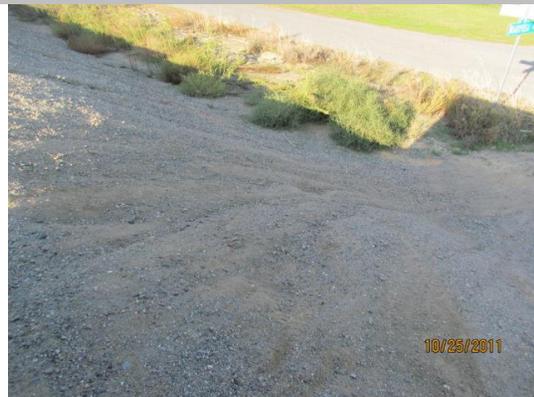
Photo 1 of 1 : SP_2015_NA0019_81_2_20150310_00002.jpg

View of the vehicle erosion along the L/S slope.

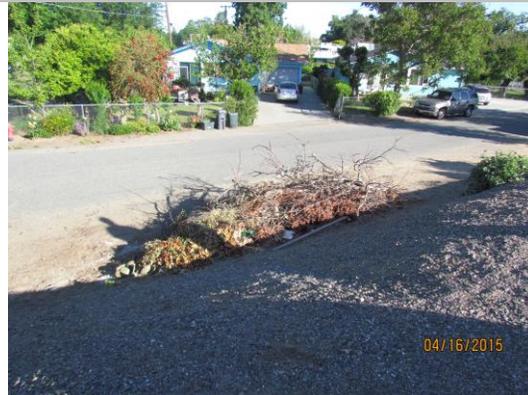
Photo 1 of 1 : SP_2015_NA0019_81_15_20150428_00015.jpg

View of the prunings along the landside toe.

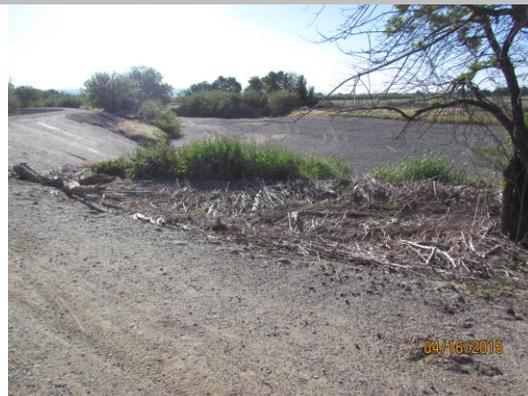
Photo 1 of 1 : SP_2015_NA0019_81_19_20150428_00016.jpg

View of the debris along the waterside slope.

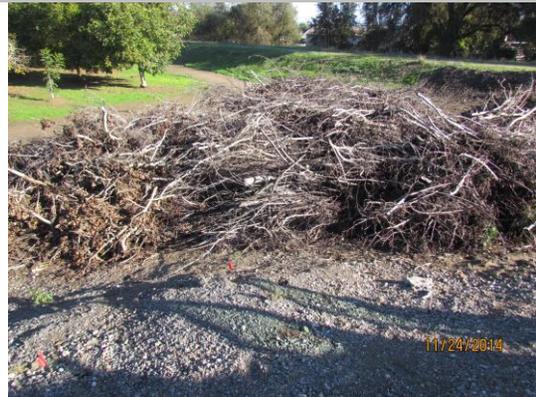
Photo 1 of 1 : SP_2015_NA0019_81_17_20150310_00008.jpg

View of the prunings along the landside slope.

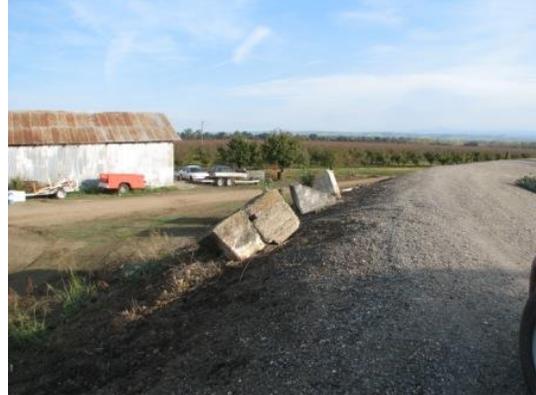
Photo 1 of 1 : SP_2015_NA0019_81_1_20150310_00001.jpg

View of the concrete stairways on the slope.

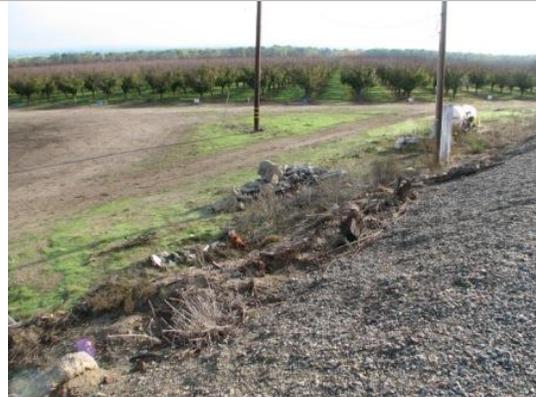
Photo 1 of 1 : SP_2015_NA0019_81_6_20150310_00004.jpg

View of the garbage and metal at the toe of the levee & along the slope of the landside.

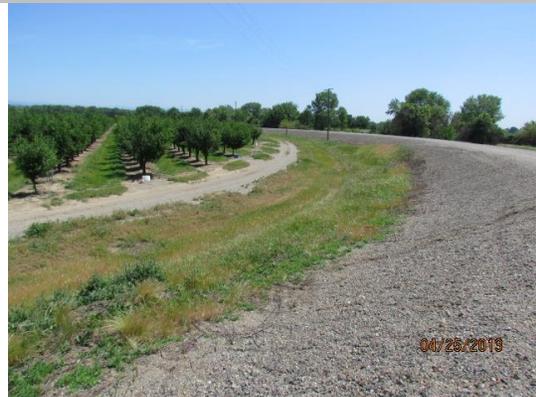
Photo 1 of 1 : SP_2015_NA0019_81_11_20150310_00005.jpg

View of the ditch along landside toe.

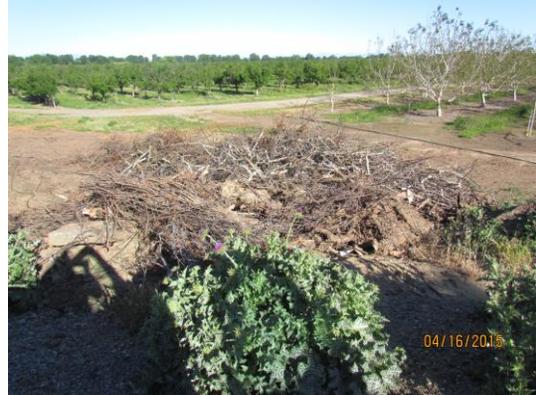
Photo 1 of 1 : SP_2015_NA0019_81_21_20150428_00017.jpg

View of the prunings along landside toe.

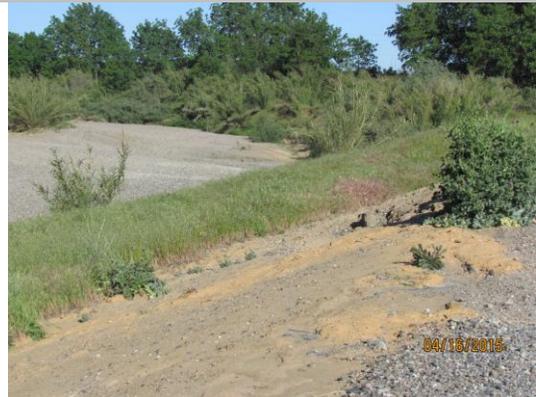
Photo 1 of 1 : SP_2015_NA0019_81_23_20150428_00018.jpg

View of the erosion along the waterside slope.

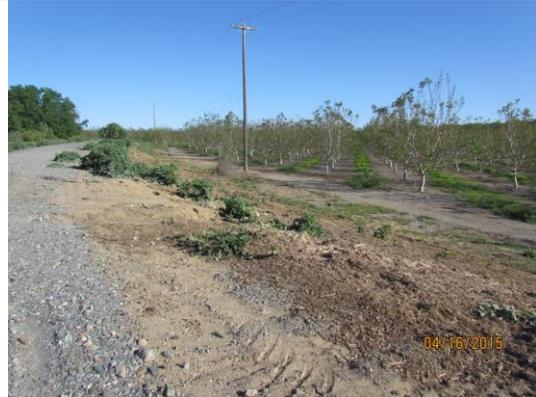
Photo 1 of 1 : SP_2015_NA0019_81_22_20150428_00019.jpg

View of the erosion along the landside slope.

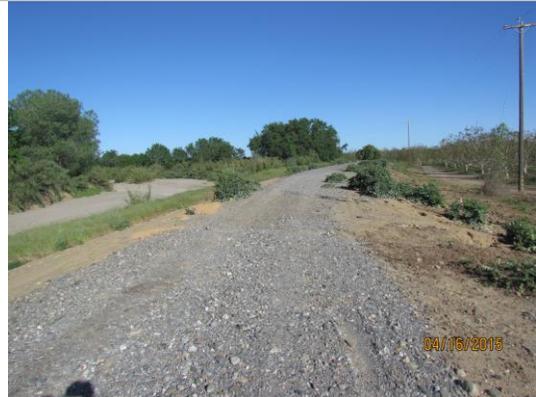
Photo 1 of 1 : SP_2015_NA0019_81_24_20150428_00020.jpg

View of the erosion on the crown roadway.

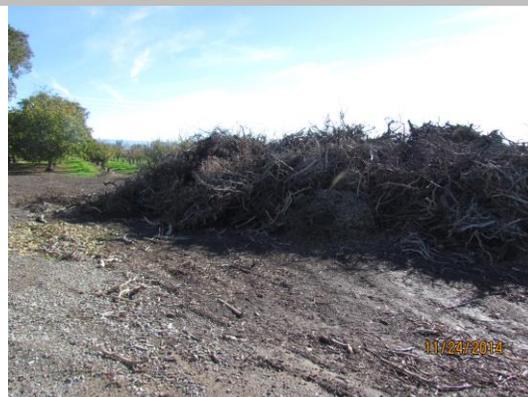
Photo 1 of 1 : SP_2015_NA0019_82_16_20150310_00007.jpg

View of the prunings along the landside slope.

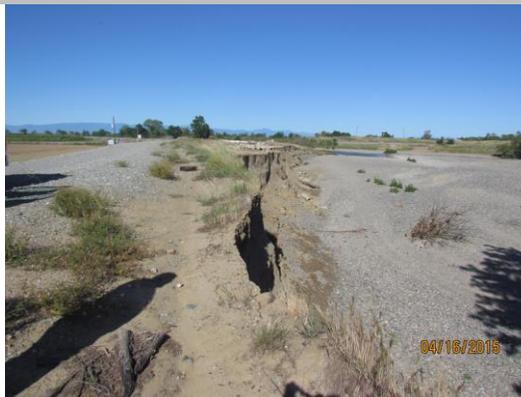
Photo 1 of 1 : SP_2015_NA0019_82_15_20150428_00013.jpg

View of the erosion along the waterside slope.

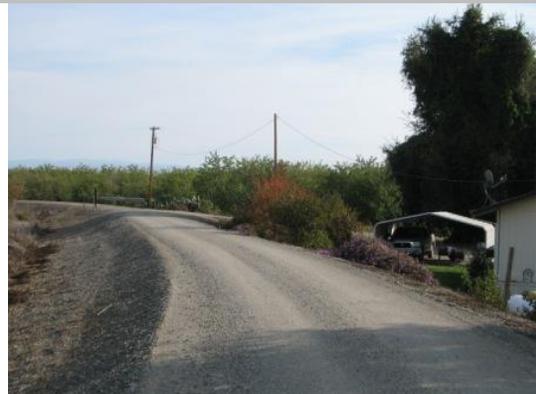
Photo 1 of 1 : SP_2015_NA0019_82_2_20150310_00002.jpg

View of the landscaping along the slope.

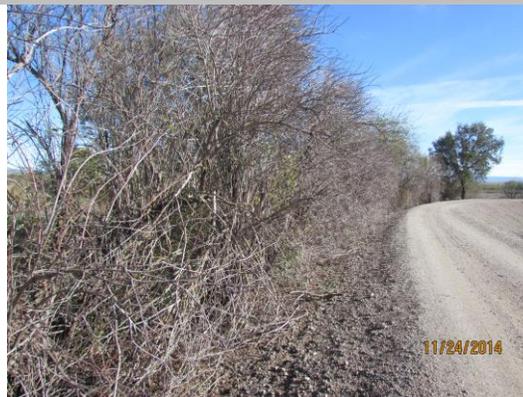
Photo 1 of 1 : SP_2015_NA0019_82_9_20150310_00006.jpg

View of the elderberries along the waterside slope and toe.
