**Flood Control Project Maintenance
Levee Inspections**

Fall 2012 Levee Maintenance Deficiency Summary Report

Yolo County Planning Resources and Public Works

Waterway		Bank	Unit Miles
Unit No. 01 Right Bank Cache Creek		Right	0.29
	Spring (March - May)	Summer (June - August)	(September - November) Fall Winter (December - February)
Unit Maintenance Rating (Fall Only)			U
Date of Inspection	03/21/2012 - 03/21/2012		10/09/2012 - 10/09/2012
DWR Inspector	John Williamson		John Williamson
Accompanied By

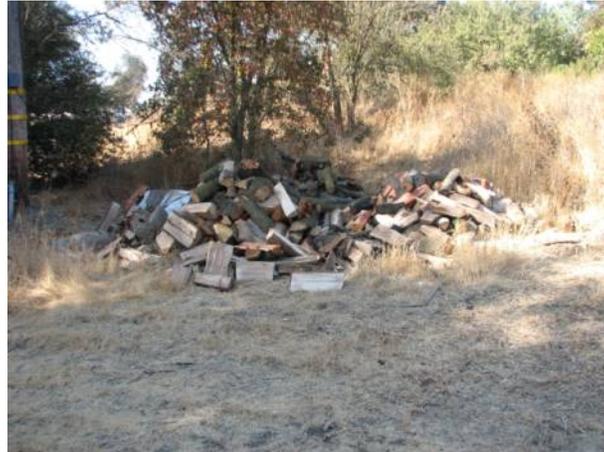
Levee Mile Report Line	4
Start Levee Mile	0.00
End Levee Mile	0.00
Location	Water Side
Category	Earthen Levee
Item	Encroachments
Firewood pile is on the levee, waterside berm area. Photo fall 2012.	
johngw_f_20121015_744.jpg

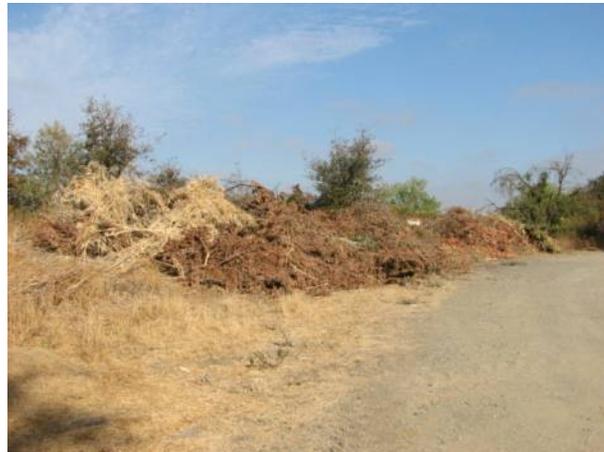
Levee Mile Report Line	5
Start Levee Mile	0.01
End Levee Mile	0.01
Location	Water Side
Category	Earthen Levee
Item	Encroachments
Pruning pile is on the waterside levee berm. Photo fall 2012.	
johngw_f_20121015_746.jpg

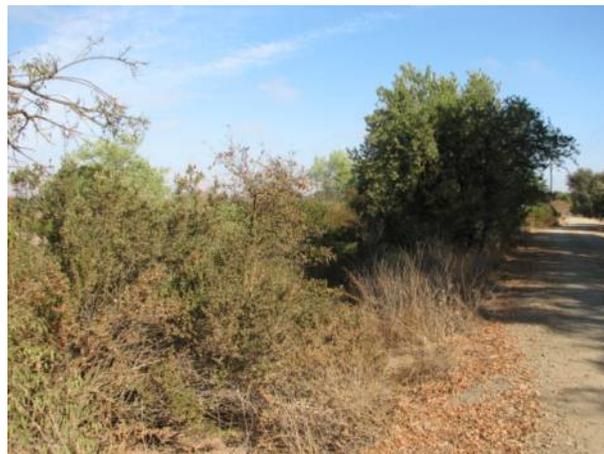
Levee Mile Report Line	6
Start Levee Mile	0.01
End Levee Mile	0.26
Location	Water Side
Category	Earthen Levee
Item	Vegetation
Vegetation and brush is taller than 12 inches. No visibility of the waterside berm. Photo fall 2012.	
johngw_f_20121015_745.jpg

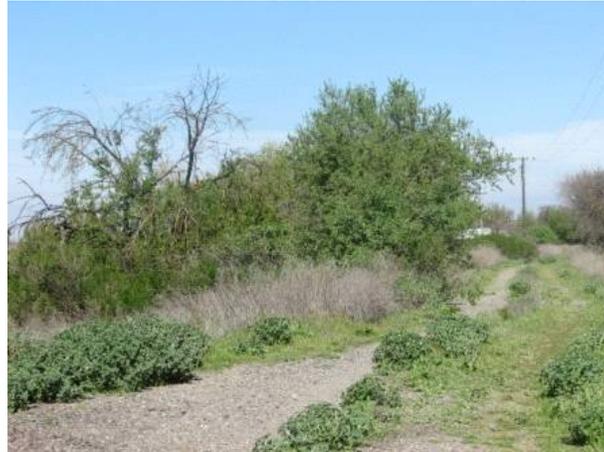
Levee Mile Report Line	8
Start Levee Mile	0.03
End Levee Mile	0.03
Location	Water Side
Category	Earthen Levee
Item	Vegetation
Photo taken spring 2012, a large Elerberry on the waterside.	
johngw_f_20120911_272.jpg

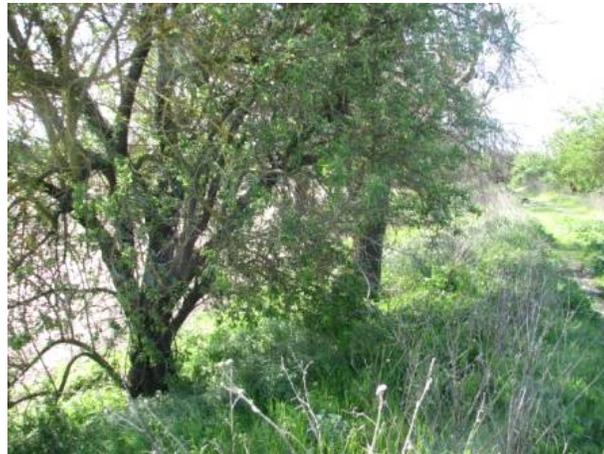
Levee Mile Report Line	9
Start Levee Mile	0.03
End Levee Mile	0.06
Location	Land Side
Category	Earthen Levee
Item	Trim / Thin Trees
The trees need to be thinned and trimmed up for visibility.	
johngw_f_20120911_275.jpg

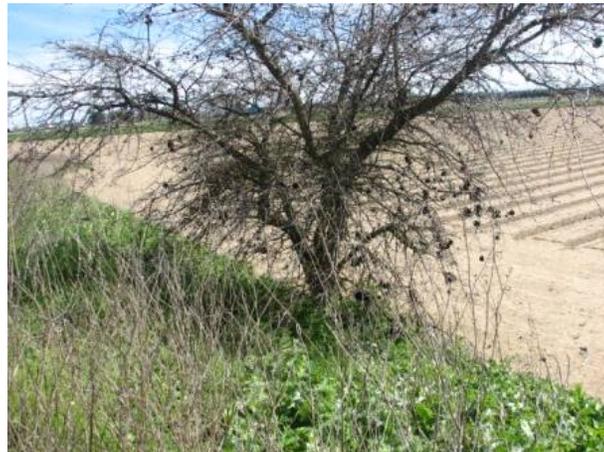
Levee Mile Report Line	10
Start Levee Mile	0.08
End Levee Mile	0.08
Location	Land Side
Category	Earthen Levee
Item	Trim / Thin Trees
The landside tree need to be raised up to meet the standards.	
johngw_f_20120911_276.jpg

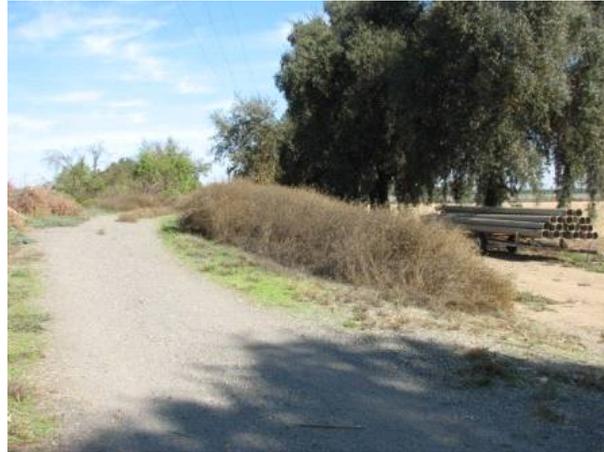
Levee Mile Report Line	11
Start Levee Mile	0.08
End Levee Mile	0.26
Location	Land Side
Category	Earthen Levee
Item	Vegetation
<p>The vegetation is taller than 12 inches tall. Photo taken fall 2011.</p>	
<p>johngw_f_20120911_260.jpg</p>

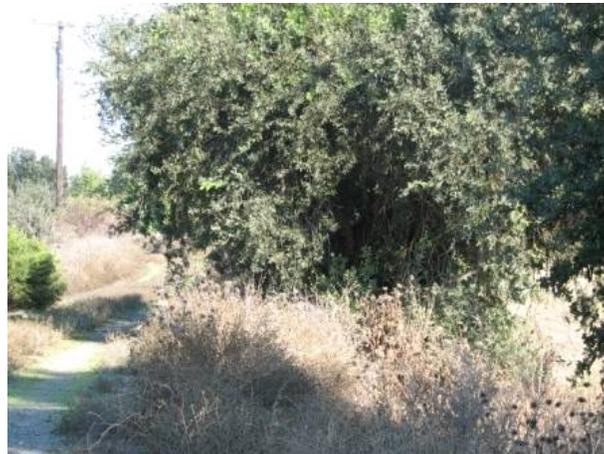
Levee Mile Report Line	12
Start Levee Mile	0.13
End Levee Mile	0.13
Location	Land Side
Category	Earthen Levee
Item	Trim / Thin Trees
<p>The tree on the landside of the levee needs to be trimmed up. Photo taken fall 2011.</p>	
<p>johngw_f_20120911_267.jpg</p>

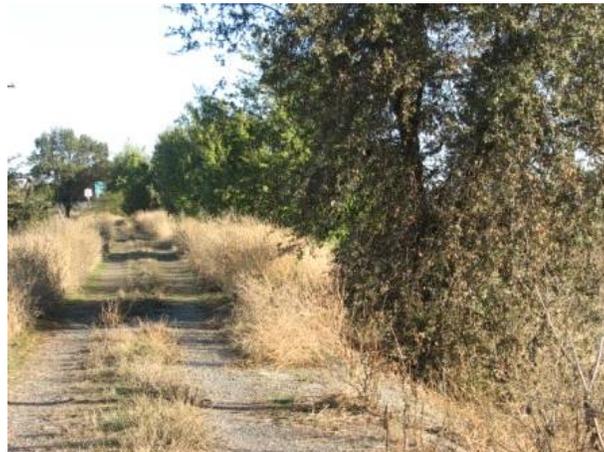
Levee Mile Report Line	13
Start Levee Mile	0.15
End Levee Mile	0.15
Location	Land Side
Category	Earthen Levee
Item	Trim / Thin Trees
<p>All trees on the landside need to be raised. This view is looking downstream.</p>	
<p>johngw_f_20120911_268.jpg</p>

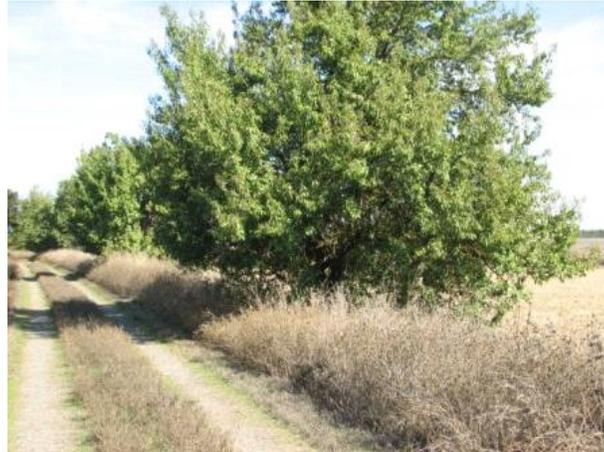
Levee Mile Report Line	14
Start Levee Mile	0.17
End Levee Mile	0.17
Location	Land Side
Category	Earthen Levee
Item	Trim / Thin Trees
The tree needs to be trimmed up for visibility photo taken fall 2011.	
johngw_f_20120911_269.jpg

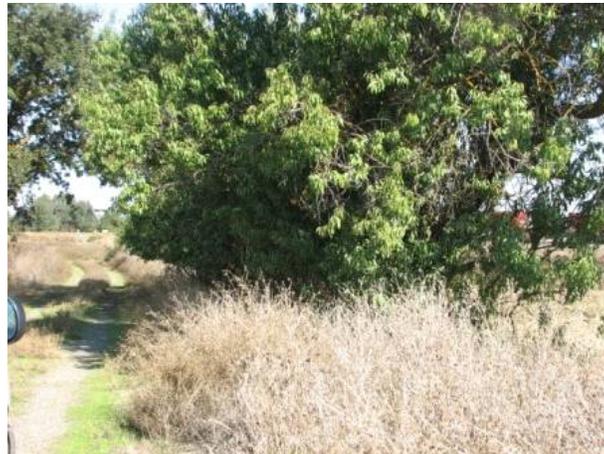
Levee Mile Report Line	15
Start Levee Mile	0.21
End Levee Mile	0.21
Location	Land Side
Category	Earthen Levee
Item	Trim / Thin Trees
The tree needs to be trimmed up for visibility photo taken fall 2011.	
johngw_f_20120911_270.jpg

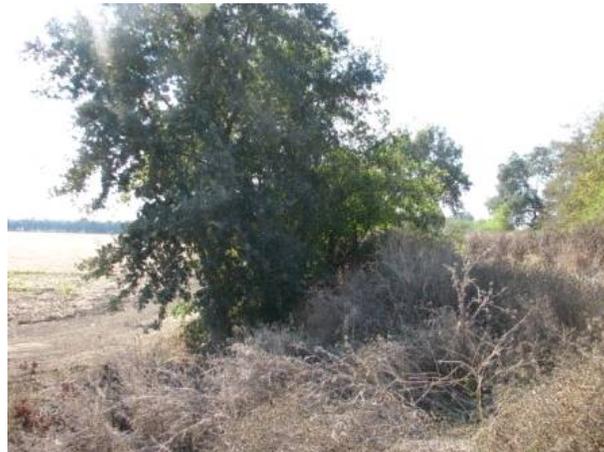
Levee Mile Report Line	16
Start Levee Mile	0.24
End Levee Mile	0.24
Location	Land Side
Category	Earthen Levee
Item	Trim / Thin Trees
The tree needs to be trimmed up. Photo taken fall of 2011.	
johngw_f_20120911_271.jpg
