**Flood Control Project Maintenance
Levee Inspections**
LMA District Cover Sheet
Spring 2016 Levee Inspection Results

Yolo County Planning Resources and Public Works

Spring 2016 Levee Inspection Results

Waterway		Bank	Unit Miles
Unit No. 01 Right Bank Cache Creek		Right	0.59

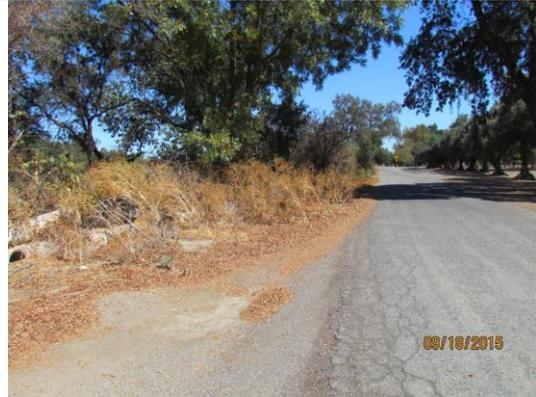
Photo 1 of 1 : SP_2016_NA0021_351_3_20160223_00004.jpg

LM Start	0.03	Rating **	M	Issue No.	3
LM End	0.30	Issue Type +	Ma	Location *	WS
Category	Earthen Levee		GPS Latitude/Longitude		
			Start	End	
Item	Vegetation		38.720879 °	38.722983 °	
			-121.810499 °	-121.806860 °	
DWR ID	DWR_NA0021_01_f_2015_3				
Comment Code					
V1 : Control annual grass and weeds on the levee slopes and easements.					
Inspector Comment

View of the vegetation on the waterward side of the levee looking downstream. Fall 2015.

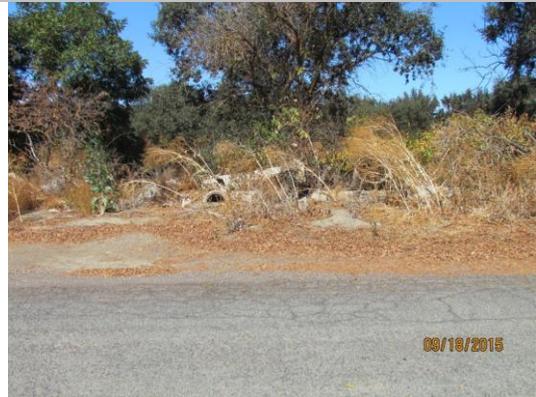
Photo 1 of 1 : SP_2016_NA0021_351_15_20160223_00015.jpg

LM Start	0.03	Rating **	M	Issue No.	15
LM End	0.03	Issue Type +	Ma	Location *	WS
Category	Earthen Levee		GPS Latitude/Longitude		
			Start	End	
Item	Encroachments		38.720895 °	38.720895 °	
			-121.810408 °	-121.810408 °	
DWR ID	DWR_NA0021_01_f_2015_15				
Comment Code					
DE : Debris					
Inspector Comment

View of the debris on the waterward side of the levee. Fall 2015.

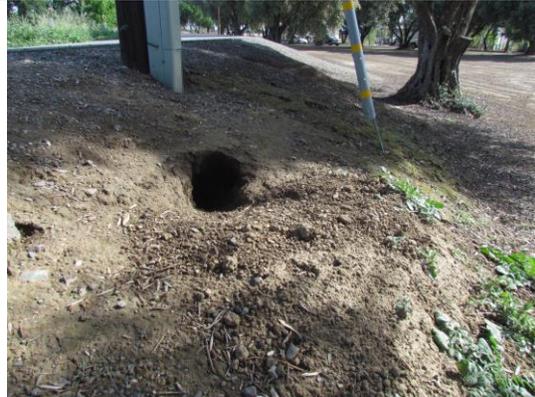
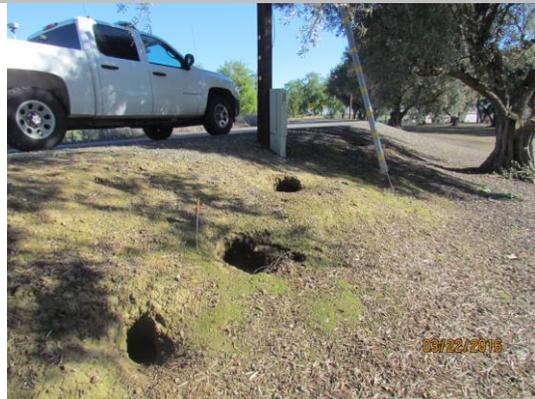
LM Start	0.19	Rating **	U	Issue No.	16
LM End	0.19	Issue Type +	Ma	Location *	LS
Category	Earthen Levee		GPS Latitude/Longitude		
			Start	End	
Item	Animal Control		38.721536 °	38.721536 °	
			-121.807711 °	-121.807711 °	
DWR ID	DWR_NA0021_01_s_2015_16				
Comment Code					
A3 : No rodents visible, but rodent burrows visible; need to backfill and compact or grout burrows.					
Inspector Comment

View of the rodent hole on the landward side of the levee looking downstream. Spring 2015.

View of the rodent holes on the landward side of the levee looking downstream. Spring 2016.

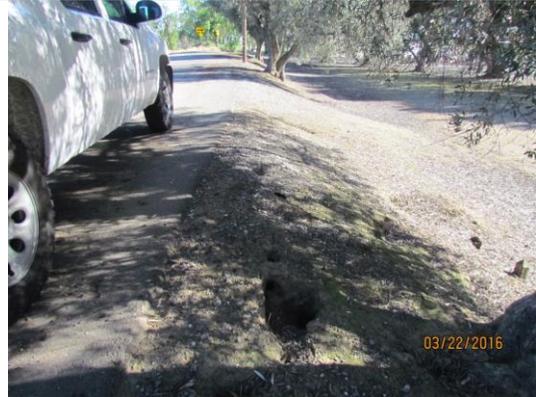
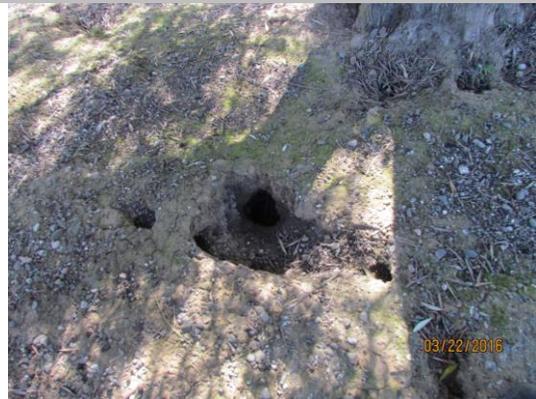
LM Start	0.20	Rating **	M	Issue No.	7
LM End	0.20	Issue Type +	Ma	Location *	LS
Category	Earthen Levee			GPS Latitude/Longitude	
				Start	End
Item	Animal Control			38.721683 °	38.721683 °
				-121.807532 °	-121.807532 °
DWR ID	DWR_NA0021_01_s_2016_7				
Comment Code					
A3 : No rodents visible, but rodent burrows visible; need to backfill and compact or grout burrows.					
Inspector Comment

Perspective view of the rodent hole on the landward side of the levee looking downstream. Spring 2016.

Animal hole is close to the shoulder of the levee. Spring 2016.

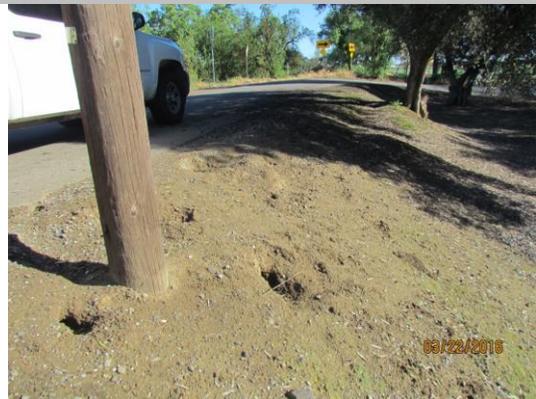
Photo 1 of 1 : SP_2016_NA0021_351_8_20160407_00030.jpg

LM Start	0.22	Rating **	U	Issue No.	8
LM End	0.22	Issue Type +	Ma	Location *	LS
Category	Earthen Levee			GPS Latitude/Longitude	
				Start	End
Item	Animal Control			38.721876 °	38.721876 °
				-121.807393 °	-121.807393 °
DWR ID	DWR_NA0021_01_s_2016_8				
Comment Code					
A3 : No rodents visible, but rodent burrows visible; need to backfill and compact or grout burrows.					
Inspector Comment

View of the rodent holes on the landward side of the levee looking downstream. Spring 2016.

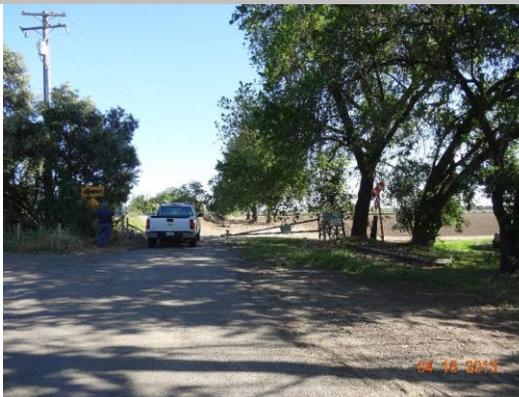
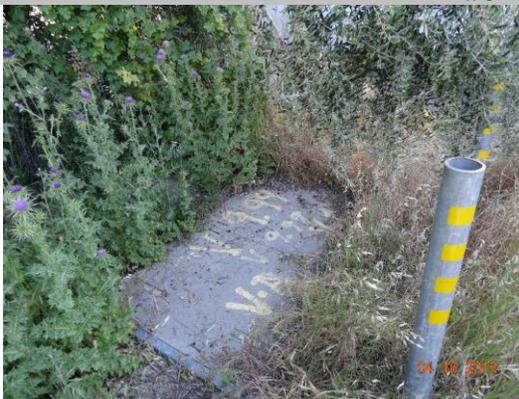
LM Start	0.24	Rating **	M	Issue No.	23
LM End	0.24	Issue Type +	En	Location *	LS
Category	Supplemental		GPS Latitude/Longitude		
			Start	End	
Item	DWR UCIP Field Study		38.722162 °	38.722162 °	
			-121.807223 °	-121.807223 °	
DWR ID					
Comment Code					
Inspector Comment					
FS_ID:39855 DS_ID:19554 EP_NO: 6790 Repair Type: Non-Urgent Crossing Status: Indicator Found UCIP Comments: Need to contact owner to determine if crossing is still active and to determine last inspection date. Will need copy of letter showing crossings passed inspection. FIELD_STRUCT_DESC: 6-inch gas line through levee, 4-feet below the crown. Pipe extends from borrow area and under the channel. Bleeder valve on waterward bank. Service vault located on landward side next to access gate. Paved access ramp on landward slope. (Permit No. 6790-1970) FS Date: 4/16/2013

View of landward side near access gate. Gas line marker located on between trees. Line runs parallel to access roadway and through levee.

Service vault located on landward toe near gate access gate.

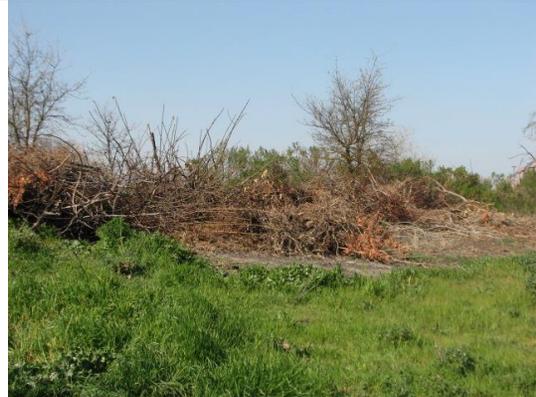
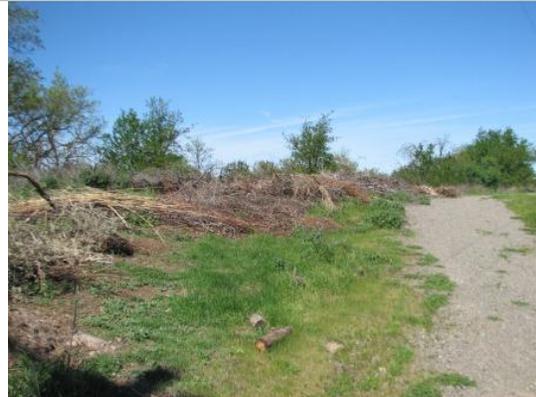
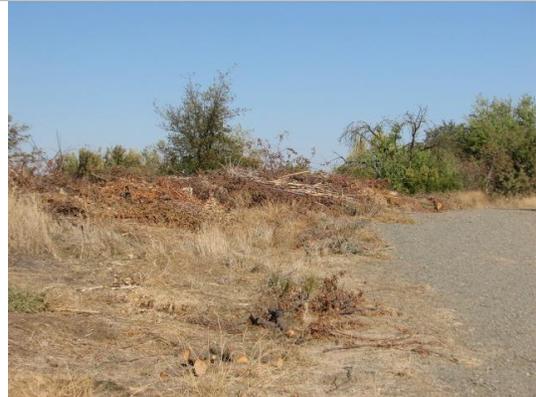
LM Start	0.26	Rating **	M	Issue No.	4
LM End	0.26	Issue Type +	Ma	Location *	WS
Category	Earthen Levee		GPS Latitude/Longitude		
			Start	End	
Item	Encroachments		38.722418 °	38.722418 °	
			-121.806999 °	-121.806999 °	
DWR ID	DWR_NA0021_01_s_2012_4				
Comment Code					
PR : Prunings					
Inspector Comment

A continuous brush pile on levee. Spring 2013

The brush pile did not get burned this last winter. Spring 2014

The latest look of the ongoing brush pile. Fall 2013

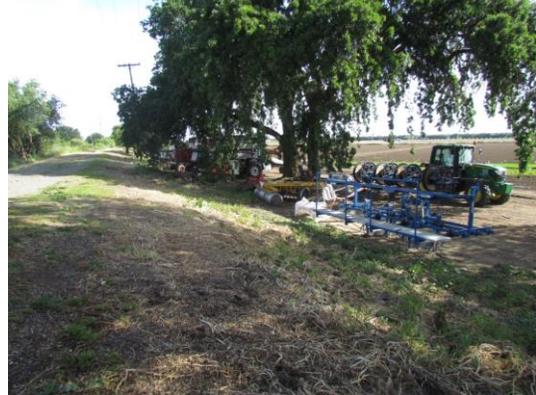
Photo 1 of 1 : SP_2016_NA0021_351_18_20160223_00018.jpg

LM Start	0.26	Rating **	M	Issue No.	18
LM End	0.26	Issue Type +	En	Location *	LS
Category	Earthen Levee		GPS Latitude/Longitude		
			Start	End	
Item	Encroachments		38.722424 °	38.722424 °	
			-121.806977 °	-121.806977 °	
DWR ID	DWR_NA0021_01_s_2015_18				
Comment Code					
EQ : Equipment					
Inspector Comment

View of equipments on the landward side of the levee looking downstream. Spring 2015.

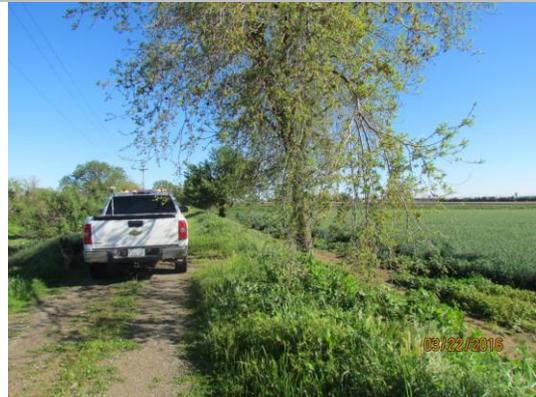
Photo 1 of 1 : SP_2016_NA0021_351_19_20160407_00031.jpg

LM Start	0.26	Rating **	M	Issue No.	19
LM End	0.49	Issue Type +	Ma	Location *	LS
Category	Earthen Levee		GPS Latitude/Longitude		
			Start	End	
Item	Vegetation		38.722473 °	38.725799 °	
			-121.806987 °	-121.806515 °	
DWR ID	DWR_NA0021_01_s_2016_19				
Comment Code					
V1 : Control annual grass and weeds on the levee slopes and easements.					
Inspector Comment

View of the vegetation on the landward side of the levee looking downstream. Spring 2016.

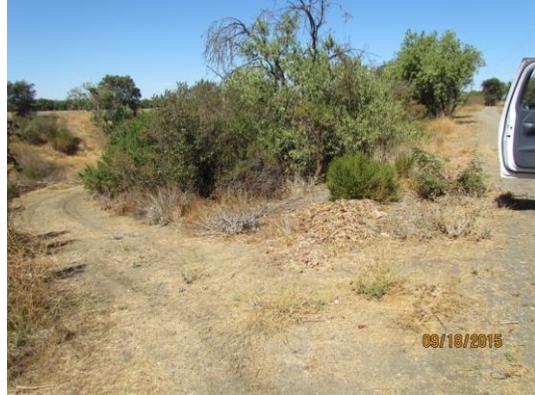
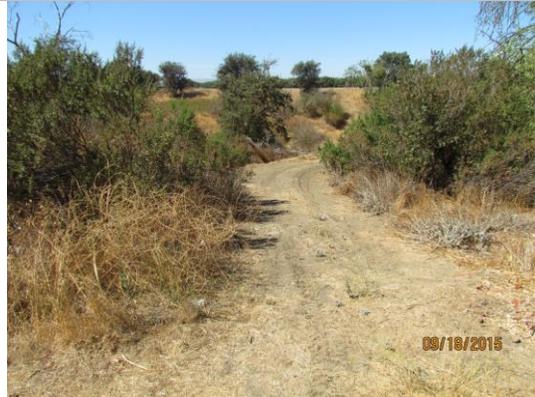
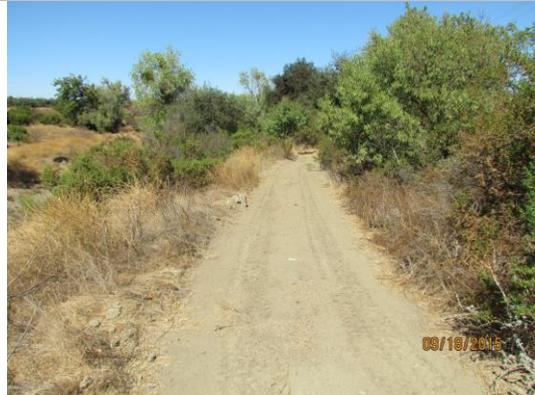
LM Start	0.27	Rating **	M	Issue No.	22
LM End	0.27	Issue Type +	Ma	Location *	WS
Category	Earthen Levee			GPS Latitude/Longitude	
				Start	End
Item	Slope Stability			38.722620 °	38.722620 °
				-121.806958 °	-121.806958 °
DWR ID	DWR_NA0021_01_f_2015_22				
Comment Code					
S3 : Repair the levee slope damaged by vehicle traffic and prevent access where possible.					
Inspector Comment					
A vehicle ramp seems to have been made.

Perspective view of the trail on the waterward side of the levee looking downstream. Fall 2015.

View of the trail on the waterward side of the levee. Fall 2015.

The trail seems to be an access point that leads down to Cache Creek. Fall 2015.

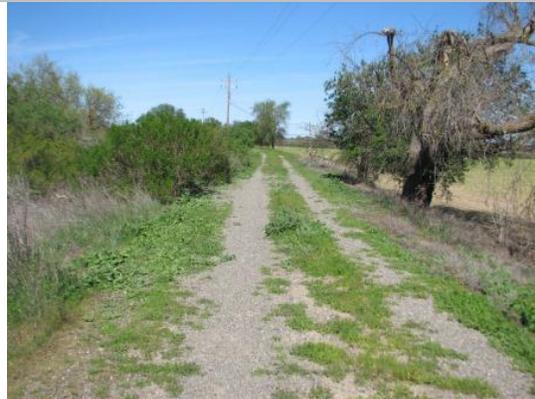
Photo 1 of 1 : SP_2016_NA0021_351_13_20160223_00013.jpg

LM Start	0.30	Rating **	M	Issue No.	13
LM End	0.50	Issue Type +	Ma	Location *	CR
Category	Earthen Levee		GPS Latitude/Longitude		
			Start	End	
Item	Vegetation		38.723017 °	38.725844 °	
			-121.806879 °	-121.806516 °	
DWR ID	DWR_NA0021_01_s_2014_13				
Comment Code					
V9 : Keep the crown roadway free of vegetation.					
Inspector Comment

Vegetation on the crown needs to be controlled. Spring 2014

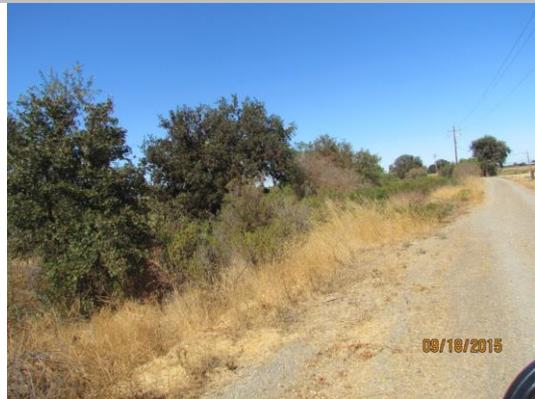
Photo 1 of 1 : SP_2016_NA0021_351_17_20160223_00017.jpg

LM Start	0.30	Rating **	U	Issue No.	17
LM End	0.50	Issue Type +	Ma	Location *	WS
Category	Earthen Levee		GPS Latitude/Longitude		
			Start	End	
Item	Vegetation		38.723041 °	38.725887 °	
			-121.806877 °	-121.806550 °	
DWR ID	DWR_NA0021_01_s_2012_17				
Comment Code					
V2 : Remove the wild growth other than native grasses from the levee slopes.					
Inspector Comment

View of the vegetation on the waterward side of the levee looking downstream. Fall 2015.

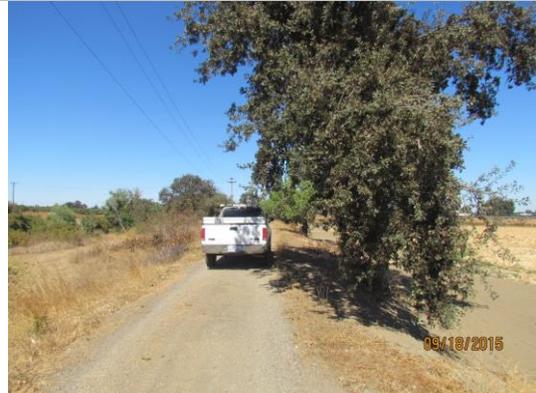
Photo 1 of 1 : SP_2016_NA0021_351_6_20160223_00008.jpg

LM Start	0.36	Rating **	M	Issue No.	6
LM End	0.36	Issue Type +	Ma	Location *	LS
Category	Earthen Levee		GPS Latitude/Longitude		
			Start	End	
Item	Trim / Thin Trees		38.723903 °	38.723903 °	
			-121.806613 °	-121.806613 °	
DWR ID	DWR_NA0021_01_s_2012_6				
Comment Code					
T1 : Trim trees to at least five feet above ground level.					
Inspector Comment

View of the tree on the landward side of the levee looking downstream. Fall 2015.

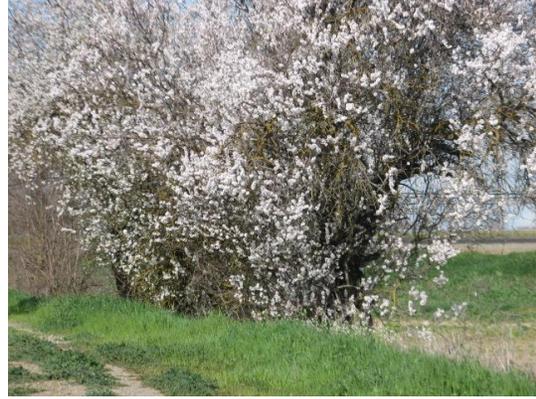
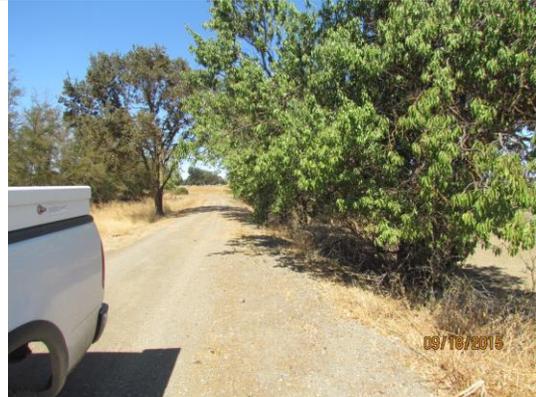
LM Start	0.44	Rating **	M	Issue No.	9
LM End	0.44	Issue Type +	Ma	Location *	LS
Category	Earthen Levee		GPS Latitude/Longitude		
			Start	End	
Item	Trim / Thin Trees		38.725022 °	38.725022 °	
			-121.806478 °	-121.806478 °	
DWR ID	DWR_NA0021_01_s_2012_9				
Comment Code					
T1 : Trim trees to at least five feet above ground level.					
Inspector Comment

Trees need to be trimmed to 5'. Spring 2013

View of the tree that needs to be trimmed on the landward side of the levee looking downstream. Fall 2015.

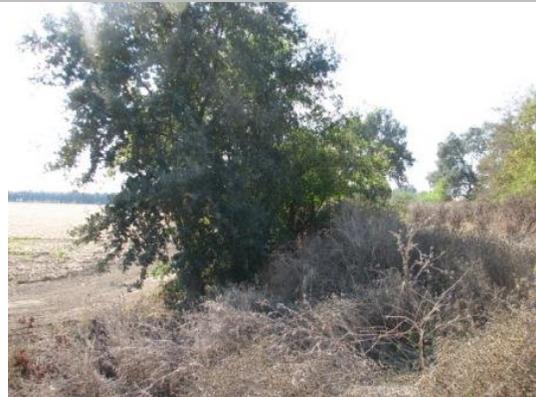
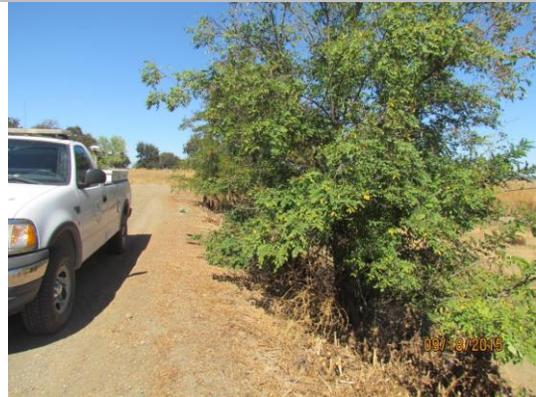
LM Start	0.47	Rating **	M	Issue No.	10
LM End	0.47	Issue Type +	Ma	Location *	LS
Category	Earthen Levee			GPS Latitude/Longitude	
				Start	End
Item	Trim / Thin Trees			38.725427 °	38.725427 °
				-121.806470 °	-121.806470 °
DWR ID	DWR_NA0021_01_s_2012_10				
Comment Code					
T1 : Trim trees to at least five feet above ground level.					
Inspector Comment

The tree needs to be trimmed up. Photo taken fall of 2011.

View of the tree on the landwardside of the levee looking downstream. Fall 2015.
