**Flood Control Project Maintenance
Levee Inspections**

Maintenance Issue Types Only, Levee Inspection Report By Mile - Spring 2015

Yolo County Planning Resources and Public Works

Waterway	Bank	Unit Miles	Inspection Start/End	Inspector
Unit No. 01 Right Bank Cache Creek	Right	0.59	04/09/2015 04/09/2015	Jai Lor

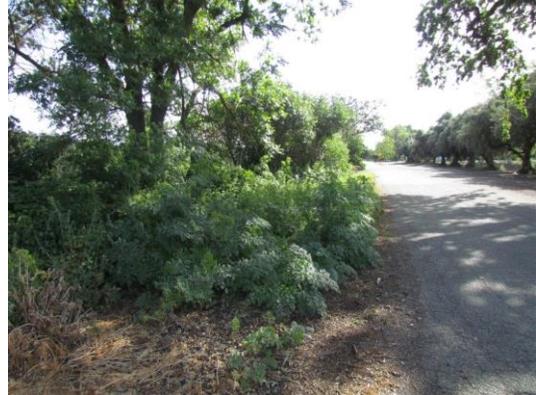
Photo 1 of 1 : SP_2015_NA0021_351_3_20150413_00018.jpg

LM Start	0.03	Rating **	U	Issue No.	3
LM End	0.03	Issue Type +	Ma	Location *	WS
Category	Earthen Levee		GPS Latitude/Longitude		
			Start	End	
Item	Vegetation		38.720908 °	38.720908 °	
			-121.810398 °	-121.810398 °	
DWR ID	DWR_NA0021_01_s_2015_3				
Action/Comments					
Control annual grass and weeds on the levee slopes and easements.

View of vegetation on the waterward side of the levee looking downstream. Spring 2015.

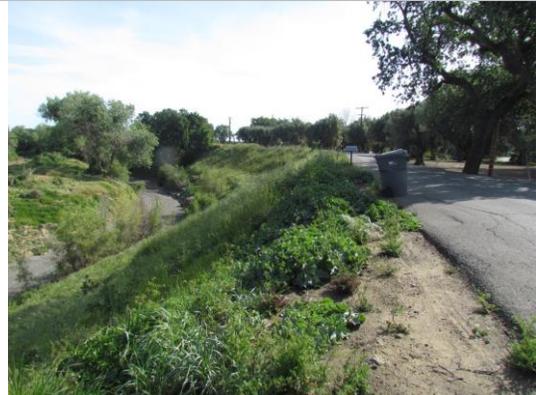
Photo 1 of 1 : SP_2015_NA0021_351_15_20150413_00019.jpg

LM Start	0.14	Rating **	M	Issue No.	15
LM End	0.47	Issue Type +	Ma	Location *	WS
Category	Earthen Levee		GPS Latitude/Longitude		
			Start	End	
Item	Vegetation		38.721297 °		
			-121.808512 °		
DWR ID	DWR_NA0021_01_s_2015_15				
Action/Comments					
Control annual grass and weeds on the levee slopes and easements.

View of vegetation on the waterward side of the levee looking downstream. Spring 2015.

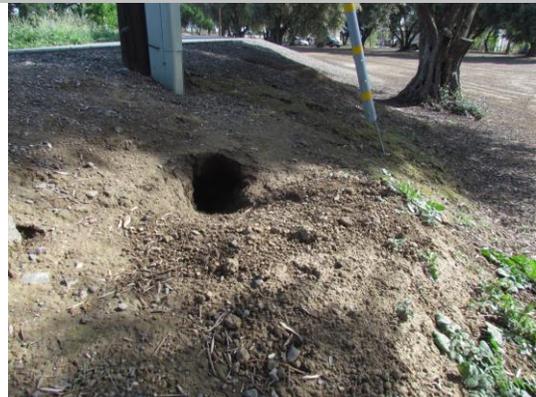
Photo 1 of 1 : SP_2015_NA0021_351_16_20150413_00020.jpg

LM Start	0.18	Rating **	U	Issue No.	16
LM End	0.22	Issue Type +	Ma	Location *	LS
Category	Earthen Levee		GPS Latitude/Longitude		
			Start	End	
Item	Animal Control		38.721542 °	38.721918 °	
			-121.807778 °	-121.807373 °	
DWR ID	DWR_NA0021_01_s_2015_16				
Action/Comments					
Exterminate rodents and backfill and compact or grout burrows.

View of the rodent hole on the landward side of the levee looking downstream. Spring 2015.

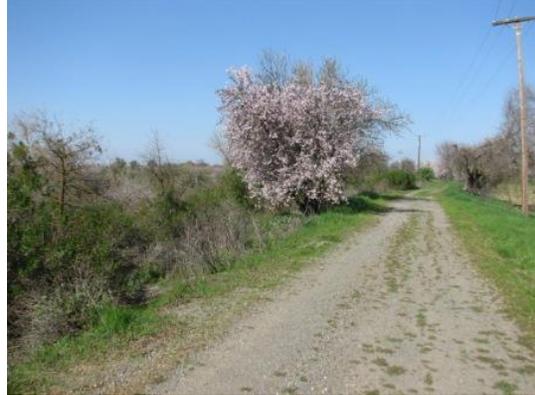
Photo 1 of 3 : SP_2015_NA0021_351_17_20150401_00014.jpg

LM Start	0.25	Rating **	U	Issue No.	17
LM End	0.50	Issue Type +	Ma	Location *	WS
Category	Earthen Levee			GPS Latitude/Longitude	
				Start	End
Item	Vegetation			38.722220 °	38.725887 °
				-121.806966 °	-121.806550 °
DWR ID	DWR_NA0021_01_s_2012_17				
Action/Comments					
Remove the wild growth other than native grasses from the levee slopes.

Vegetation and brush is taller than 12 inches. No visibility of the waterside berm. Spring 2013

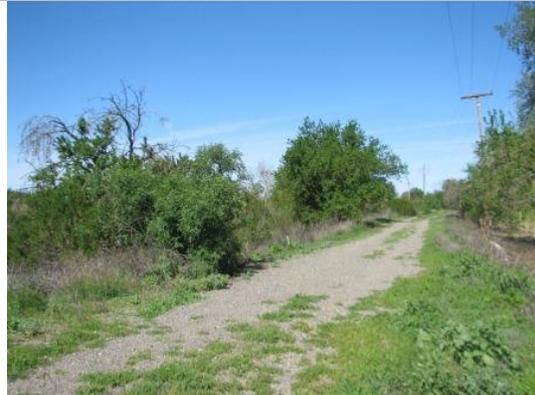
Photo 2 of 3 : SP_2015_NA0021_351_17_20150401_00015.jpg

Tall grasses and brush on the waterside berm area. Spring 2014

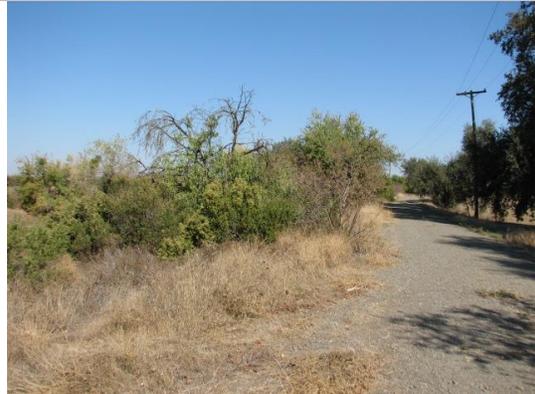
Photo 3 of 3 : SP_2015_NA0021_351_17_20150401_00016.jpg

The vegetation on the waterside is over grown. Fall 2013

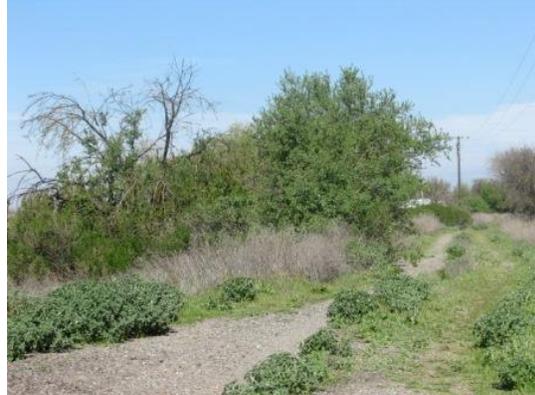
Photo 1 of 1 : SP_2015_NA0021_351_14_20150401_00013.jpg

LM Start	0.27	Rating **	A/W	Issue No.	14
LM End	0.27	Issue Type +	Ma	Location *	WS
Category	Earthen Levee		GPS Latitude/Longitude		
			Start	End	
Item	Vegetation		38.722633 °	38.722633 °	
			-121.806938 °	-121.806938 °	
DWR ID	DWR_NA0021_01_s_2012_14				
Action/Comments					
Elderberries are blocking visibility and flood fight capability.

Photo taken spring 2012, a large Elderberry on the waterside.

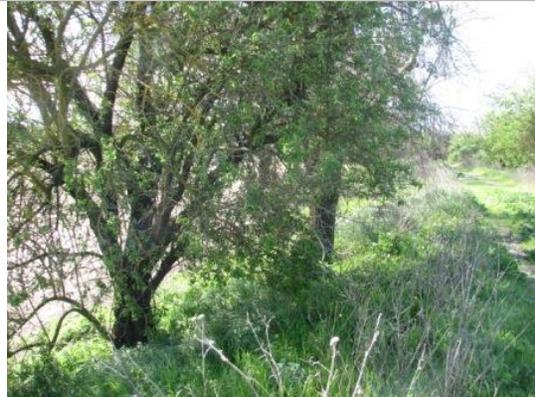
Photo 1 of 1 : SP_2015_NA0021_351_19_20150401_00017.jpg

LM Start	0.28	Rating **	M	Issue No.	19
LM End	0.30	Issue Type +	Ma	Location *	LS
Category	Earthen Levee		GPS Latitude/Longitude		
			Start	End	
Item	Trim / Thin Trees		38.722699 °	38.723001 °	
			-121.806920 °	-121.806864 °	
DWR ID	DWR_NA0021_01_s_2012_19				
Action/Comments					
Trim and thin trees to allow visibility of the ground and room to flood fight.

The trees need to be thinned and trimmed up for visibility.

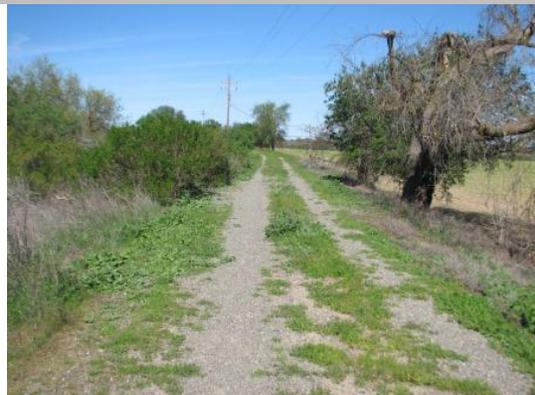
Photo 1 of 1 : SP_2015_NA0021_351_13_20150401_00012.jpg

LM Start	0.30	Rating **	M	Issue No.	13
LM End	0.50	Issue Type +	Ma	Location *	CR
Category	Earthen Levee		GPS Latitude/Longitude		
			Start	End	
Item	Vegetation		38.723017 °	38.725844 °	
			-121.806879 °	-121.806516 °	
DWR ID	DWR_NA0021_01_s_2014_13				
Action/Comments					
Keep the crown roadway free of vegetation.

Vegetation on the crown needs to be controlled. Spring 2014

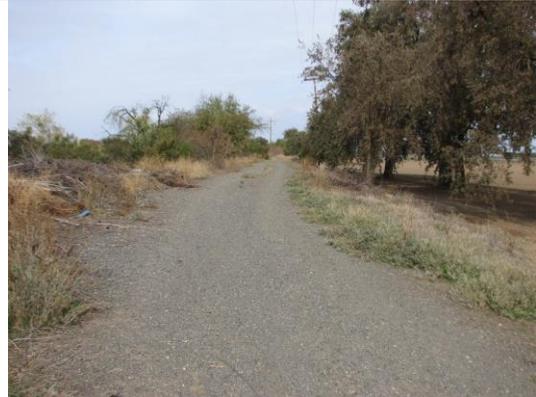
Photo 1 of 3 : SP_2015_NA0021_351_1_20150401_00002.jpg

LM Start	0.33	Rating **	M	Issue No.	1
LM End	0.50	Issue Type +	Ma	Location *	LS
Category	Earthen Levee		GPS Latitude/Longitude		
			Start	End	
Item	Vegetation		38.723381 °	38.725835 °	
			-121.806786 °	-121.806526 °	
DWR ID	DWR_NA0021_01_s_2015_1				
Action/Comments					
Remove the wild growth other than native grasses from the levee slopes. Inspector Comments: This area now has been declared a habitat restoration area by the Cache Creek Conservancy.

Vegetation on levee slopes and crown. Fall 2014.

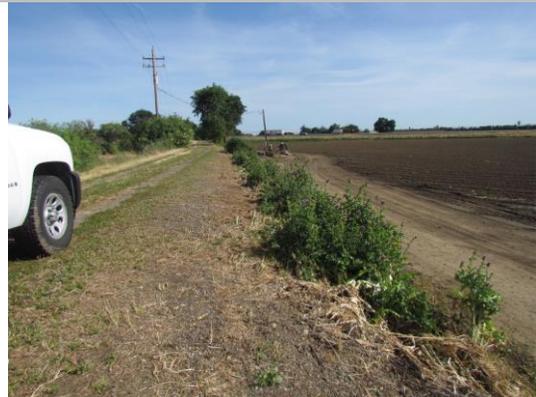
Photo 2 of 3 : SP_2015_NA0021_351_1_20150413_00022.jpg

View of vegetation on the landward side of the levee looking downstream. Spring 2015.

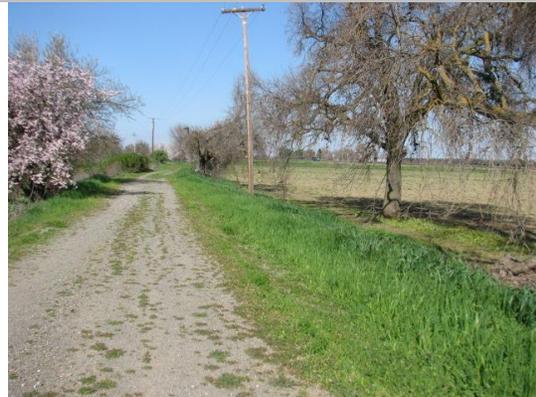
Photo 3 of 3 : SP_2015_NA0021_351_1_20150401_00003.jpg

Vegetation needs to be mowed taller than 12". Spring 2013

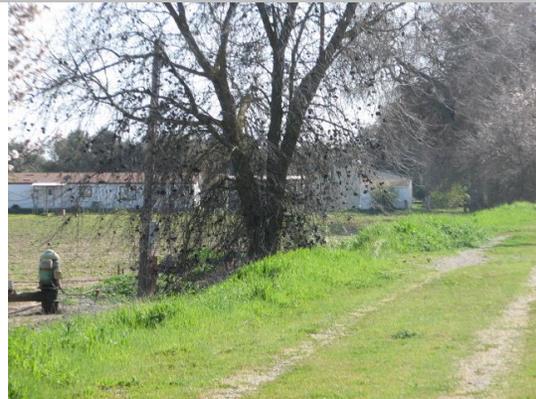
Photo 1 of 1 : SP_2015_NA0021_351_6_20150401_00007.jpg

LM Start	0.36	Rating **	M	Issue No.	6
LM End	0.36	Issue Type +	Ma	Location *	LS
Category	Earthen Levee		GPS Latitude/Longitude		
			Start	End	
Item	Trim / Thin Trees		38.723903 °	38.723903 °	
			-121.806613 °	-121.806613 °	
DWR ID	DWR_NA0021_01_s_2012_6				
Action/Comments					
Trim trees to at least five feet above ground level.

Tree needs to be trimmed up 5'. Spring 2013

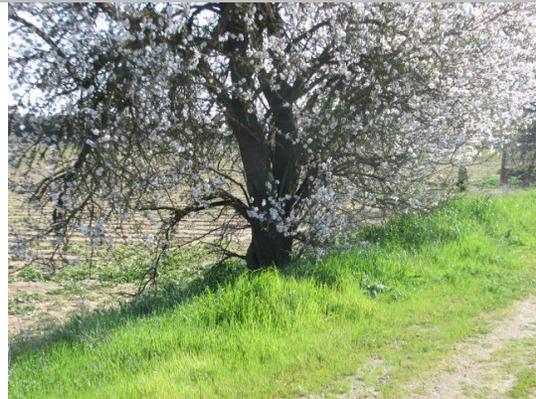
Photo 1 of 1 : SP_2015_NA0021_351_7_20150401_00008.jpg

LM Start	0.38	Rating **	M	Issue No.	7
LM End	0.38	Issue Type +	Ma	Location *	LS
Category	Earthen Levee		GPS Latitude/Longitude		
			Start	End	
Item	Trim / Thin Trees		38.724165 °	38.724165 °	
			-121.806552 °	-121.806552 °	
DWR ID	DWR_NA0021_01_s_2012_7				
Action/Comments					
Trim trees to at least five feet above ground level.

Tree needs to be trimmed to 5'. Spring 2013

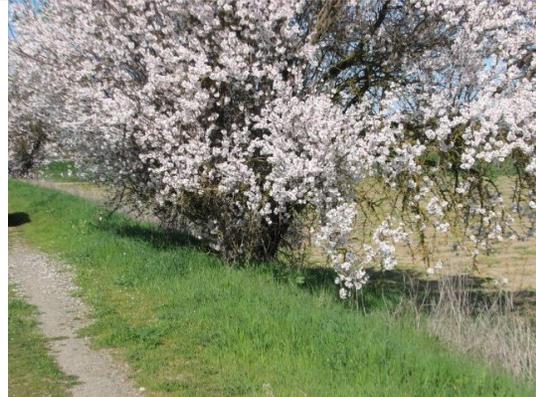
Photo 1 of 1 : SP_2015_NA0021_351_8_20150401_00009.jpg

LM Start	0.40	Rating **	M	Issue No.	8
LM End	0.40	Issue Type +	Ma	Location *	LS
Category	Earthen Levee		GPS Latitude/Longitude		
			Start	End	
Item	Trim / Thin Trees		38.724445 °	38.724445 °	
			-121.806505 °	-121.806505 °	
DWR ID	DWR_NA0021_01_s_2012_8				
Action/Comments					
Trim trees to at least five feet above ground level.

Trees need to be trimmed to 5'. Spring 2013

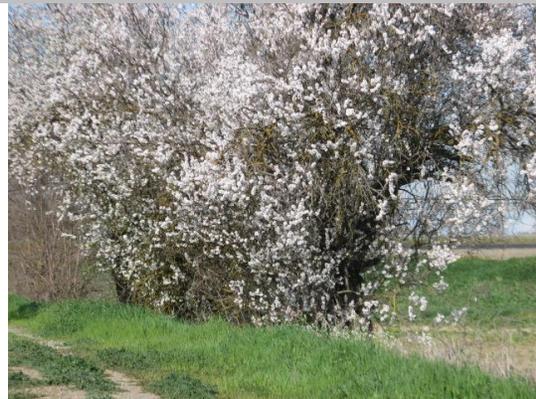
Photo 1 of 1 : SP_2015_NA0021_351_9_20150401_00010.jpg

LM Start	0.44	Rating **	M	Issue No.	9
LM End	0.44	Issue Type +	Ma	Location *	LS
Category	Earthen Levee		GPS Latitude/Longitude		
			Start	End	
Item	Trim / Thin Trees		38.725022 °	38.725022 °	
			-121.806478 °	-121.806478 °	
DWR ID	DWR_NA0021_01_s_2012_9				
Action/Comments					
Trim trees to at least five feet above ground level.

Trees need to be trimmed to 5'. Spring 2013

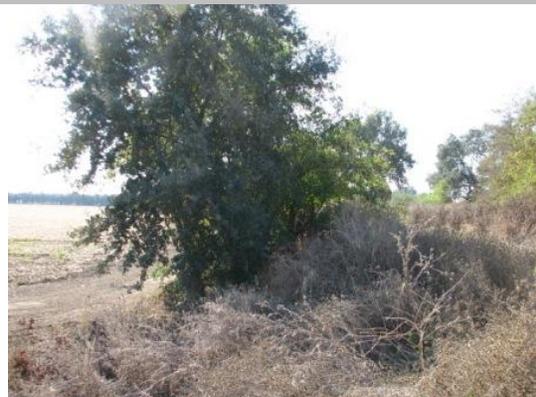
Photo 1 of 1 : SP_2015_NA0021_351_10_20150401_00011.jpg

LM Start	0.47	Rating **	M	Issue No.	10
LM End	0.47	Issue Type +	Ma	Location *	LS
Category	Earthen Levee		GPS Latitude/Longitude		
			Start	End	
Item	Trim / Thin Trees		38.725427 °	38.725427 °	
			-121.806470 °	-121.806470 °	
DWR ID	DWR_NA0021_01_s_2012_10				
Action/Comments					
Trim trees to at least five feet above ground level.

The tree needs to be trimmed up. Photo taken fall of 2011.
