**Flood Control Project Maintenance
Levee Inspections**

Fall 2011 Levee Maintenance Deficiency Summary Report

Yolo County Service Area 6

Waterway		Bank	Unit Miles
Unit No. 01 Right Bank of Sacramento River at Knights Landing		Right	5.97

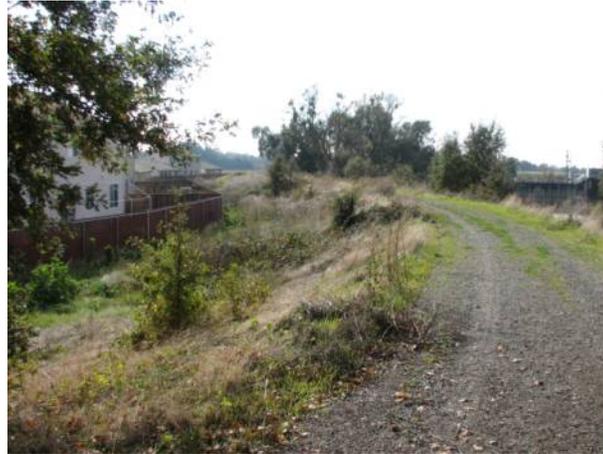
Levee Mile Report Line	1
Start Levee Mile	0.00
End Levee Mile	0.20
Location	Land Side
Category	Earthen Levee
Item	Vegetation

LMIR No.	Levee Mile		Category	Item	Location	Rating	Action/Comment	GPS Latitude/Longitude		Issue No. Photo
	Start	End						Start	End	
1	0.00	0.20	Earthen Levee	Vegetation	LS	M	Remove the wild growth other than native grasses from the levee slopes.	38.799184 ° -121.724419 °	38.801218 ° -121.722223 °	91 Y
2	0.03	0.20	Earthen Levee	Vegetation	WS	M	Remove the wild growth other than native grasses from the levee slopes.	38.799606 ° -121.724048 °	38.801368 ° -121.722054 °	6 Y
3	0.15	0.15	Earthen Levee	Trim / Thin Trees	LS	M	Thin trees to allow visibility of the ground and room to flood fight.	38.800828 ° -121.722903 °	38.800828 ° -121.722903 °	30 Y
4	0.15	0.15	Earthen Levee	Encroachments	WS	PO	Buildings	38.800828 ° -121.722902 °	38.800828 ° -121.722902 °	29 Y
5	0.22	0.26	Earthen Levee	Encroachments	LS	PO	Buildings Inspector Comments: RV park runs on and along levee to bridge	38.801500 ° -121.721878 °	38.801613 ° -121.721328 °	28 Y

A view of the vegetation on the landside. Grasses are taller than 12 inches. Fall 2011

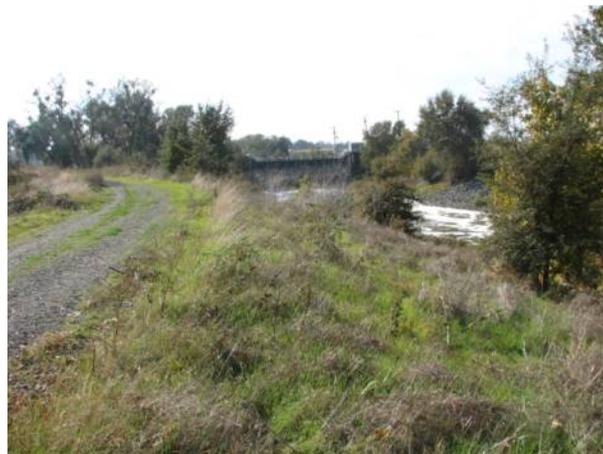
Levee Mile Report Line	2
Start Levee Mile	0.03
End Levee Mile	0.20
Location	Water Side
Category	Earthen Levee
Item	Vegetation

Grasses are taller than 12 inches with brush that obstruct the view. Fall 2011

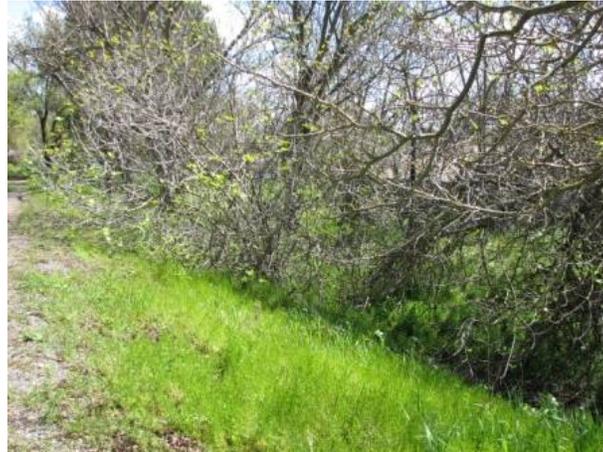
Levee Mile Report Line	3
Start Levee Mile	0.15
End Levee Mile	0.15
Location	Land Side
Category	Earthen Levee
Item	Trim / Thin Trees
Fig tree and other trees on landside need to be trimmed.	
johngw_f_20110923_931.jpg

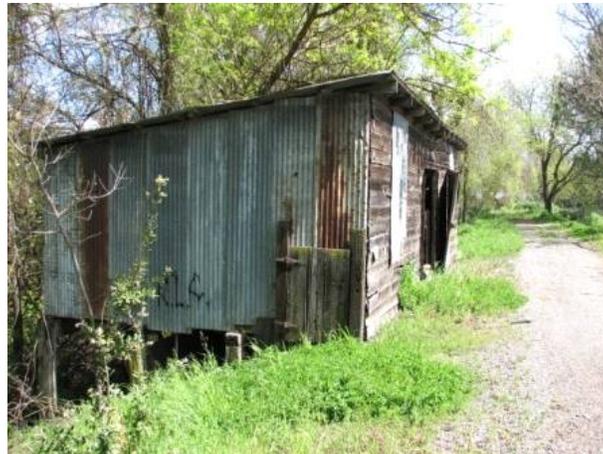
Levee Mile Report Line	4
Start Levee Mile	0.15
End Levee Mile	0.15
Location	Water Side
Category	Earthen Levee
Item	Encroachments
Building on waterside.	
johngw_f_20110923_930.jpg

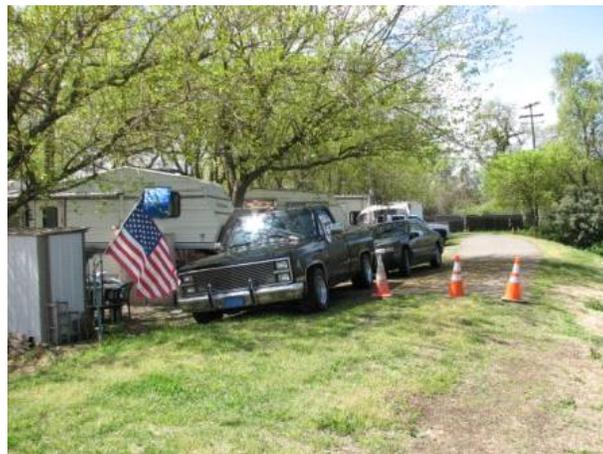
Levee Mile Report Line	5
Start Levee Mile	0.22
End Levee Mile	0.26
Location	Land Side
Category	Earthen Levee
Item	Encroachments
RV park trailers and vehicles on levee.	
johngw_f_20110923_929.jpg

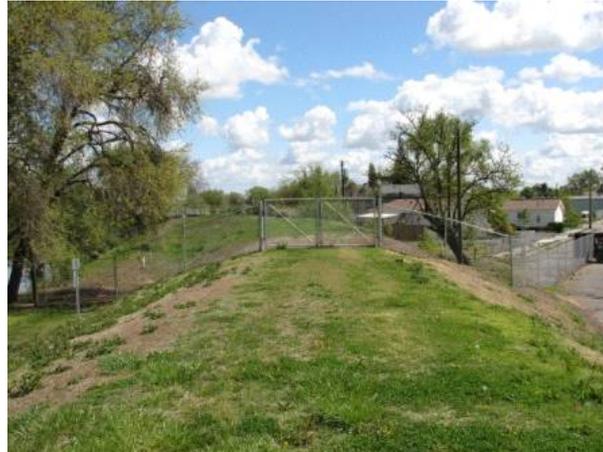
6	0.31	0.33	Earthen Levee	Encroachments	LS	PO	Landscaping Inspector Comments: This is a two year old home. I have talked to the owner about a permit and he continues to landscape the landside slope with no permit. Owner has added fence across levee. Gave her an application, did field investigation report.	38.801720 ° -121.720447 °	38.801840 ° -121.720030 °	27 Y
7	0.35	0.39	Earthen Levee	Encroachments	LS	PO	Buildings Inspector Comments: Apartments with chainlink fence with lathe woven into it.	38.801967 ° -121.719727 °	38.802105 ° -121.718963 °	26 Y
8	0.50	0.57	Earthen Levee	Encroachments	WS	PO	Landscaping	38.802238 ° -121.716875 °	38.801960 ° -121.715700 °	24 Y
9	0.51	0.57	Earthen Levee	Encroachments	LS	PO	Buildings	38.802172 ° -121.716705 °	38.801958 ° -121.715758 °	25 Y
10	0.57	0.71	Earthen Levee	Encroachments	LS	CO	Landscaping Inspector Comments: Oleander hedge	38.801968 ° -121.715707 °	38.801077 ° -121.713335 °	22 Y

Levee Mile Report Line	6
Start Levee Mile	0.31
End Levee Mile	0.33
Location	Land Side
Category	Earthen Levee
Item	Encroachments
Fence across levee.	
johngw_f_20110923_927.jpg

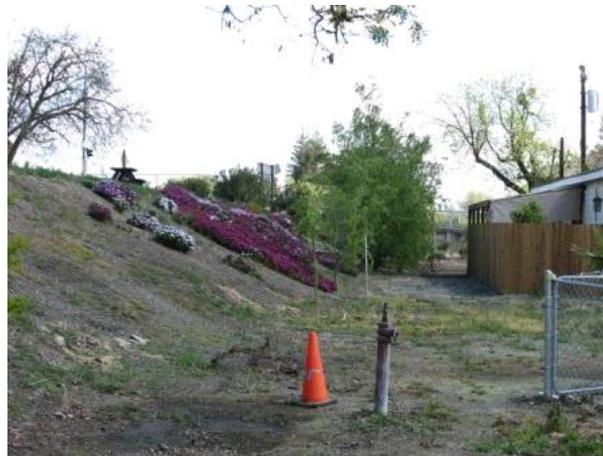
Levee Mile Report Line	6
Start Levee Mile	0.31
End Levee Mile	0.33
Location	Land Side
Category	Earthen Levee
Item	Encroachments
Landscaping on levee slope.	
johngw_f_20110923_928.jpg

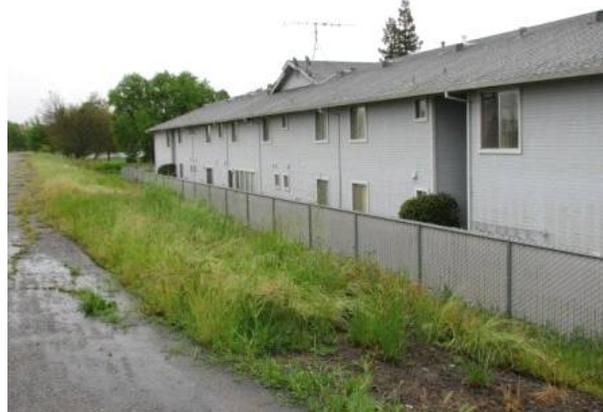
Levee Mile Report Line	7
Start Levee Mile	0.35
End Levee Mile	0.39
Location	Land Side
Category	Earthen Levee
Item	Encroachments
Apartments and fence.	
johngw_f_20110923_926.jpg

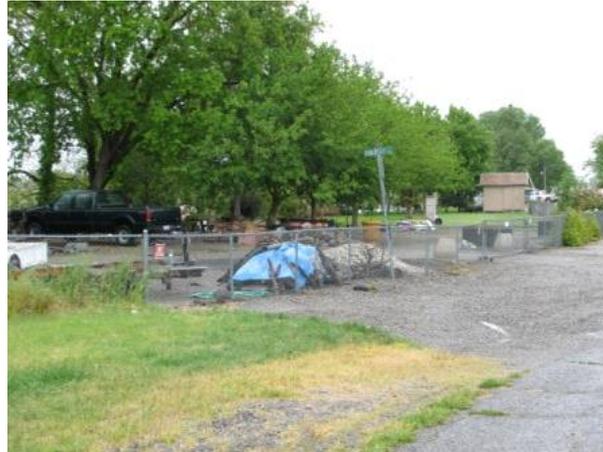
Levee Mile Report Line	8
Start Levee Mile	0.50
End Levee Mile	0.57
Location	Water Side
Category	Earthen Levee
Item	Encroachments
On levee crown	
johngw_f_20110923_924.jpg

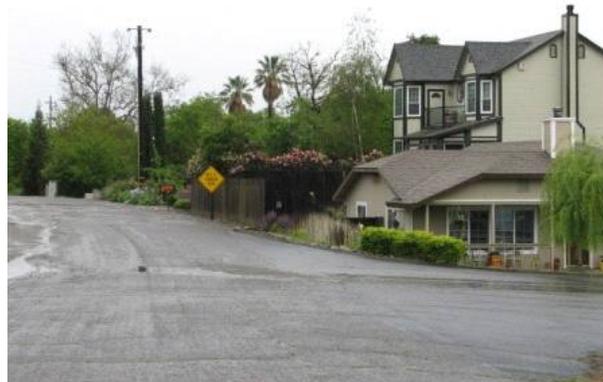
Levee Mile Report Line	9
Start Levee Mile	0.51
End Levee Mile	0.57
Location	Land Side
Category	Earthen Levee
Item	Encroachments
Houses on levee.	
johngw_f_20110923_925.jpg

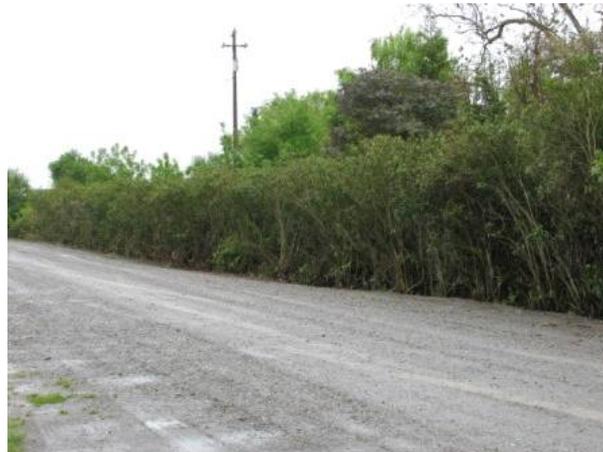
Levee Mile Report Line	10
Start Levee Mile	0.57
End Levee Mile	0.71
Location	Land Side
Category	Earthen Levee
Item	Encroachments
Oleanders along the shoulder.	
johngw_f_20110923_922.jpg

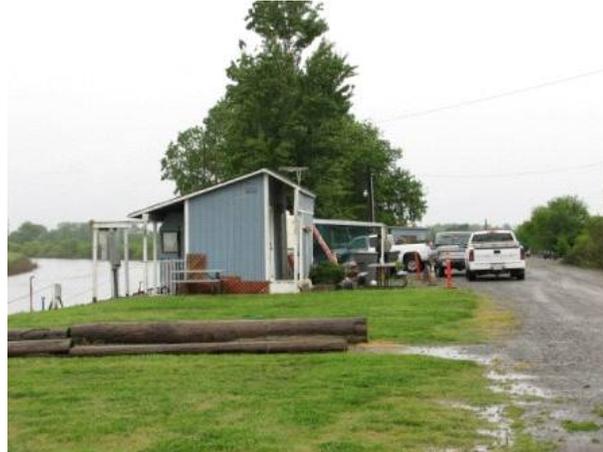
11	0.57	0.65	Earthen Levee	Encroachments	WS	PO	Buildings Inspector Comments: Yolo Sutter Yacht Club	38.801965 ° -121.715705 °	38.801468 ° -121.714348 °	23 Y
12	0.73	0.73	Earthen Levee	Vegetation	LS	M	Remove the wild growth other than native grasses from the levee slopes.	38.800960 ° -121.713153 °	38.800960 ° -121.713153 °	2 Y
13	0.97	1.14	Earthen Levee	Vegetation	LS	M	Remove the wild growth other than native grasses from the levee slopes.	38.800188 ° -121.708918 °	38.800577 ° -121.705830 °	21 Y
14	1.18	1.34	Earthen Levee	Vegetation	LS	M	Remove the wild growth other than native grasses from the levee slopes.	38.800778 ° -121.705135 °	38.802058 ° -121.702633 °	20 Y
15	1.78	1.78	Earthen Levee	Encroachments	WS	M	Prunings	38.797916 ° -121.697980 °	38.797916 ° -121.697980 °	9 Y
16	1.91	1.91	Earthen Levee	Encroachments	LS	C	Landscaping Inspector Comments: Sprinklers trenched into levee slope.	38.796394 ° -121.696700 °	38.796394 ° -121.696700 °	10 Y

Levee Mile Report Line	11
Start Levee Mile	0.57
End Levee Mile	0.65
Location	Water Side
Category	Earthen Levee
Item	Encroachments
Yacht club	
johngw_f_20110923_923.jpg

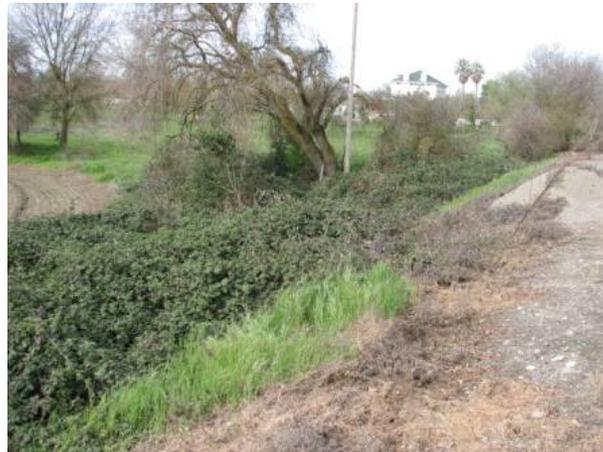
Levee Mile Report Line	12
Start Levee Mile	0.73
End Levee Mile	0.73
Location	Land Side
Category	Earthen Levee
Item	Vegetation
The berry vines block good visibility to see levee slope.	
johngw_f_20110923_911.jpg

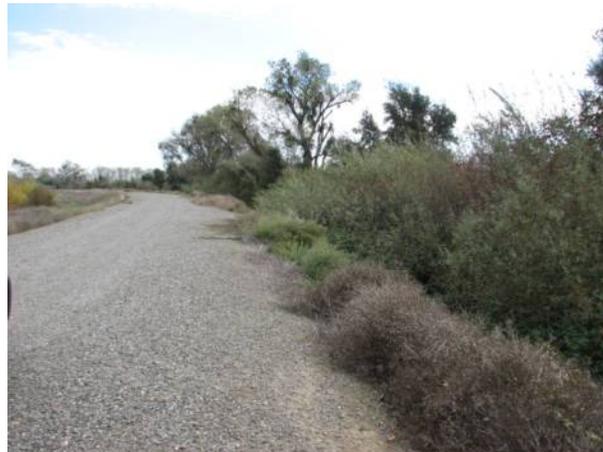
Levee Mile Report Line	13
Start Levee Mile	0.97
End Levee Mile	1.14
Location	Land Side
Category	Earthen Levee
Item	Vegetation
The vegetation completely blocks the view of the levee slope. Fall 2011	
johngw_f_20111118_566.jpg

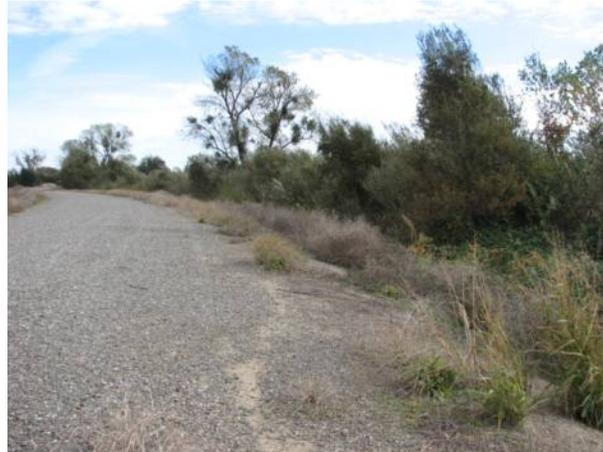
Levee Mile Report Line	14
Start Levee Mile	1.18
End Levee Mile	1.34
Location	Land Side
Category	Earthen Levee
Item	Vegetation
The vegetation blocks the view of the levee slope. Fall 2011	
johngw_f_20111118_567.jpg

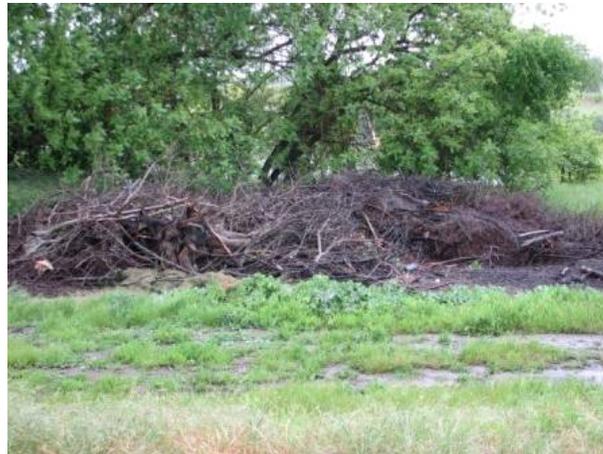
Levee Mile Report Line	15
Start Levee Mile	1.78
End Levee Mile	1.78
Location	Water Side
Category	Earthen Levee
Item	Encroachments
Prunings	
johngw_f_20110923_914.jpg

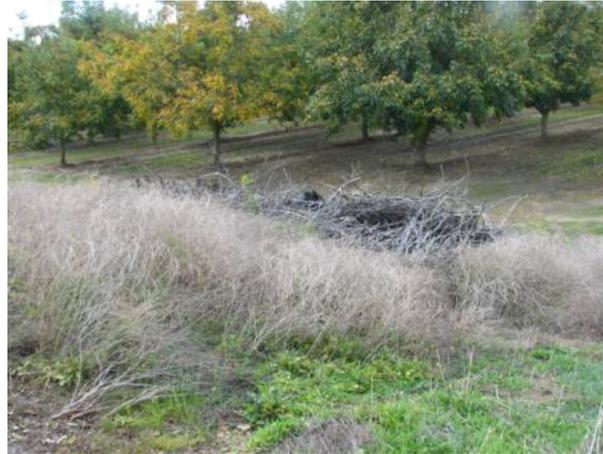
Levee Mile Report Line	18
Start Levee Mile	1.99
End Levee Mile	1.99
Location	Land Side
Category	Earthen Levee
Item	Encroachments
A pile of prunings is stacked on the levee slope near the toe. Fall 2011	
johngw_f_20111118_569.jpg

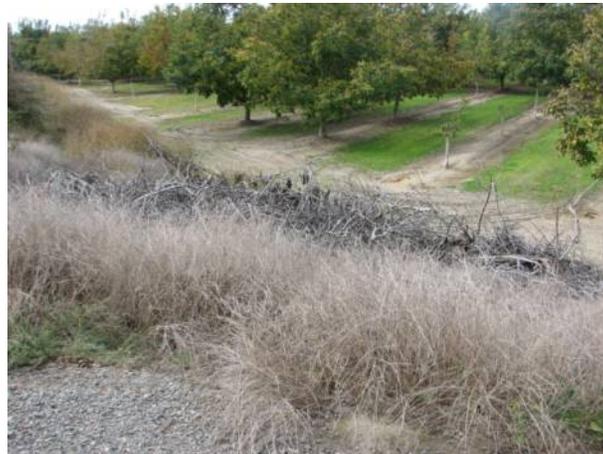
Levee Mile Report Line	19
Start Levee Mile	2.06
End Levee Mile	2.06
Location	Land Side
Category	Earthen Levee
Item	Encroachments
Another pile of prunings is stacked on the levee slope. Fall 2011	
johngw_f_20111118_570.jpg

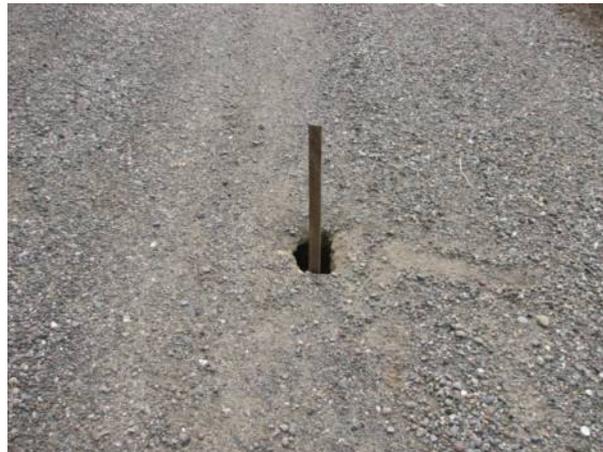
Levee Mile Report Line	20
Start Levee Mile	2.07
End Levee Mile	2.07
Location	Crown
Category	Earthen Levee
Item	Animal Control
A rodent hole in the crown of the levee. Fall 2011	
johngw_f_20111118_571.jpg

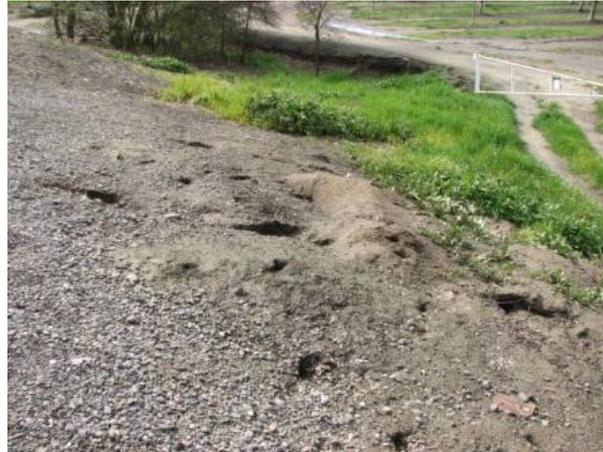
Levee Mile Report Line	21
Start Levee Mile	2.18
End Levee Mile	2.18
Location	Land Side
Category	Earthen Levee
Item	Animal Control
There are multiple rodent holes but no visible rodents. Need to backfill and compact.	
johngw_f_20110923_913.jpg

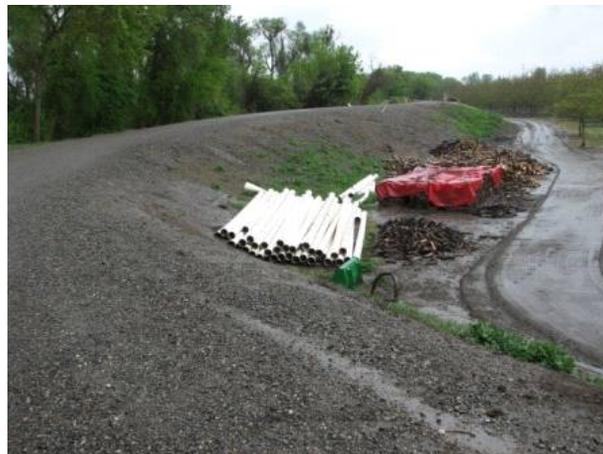
Levee Mile Report Line	22
Start Levee Mile	2.22
End Levee Mile	2.22
Location	Land Side
Category	Earthen Levee
Item	Encroachments
Pipe along toe	
johngw_f_20110923_936.jpg

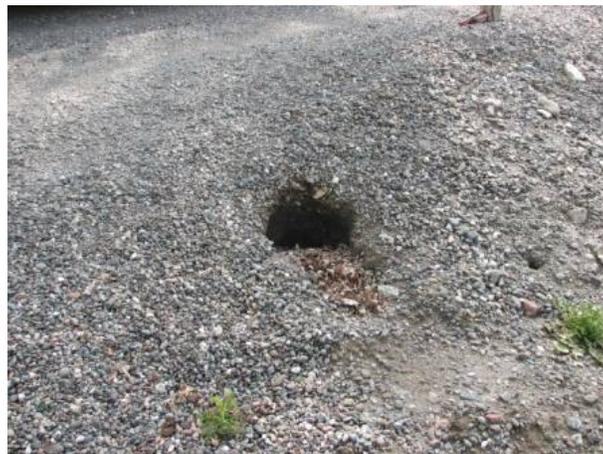
Levee Mile Report Line	23
Start Levee Mile	2.22
End Levee Mile	2.22
Location	Land Side
Category	Earthen Levee
Item	Animal Control
A rodent hole needs to be backfilled and compacted.	
johngw_f_20110923_934.jpg

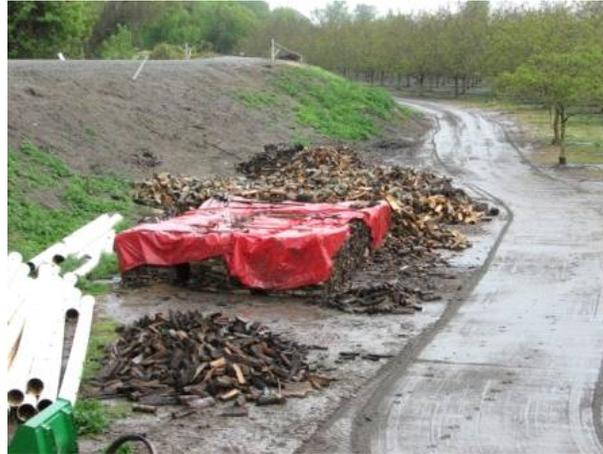
Levee Mile Report Line	24
Start Levee Mile	2.24
End Levee Mile	2.24
Location	Land Side
Category	Earthen Levee
Item	Encroachments
Firewood stacked up	
johngw_f_20110923_935.jpg

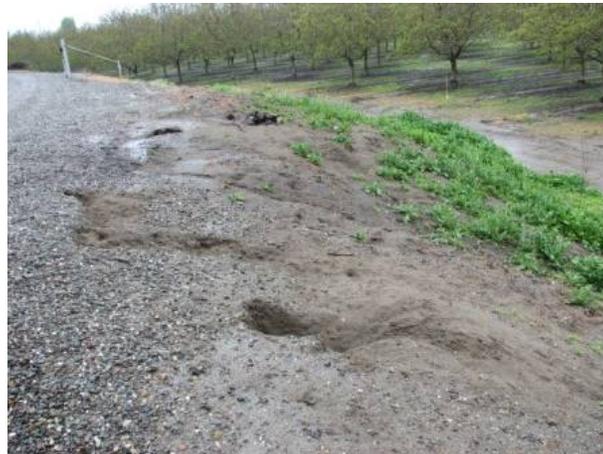
Levee Mile Report Line	25
Start Levee Mile	2.25
End Levee Mile	2.25
Location	Land Side
Category	Earthen Levee
Item	Animal Control
Rodents	
johngw_f_20110923_937.jpg

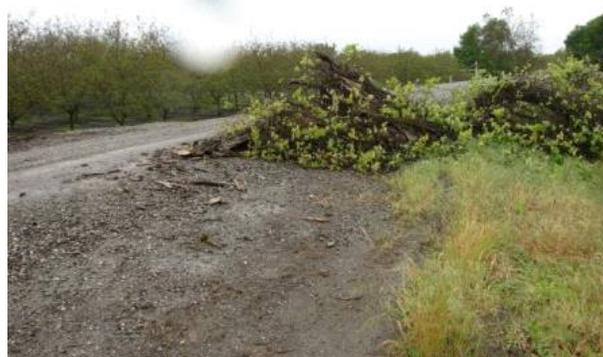
Levee Mile Report Line	26
Start Levee Mile	2.30
End Levee Mile	2.30
Location	Water Side
Category	Earthen Levee
Item	Trim / Thin Trees
Tree across levee	
johngw_f_20110923_938.jpg

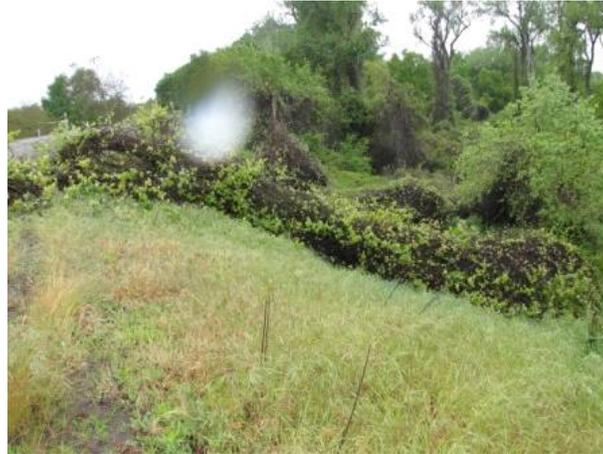
Levee Mile Report Line	26
Start Levee Mile	2.30
End Levee Mile	2.30
Location	Water Side
Category	Earthen Levee
Item	Trim / Thin Trees

Water side view.

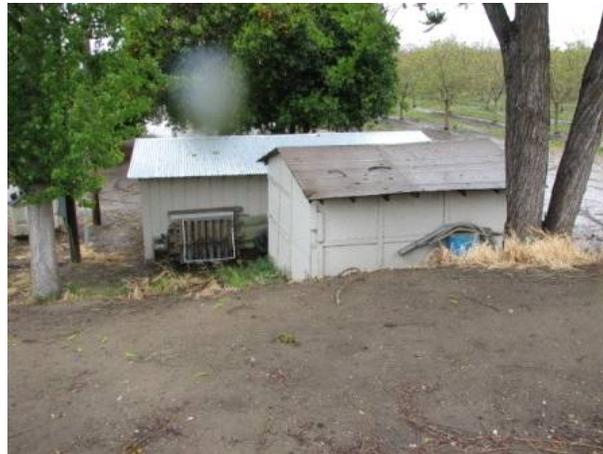
Levee Mile Report Line	27
Start Levee Mile	2.62
End Levee Mile	2.62
Location	Land Side
Category	Earthen Levee
Item	Encroachments

27	2.62	2.62	Earthen Levee	Encroachments	LS	PO	Buildings	38.786964 ° -121.694239 °	38.786964 ° -121.694239 °	11 Y
28	2.62	2.62	Earthen Levee	Animal Control	CR	M	No rodents visible, but rodent burrows visible; need to backfill and compact or grout burrows.	38.787038 ° -121.694237 °	38.787038 ° -121.694237 °	86 Y
29	2.72	2.72	Earthen Levee	Erosion / Bank Caving	LS	M	Schedule repair of erosion site prior to the next inspection.	38.785613 ° -121.694266 °	38.785613 ° -121.694266 °	87 Y
30	2.97	2.97	Earthen Levee	Animal Control	LS	M	No rodents visible, but rodent burrows visible; need to backfill and compact or grout burrows.	38.782985 ° -121.691518 °	38.782985 ° -121.691518 °	14 Y
31	3.10	3.24	Supplemental Survey	USACE Erosion Survey	WS	M	Inspector Comments: 2006 - Short section is into the levee toe, rest is near the levee toe. Mass failure and fluvial erosion of depositional material. Rock at the upstream and downstream ends. 2011: Minor new erosion. [2011 Site ID: SAC_86-9_R]	38.780407 ° -121.688238 °	38.779137 ° -121.687432 °	3 Y

Garage at toe

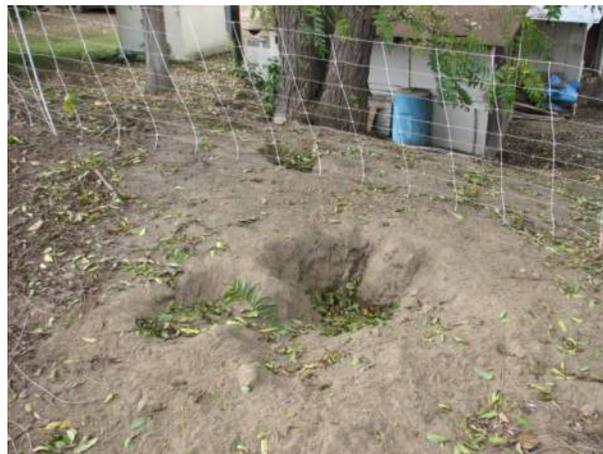
Levee Mile Report Line	28
Start Levee Mile	2.62
End Levee Mile	2.62
Location	Crown
Category	Earthen Levee
Item	Animal Control

A very large rodent hole at the shoulder of the levee. Fall 2011

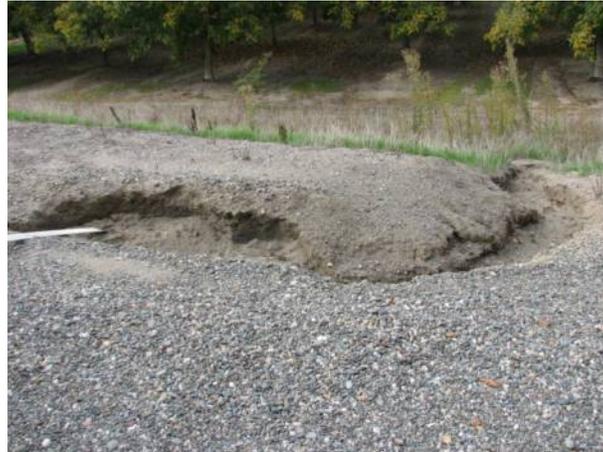
Levee Mile Report Line	29
Start Levee Mile	2.72
End Levee Mile	2.72
Location	Land Side
Category	Earthen Levee
Item	Erosion / Bank Caving
Eroision caused by a build up of water then running off the slope. Fall 2011	
johngw_f_20111118_573.jpg

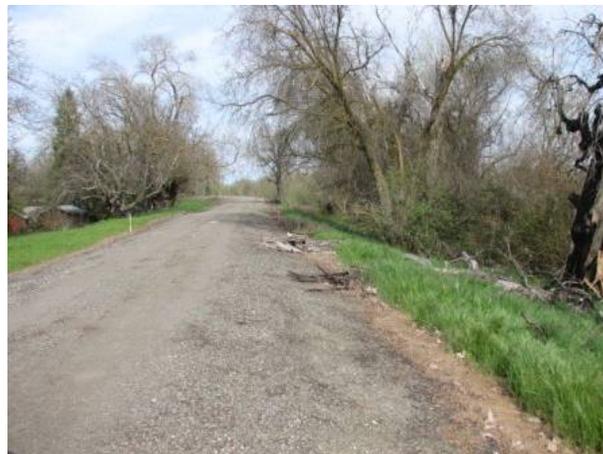
Levee Mile Report Line	33
Start Levee Mile	3.16
End Levee Mile	3.16
Location	Water Side
Category	Earthen Levee
Item	Encroachments
Multiple piles of wooden debris along shoulder along with fallen tree.	
johngw_f_20110923_933.jpg

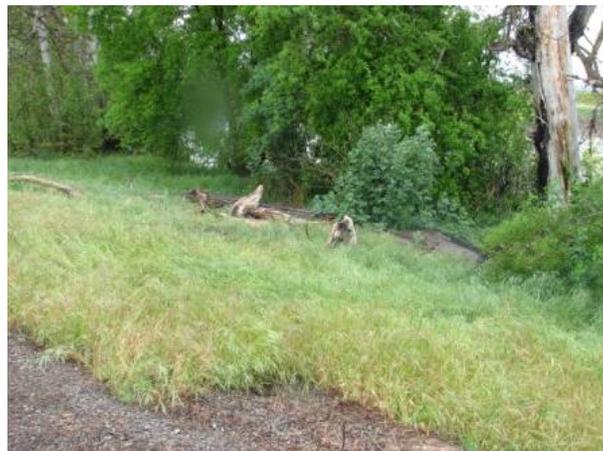
Levee Mile Report Line	34
Start Levee Mile	3.25
End Levee Mile	3.25
Location	Water Side
Category	Earthen Levee
Item	Trim / Thin Trees
Branches from dead trees, water side	
johngw_f_20110923_918.jpg

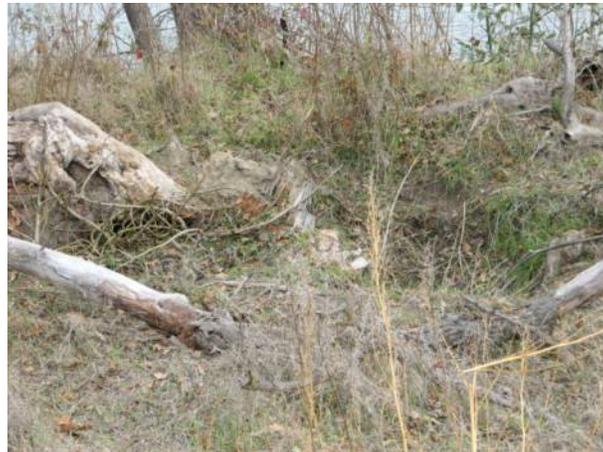
Levee Mile Report Line	35
Start Levee Mile	3.31
End Levee Mile	3.31
Location	Water Side
Category	Earthen Levee
Item	Trim / Thin Trees
This is the root ball of the tree. It has created a large void in the berm. Fall 2011	
johngw_f_20111118_575.jpg

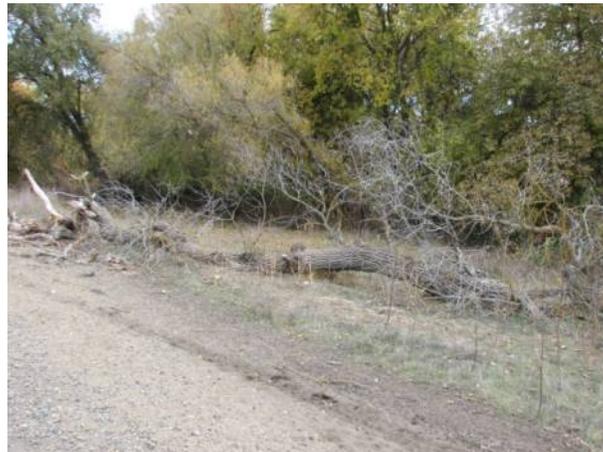
Levee Mile Report Line	36
Start Levee Mile	3.70
End Levee Mile	3.70
Location	Water Side
Category	Earthen Levee
Item	Encroachments
Another tree has fallen on the waterside slope. Fall 2011	
johngw_f_20111118_576.jpg
