**Flood Control Project Maintenance
Levee Inspections**

Maintenance Issue Types Only, Levee Inspection Report By Mile - Spring 2016

Yolo County Service Area 6

Waterway	Bank	Unit Miles	Inspection Start/End	Inspector
Unit No. 01 Right Bank of Sacramento River at Knights Landing	Right	5.87	04/12/2016 04/12/2016	Jai Lor

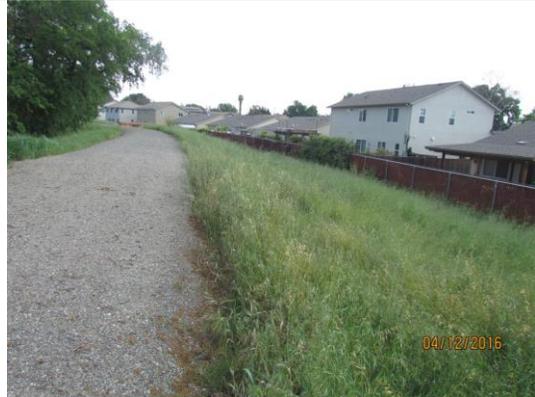
Photo 1 of 1 : SP_2016_NA0022_350_67_20160413_00141.jpg

LM Start	0.00	Rating **	U	Issue No.	67
LM End	0.20	Issue Type +	Ma	Location *	LS
Category	Earthen Levee		GPS Latitude/Longitude		
			Start	End	
Item	Vegetation		38.799173 °	38.801334 °	
			-121.724448 °	-121.722108 °	
DWR ID	DWR_NA0022_01_f_2015_67				
Comment Code					
V1 : Control annual grass and weeds on the levee slopes and easements.					
Inspector Comment					
Clear vegetation on landside slope.

View of the vegetation on the landward side of the levee looking downstream. Spring 2016.

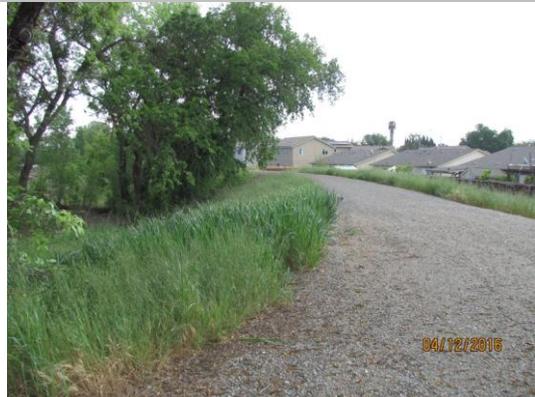
Photo 1 of 1 : SP_2016_NA0022_350_68_20160413_00142.jpg

LM Start	0.00	Rating **	U	Issue No.	68
LM End	0.20	Issue Type +	Ma	Location *	WS
Category	Earthen Levee		GPS Latitude/Longitude		
			Start	End	
Item	Vegetation		38.799173 °	38.801337 °	
			-121.724448 °	-121.722110 °	
DWR ID	DWR_NA0022_01_f_2015_68				
Comment Code					
V1 : Control annual grass and weeds on the levee slopes and easements.					
Inspector Comment					
Clear vegetation 20 feet off shoulder.

View of the vegetation on the waterward side of the levee looking downstream. Spring 2016.

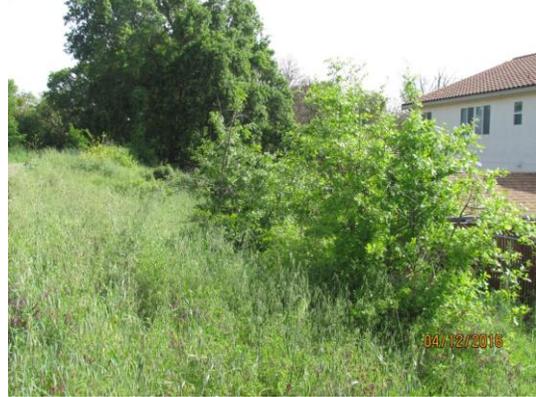
Photo 1 of 1 : SP_2016_NA0022_350_65_20160413_00143.jpg

View of the small oak trees on the landward side of the levee looking downstream. Spring 2016.

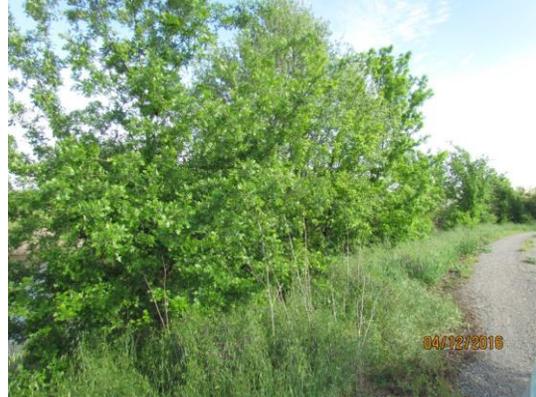
Photo 1 of 1 : SP_2016_NA0022_350_66_20160413_00144.jpg

LM Start	0.07	Rating **	M	Issue No.	66
LM End	0.11	Issue Type +	Ma	Location *	WS
Category	Earthen Levee		GPS Latitude/Longitude		
			Start	End	
Item	Vegetation		38.800005 °	38.800515 °	
			-121.723875 °	-121.723418 °	
DWR ID	DWR_NA0022_01_s_2016_66				
Comment Code					
V2 : Remove the wild growth other than native grasses from the levee slopes.					
Inspector Comment					
Remove oak tree that are less than 4" in diameter at chest height from within 20' of waterside levee slope and trim trees.

View of the oak trees on the waterward side of the levee looking downstream. Spring 2016.

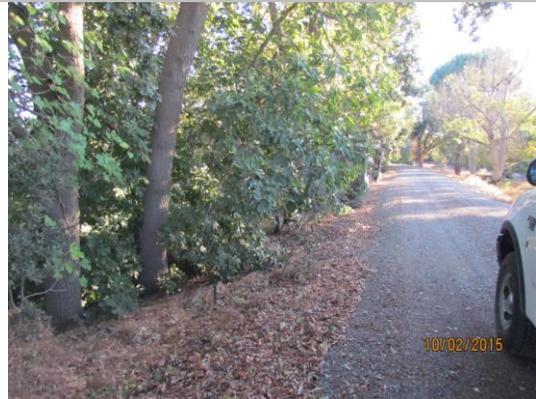
Photo 1 of 1 : SP_2016_NA0022_350_6_20160304_00007.jpg

View of the vegetation and trees on the waterward side of the levee looking downstream. Fall 2015.

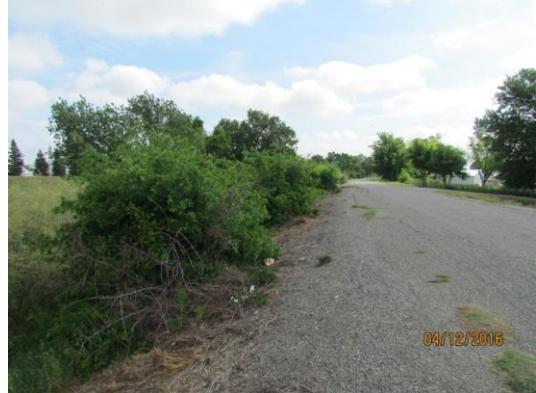
Photo 1 of 1 : SP_2016_NA0022_350_102_20160413_00149.jpg

View of the trees on the waterward side of the levee looking downstream. Spring 2016.

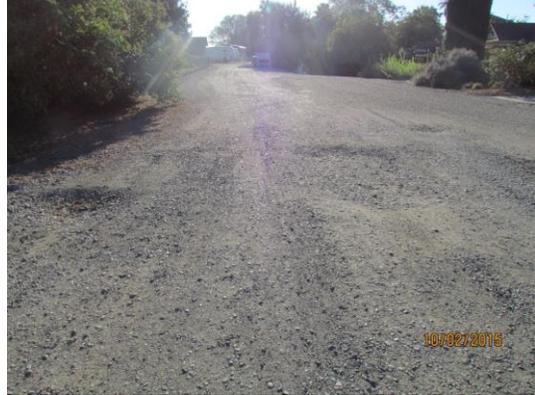
Photo 1 of 1 : SP_2016_NA0022_350_69_20160304_00048.jpg

LM Start	0.53	Rating **	M	Issue No.	69
LM End	0.53	Issue Type +	Ma	Location *	CR
Category	Earthen Levee			GPS Latitude/Longitude	
				Start	End
Item	Crown Surface / Depressions / Rutting			38.801950 °	38.801950 °
				-121.716299 °	-121.716299 °
DWR ID	DWR_NA0022_01_f_2015_69				
Comment Code					
C2 : Repair depressions or ruts in the crown or slope.					
Inspector Comment

View of the depression on the crown of the levee looking downstream. Fall 2015.

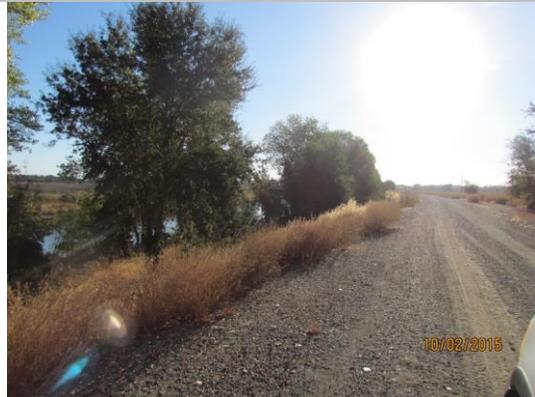
Photo 1 of 1 : SP_2016_NA0022_350_71_20160304_00050.jpg

LM Start	0.68	Rating **	M	Issue No.	71
LM End	0.95	Issue Type +	Ma	Location *	WS
Category	Earthen Levee			GPS Latitude/Longitude	
				Start	End
Item	Vegetation			38.801181 °	38.800237 °
				-121.713724 °	-121.708977 °
DWR ID	DWR_NA0022_01_f_2015_71				
Comment Code					
V1 : Control annual grass and weeds on the levee slopes and easements.					
Inspector Comment

View of the vegetation on the waterward side of the levee looking downstream. Fall 2015.

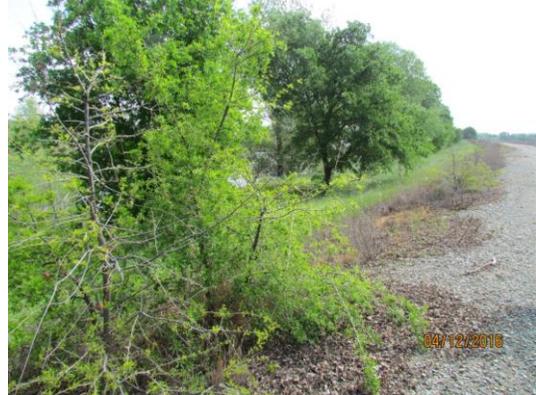
Photo 1 of 1 : SP_2016_NA0022_350_106_20160413_00151.jpg

View of the small tree on the waterward side of the levee looking downstream. Spring 2016.

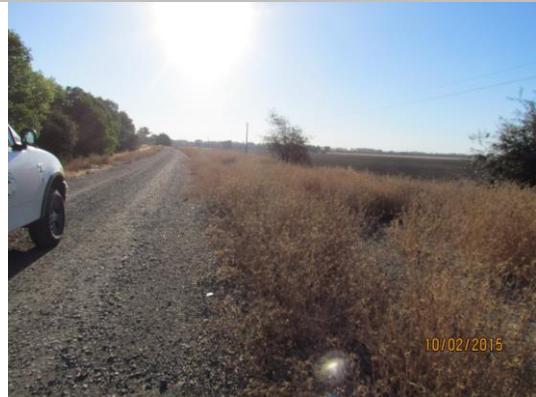
Photo 1 of 1 : SP_2016_NA0022_350_72_20160304_00051.jpg

LM Start	0.73	Rating **	M	Issue No.	72
LM End	0.95	Issue Type +	Ma	Location *	LS
Category	Earthen Levee			GPS Latitude/Longitude	
				Start	End
Item	Vegetation			38.800949 °	38.800230 °
				-121.712939 °	-121.709004 °
DWR ID	DWR_NA0022_01_f_2015_72				
Comment Code					
V1 : Control annual grass and weeds on the levee slopes and easements.					
Inspector Comment

View of the vegetation on the landward side of the levee looking downstream. Fall 2015.

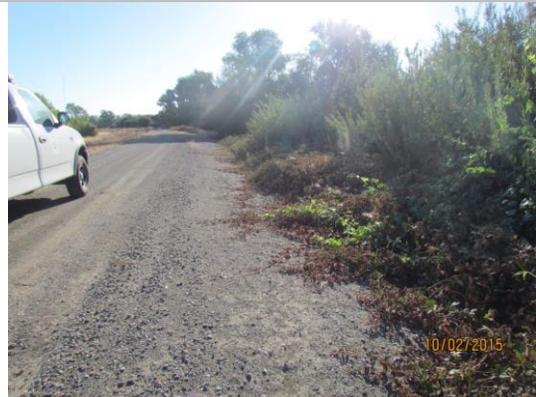
Photo 1 of 1 : SP_2016_NA0022_350_21_20160304_00019.jpg

View of the vegetation on the landward side of the levee looking downstream. Fall 2015.

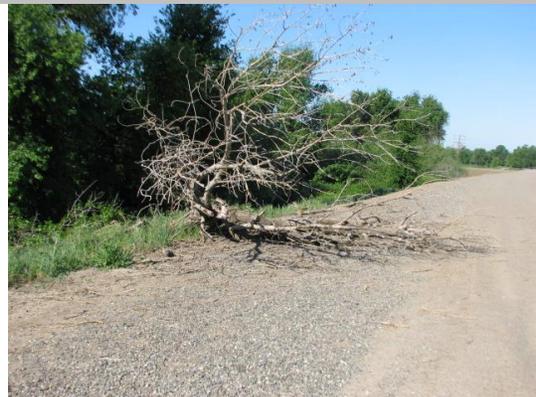
Photo 1 of 1 : SP_2016_NA0022_350_17_20160304_00016.jpg

LM Start	1.01	Rating **	M	Issue No.	17
LM End	1.01	Issue Type +	Ma	Location *	LS
Category	Earthen Levee		GPS Latitude/Longitude		
			Start	End	
Item	Encroachments		38.800246 °	38.800246 °	
			-121.707858 °	-121.707858 °	
DWR ID	DWR_NA0022_01_s_2014_17				
Comment Code					
TR : Tree or limb					
Inspector Comment					
Trees blocking visibility and a dead tree on the levee slope.

A tree has fallen on the crown and blocks visibility. Spring 2014

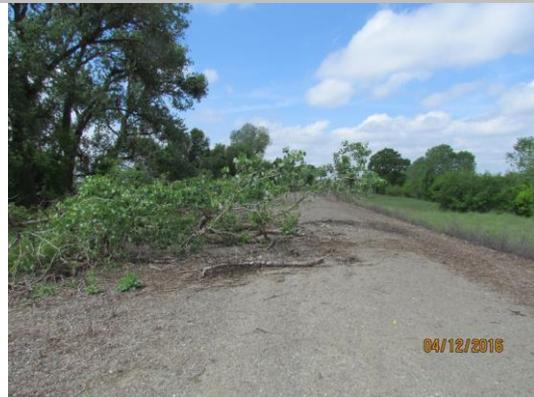
Photo 1 of 1 : SP_2016_NA0022_350_109_20160413_00152.jpg

View of the tree blocking the crown of the levee looking upstream. Spring 2016.

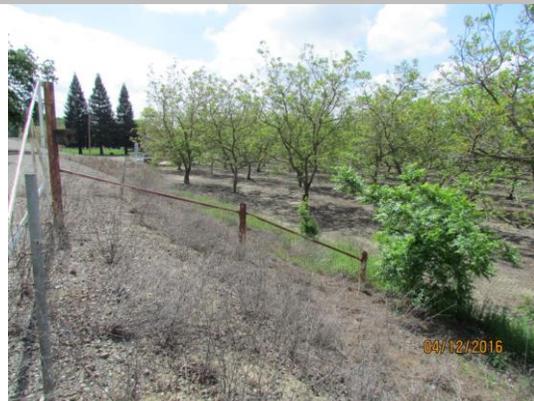
Photo 1 of 1 : SP_2016_NA0022_350_112_20160413_00153.jpg

View of the tree at the toe of the levee on the landward side looking downstream. Spring 2016.

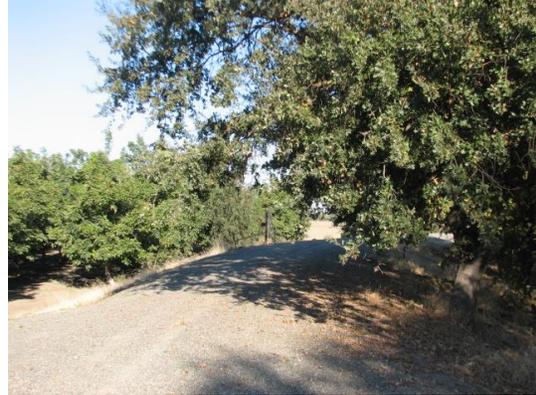
Photo 1 of 1 : SP_2016_NA0022_350_9_20160304_00010.jpg

Trees need to be trimmed up to 12 feet above the crown. Fall 2013

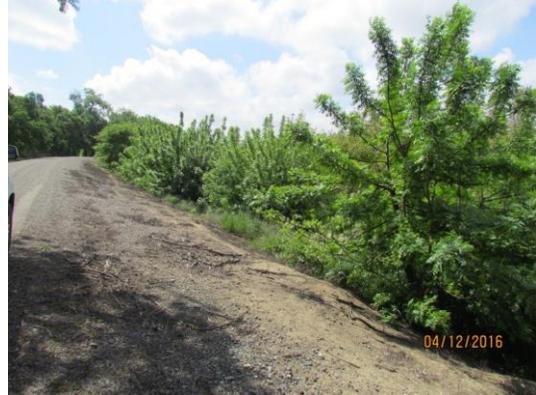
Photo 1 of 1 : SP_2016_NA0022_350_116_20160413_00154.jpg

View of the trees on the waterward side of the levee looking downstream. Spring 2016.

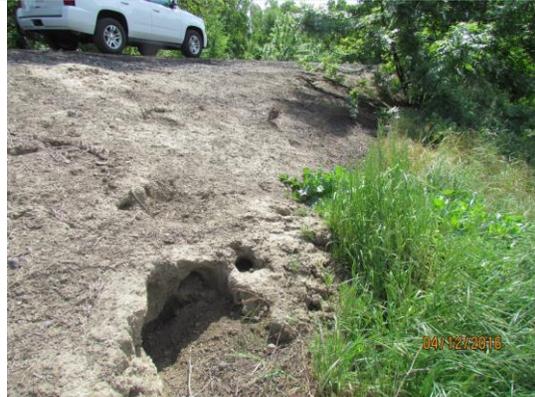
Photo 1 of 1 : SP_2016_NA0022_350_119_20160413_00155.jpg

View of the rodent hole on the landward side of the levee. Spring 2016.

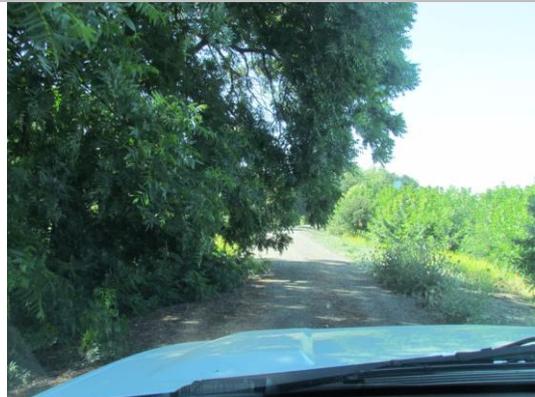
Photo 1 of 1 : SP_2016_NA0022_350_74_20160304_00053.jpg

LM Start	1.96	Rating **	M	Issue No.	74
LM End	1.96	Issue Type +	Ma	Location *	CR
Category	Earthen Levee		GPS Latitude/Longitude		
			Start	End	
Item	Trim / Thin Trees		38.795401 °	38.795401 °	
			-121.695947 °	-121.695947 °	
DWR ID	DWR_NA0022_01_s_2015_74				
Comment Code					
T4 : Trim trees over roadway to at least 12 feet above ground level.					
Inspector Comment

View of the trees on the crown of the levee looking downstream. Spring 2015.

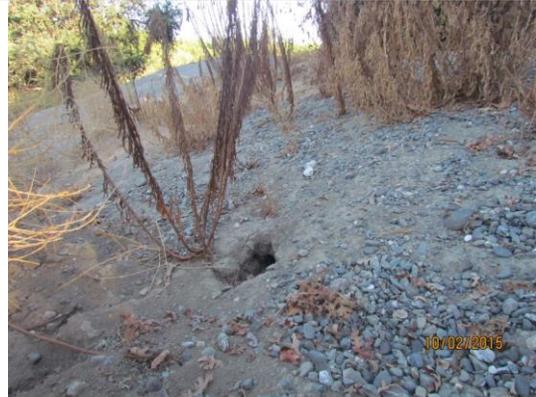
Photo 1 of 1 : SP_2016_NA0022_350_8_20160304_00009.jpg

View of the rodent hole on the landward side of the levee looking downstream. Fall 2015.

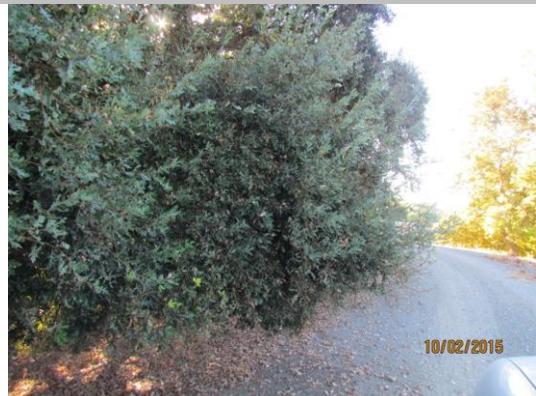
Photo 1 of 1 : SP_2016_NA0022_350_91_20160304_00064.jpg

View of the trees on the waterward side of the levee looking downstream. Fall 2015.

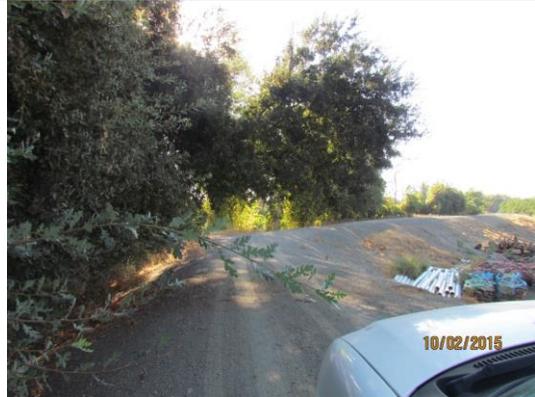
Photo 1 of 1 : SP_2016_NA0022_350_25_20160304_00023.jpg

View of the tree branch above the crown of the levee looking downstream. Fall 2015.

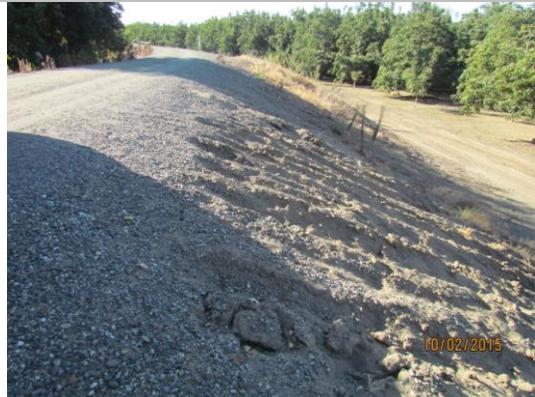
Photo 1 of 1 : SP_2016_NA0022_350_93_20160304_00067.jpg

LM Start	2.21	Rating **	M	Issue No.	93
LM End	2.21	Issue Type +	Ma	Location *	LS
Category	Earthen Levee		GPS Latitude/Longitude		
			Start	End	
Item	Slope Stability		38.792055 °	38.792055 °	
			-121.695446 °	-121.695446 °	
DWR ID	DWR_NA0022_01_f_2015_93				
Comment Code					
S3 : Repair the levee slope damaged by vehicle traffic and prevent access where possible.					
Inspector Comment

View of the slope stability on the landward side of the levee looking downstream. Fall 2015.

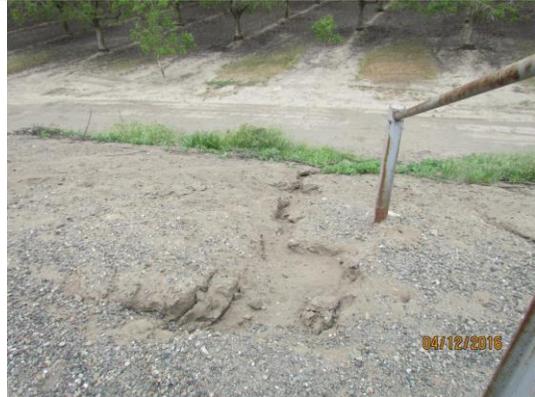
Photo 1 of 2 : SP_2016_NA0022_350_35_20160413_00157.jpg

LM Start	2.24	Rating **	M	Issue No.	35
LM End	2.25	Issue Type +	Ma	Location *	LS
Category	Earthen Levee			GPS Latitude/Longitude	
				Start	End
Item	Erosion / Bank Caving			38.791652 °	38.791468 °
				-121.695403 °	-121.695342 °
DWR ID	DWR_NA0022_01_s_2016_35				
Comment Code					
E1 : Note and monitor erosion site.					
Inspector Comment					
Repair rills on landward side of the levee.

Erosion is on the landward side of the levee. Spring 2016.

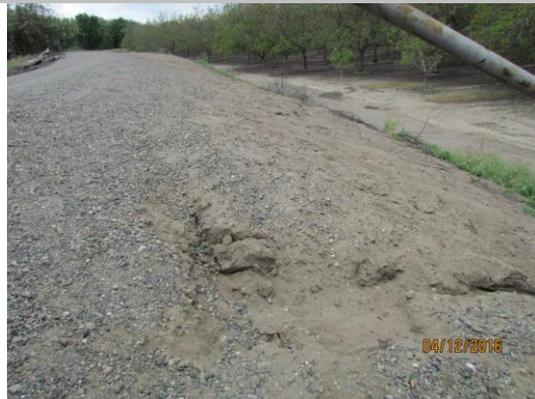
Photo 2 of 2 : SP_2016_NA0022_350_35_20160413_00158.jpg

Perspective view of the erosion on the landward side of the levee. Spring 2016.

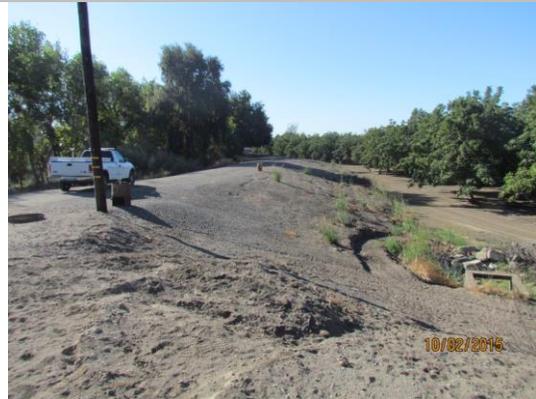
Photo 1 of 3 : SP_2016_NA0022_350_96_20160304_00070.jpg

Perspective view of the erosion around the pipe on the landward side of the levee looking downstream. Fall 2015.

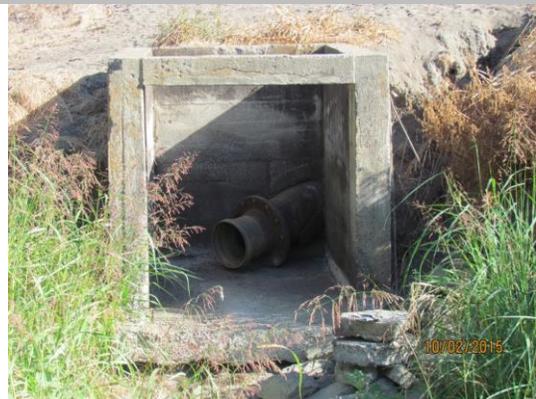
Photo 2 of 3 : SP_2016_NA0022_350_96_20160304_00071.jpg

View of the pipe in the concrete box. Fall 2015.

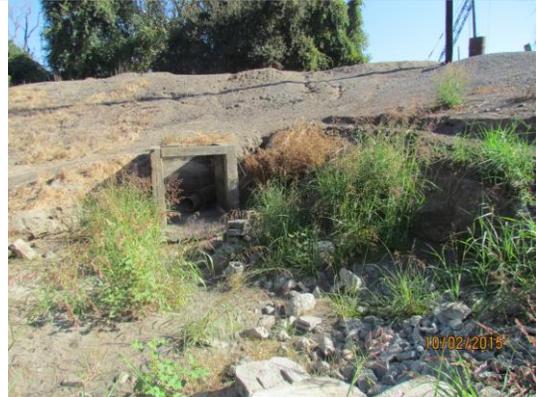
Photo 3 of 3 : SP_2016_NA0022_350_96_20160304_00072.jpg

The erosion is within the levee prism. Fall 2015.

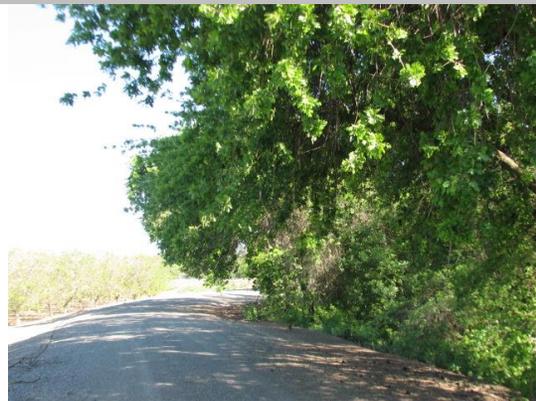
Photo 1 of 1 : SP_2016_NA0022_350_32_20160304_00030.jpg

Trees need to be trimmed up to at least 12 feet above the crown. Spring 2014

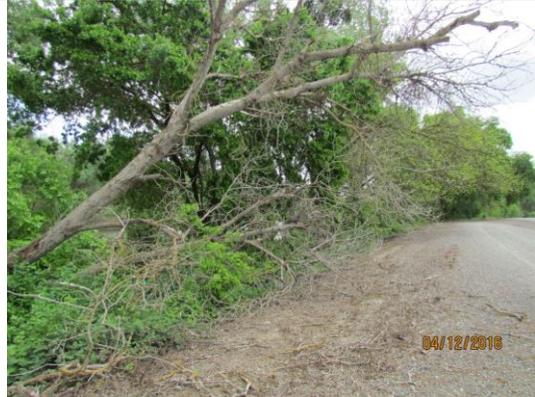
Photo 1 of 1 : SP_2016_NA0022_350_122_20160413_00160.jpg

View of the tree limbs on the waterward side of the levee looking downstream. Spring 2016.

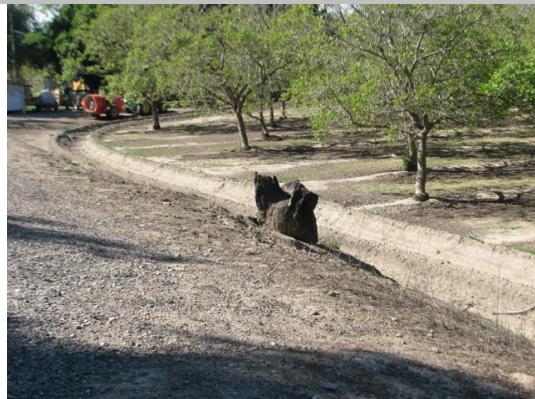
Photo 1 of 1 : SP_2016_NA0022_350_37_20160304_00034.jpg

Tree stump decomposing and may pose a risk to the levee. Spring 2014

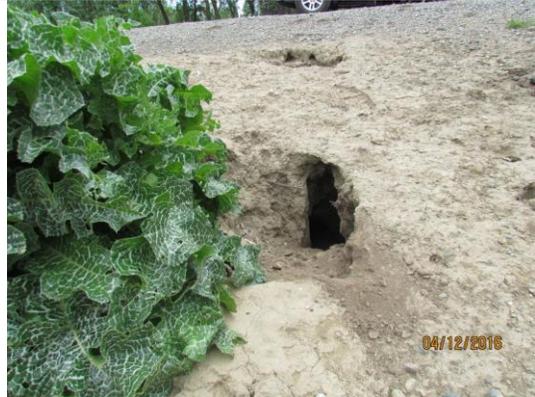
Photo 1 of 2 : SP_2016_NA0022_350_123_20160413_00161.jpg

View of the rodent hole next to a tree stump on the landward side of the levee. Spring 2016.

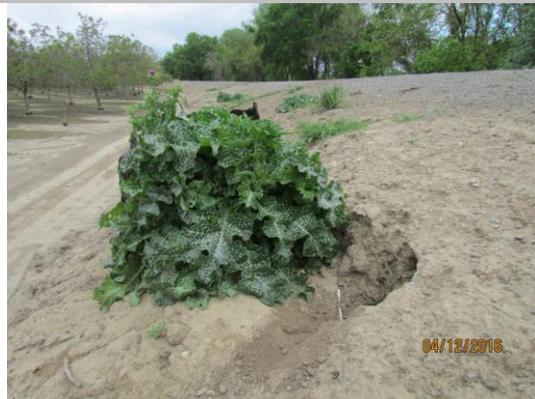
Photo 2 of 2 : SP_2016_NA0022_350_123_20160413_00162.jpg

Perspective view of the rodent hole looking upstream. Spring 2016.

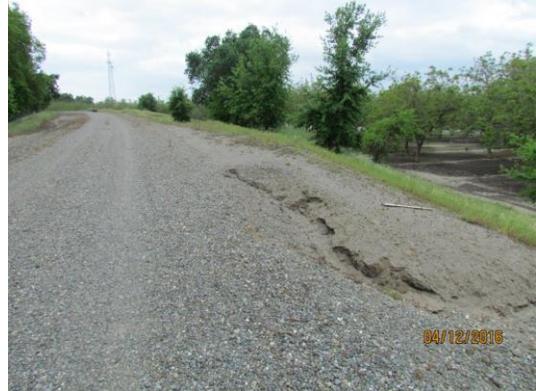
Photo 1 of 1 : SP_2016_NA0022_350_87_20160413_00164.jpg

LM Start	2.67	Rating **	U	Issue No.	87
LM End	2.67	Issue Type +	Ma	Location *	LS
Category	Earthen Levee			GPS Latitude/Longitude	
				Start	End
Item	Erosion / Bank Caving			38.785657 °	38.785657 °
				-121.694313 °	-121.694313 °
DWR ID	DWR_NA0022_01_s_2012_87				
Comment Code					
E2 : Schedule repair of erosion site prior to the next inspection.					
Inspector Comment

View of the erosion on the landward side of the levee looking downstream. Spring 2016.

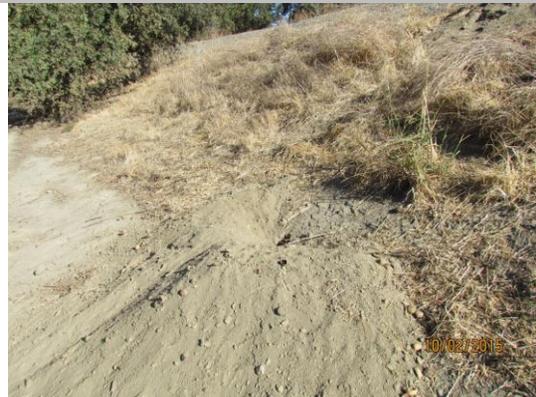
Photo 1 of 2 : SP_2016_NA0022_350_52_20160304_00044.jpg

View of the rodent hole and material on the landward side of the levee. Fall 2015.

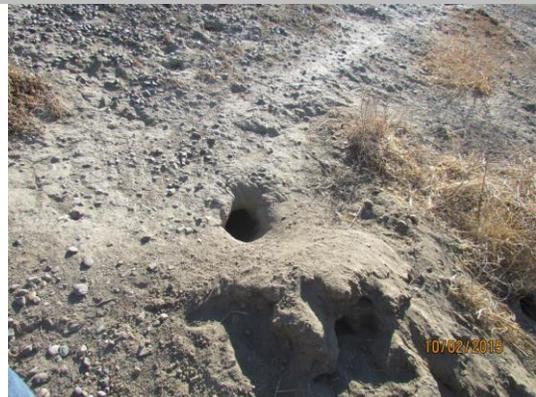
Photo 2 of 2 : SP_2016_NA0022_350_52_20160304_00045.jpg

There are multiple rodent holes in this area. Fall 2015.

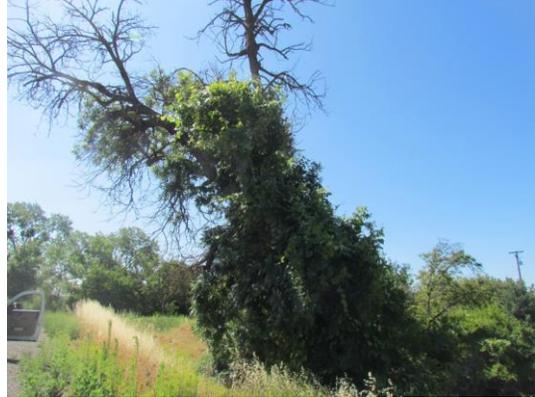
Photo 1 of 1 : SP_2016_NA0022_350_77_20160304_00054.jpg

View of the dying tree on the landward side of the levee looking downstream. Spring 2015.

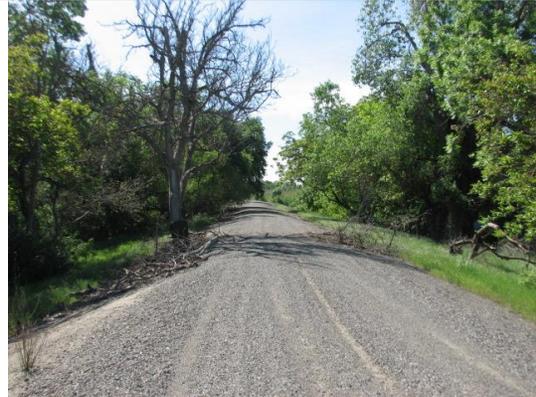
Photo 1 of 1 : SP_2016_NA0022_350_43_20160304_00038.jpg

A tree is dying and needs to be monitored as it may pose a threat to the levee. Spring 2014

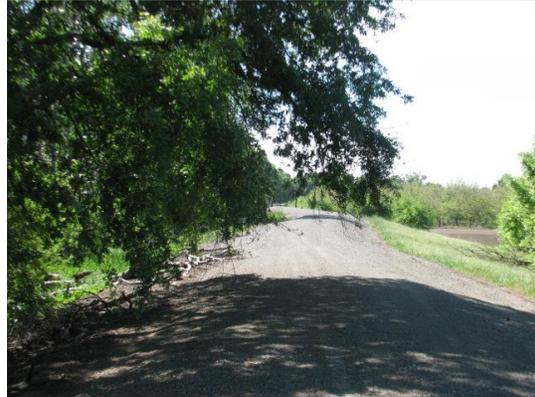
Photo 1 of 1 : SP_2016_NA0022_350_46_20160304_00041.jpg

Trees need to be trimmed up to at least 12 feet above the crown. Spring 2014

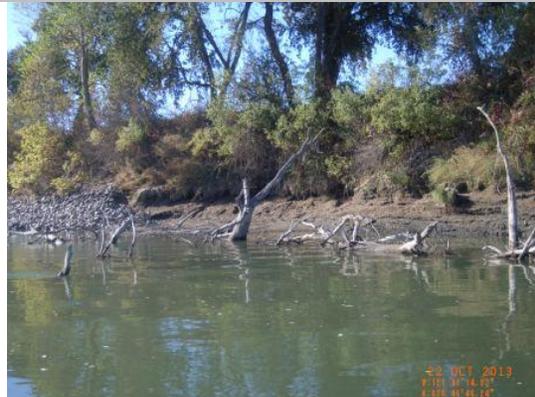
Photo 1 of 1 : SP_2016_NA0022_350_5_20160304_00006.jpg

LM Start	3.18	Rating **	M	Issue No.	5
LM End	3.28	Issue Type +	Ma	Location *	WS
Category	Supplemental			GPS Latitude/Longitude	
				Start	End
Item	2015 USACE Erosion Survey, DRAFT			38.780407 °	38.779137 °
				-121.688238 °	-121.687432 °
DWR ID	DWR_NA0022_01_s_2016_5				
Comment Code					
Inspector Comment					
2006 - Short section is into the levee toe, rest is near the levee toe. Mass failure and fluvial erosion of depositional material. Rock at the upstream and downstream ends. 2011 - Minor new erosion. 2012 - Slope continues to steepen, tree roots have become exposed, and new eddy formed. 2015: No observed changes. [2015 Site ID: SAC_86-9_R]

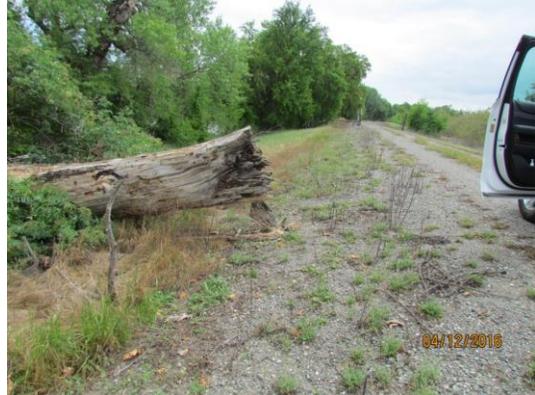
Photo 1 of 1 : SP_2016_NA0022_350_15_20160413_00165.jpg

View of the fallen tree on the waterward slope of the levee looking downstream. Spring 2016.

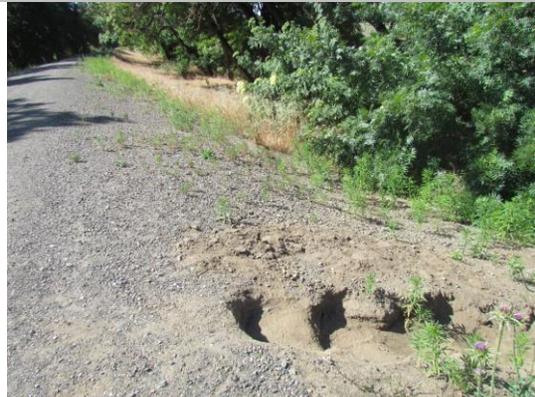
Photo 1 of 2 : SP_2016_NA0022_350_79_20160304_00055.jpg

LM Start	3.41	Rating **	M	Issue No.	79
LM End	3.41	Issue Type +	Ma	Location *	LS
Category	Earthen Levee			GPS Latitude/Longitude	
				Start	End
Item	Slope Stability			38.777204 °	38.777204 °
				-121.687045 °	-121.687045 °
DWR ID	DWR_NA0022_01_s_2015_79				
Comment Code					
S2 : Repair the levee slope damaged by foot traffic and prevent access where possible.					
Inspector Comment					
Stairs have eroded and turned into a slope stability.

View of the stairs on the landward side of the levee looking downstream. Spring 2015.

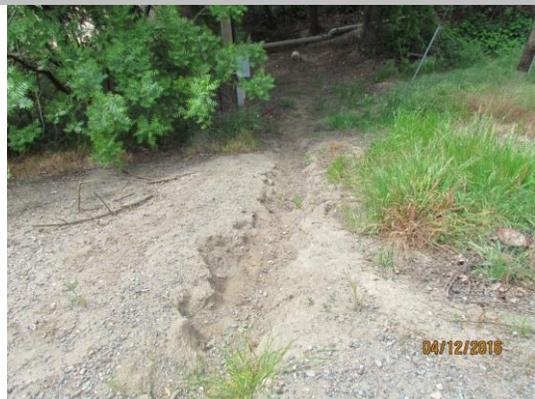
Photo 2 of 2 : SP_2016_NA0022_350_79_20160413_00166.jpg

Dirt stairs has eroded and caused a slope stability. Spring 2016.

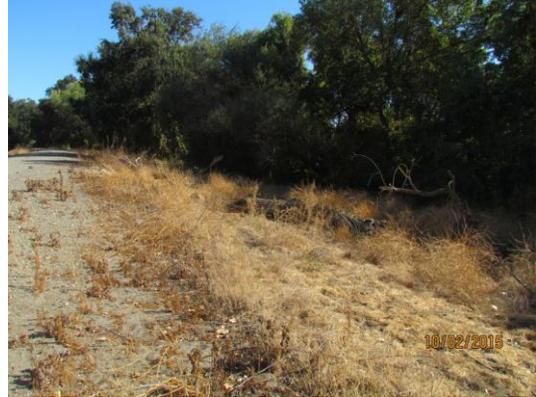
Photo 1 of 1 : SP_2016_NA0022_350_89_20160304_00063.jpg

View of the fallen tree on the waterward side of the levee looking upstream. Fall 2015.

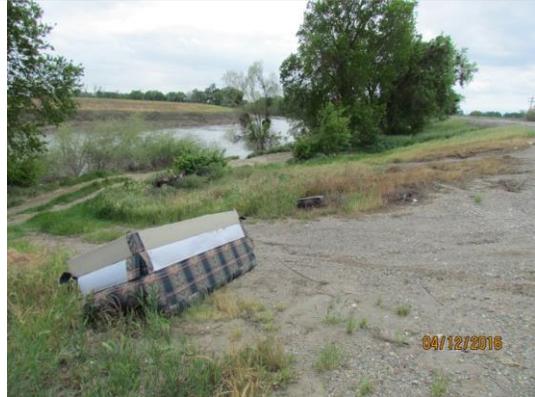
Photo 1 of 1 : SP_2016_NA0022_350_98_20160413_00167.jpg

View of the couch on the waterward side of the levee looking downstream. Spring 2016.

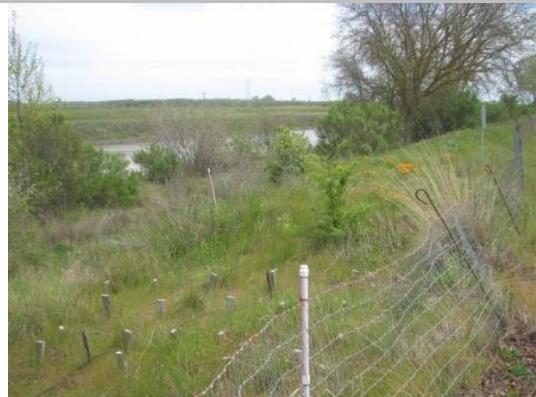
Photo 2 of 2 : SP_2016_NA0022_350_36_20160304_00033.jpg

Fence, irrigation and stakes in the revegetation site.

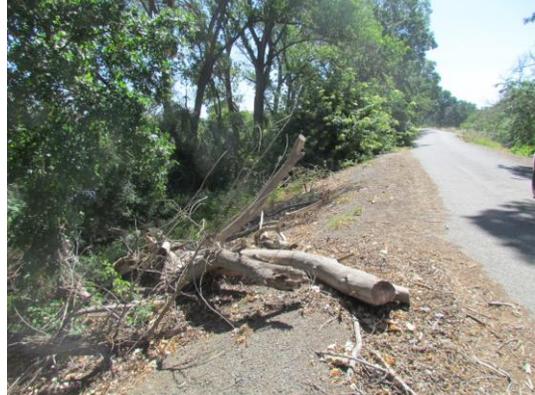
Photo 1 of 1 : SP_2016_NA0022_350_82_20160304_00057.jpg

View of the fallen tree on the waterward side of the levee looking downstream. Spring 2015.

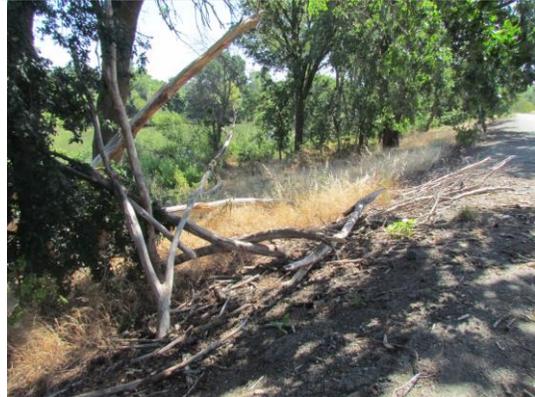
Photo 1 of 1 : SP_2016_NA0022_350_83_20160304_00058.jpg

View of the tree and tree limbs on the waterward side of the levee looking downstream. Spring 2015.
