**Flood Control Project Maintenance
Levee Inspections**
LMA District Cover Sheet
Spring 2011 Levee Inspection Results
Yolo County Service Area 6

**Flood Control Project Maintenance
Levee Inspections
Unit Cover Sheet
Spring 2011 Levee Inspection Results
Yolo County Service Area 6**

Levee Inspection Report By Mile - Spring 2011

Waterway	Bank	Unit Miles	Inspection Start/End	Inspector
Unit No. 01 Right Bank of Sacramento River at Knights Landing	Right	5.97	03/15/2011 03/17/2011	John Williamson

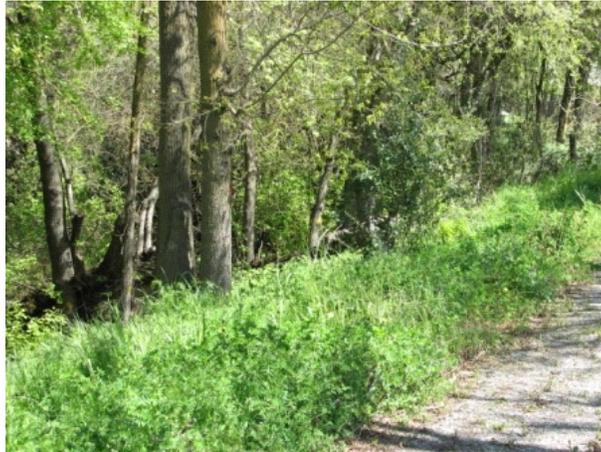
Levee Mile Report Line	3
Start Levee Mile	0.12
End Levee Mile	0.20
Location	Water Side
Category	Earthen Levee
Item	Vegetation
Remove all brush except grasses	
johngw_s_20110228_145.jpg

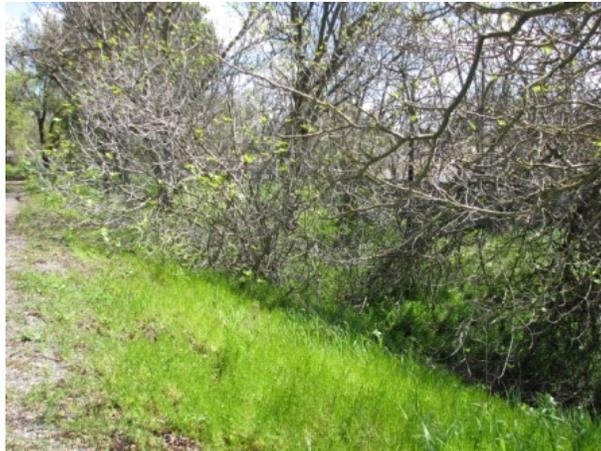
Levee Mile Report Line	4
Start Levee Mile	0.15
End Levee Mile	0.15
Location	Land Side
Category	Earthen Levee
Item	Trim / Thin Trees
Fig tree on landside other trees need to be trimmed	
johngw_s_20110228_165.jpg

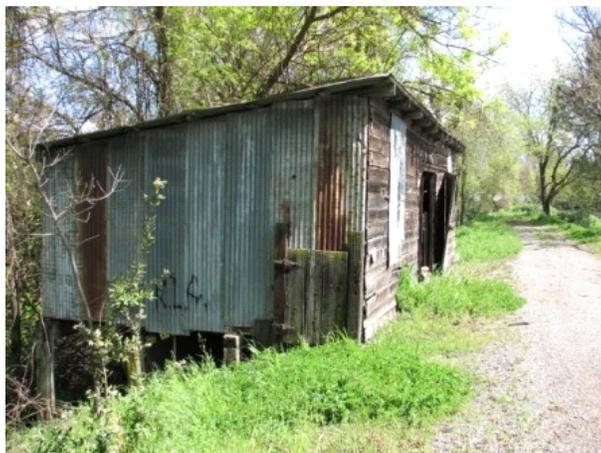
Levee Mile Report Line	5
Start Levee Mile	0.15
End Levee Mile	0.15
Location	Water Side
Category	Earthen Levee
Item	Encroachments
Building on waterside	
johngw_s_20110228_164.jpg

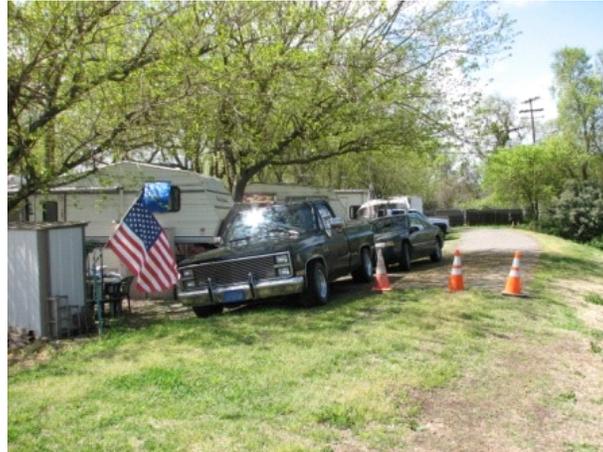
Levee Mile Report Line	6
Start Levee Mile	0.22
End Levee Mile	0.26
Location	Land Side
Category	Earthen Levee
Item	Encroachments
RV park trailers and vehicles on levee	
johngw_s_20110228_163.jpg

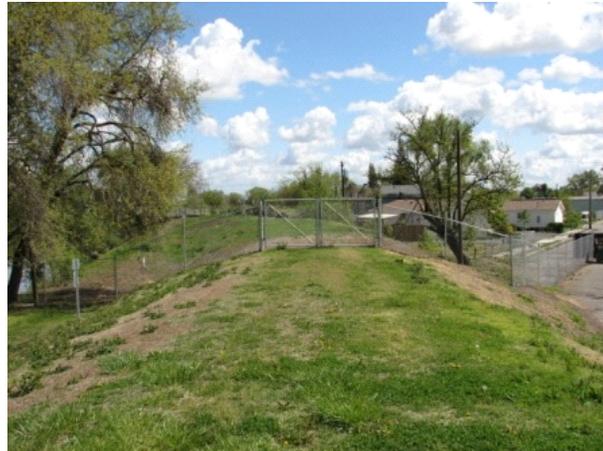
Levee Mile Report Line	7
Start Levee Mile	0.31
End Levee Mile	0.33
Location	Land Side
Category	Earthen Levee
Item	Encroachments
Fence across levee	
johngw_s_20110228_161.jpg

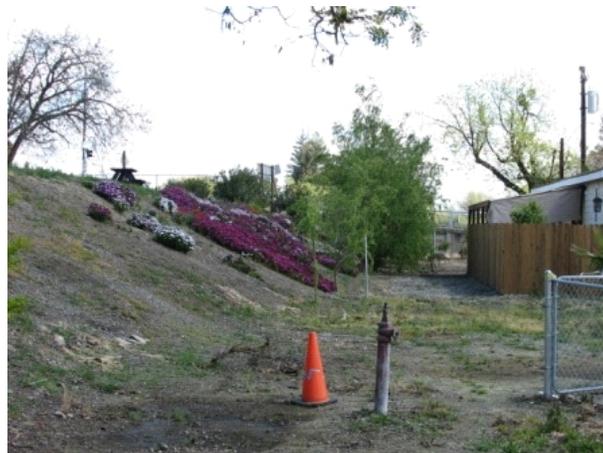
Levee Mile Report Line	7
Start Levee Mile	0.31
End Levee Mile	0.33
Location	Land Side
Category	Earthen Levee
Item	Encroachments
Landscape on levee slope	
johngw_s_20110228_162.jpg

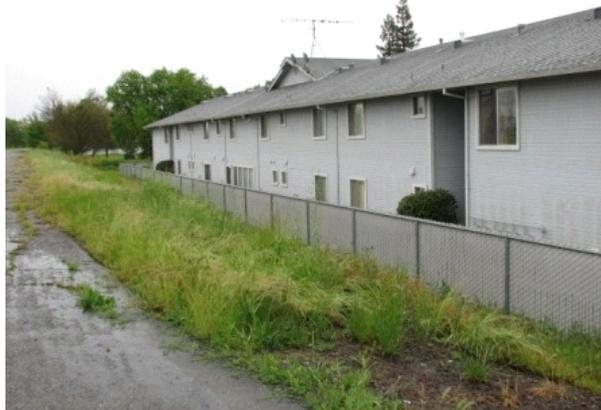
Levee Mile Report Line	8
Start Levee Mile	0.35
End Levee Mile	0.39
Location	Land Side
Category	Earthen Levee
Item	Encroachments
Apartments and fence	
johngw_s_20110228_160.jpg

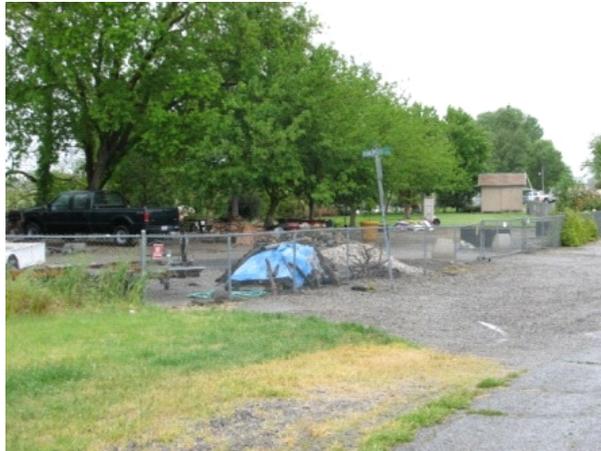
Levee Mile Report Line	9
Start Levee Mile	0.50
End Levee Mile	0.57
Location	Water Side
Category	Earthen Levee
Item	Encroachments
On levee crown	
johngw_s_20110228_158.jpg

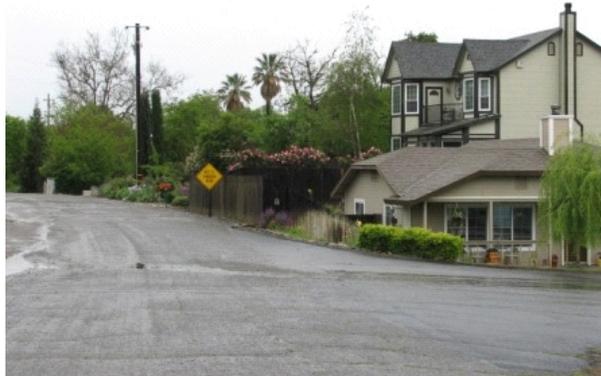
Levee Mile Report Line	10
Start Levee Mile	0.51
End Levee Mile	0.57
Location	Land Side
Category	Earthen Levee
Item	Encroachments
Houses on levee	
johngw_s_20110228_159.jpg

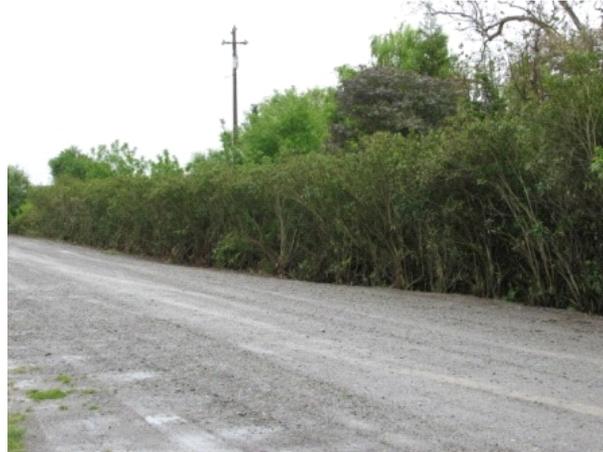
Levee Mile Report Line	11
Start Levee Mile	0.57
End Levee Mile	0.71
Location	Land Side
Category	Earthen Levee
Item	Encroachments
Oleanders along shoulder	
johngw_s_20110228_156.jpg

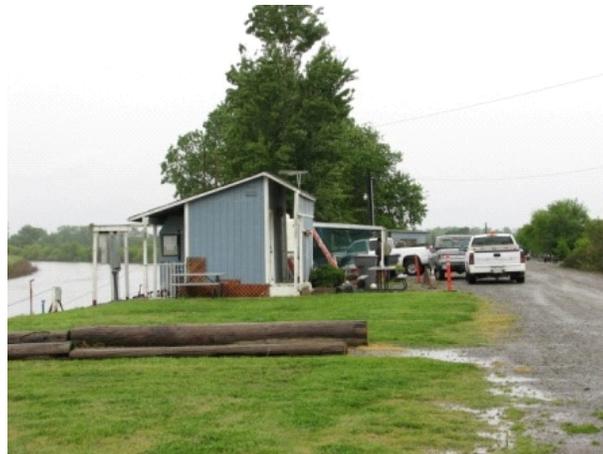
Levee Mile Report Line	12
Start Levee Mile	0.57
End Levee Mile	0.65
Location	Water Side
Category	Earthen Levee
Item	Encroachments
Yacht club	
johngw_s_20110228_157.jpg

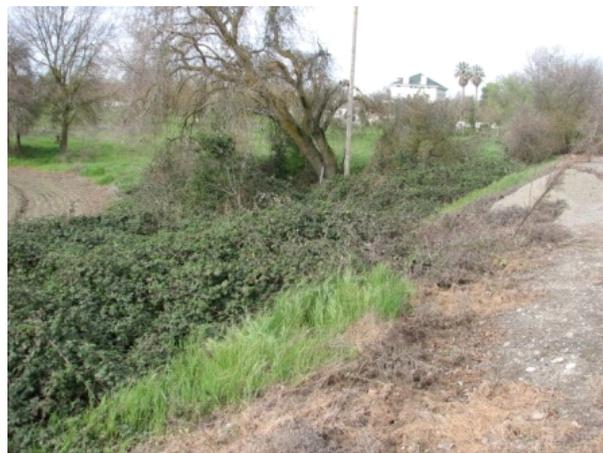
Levee Mile Report Line	13
Start Levee Mile	0.73
End Levee Mile	0.73
Location	Land Side
Category	Earthen Levee
Item	Vegetation
The berry vines block good visibility to see levee slope.	
johngw_s_20110321_394.jpg

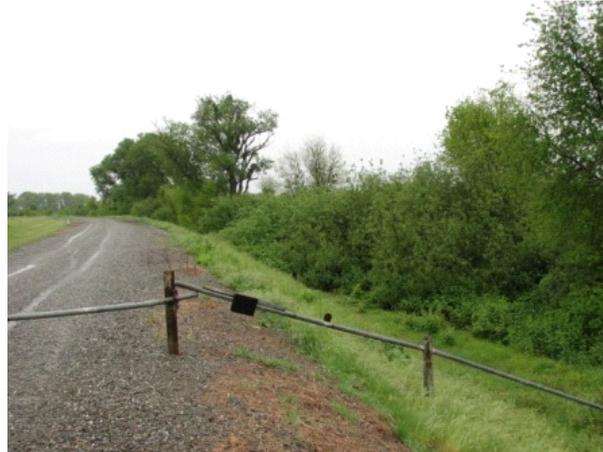
Levee Mile Report Line	16
Start Levee Mile	0.97
End Levee Mile	1.14
Location	Land Side
Category	Earthen Levee
Item	Vegetation
Vegetation on landside	
johngw_s_20110228_155.jpg

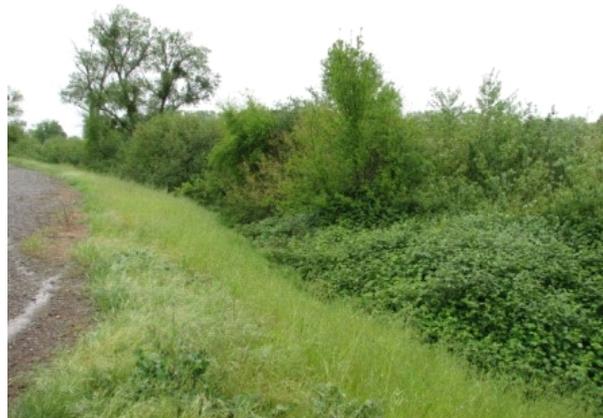
Levee Mile Report Line	17
Start Levee Mile	1.18
End Levee Mile	1.34
Location	Land Side
Category	Earthen Levee
Item	Vegetation
Vegetation on landside	
johngw_s_20110228_154.jpg

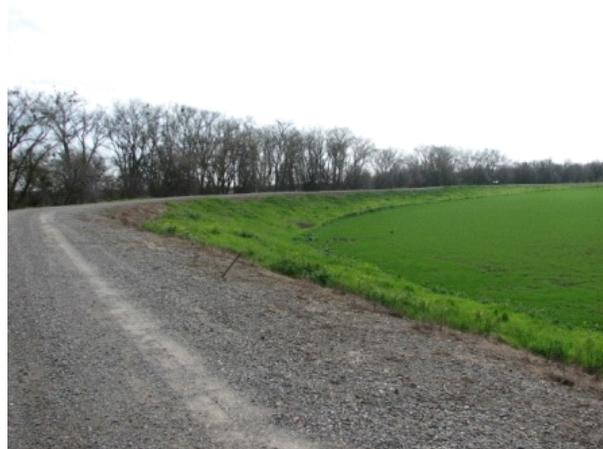
Levee Mile Report Line	18
Start Levee Mile	1.40
End Levee Mile	1.40
Location	Land Side
Category	Earthen Levee
Item	Vegetation
The landside levee slope has a well maintained grass.	
johngw_s_20110321_395.jpg

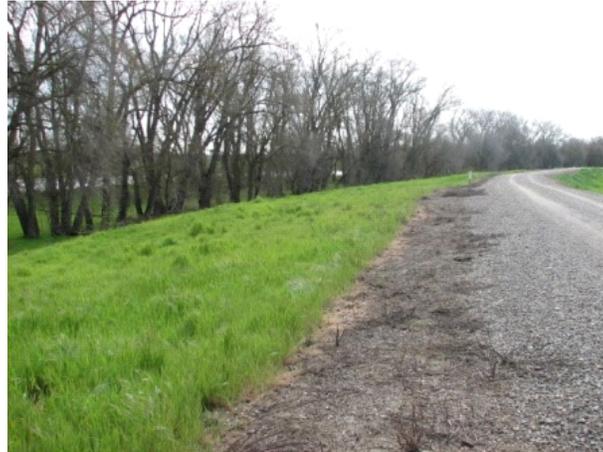
Levee Mile Report Line	19
Start Levee Mile	1.47
End Levee Mile	1.47
Location	Water Side
Category	Earthen Levee
Item	Vegetation
The waterside slope is well maintained.	
johngw_s_20110321_396.jpg

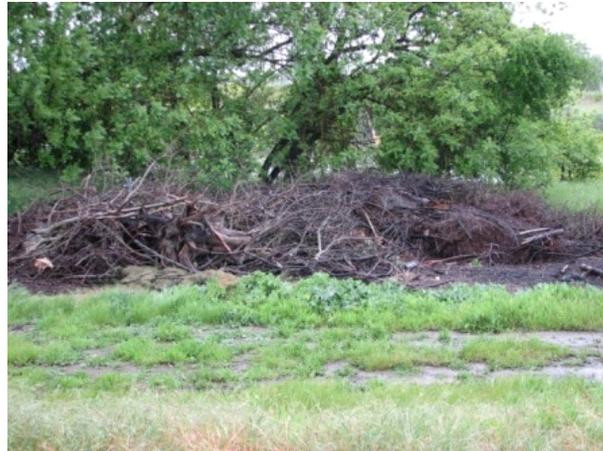
Levee Mile Report Line	20
Start Levee Mile	1.78
End Levee Mile	1.78
Location	Water Side
Category	Earthen Levee
Item	Encroachments
prunings	
johngw_s_20110228_146.jpg

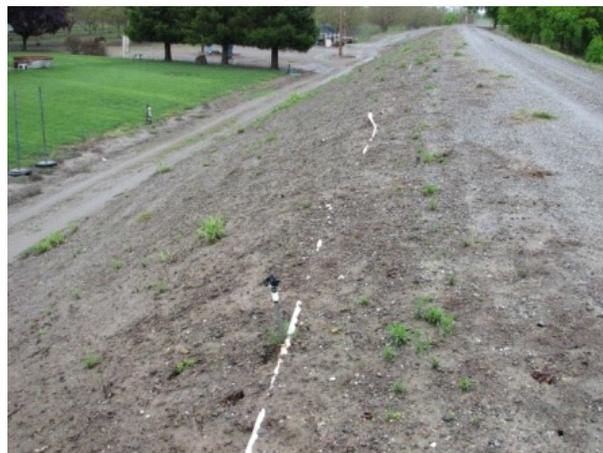
21	1.91	1.91	Earthen Levee	Encroachments	LS	PO	Landscaping Inspector Comments: sprinklers trenched into levee slope	38.796394 ° -121.696700 °	38.796394 ° -121.696700 °	10 Y
22	1.99	1.99	Earthen Levee	Encroachments	LS	C	Prunings	38.795518 ° -121.695965 °	38.795518 ° -121.695965 °	19
23	2.07	2.07	Earthen Levee	Encroachments	LS	C	Prunings	38.794347 ° -121.695690 °	38.794347 ° -121.695690 °	18
24	2.18	2.18	Earthen Levee	Animal Control	LS	M	No rodents visible, but rodent burrows visible; need to backfill and compact or grout burrows.	38.792956 ° -121.696025 °	38.792956 ° -121.696025 °	8 Y
25	2.22	2.22	Earthen Levee	Encroachments	LS	M	Pipe	38.792499 ° -121.695508 °	38.792499 ° -121.695508 °	40 Y
26	2.22	2.22	Earthen Levee	Animal Control	LS	M	No rodents visible, but rodent burrows visible; need to backfill and compact or grout burrows.	38.792428 ° -121.695495 °	38.792428 ° -121.695495 °	35 Y
27	2.24	2.24	Earthen Levee	Encroachments	LS	M	Firewood	38.792283 ° -121.695447 °	38.792283 ° -121.695447 °	39 Y

Levee Mile Report Line	21
Start Levee Mile	1.91
End Levee Mile	1.91
Location	Land Side
Category	Earthen Levee
Item	Encroachments
sprinklers and landscape	
johngw_s_20110228_147.jpg

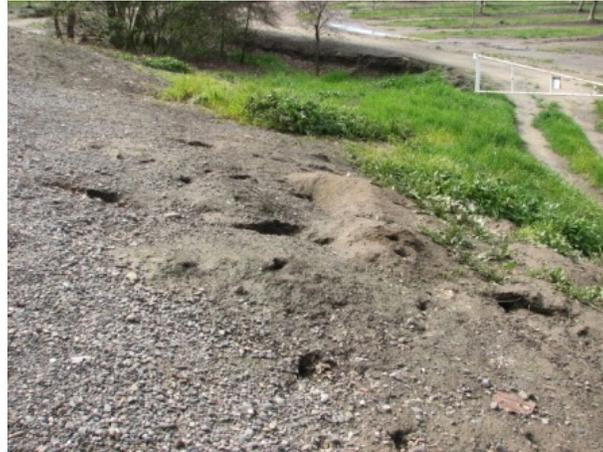
Levee Mile Report Line	24
Start Levee Mile	2.18
End Levee Mile	2.18
Location	Land Side
Category	Earthen Levee
Item	Animal Control
<p>There is multiple rodent holes but no visiable rodents. Need to backfill and compact.</p>	
<p>johngw_s_20110321_397.jpg</p>

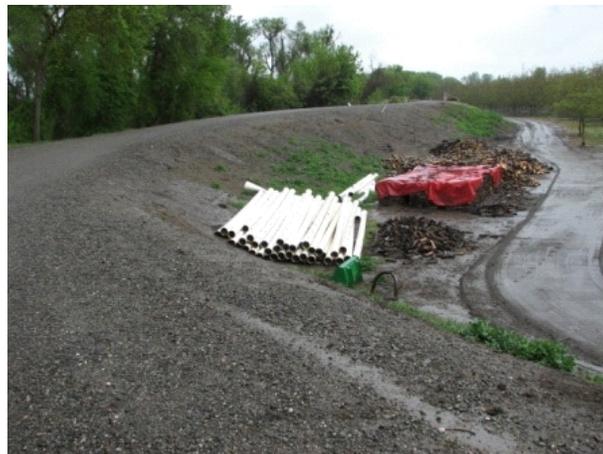
Levee Mile Report Line	25
Start Levee Mile	2.22
End Levee Mile	2.22
Location	Land Side
Category	Earthen Levee
Item	Encroachments
<p>Pipe along toe</p>	
<p>johngw_s_20110228_168.jpg</p>

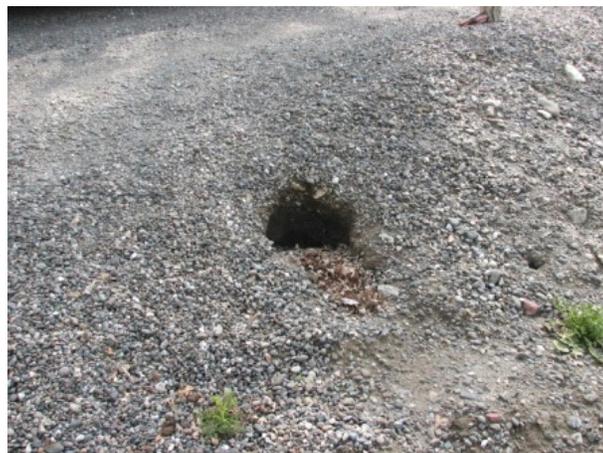
Levee Mile Report Line	26
Start Levee Mile	2.22
End Levee Mile	2.22
Location	Land Side
Category	Earthen Levee
Item	Animal Control
<p>A rodent hole needs to be backfilled and compacted.</p>	
<p>johngw_s_20110321_398.jpg</p>

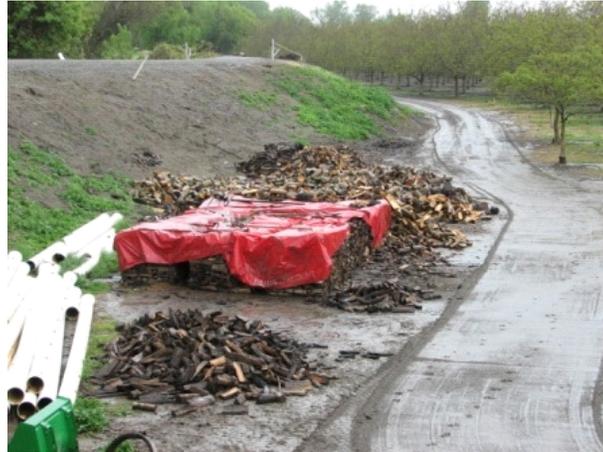
Levee Mile Report Line	27
Start Levee Mile	2.24
End Levee Mile	2.24
Location	Land Side
Category	Earthen Levee
Item	Encroachments
Firewood stacked up	
johngw_s_20110228_167.jpg

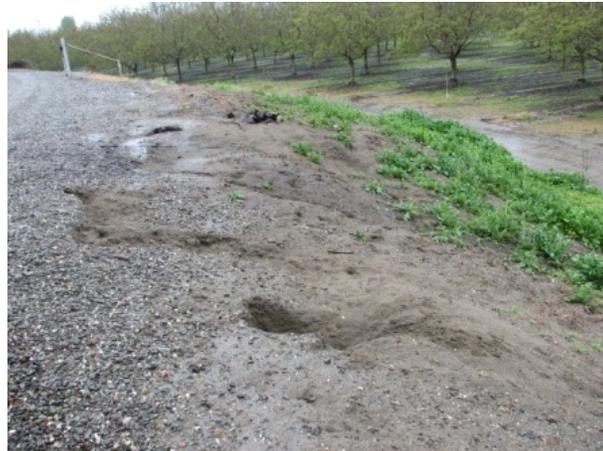
28	2.25	2.25	Earthen Levee	Animal Control	LS	M	No rodents visible, but rodent burrows visible; need to backfill and compact or grout burrows.	38.792128 ° -121.695400 °	38.792128 ° -121.695400 °	41 Y
29	2.30	2.30	Earthen Levee	Trim / Thin Trees	WS	U	Trim and thin trees to allow visibility of the ground and room to flood fight. Inspector Comments: tree fell across crown, but still accessible. Tree needs to cut up and remove or burned.	38.791321 ° -121.695261 °	38.791321 ° -121.695261 °	52 Y
30	2.62	2.62	Earthen Levee	Encroachments	LS	PO	Buildings	38.786964 ° -121.694239 °	38.786964 ° -121.694239 °	11 Y
31	2.97	2.97	Earthen Levee	Animal Control	LS	M	No rodents visible, but rodent burrows visible; need to backfill and compact or grout burrows.	38.782985 ° -121.691518 °	38.782985 ° -121.691518 °	14
32	2.97	2.97	Earthen Levee	Encroachments	LS	C	Prunings	38.782985 ° -121.691518 °	38.782985 ° -121.691518 °	13

Levee Mile Report Line	28
Start Levee Mile	2.25
End Levee Mile	2.25
Location	Land Side
Category	Earthen Levee
Item	Animal Control
Rodents	
johngw_s_20110228_169.jpg

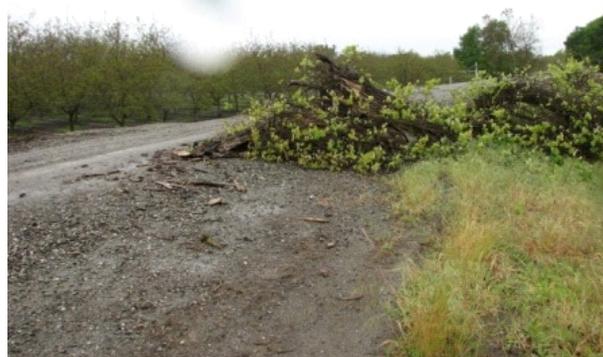
Levee Mile Report Line	29
Start Levee Mile	2.30
End Levee Mile	2.30
Location	Water Side
Category	Earthen Levee
Item	Trim / Thin Trees
Tree across levee	
johngw_s_20110228_171.jpg

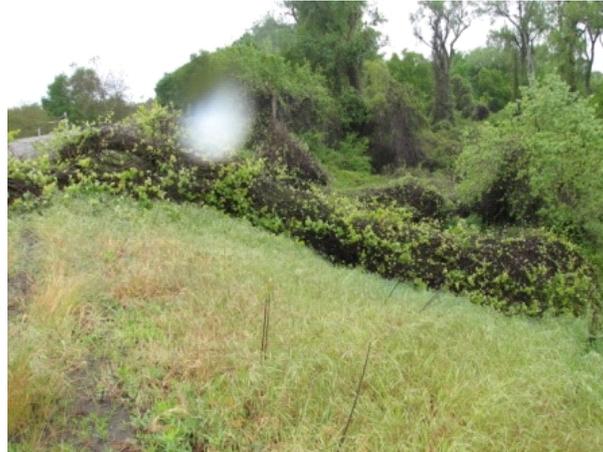
Levee Mile Report Line	29
Start Levee Mile	2.30
End Levee Mile	2.30
Location	Water Side
Category	Earthen Levee
Item	Trim / Thin Trees
Water side view	
johngw_s_20110228_172.jpg

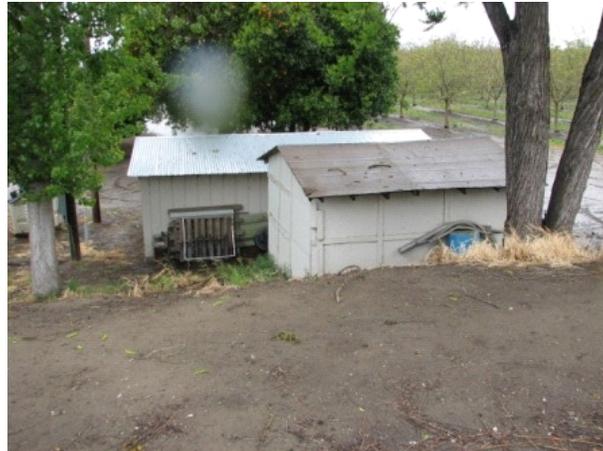
Levee Mile Report Line	30
Start Levee Mile	2.62
End Levee Mile	2.62
Location	Land Side
Category	Earthen Levee
Item	Encroachments
Garage at toe	
johngw_s_20110228_148.jpg

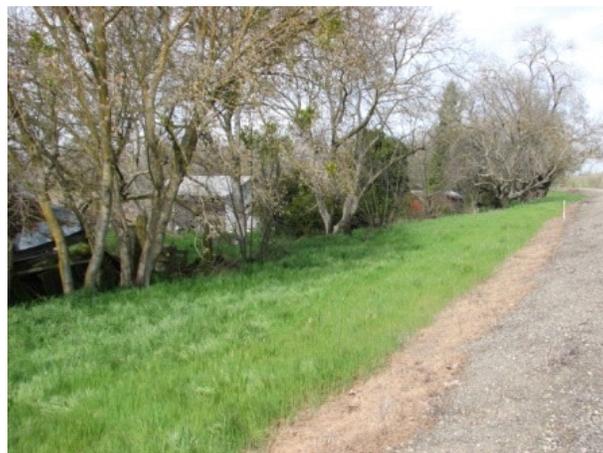
33	3.12	3.19	Earthen Levee	Encroachments	LS	PO	Buildings	38.781828 ° -121.689415 °	38.780852 ° -121.688887 °	12 Y
34	3.16	3.16	Earthen Levee	Encroachments	WS	M	Prunings	38.781358 ° -121.689118 °	38.781358 ° -121.689118 °	34 Y

Levee Mile Report Line	33
Start Levee Mile	3.12
End Levee Mile	3.19
Location	Land Side
Category	Earthen Levee
Item	Encroachments
The buildings are encroaching into the levee slope.	
johngw_s_20110321_399.jpg

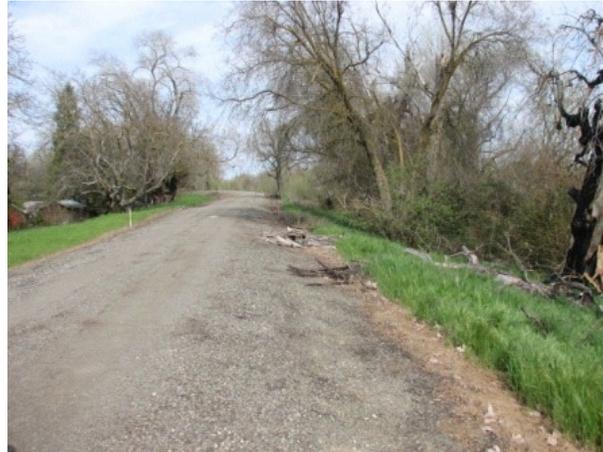
Levee Mile Report Line	34
Start Levee Mile	3.16
End Levee Mile	3.16
Location	Water Side
Category	Earthen Levee
Item	Encroachments
Multiple piles of wooden debris along shoulder along with fallen tree.	
johngw_s_20110321_400.jpg

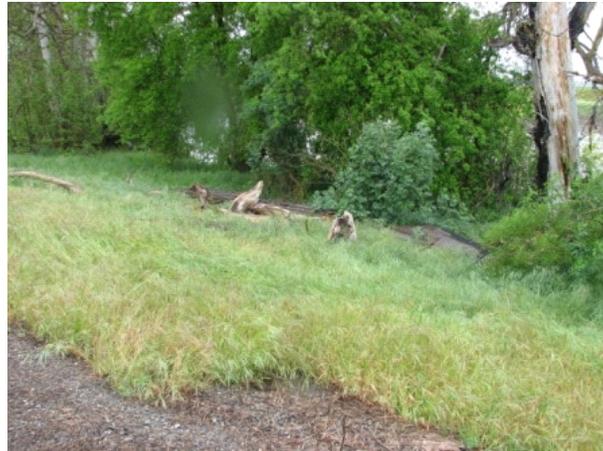
LMR No.	Levee Mile		Category	Item	* Location	** Rating	Action/Comment	GPS Latitude/Longitude		Issue No. Photo
	Start	End						Start	End	
35	3.25	3.25	Earthen Levee	Trim / Thin Trees	WS	M	Trim and thin trees to allow visibility of the ground and room to flood fight. Inspector Comments: dead tree broken during winter storms, needs to be cleaned up	38.780041 ° -121.688499 °	38.780041 ° -121.688499 °	15 Y
36	3.33	3.33	Earthen Levee	Trim / Thin Trees	WS	M	Trim and thin trees to allow visibility of the ground and room to flood fight. Inspector Comments: fallen tree from winter storms, needs to be cleaned up	38.779046 ° -121.687839 °	38.779046 ° -121.687839 °	16 Y
37	3.40	3.40	Earthen Levee	Encroachments	LS	C	Prunings	38.778167 ° -121.687357 °	38.778167 ° -121.687357 °	17
38	4.74	4.95	Supplemental	USACE Erosion Survey	WS	U	Inspector Comments: 2009: 5 ft berm, 1.5:1 slope, slumping, silts, 3.21 ft/s [2009 SiteID:SAC_85-4_R]	38.763314 ° -121.684039 °	38.763486 ° -121.687567 °	33 Y

Levee Mile Report Line	35
Start Levee Mile	3.25
End Levee Mile	3.25
Location	Water Side
Category	Earthen Levee
Item	Trim / Thin Trees
Branches from dead trees, water side	
johngw_s_20110228_150.jpg

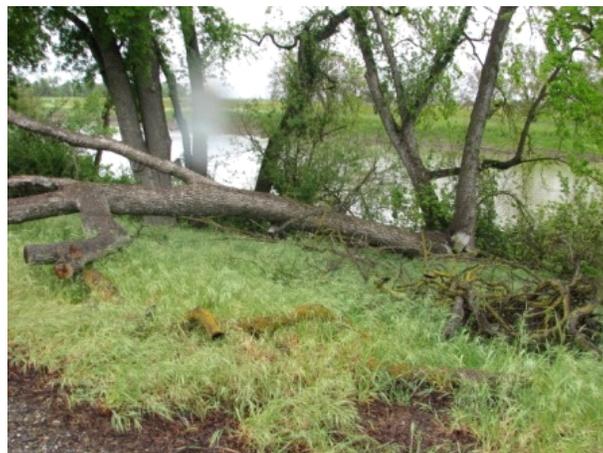
Levee Mile Report Line	36
Start Levee Mile	3.33
End Levee Mile	3.33
Location	Water Side
Category	Earthen Levee
Item	Trim / Thin Trees
Winter storm damage	
johngw_s_20110228_151.jpg

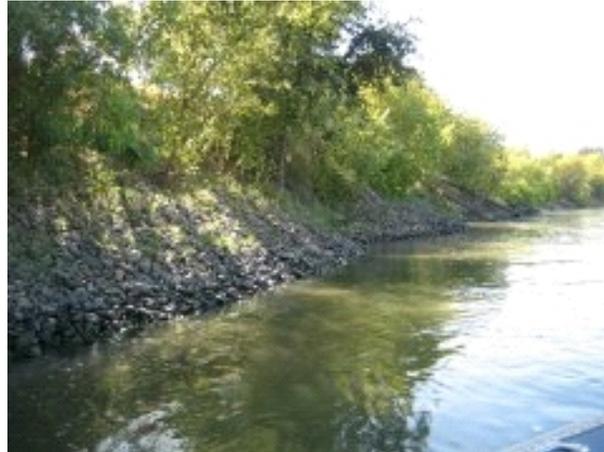
Levee Mile Report Line	38
Start Levee Mile	4.74
End Levee Mile	4.95
Location	Water Side
Category	Supplemental
Item	USACE Erosion Survey
2009: 5 ft berm, 1.5:1 slope, slumping, silts, 3.21 ft/s [2009 SiteID:SAC_85-4_R]	
johngw_s_20110228_166.JPG
