**Flood Control Project Maintenance
Levee Inspections**
LMA District Cover Sheet
Spring 2014 Levee Inspection Results
Yolo County Service Area 6

**Flood Control Project Maintenance
Levee Inspections
Unit Cover Sheet
Spring 2014 Levee Inspection Results
Yolo County Service Area 6**

Waterway	Bank	Unit Miles
Unit No. 01 Right Bank of Sacramento River at Knights Landing	Right	5.97

Levee Inspection Report By Mile - Spring 2014

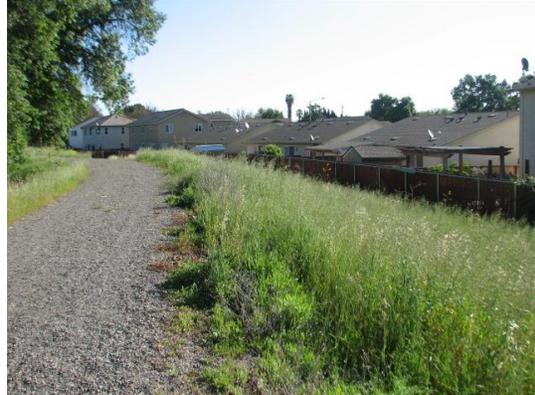
Photo 1 of 1 : johngw_s_20140421_844.jpg

LM Start	0.00	Rating **	M	Issue No.	10
LM End	0.20	Issue Type +	Ma	Location *	LS
Category	Earthen Levee		GPS Latitude/Longitude		
			Start	End	
Item	Vegetation		38.799172 °	38.801301 °	
			-121.724432 °	-121.722146 °	
DWR ID	DWR_NA0022_01_s_2014_10				
Action/Comments					
Control annual grass and weeds on the levee slopes and easements.

Tall grasses and vegetation partially blocks visibility. Spring 2014

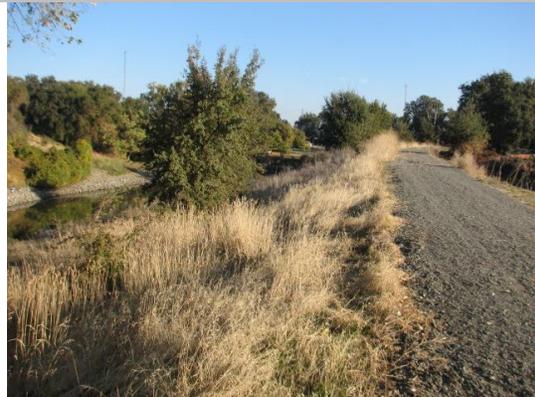
Photo 1 of 2 : johngw_s_20140414_153.jpg

LM Start	0.00	Rating **	M	Issue No.	31
LM End	0.20	Issue Type +	Ma	Location *	WS
Category	Earthen Levee		GPS Latitude/Longitude		
			Start	End	
Item	Vegetation		38.799184 °	38.801220 °	
			-121.724417 °	-121.722229 °	
DWR ID	DWR_NA0022_01_s_2012_31				
Action/Comments					
Control annual grass and weeds on the levee slopes and easements.

The vegetation partially blocks visibility. Fall 2013

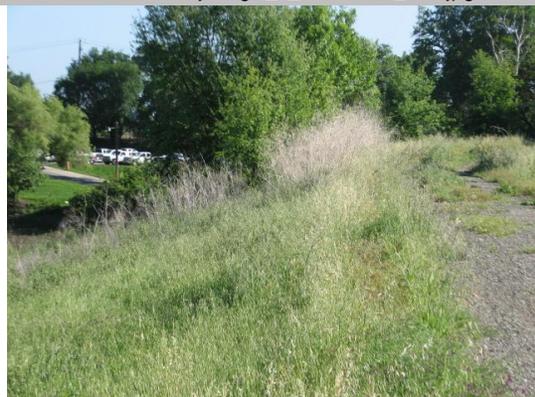
Photo 2 of 2 : johngw_s_20140421_845.jpg

Tall grasses and vegetation partially blocks visibility. Spring 2014

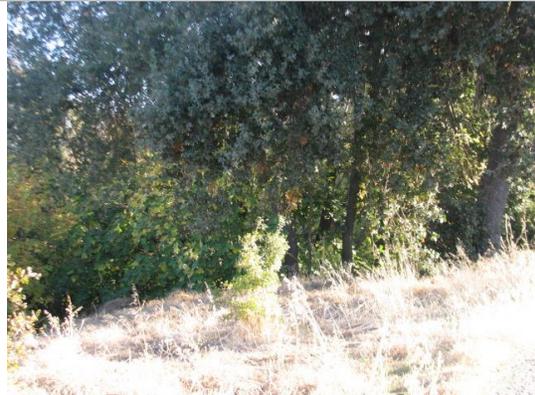
Photo 1 of 3 : johngw_s_20140414_130.jpg

LM Start	0.03	Rating **	U	Issue No.	6
LM End	0.20	Issue Type +	Ma	Location *	WS
Category	Earthen Levee		GPS Latitude/Longitude		
			Start	End	
Item	Vegetation		38.799606 °	38.801368 °	
			-121.724048 °	-121.722054 °	
DWR ID	DWR_NA0022_01_s_2012_6				
Action/Comments					
Remove the wild growth other than native grasses from the levee

Tall vegetation, trees and brush block visibility. Fall 2013

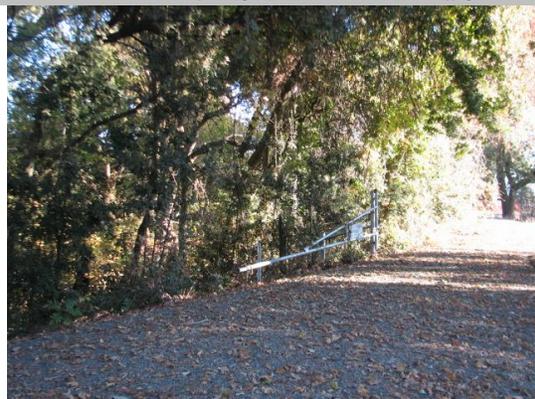
Photo 2 of 3 : johngw_s_20140414_131.jpg

Trees and brush block visibility. Fall 2013

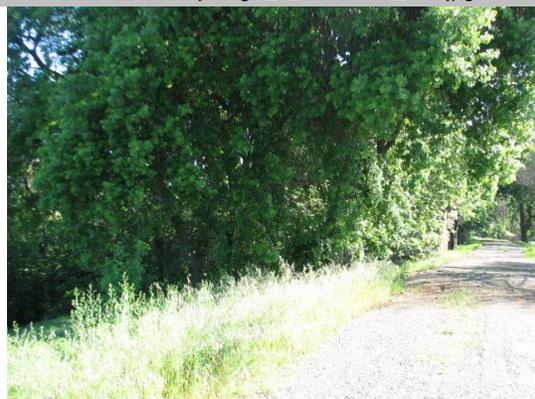
Photo 3 of 3 : johngw_s_20140421_847.jpg

Tall vegetation and trees block visibility. Spring 2014

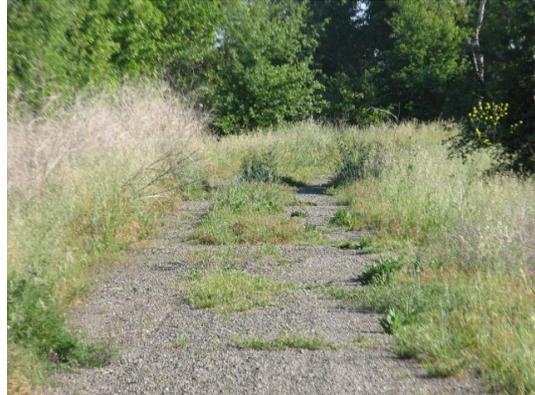
Photo 1 of 1 : johngw_s_20140421_846.jpg

The vegetation needs to be controlled on the crown. Spring 2014

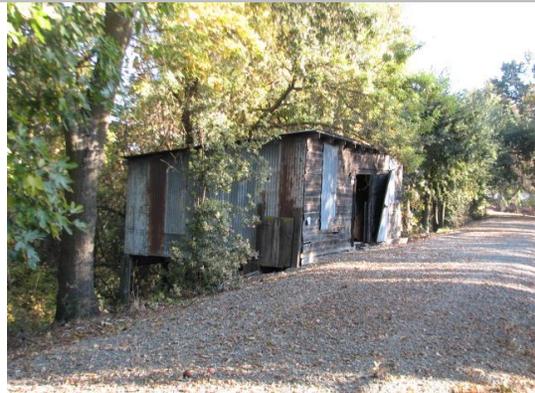
Photo 1 of 1 : johngw_s_20140414_150.jpg

LM Start	0.15	Rating **	M	Issue No.	29
LM End	0.15	Issue Type +	En	Location *	WS
Category	Earthen Levee		GPS Latitude/Longitude		
			Start	End	
Item	Encroachments		38.800828 °	38.800828 °	
			-121.722902 °	-121.722902 °	
DWR ID	DWR_NA0022_01_s_2012_29				
Action/Comments					
Building

The old barn is on the waterside of the levee. Fall 2013

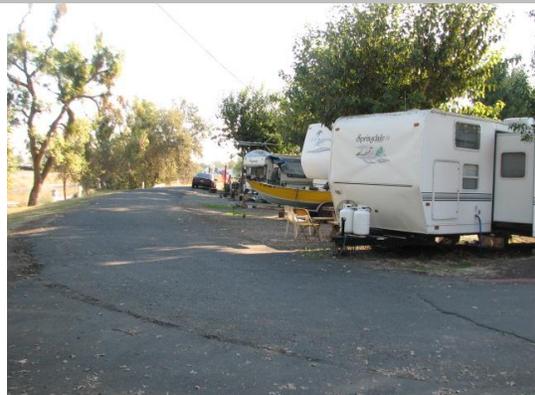
Photo 1 of 2 : johngw_s_20140414_149.jpg

LM Start	0.22	Rating **	M	Issue No.	28
LM End	0.26	Issue Type +	En	Location *	LS
Category	Earthen Levee		GPS Latitude/Longitude		
			Start	End	
Item	Encroachments		38.801500 °	38.801613 °	
			-121.721878 °	-121.721328 °	
DWR ID	DWR_NA0022_01_s_2012_28				
Action/Comments					
Building Inspector Comments: RV park runs on and along levee to bridge

The RV park is encroached into the levee crown. Fall 2013

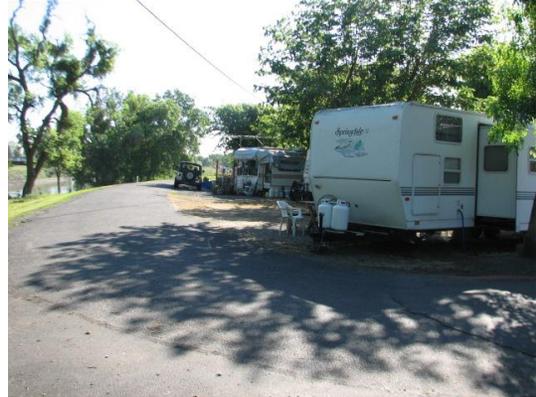
Photo 2 of 2 : johngw_s_20140421_848.jpg

Trailers on the crown of the levee. Spring 2014

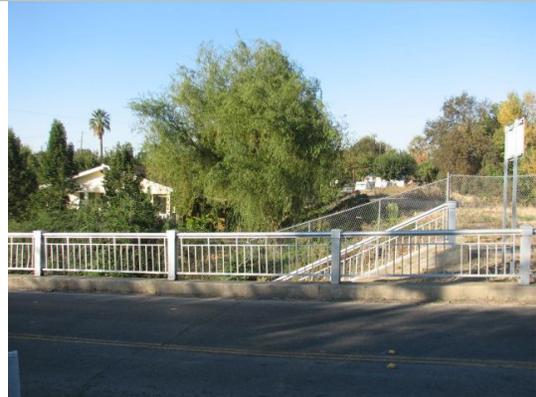
Photo 1 of 1 : johngw_s_20140414_148.jpg

LM Start	0.31	Rating **	A/W	Issue No.	27
LM End	0.33	Issue Type +	En	Location *	LS
Category	Earthen Levee		GPS Latitude/Longitude		
			Start	End	
Item	Vegetation		38.801720 °	38.801840 °	
			-121.720447 °	-121.720030 °	
DWR ID	DWR_NA0022_01_s_2012_27				
Action/Comments					
Landscaping Inspector Comments: I have talked to the owner about a permit and he continues to landscape the landside slope with no permit. Owner has added fence across levee. I gave her an application and did a field investigation report.

Landscaping is encroach into the levee easement. Fall 2013

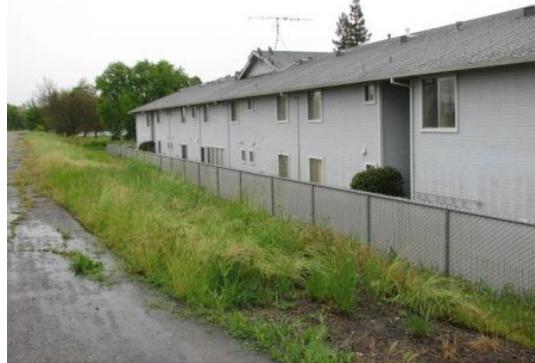
Photo 1 of 1 : johngw_s_20140414_147.jpg

The apartments and fence along the toe of the levee. Fall 2013

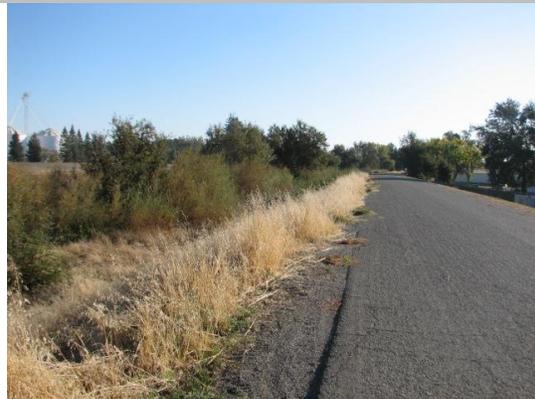
Photo 1 of 1 : johngw_s_20140414_169.jpg

LM Start	0.35	Rating **	M	Issue No.	91
LM End	0.50	Issue Type +	Ma	Location *	WS
Category	Earthen Levee		GPS Latitude/Longitude		
			Start	End	
Item	Vegetation		38.801913 °	38.802150 °	
			-121.719610 °	-121.716863 °	
DWR ID	DWR_NA0022_01_f_2013_91				
Action/Comments					
Control annual grass and weeds on the levee slopes and easements.

Tall vegetation block visibility on the waterside. Fall 2013

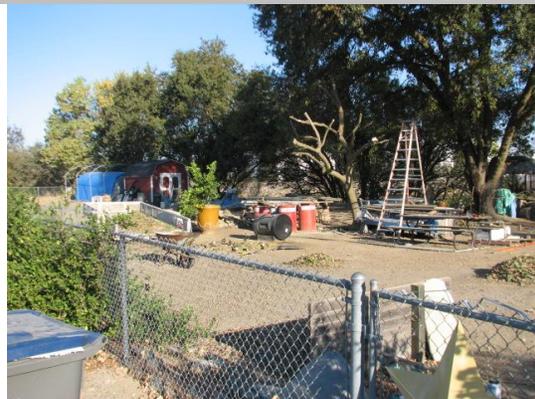
Photo 1 of 1 : johngw_s_20140414_170.jpg

LM Start	0.50	Rating **	M	Issue No.	395
LM End	0.55	Issue Type +	En	Location *	WS
Category	Earthen Levee		GPS Latitude/Longitude		
			Start	End	
Item	Encroachments		38.802120 °	38.801882 °	
			-121.716867 °	-121.716165 °	
DWR ID	DWR_NA0022_01_f_2013_395				
Action/Comments					
Material

Material blocking visibility on the waterside of the levee. Fall 2013

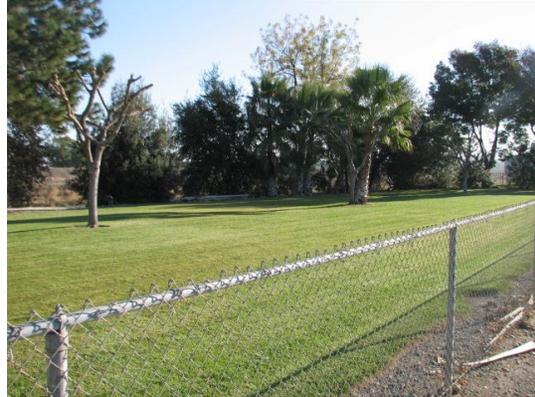
Photo 1 of 1 : johngw_s_20140414_146.jpg

The lawn area is on the levee waterside and crown. Fall 2013

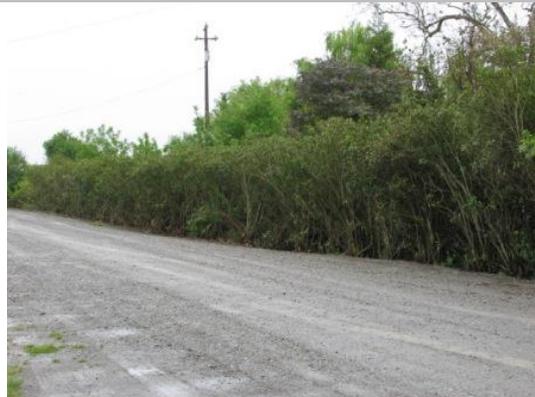
Photo 1 of 1 : johngw_s_20140414_144.jpg

LM Start	0.57	Rating **	U	Issue No.	22
LM End	0.71	Issue Type +	En	Location *	LS
Category	Earthen Levee		GPS Latitude/Longitude		
			Start	End	
Item	Vegetation		38.801968 °	38.801077 °	
			-121.715707 °	-121.713335 °	
DWR ID	DWR_NA0022_01_s_2012_22				
Action/Comments					
Landscaping Inspector Comments: Oleander hedge

Oleanders along the shoulder.

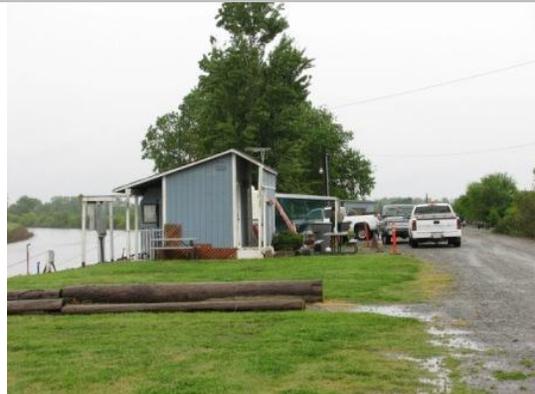
Photo 1 of 1 : johngw_s_20140414_145.jpg

LM Start	0.57	Rating **	A/W	Issue No.	23
LM End	0.65	Issue Type +	En	Location *	WS
Category	Earthen Levee		GPS Latitude/Longitude		
			Start	End	
Item	Encroachments		38.801965 °	38.801468 °	
			-121.715705 °	-121.714348 °	
DWR ID	DWR_NA0022_01_s_2012_23				
Action/Comments					
Building Inspector Comments: Yolo Sutter Yacht Club

The Yacht club is on the crown. Fall 2013

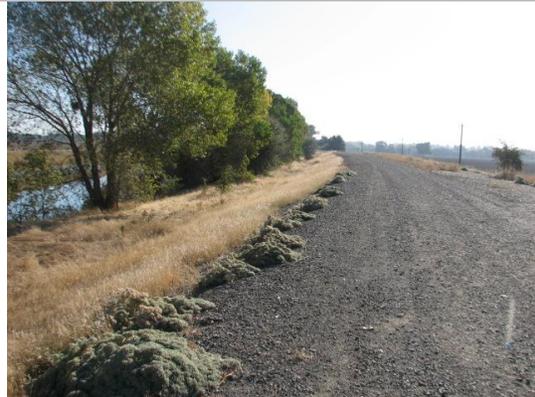
Photo 1 of 2 : johngw_s_20140414_173.jpg

Tall grasses partially block visibility. Fall 2013

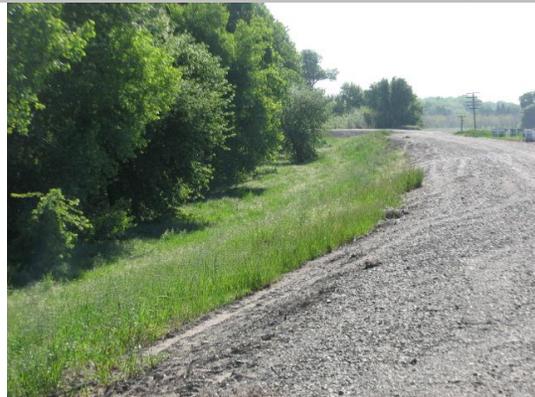
Photo 2 of 2 : johngw_s_20140421_850.jpg

Tall grasses and vegetation partially blocks visibility. Spring 2014

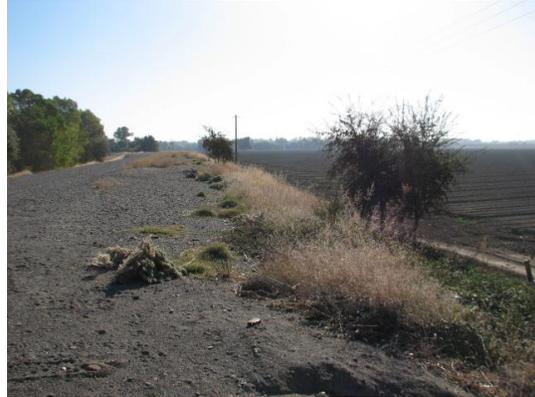
Photo 1 of 2 : johngw_s_20140414_172.jpg

Tall grasses partially blocks visibility. Fall 2013

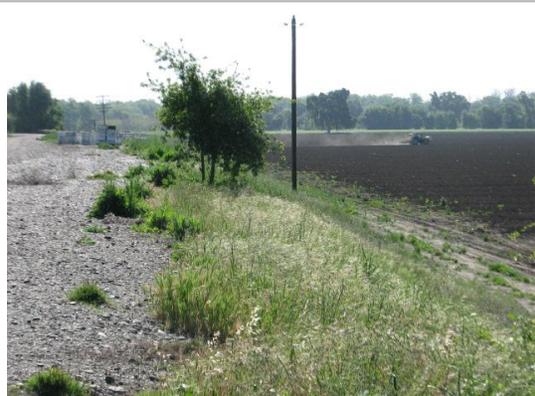
Photo 2 of 2 : johngw_s_20140421_851.jpg

Tall grasses and vegetation partially blocks visibility. Spring 2014

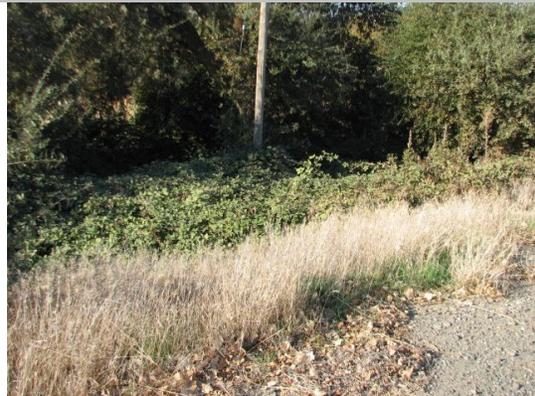
Photo 1 of 1 : johngw_s_20140414_119.jpg

The berries block visibility of the levee slope. Fall 2013

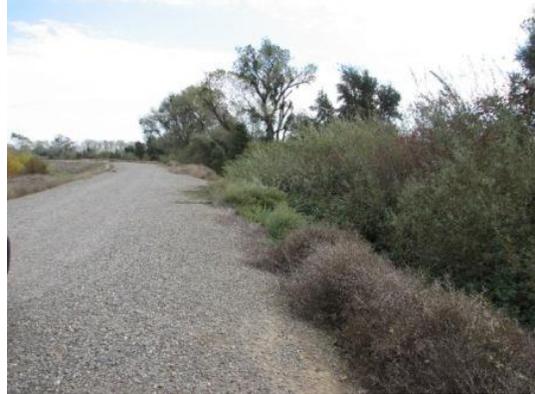
Photo 1 of 1 : johngw_s_20140414_143.jpg

The vegetation completely blocks the view of the levee slope. Fall 2011

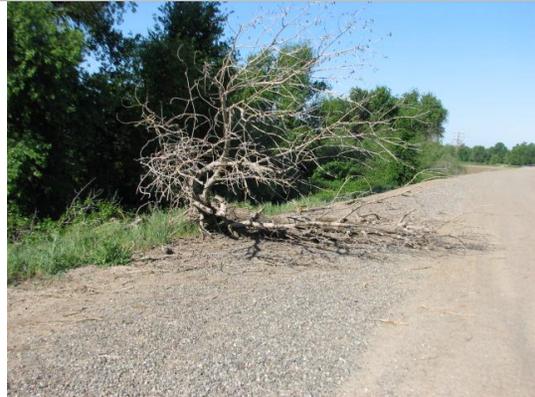
Photo 1 of 1 : johngw_s_20140421_852.jpg

A tree has fallen on the crown and blocks visibility. Spring 2014

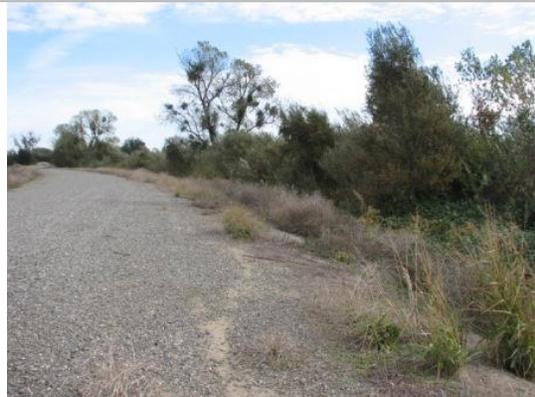
Photo 1 of 1 : johngw_s_20140414_142.jpg

The vegetation blocks the view of the levee slope. Fall 2011

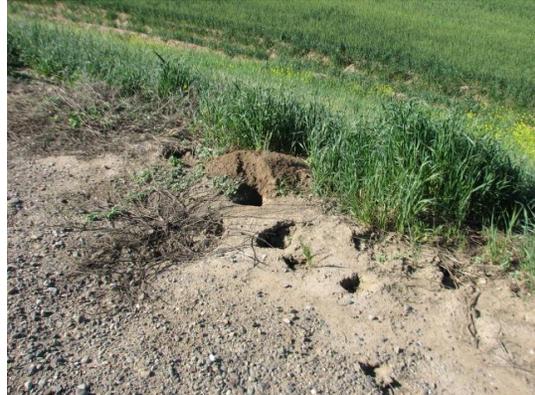
Photo 1 of 1 : johngw_s_20140421_853.jpg

Many rodent holes are in the shoulder of the crown. Spring 2014

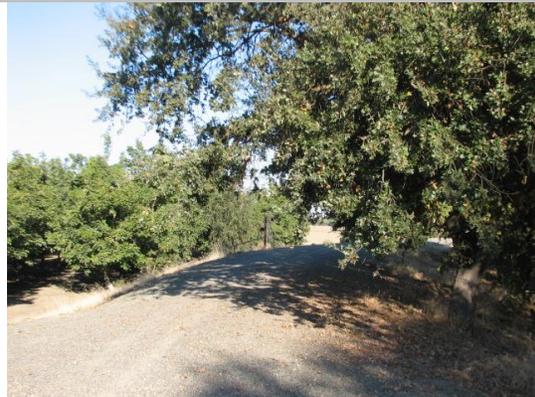
Photo 1 of 1 : johngw_s_20140414_134.jpg

Trees need to be trimmed up to 12 feet above the crown. Fall 2013

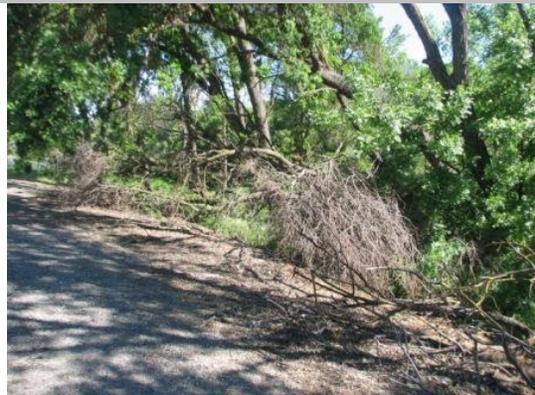
Photo 1 of 3 : johngw_s_20140414_163.jpg

Branches and small trees have fallen on the levee slope. Spring 2013

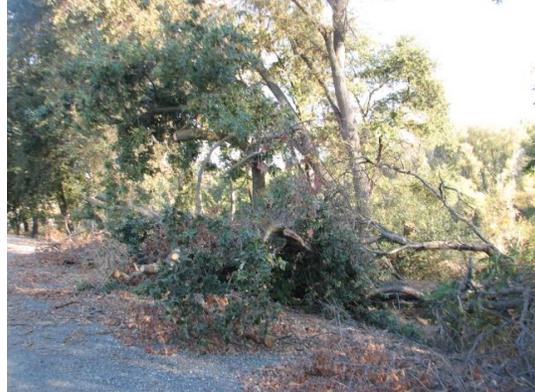
Photo 2 of 3 : johngw_s_20140414_164.jpg

A tree has fallen on the waterside levee slope and shoulder. Fall 2013

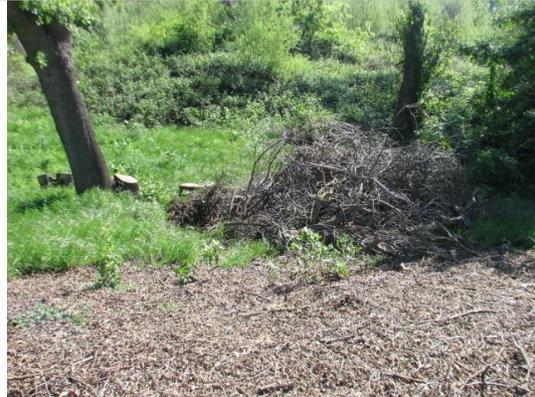
Photo 3 of 3 : johngw_s_20140421_854.jpg

The tree has been cut up but there is a brush pile left. Spring 2014

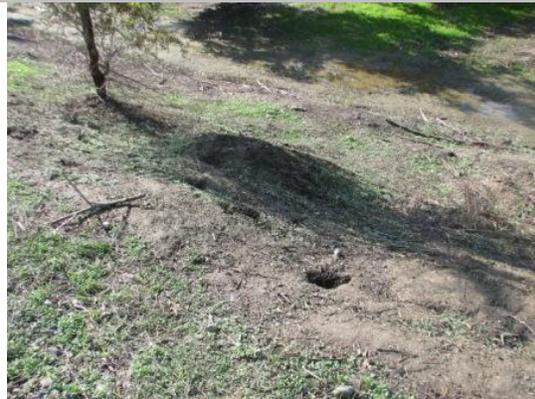
Photo 1 of 1 : johngw_s_20140414_132.jpg

Many rodent hole in this location on the slope. Fall 2012

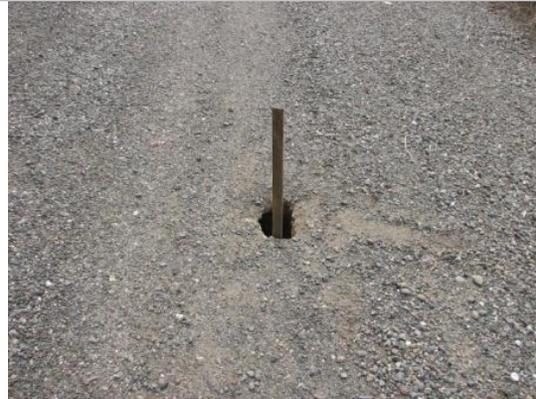
Photo 1 of 1 : johngw_s_20140414_166.jpg

A rodent hole in the crown of the levee. Fall 2011

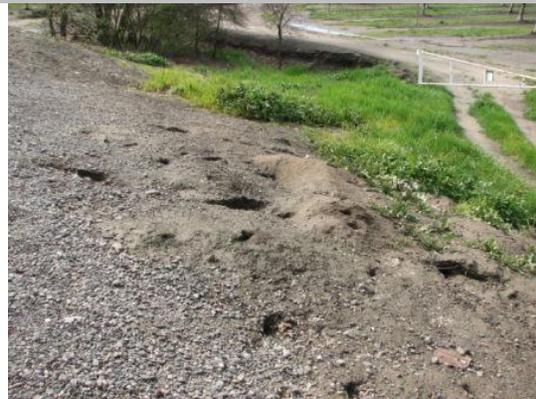
Photo 1 of 1 : johngw_s_20140414_133.jpg

There are multiple rodent holes but no visible rodents. Need to backfill and compact.

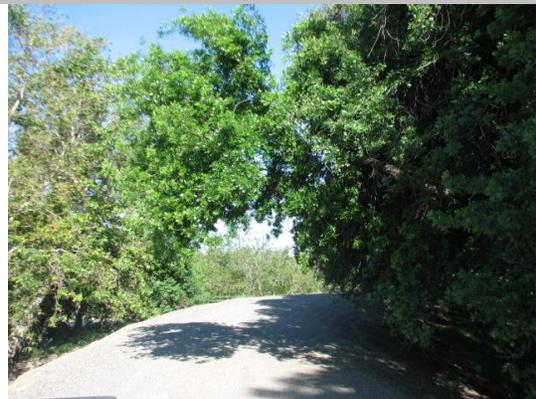
Photo 1 of 1 : johngw_s_20140421_856.jpg

Trees need to be trimmed up to at least 12 feet above the crown. Spring 2014

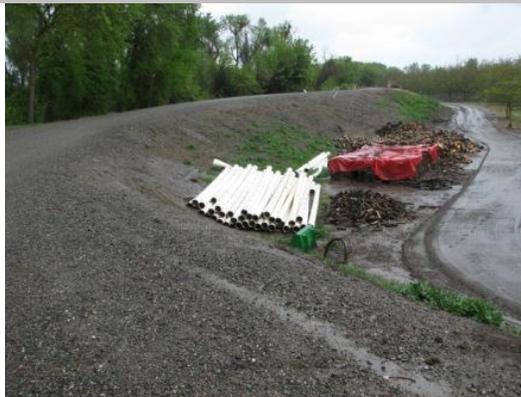
Photo 1 of 1 : johngw_s_20140414_160.jpg

Pipe along toe.

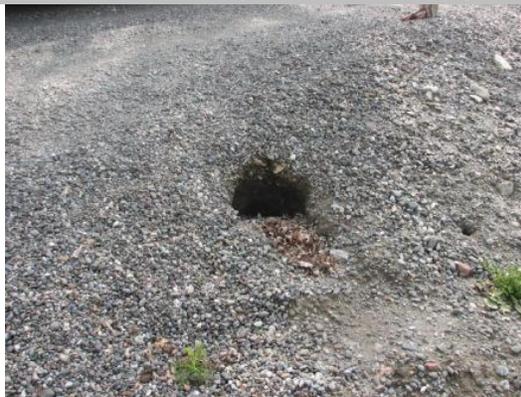
Photo 1 of 1 : johngw_s_20140414_154.jpg

A rodent hole needs to be backfilled and compacted.

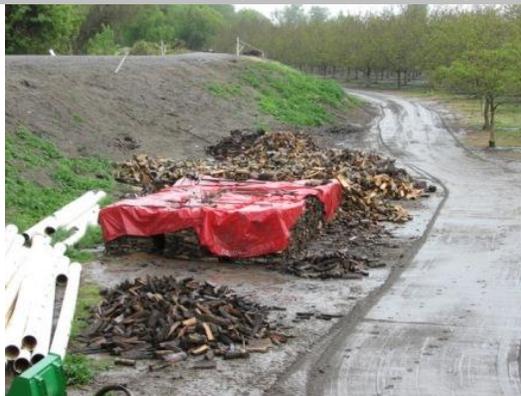
Photo 1 of 2 : johngw_s_20140414_158.jpg

Firewood stacked up.

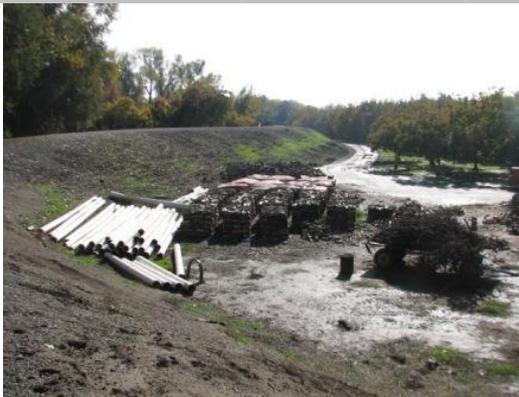
Photo 2 of 2 : johngw_s_20140414_159.jpg

The firewood pile is continuing to grow along the toe of the levee. Fall 2012

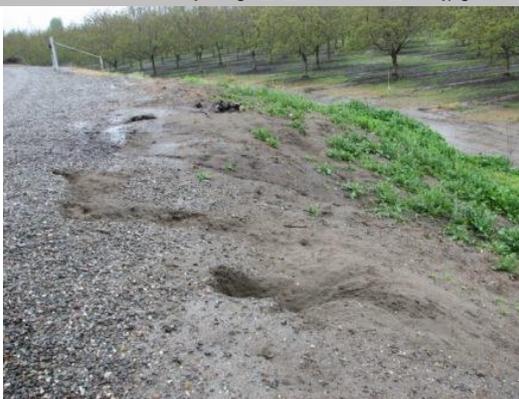
Photo 1 of 1 : johngw_s_20140414_161.jpg

Rodents

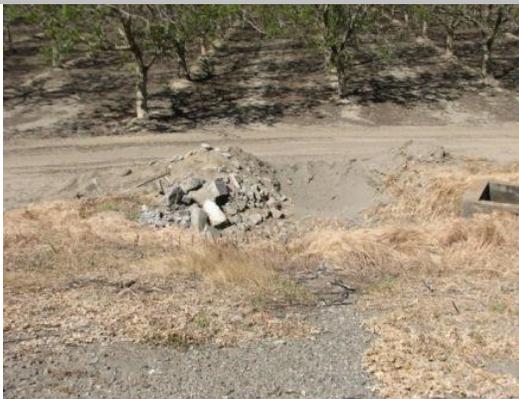
Photo 1 of 1 : johngw_s_20140414_165.jpg

Concrete debris is at the toe of the levee. Spring 2013

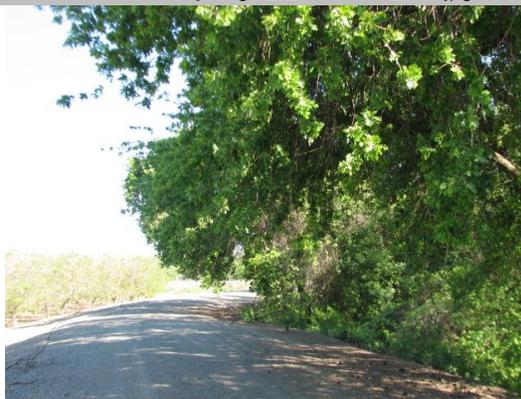
Photo 1 of 1 : johngw_s_20140421_857.jpg

Trees need to be trimmed up to at least 12 feet above the crown. Spring 2014

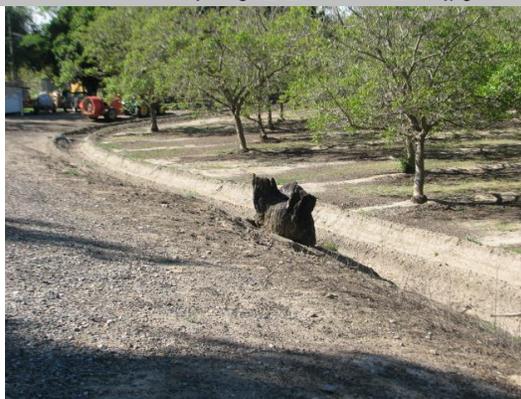
Photo 1 of 1 : johngw_s_20140421_858.jpg

Tree stump decomposing and may pose a risk to the levee. Spring 2014

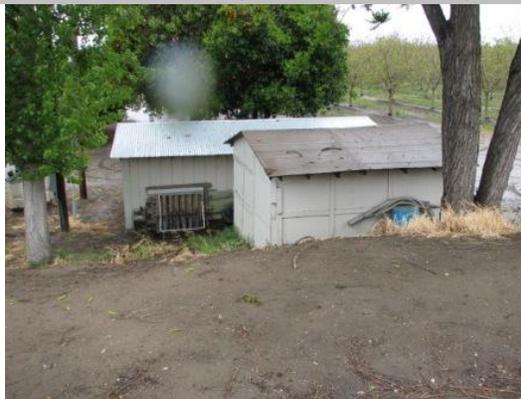
Photo 1 of 1 : johngw_s_20140414_135.jpg

Garage at toe.

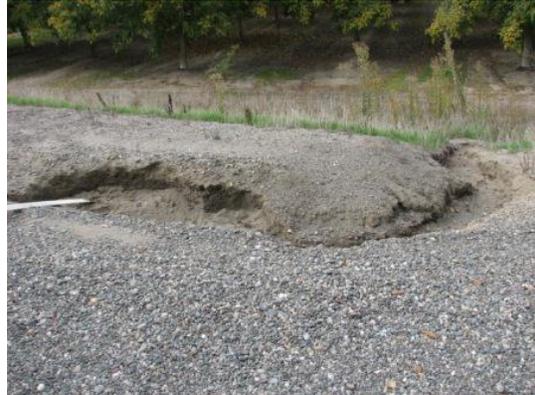
Photo 1 of 1 : johngw_s_20140414_167.jpg

LM Start	2.72	Rating **	M	Issue No.	87
LM End	2.72	Issue Type +	Ma	Location *	LS
Category	Earthen Levee		GPS Latitude/Longitude		
			Start	End	
Item	Erosion / Bank Caving		38.785613 °	38.785613 °	
			-121.694266 °	-121.694266 °	
DWR ID	DWR_NA0022_01_s_2012_87				
Action/Comments					
Schedule repair of erosion site prior to the next inspection.

Erosion caused by a build up of water then running off the slope. Fall 2011

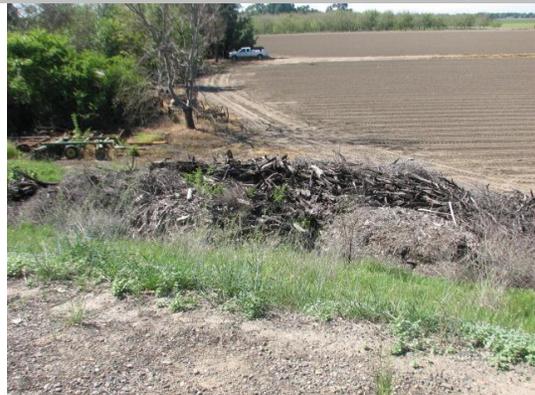
Photo 1 of 1 : johngw_s_20140421_859.jpg

A large pruning pile near the toe of the levee. Spring 2014

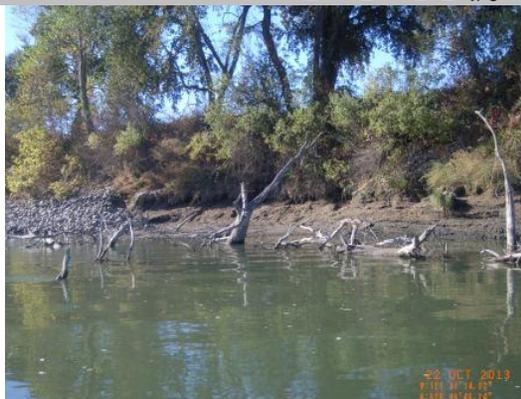
Photo 1 of 1 : USACE2013A_SAC_86-9_R_5.jpg

LM Start	3.10	Rating **	M	Issue No.	5
LM End	3.33	Issue Type +	Ma	Location *	WS
Category	Supplemental			GPS Latitude/Longitude	
				Start	End
Item	USACE Erosion Survey			38.780407 °	38.779137 °
				-121.688238 °	-121.687432 °
DWR ID					
Action/Comments					
Inspector Comments: 2006 - Short section is into the levee toe, rest is near the levee toe. Mass failure and fluvial erosion of depositional material. Rock at the upstream and downstream ends. 2011 - Minor new erosion. 2012 - Slope continues to steepen, tree roots have become exposed, and new eddy formed. 2013: No observed changes. [2013 Site ID: SAC_86-9_R]

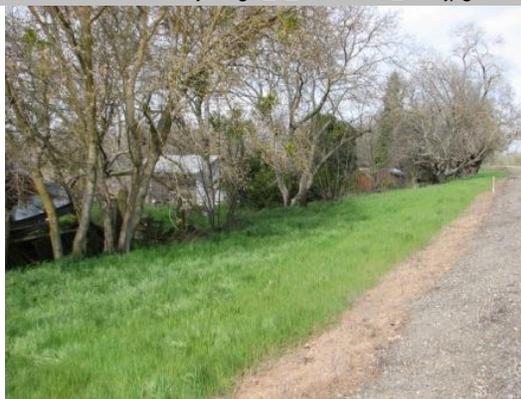
Photo 1 of 2 : johngw_s_20140414_136.jpg

The buildings are encroaching into the levee slope.

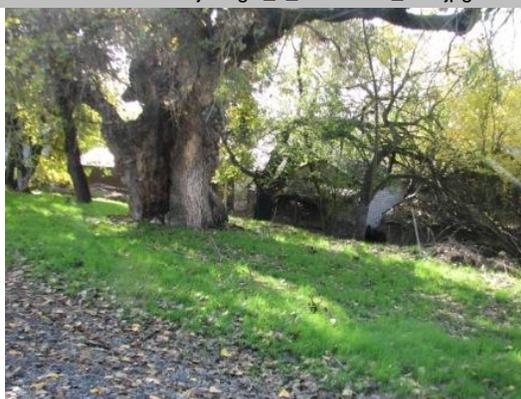
Photo 2 of 2 : johngw_s_20140414_137.jpg

Buildings are located at the toe of the levee. Fall 2012

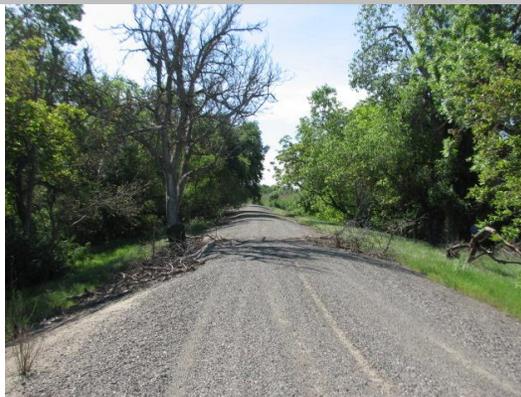
Photo 1 of 1 : johngw_s_20140421_860.jpg

A tree is dying and needs to be monitored may pose a threat to the levee. Spring 2014

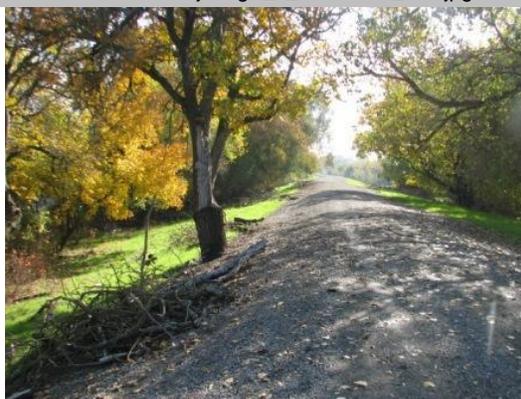
Photo 1 of 2 : johngw_s_20140414_151.jpg

Piles of prunings are on the waterside slope. Fall 2012

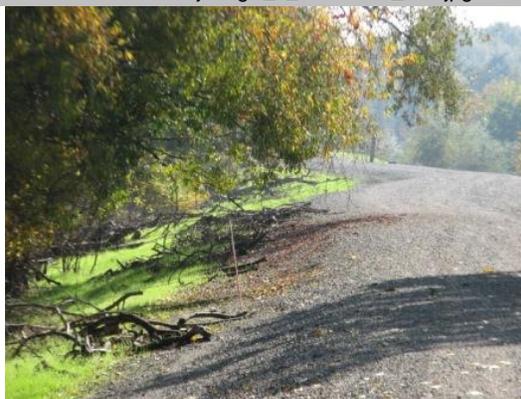
Photo 2 of 2 : johngw_s_20140414_152.jpg

Many piles are on the slope. Fall 2012.

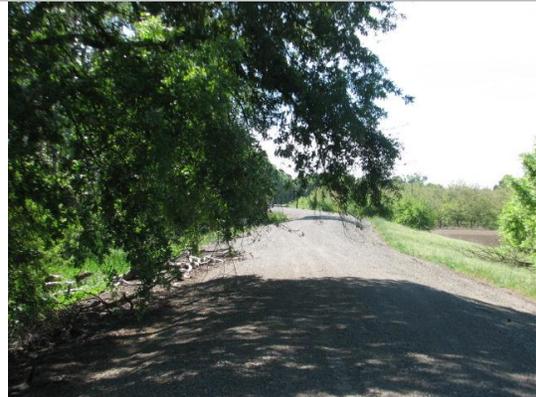
Photo 1 of 1 : johngw_s_20140421_861.jpg

Trees need to be trimmed up to at least 12 feet above the crown. Spring 2014

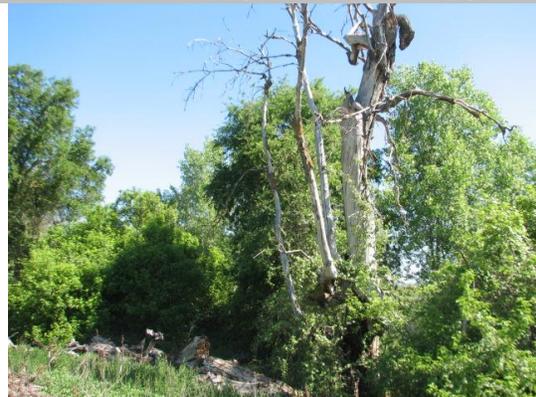
Photo 1 of 1 : johngw_s_20140421_862.jpg

Trees have fallen and others are dying need to be monitor. They may pose a threat to the levee. Spring 2014

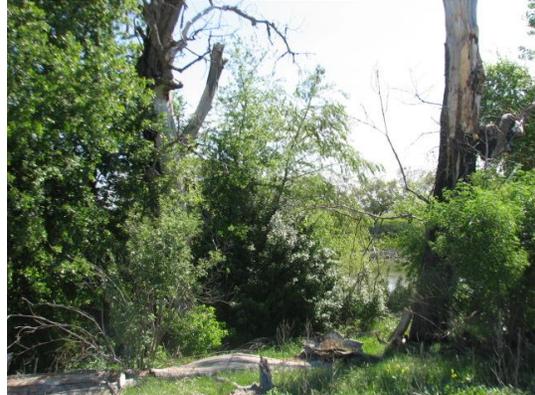
Photo 1 of 1 : johngw_s_20140421_863.jpg

Monitor dying trees they may pose to be a threat to the levee. Spring 2014

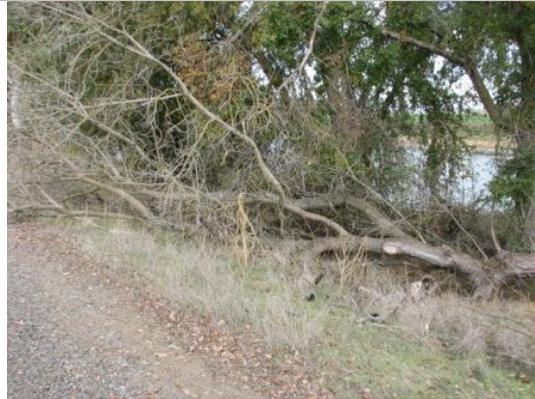
Photo 1 of 2 : johngw_s_20140414_139.jpg

A cottonwood tree has fallen over against the slope. Fall 2011

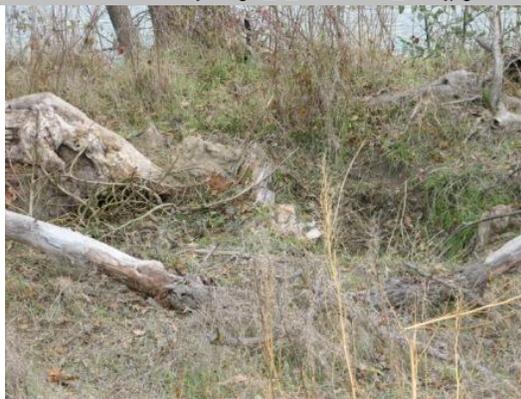
Photo 2 of 2 : johngw_s_20140414_140.jpg

This is the root ball of the tree. It has created a large void in the berm.
Fall 2011

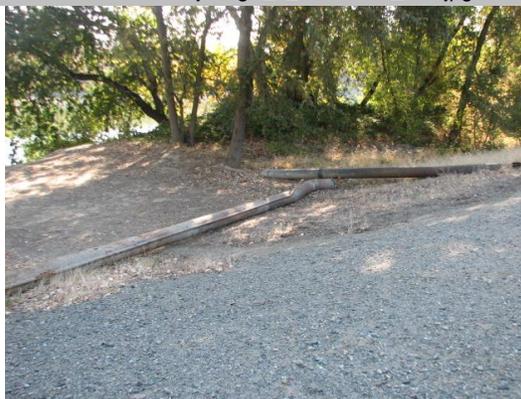
Photo 1 of 1 : johngw_s_20140414_175.jpg

Pipe has been laid on the waterside berm. Fall 2013

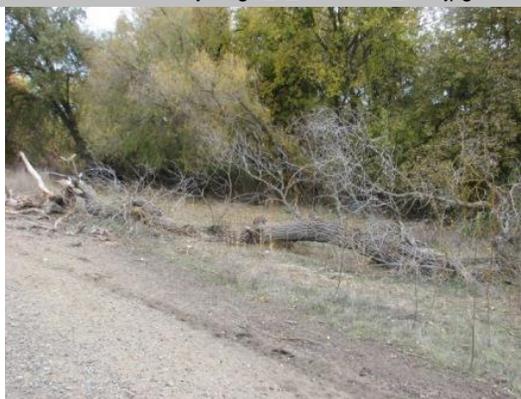
Photo 1 of 1 : johngw_s_20140414_168.jpg

Another tree has fallen on the waterside slope. Fall 2011

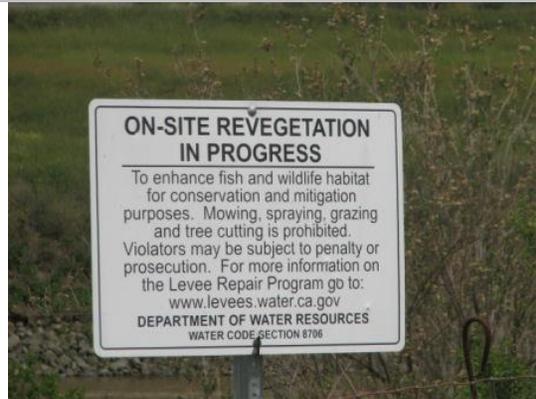
Photo 1 of 3 : johngw_s_20140414_155.jpg

USACE revegetation site photo spring 2012.

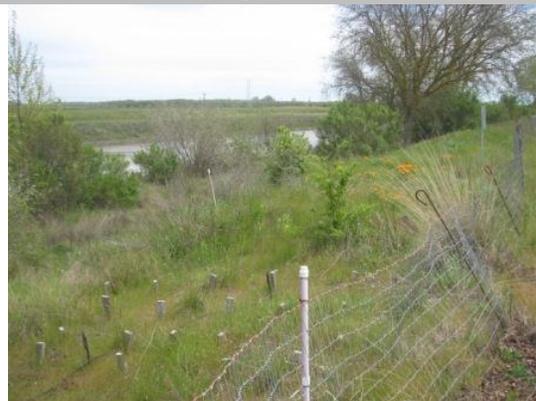
Photo 2 of 3 : johngw_s_20140414_156.jpg

Fence, irrigation and stakes in the revegetation site.

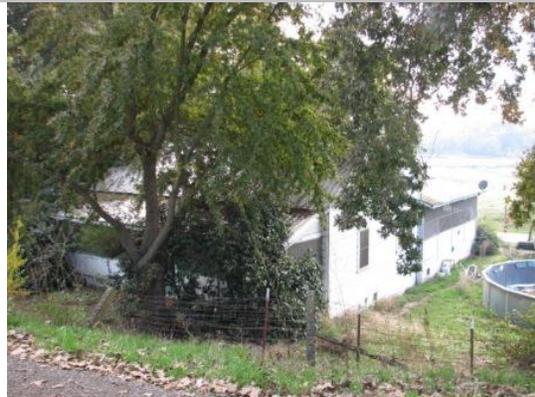
Photo 1 of 1 : johngw_s_20140414_118.jpg

The house and landscape are in the easement of the levee. Fall 2011

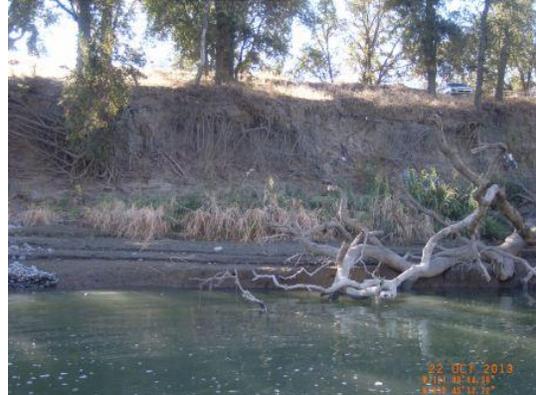
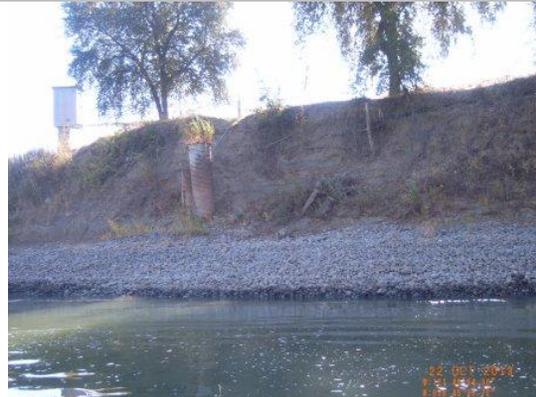
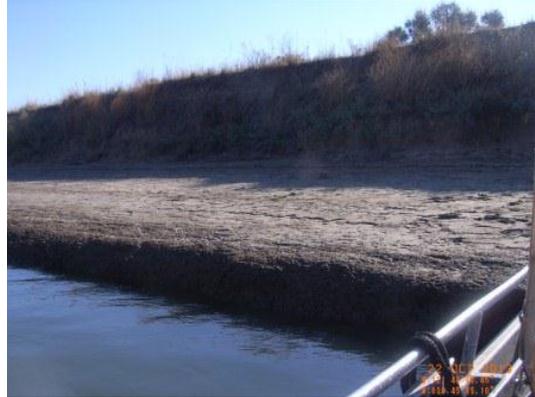
LM Start	5.78	Rating **	M	Issue No.	3
LM End	5.86	Issue Type +	Ma	Location *	WS
Category	Supplemental			GPS Latitude/Longitude	
				Start	End
Item	USACE Erosion Survey			38.758877 °	38.759390 °
				-121.669365 °	-121.667500 °
DWR ID					
Action/Comments					
Inspector Comments: 2006 - Approximately 18 to 20 ft of bank near levee at the corner of the levee and the Freemont Weir. Vertical bank with undercutting/mass failure. 2007 - Staked at top of bank for monitoring. 2011 - Site has become significantly worse with more of the toe and lower bank eroded. Many trees have fallen since last year. 2012 - Site looks worse with more erosion around trees. 2013: Additional erosion into toe. [2013 Site ID: SAC_83-9_R]
