**Flood Control Project Maintenance  
Levee Inspections**

**2010 Channel Summary Report**

**Adin Community Service District**

**Flood Control Project Maintenance  
Channel Inspections**

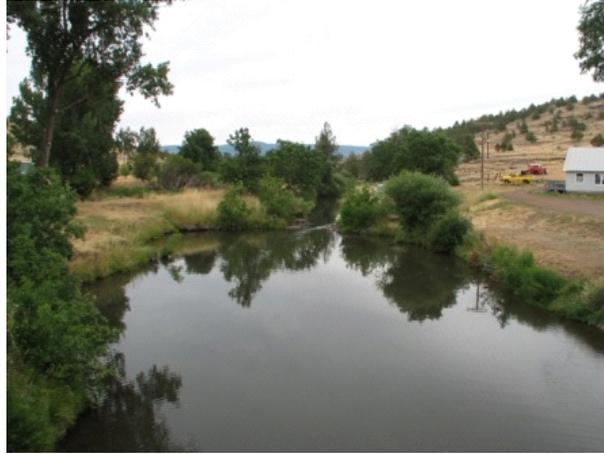
Levee Mile Report Line	1
Start Levee Mile	0.00
End Levee Mile	0.00
Location	
Category	Channels
Item	Vegetation & Obstructions
View from Main Street (Highway 299) towards the gauging station.	
rduffey_c_20100914_090.jpg

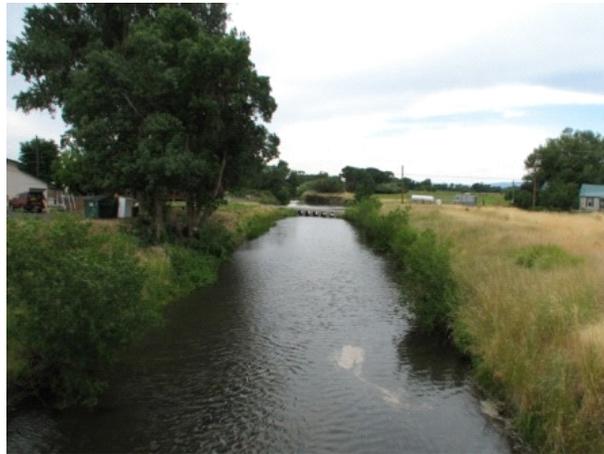
Levee Mile Report Line	6
Start Levee Mile	0.00
End Levee Mile	0.00
Location	
Category	Channels
Item	Vegetation & Obstructions
View from Main Street (Highway 299) towards the Ash St. low water crossing.	
rduffey_c_20100914_091.jpg

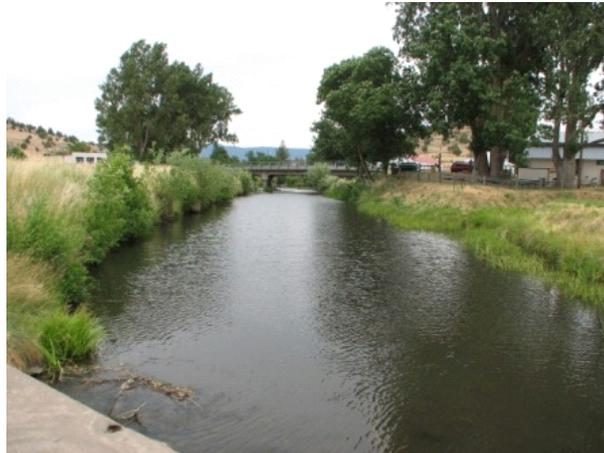
Levee Mile Report Line	11
Start Levee Mile	0.00
End Levee Mile	0.00
Location	
Category	Channels
Item	Vegetation & Obstructions
View of the channel from Ash Street low water crossing.	
rduffey_c_20100914_092.jpg

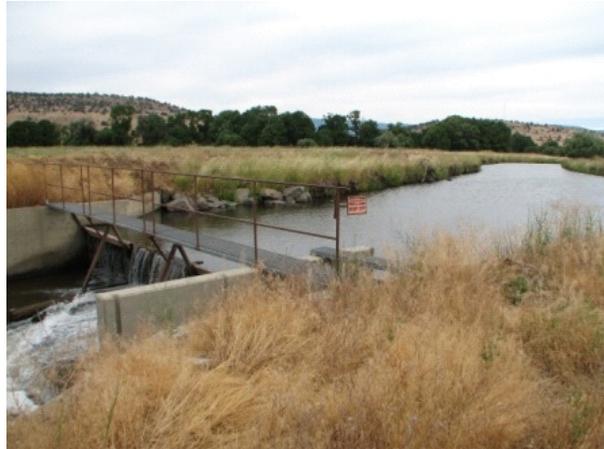
Levee Mile Report Line	21
Start Levee Mile	0.00
End Levee Mile	0.00
Location	
Category	Channels
Item	Vegetation & Obstructions
View of the upstream side of the weir.	
rduffey_c_20100923_094.jpg

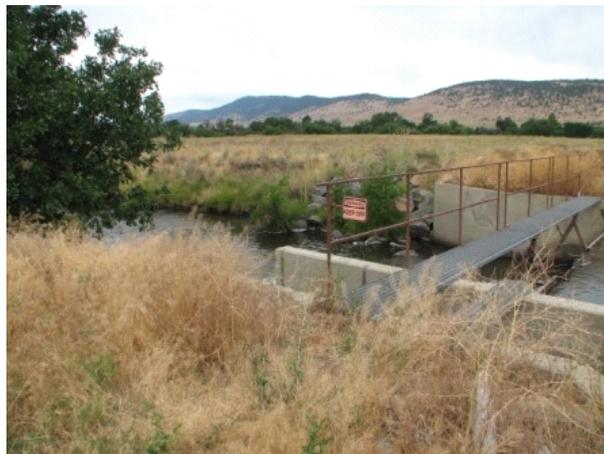
Levee Mile Report Line	26
Start Levee Mile	0.00
End Levee Mile	0.00
Location	
Category	Channels
Item	Vegetation & Obstructions
View of the downstream side of the dam & fish ladder constructed by Dept. of Fish & Game in October 1999.	
rduffey_c_20100923_095.jpg

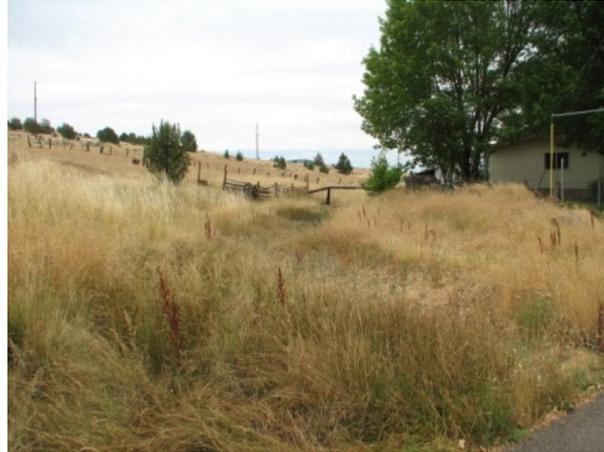
Levee Mile Report Line	1
Start Levee Mile	0.00
End Levee Mile	0.00
Location	
Category	Channels
Item	Vegetation & Obstructions
Upstream at Adin Street. Minimal growth in channel.	
rduffey_c_20100914_096.jpg

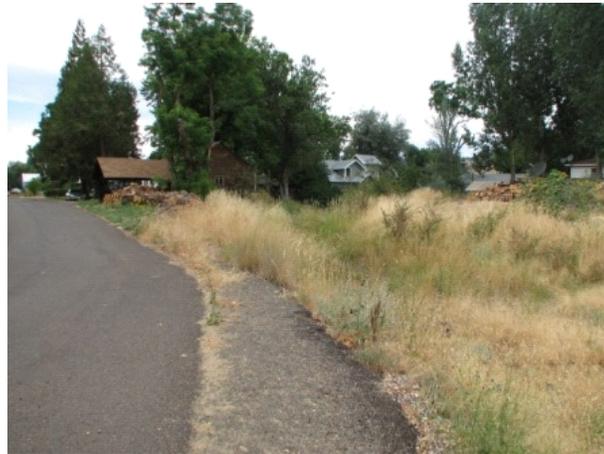
Levee Mile Report Line	6
Start Levee Mile	0.00
End Levee Mile	0.00
Location	
Category	Channels
Item	Vegetation & Obstructions
Downstream from Adin Street. Minimal growth in channel.	
rduffey_c_20100914_097.jpg

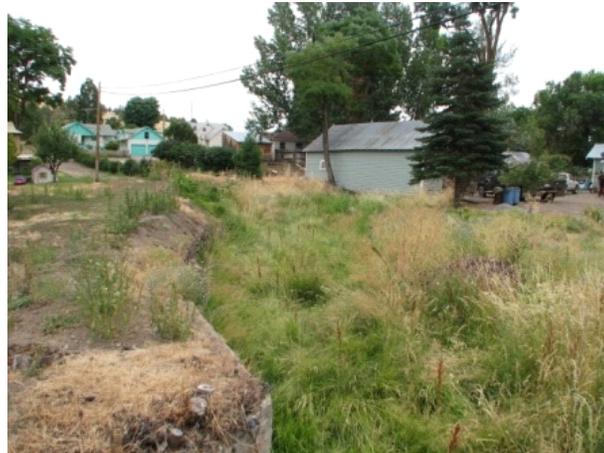
Levee Mile Report Line	11
Start Levee Mile	0.00
End Levee Mile	0.00
Location	
Category	Channels
Item	Vegetation & Obstructions
Upstream from Main Street. Minimal growth in channel.	
rduffey_c_20100914_098.jpg

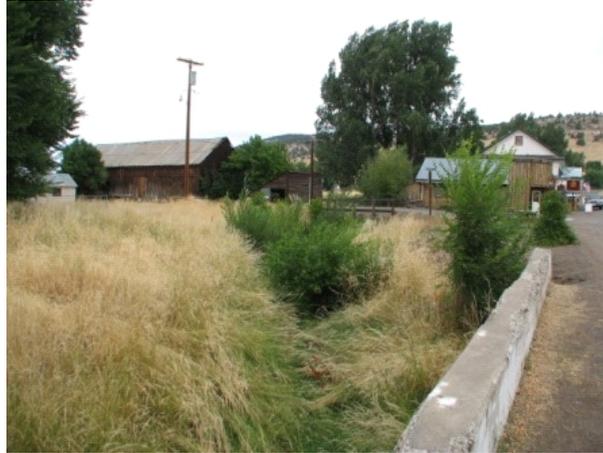
Levee Mile Report Line	16
Start Levee Mile	0.00
End Levee Mile	0.00
Location	
Category	Channels
Item	Vegetation & Obstructions
View of the minimal vegetation in channel.	
rduffey_c_20100914_099.jpg
