**Flood Control Project Maintenance  
Levee Inspections**  
**2014 Channel Summary Report**  
**Overall Unit and Item Ratings**

**Adin Community Service District**

**2014 Channel Inspection Results**

**Levee Inspection Report By Mile - Channel 2014**

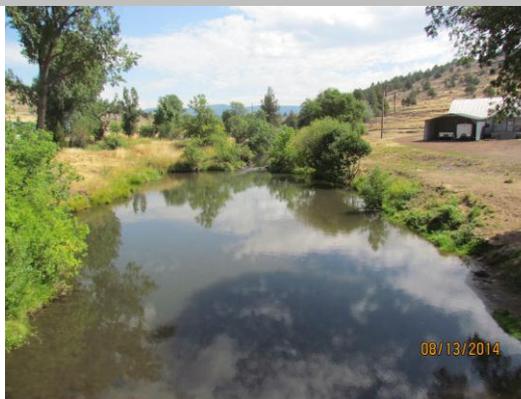
Photo 1 of 1 : CH\_2014\_NA0030\_1\_1\_20140821\_00007.jpg

Rating **	A	Issue No.	1	GPS Lat/Long
Issue Type +	Ma	Location *		41.197770 °
Category	Rivers, Channels & Designated Flood			-120.944100 °
Item	Vegetation & Obstructions			
DWR ID	DWR_NA0030_1_c_2012_1			
Action/Comments				
Inspector Comments: The channel is clear of vegetation & obstructions.

View from Main Street (Highway 299) towards the gaging station.

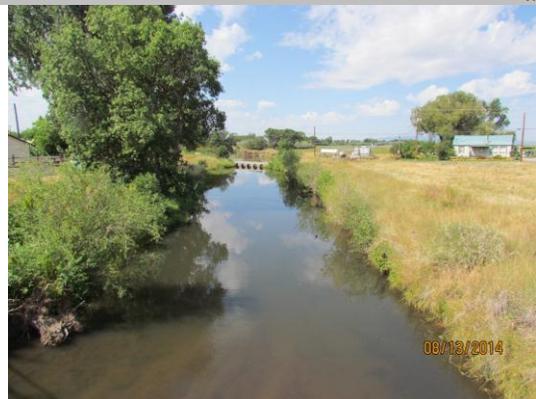
Photo 1 of 1 : CH\_2014\_NA0030\_1\_6\_20140821\_00008.jpg

Check Point / View			
<b>Main Street / Down</b>			
Rating **	A	Issue No. <b>6</b>	GPS Lat/Long
Issue Type +	Ma	Location *	41.197770 °
Category	Rivers, Channels & Designated Flood		-120.944100 °
Item	Vegetation & Obstructions		
DWR ID	DWR_NA0030_1_c_2012_6		
Action/Comments			
Inspector Comments: The channel is clear of vegetation & obstructions.

View from Main Street (Highway 299) towards the Ash St. low water crossing.

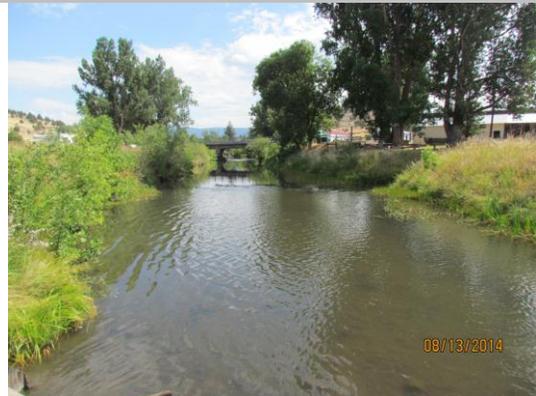
Photo 1 of 1 : CH\_2014\_NA0030\_1\_11\_20140821\_00009.jpg

Check Point / View				
<b>Ash Street / Up</b>				
Rating **	A	Issue No.	11	GPS Lat/Long
Issue Type +	Ma	Location *		41.197660 °
Category	Rivers, Channels & Designated Flood			-120.944220 °
Item	Vegetation & Obstructions			
DWR ID	DWR_NA0030_1_c_2012_11			
Action/Comments				
Inspector Comments: The channel is clear of vegetation & obstructions.

View of the channel from Ash Street low water crossing.

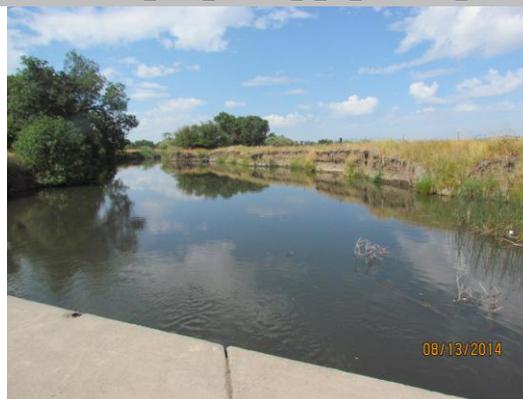
Photo 1 of 1 : CH\_2014\_NA0030\_1\_18\_20140821\_00012.jpg

Rating **	M	Issue No. <b>18</b>	GPS Lat/Long
Issue Type +	Ma	Location *	41.197660 °
Category	Rivers, Channels & Designated Flood		-120.944220 °
Item	Erosion / Bank Caving		
DWR ID	DWR_NA0030_1_c_2012_18		
Action/Comments			
Inspector Comments: Monitor erosion during high flows.

View of the moderate erosion on both banks.

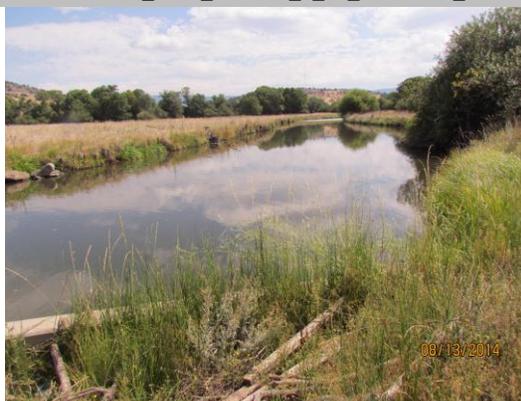
Photo 1 of 1 : CH\_2014\_NA0030\_1\_31\_20140821\_00011.jpg

Check Point / View			
<b>Downstream limit/fish ladder &amp; walkway / Up</b>			
Rating **	A	Issue No. <b>31</b>	GPS Lat/Long
Issue Type +	Ma	Location *	41.192990 °
Category	Rivers, Channels & Designated Flood		-120.954530 °
Item	Vegetation & Obstructions		
DWR ID	DWR_NA0030_1_c_2012_31		
Action/Comments			
Inspector Comments: The channel is clear of vegetation & obstructions.

View of the upstream side of the weir.

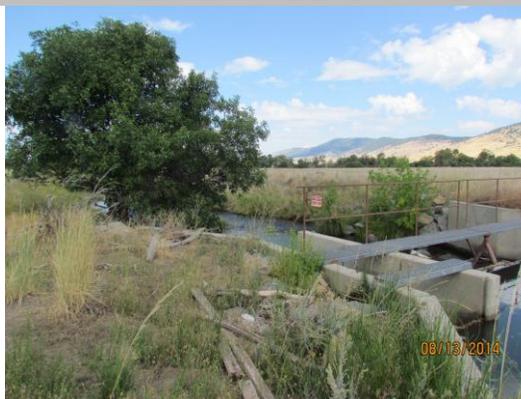
Photo 1 of 1 : CH\_2014\_NA0030\_1\_36\_20140821\_00010.jpg

Check Point / View			
<b>Downstream limit/fish ladder &amp; walkway / Down</b>			
Rating **	A	Issue No.	36
Issue Type +	Ma	Location *	41.192990 °
Category	Rivers, Channels & Designated Flood		-120.954530 °
Item	Vegetation & Obstructions		
DWR ID	DWR_NA0030_1_c_2012_36		
Action/Comments			
Inspector Comments: The channel is clear of vegetation & obstructions.

View of the downstream side of the dam, fish ladder constructed by Dept. of Fish and Game in October 1999.

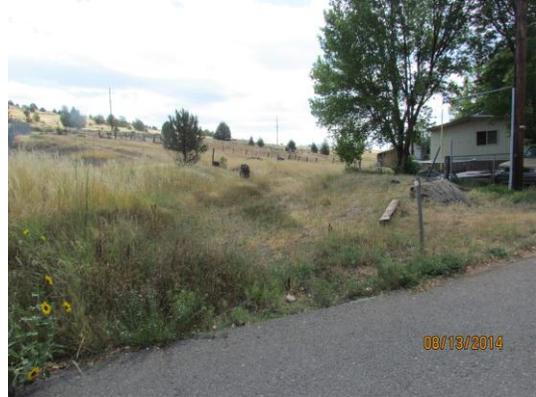
Photo 1 of 1 : CH\_2014\_NA0030\_2\_1\_20140821\_00007.jpg

Check Point / View			
<b>Adin Street / Up</b>			
Rating **	A	Issue No.	1
Issue Type +	Ma	Location *	41.195370 °
Category	Rivers, Channels & Designated Flood		-120.943190 °
Item	Vegetation & Obstructions		
DWR ID	DWR_NA0030_2_c_2012_1		
Action/Comments			
Inspector Comments: Remove all vegetation in channel before winter. Mike Williamson said they will remove the vegetation before winter.

Upstream at Adin Street. Minor vegetation in channel.

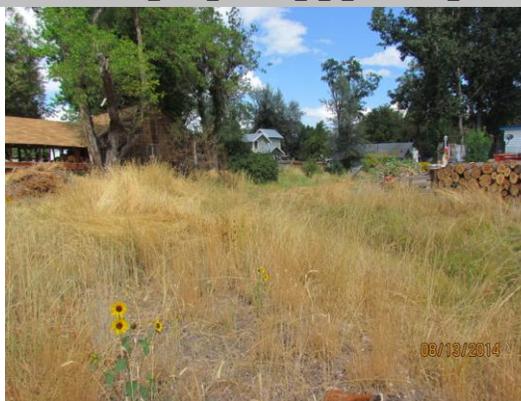
Photo 1 of 1 : CH\_2014\_NA0030\_2\_6\_20140821\_00008.jpg

Check Point / View			
<b>Adin Street / Down</b>			
Rating **	A	Issue No. <b>6</b>	GPS Lat/Long
Issue Type +	Ma	Location *	41.195370 °
Category	Rivers, Channels & Designated Flood		-120.943190 °
Item	Vegetation & Obstructions		
DWR ID	DWR_NA0030_2_c_2012_6		
Action/Comments			
Inspector Comments: Remove all vegetation in channel before winter.

Downstream from Adin street. Minor vegetation in channel.

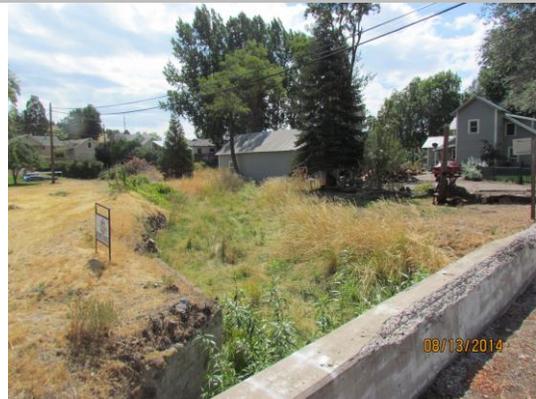
Photo 1 of 1 : CH\_2014\_NA0030\_2\_11\_20140821\_00009.jpg

Check Point / View				
<b>Main Street / Up</b>				
Rating **	A	Issue No.	11	GPS Lat/Long
Issue Type +	Ma	Location *		41.196350 °
Category	Rivers, Channels & Designated Flood			-120.944250 °
Item	Vegetation & Obstructions			
DWR ID	DWR_NA0030_2_c_2012_11			
Action/Comments				
Inspector Comments: Remove all vegetation in channel before winter.

Upstream from Main Street. Minor vegetation in channel.

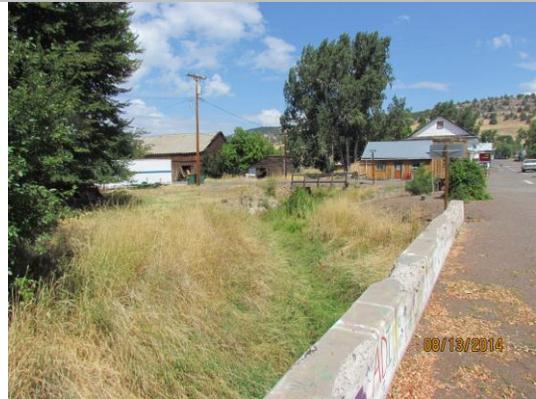
Photo 1 of 2 : CH\_2014\_NA0030\_2\_16\_20140821\_00010.jpg

Check Point / View				
<b>Main Street / Down</b>				
Rating **	A	Issue No.	<b>16</b>	GPS Lat/Long
Issue Type +	Ma	Location *		41.196350 °
Category	Rivers, Channels & Designated Flood			-120.944250 °
Item	Vegetation & Obstructions			
DWR ID	DWR_NA0030_2_c_2012_16			
Action/Comments				
Inspector Comments: Remove all vegetation from channel before winter.

View of the minor vegetation in channel.

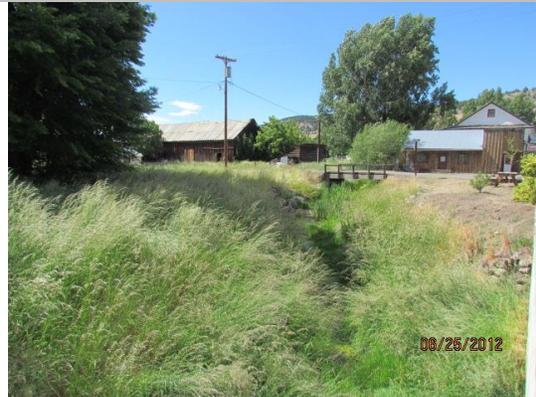
Photo 2 of 2 : CH\_2014\_NA0030\_2\_16\_20140714\_00006.jpg

Rating **	A	Issue No.	<b>16 (cont)</b>	GPS Lat/Long
Issue Type +	Ma	Location *		41.196350 °
Category	Rivers, Channels & Designated Flood			-120.944250 °
Item	Vegetation & Obstructions			
DWR ID	DWR_NA0030_2_c_2012_16

View of the minimal vegetation in channel.
