**Flood Control Project Maintenance
Levee Inspections**
2015 Channel Summary Report
Overall Unit and Item Ratings

Adin Community Service District

Levee Inspection Report By Mile - Channel 2015

Channel	Channel Length	Inspection Start/End	Inspector
Ash Creek	1.00	07/16/2015 07/16/2015	Bob Duffey

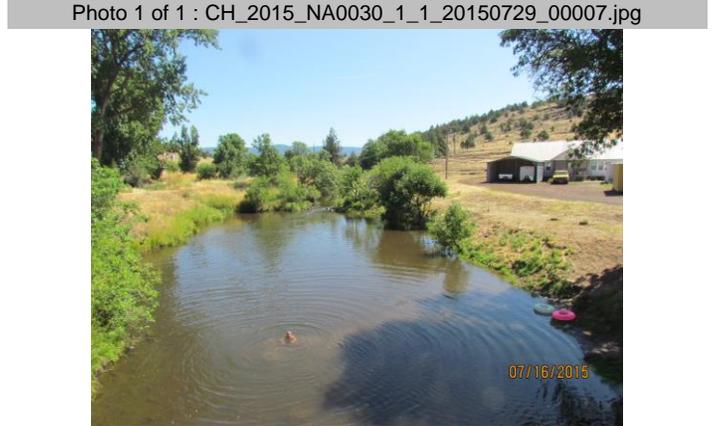
Check Point / View			
Main Street / Up			
Rating **	A	Issue No.	1
Issue Type +	Ma	Location *	41.197770 °
Category	Rivers, Channels & Designated Flood		-120.944100 °
Item	Vegetation & Obstructions		
DWR ID	DWR_NA0030_1_c_2012_1		
Action/Comments			
Inspector Comments: The channel is clear of vegetation & obstructions.

View from Main Street(highway 299) towards the gaging station.

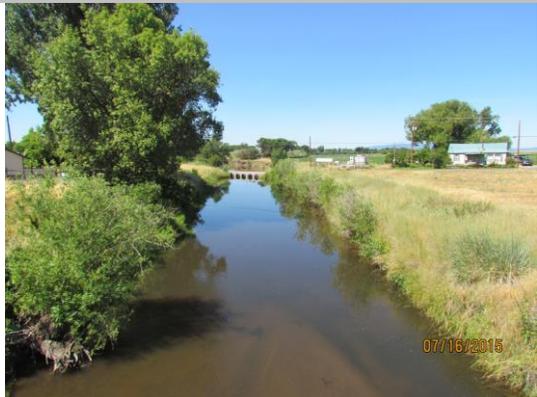
Photo 1 of 1 : CH_2015_NA0030_1_6_20150729_00008.jpg

Check Point / View			
Main Street / Down			
Rating **	A	Issue No.	6
Issue Type +	Ma	Location *	GPS Lat/Long
Category	Rivers, Channels & Designated Flood		41.197770 °
Item	Vegetation & Obstructions		-120.944100 °
DWR ID	DWR_NA0030_1_c_2012_6		
Action/Comments			
Inspector Comments: The channel is clear of vegetation & obstructions.

View from Main Street (highway 299) towards the Ash Street low water crossing

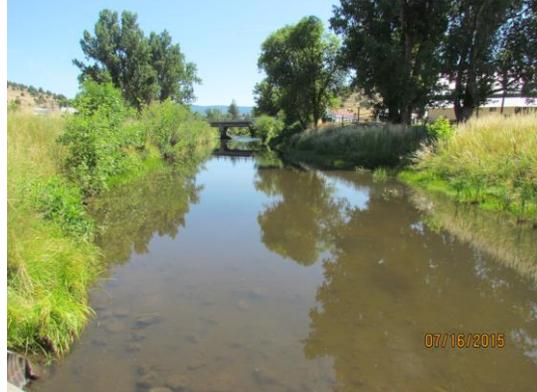
Photo 1 of 1 : CH_2015_NA0030_1_11_20150729_00009.jpg

Check Point / View				
Ash Street / Up				
Rating **	A	Issue No.	11	GPS Lat/Long
Issue Type +	Ma	Location *		41.197138 °
Category	Rivers, Channels & Designated Flood			-120.945271 °
Item	Vegetation & Obstructions			
DWR ID	DWR_NA0030_1_c_2012_11			
Action/Comments				
Inspector Comments: The channel is clear of vegetation & obstructions.

View of the channel from Ash Street low water crossing.

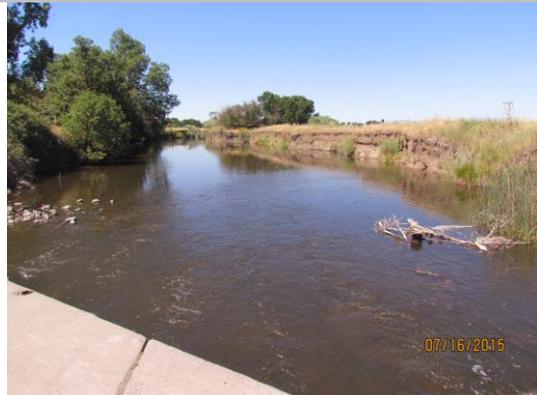
Photo 1 of 1 : CH_2015_NA0030_1_18_20150729_00010.jpg

Rating **	M	Issue No.	18	GPS Lat/Long
Issue Type +	Ma	Location *		41.197138 °
Category	Rivers, Channels & Designated Flood			-120.945271 °
Item	Erosion / Bank Caving			
DWR ID	DWR_NA0030_1_c_2012_18			
Action/Comments				
Inspector Comments: Monitor erosion during high flows.

View of the moderate erosion on both banks.

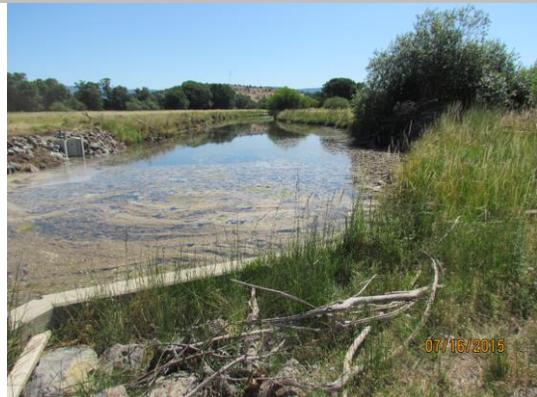
Photo 1 of 2 : CH_2015_NA0030_1_31_20150729_00011.jpg

Check Point / View			
Downstream limit/fish ladder & walkway / Up			
Rating **	A	Issue No.	31
Issue Type +	Ma	Location *	41.192990 °
Category	Rivers, Channels & Designated Flood		-120.954530 °
Item	Vegetation & Obstructions		
DWR ID	DWR_NA0030_1_c_2012_31		
Action/Comments			
Inspector Comments: The channel is clear of vegetation & obstructions.

View of the new pipe placed on the right bank upstream of weir in 2015.

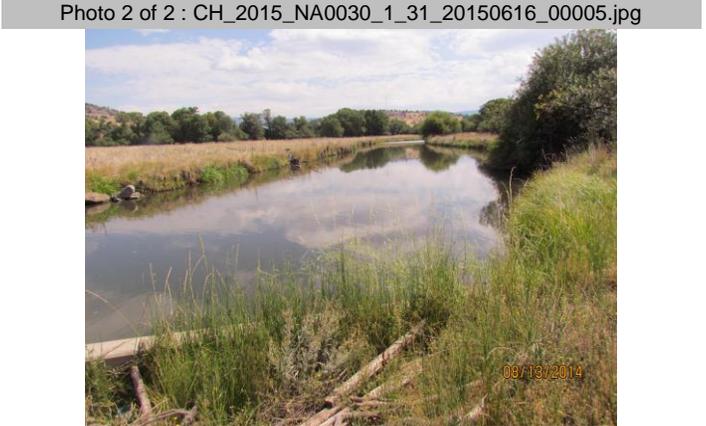
Check Point / View			
Downstream limit/fish ladder & walkway / Up (cont)			
Rating **	A	Issue No.	31 (cont)
Issue Type +	Ma	Location *	GPS Lat/Long
Category	Rivers, Channels & Designated Flood		41.192990 ° -120.954530 °
Item	Vegetation & Obstructions		
DWR ID	DWR_NA0030_1_c_2012_31		
Action/Comments			
Inspector Comments: The channel is clear of vegetation & obstructions.

View of the upstream side of the weir.

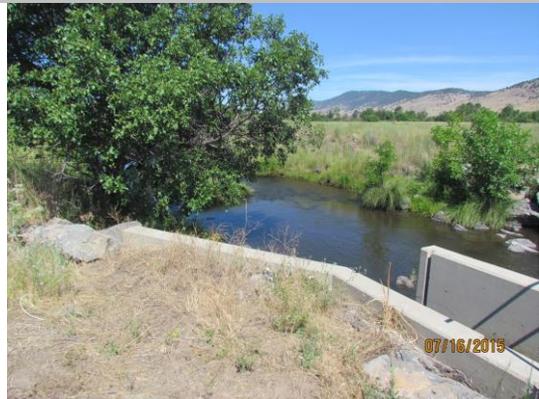
Photo 1 of 2 : CH_2015_NA0030_1_36_20150729_00012.jpg

Check Point / View				
Downstream limit/fish ladder & walkway / Down				
Rating **	A	Issue No.	36	GPS Lat/Long
Issue Type +	Ma	Location *		41.192990 °
Category	Rivers, Channels & Designated Flood			-120.954530 °
Item	Vegetation & Obstructions			
DWR ID	DWR_NA0030_1_c_2012_36			
Action/Comments				
Inspector Comments: The channel is clear of vegetation & obstructions.

View of the downstream side of the water control structure and fish ladder construction by Dept of Fish and Game in October 1999.

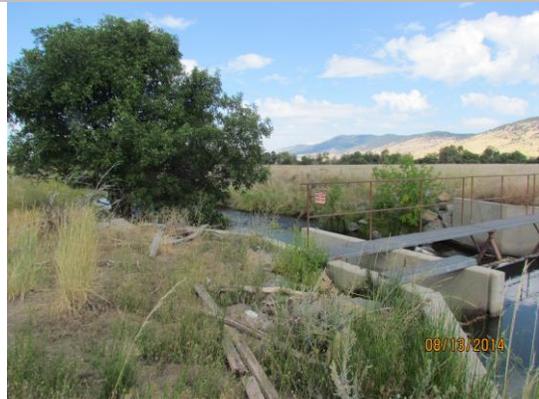
Photo 2 of 2 : CH_2015_NA0030_1_36_20150616_00006.jpg

Check Point / View				
Downstream limit/fish ladder & walkway / Down (cont)				
Rating **	A	Issue No.	36 (cont)	GPS Lat/Long
Issue Type +	Ma	Location *		41.192990 °
Category	Rivers, Channels & Designated Flood			-120.954530 °
Item	Vegetation & Obstructions			
DWR ID	DWR_NA0030_1_c_2012_36			
Action/Comments				
Inspector Comments: The channel is clear of vegetation & obstructions.

View of the downstream side of the dam, fish ladder constructed by Dept. of Fish and Game in October 1999.

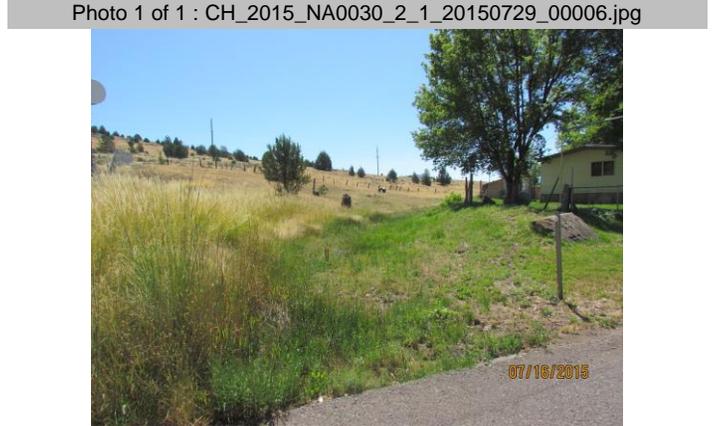
Check Point / View			
Adin Street / Up			
Rating **	A	Issue No.	1
Issue Type +	Ma	Location *	41.195370 °
Category	Rivers, Channels & Designated Flood		-120.943190 °
Item	Vegetation & Obstructions		
DWR ID	DWR_NA0030_2_c_2012_1		
Action/Comments			
Inspector Comments: Remove all vegetation in channel before winter. Mike Williamson said they will remove the vegetation before winter.

Upstream at Adin Street. Minimal vegetation in channel.

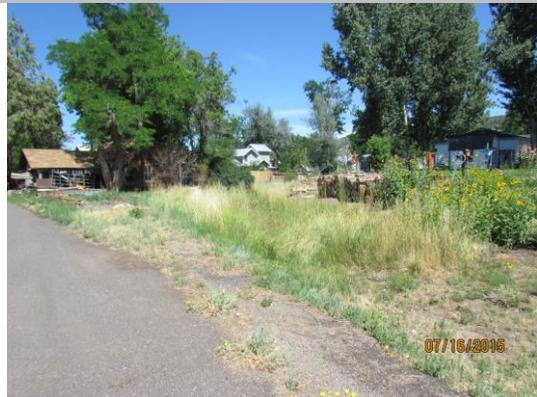
Photo 1 of 1 : CH_2015_NA0030_2_6_20150729_00007.jpg

Check Point / View			
Adin Street / Down			
Rating **	A	Issue No. 6	GPS Lat/Long
Issue Type +	Ma	Location *	41.195370 °
Category	Rivers, Channels & Designated Flood		-120.943190 °
Item	Vegetation & Obstructions		
DWR ID	DWR_NA0030_2_c_2012_6		
Action/Comments			
Inspector Comments: Remove all vegetation in channel before winter.

Downstream from Adin Street. Minimal vegetation in channel.

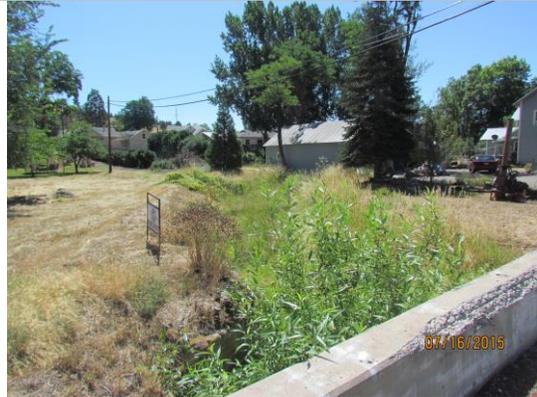
Photo 1 of 1 : CH_2015_NA0030_2_11_20150729_00008.jpg

Check Point / View				
Main Street / Up				
Rating **	A	Issue No.	11	GPS Lat/Long
Issue Type +	Ma	Location *		41.196350 °
Category	Rivers, Channels & Designated Flood			-120.944250 °
Item	Vegetation & Obstructions			
DWR ID	DWR_NA0030_2_c_2012_11			
Action/Comments				
Inspector Comments: Remove all vegetation in channel before winter.

Upstream from Main Street. Minimal vegetation in channel.

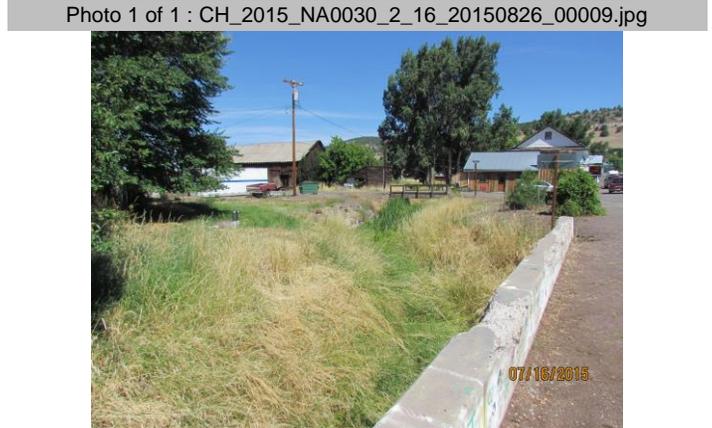
Check Point / View				
Main Street / Down				
Rating **	A	Issue No.	16	GPS Lat/Long
Issue Type +	Ma	Location *		41.196350 °
Category	Rivers, Channels & Designated Flood			-120.944250 °
Item	Vegetation & Obstructions			
DWR ID	DWR_NA0030_2_c_2012_16			
Action/Comments				
Inspector Comments: Remove all vegetation from channel before winter.

View from Main Street looking downstream at minimal vegetation in channel.
