**Flood Control Project Maintenance
Levee Inspections**

2016 Channel Summary Report

Adin Community Service District

Levee Inspection Report By Mile - Channel 2016

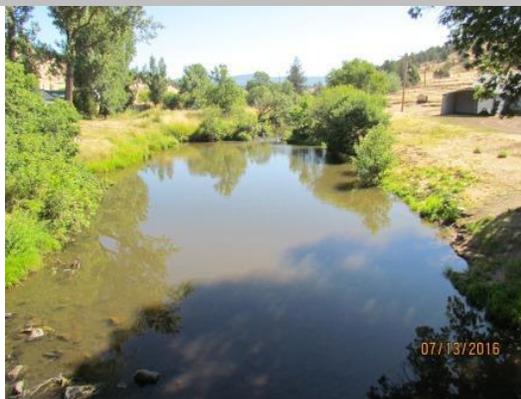
Photo 1 of 1 : CH_2016_NA0030_1_1_20160726_00009.jpg

Rating **	A	Issue No.	1	GPS Lat/Long
Issue Type +	Ma	Location *		41.197770 °
Category	Rivers, Channels & Designated Flood			-120.944100 °
Item	Vegetation & Obstructions			
DWR ID	DWR_NA0030_1_c_2012_1			
Action/Comments				
Inspector Comments: The channel is clear of vegetation & obstructions.

View from Main Street(highway 299) towards the gaging station.

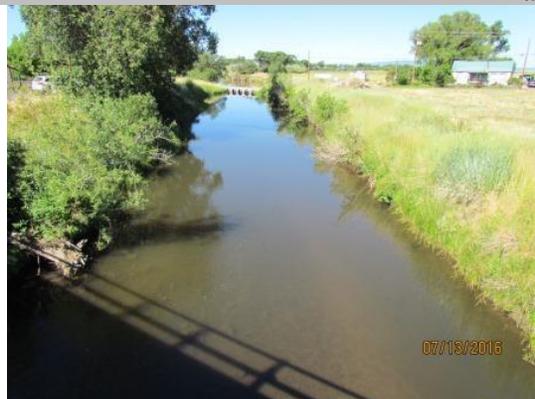
Photo 1 of 1 : CH_2016_NA0030_1_6_20160726_00010.jpg

Check Point / View			
Main Street / Down			
Rating **	A	Issue No. 6	GPS Lat/Long
Issue Type +	Ma	Location *	41.197770 °
Category	Rivers, Channels & Designated Flood		-120.944100 °
Item	Vegetation & Obstructions		
DWR ID	DWR_NA0030_1_c_2012_6		
Action/Comments			
Inspector Comments: The channel is clear of vegetation & obstructions.

View from Main Street (highway 299) towards the Ash Street low water crossing.

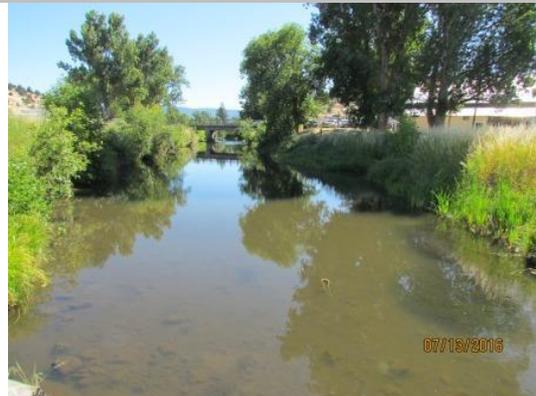
Photo 1 of 1 : CH_2016_NA0030_1_11_20160726_00011.jpg

Check Point / View				
Ash Street / Up				
Rating **	A	Issue No.	11	GPS Lat/Long
Issue Type +	Ma	Location *		41.197138 °
Category	Rivers, Channels & Designated Flood			-120.945271 °
Item	Vegetation & Obstructions			
DWR ID	DWR_NA0030_1_c_2012_11			
Action/Comments				
Inspector Comments: The channel is clear of vegetation & obstructions.

View of the channel from Ash Street low water crossing.

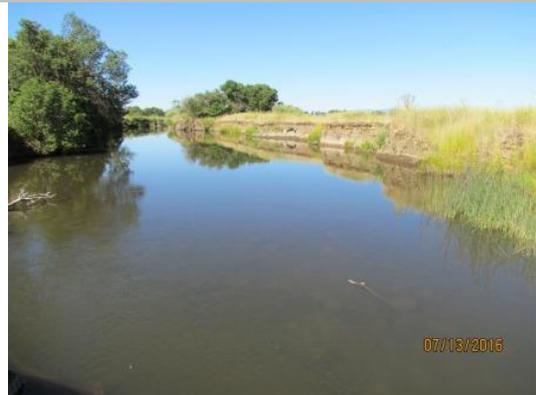
Photo 1 of 1 : CH_2016_NA0030_1_18_20160726_00012.jpg

Rating **	M	Issue No. 18	GPS Lat/Long
Issue Type +	Ma	Location *	41.197138 °
Category	Rivers, Channels & Designated Flood		-120.945271 °
Item	Erosion / Bank Caving		
DWR ID	DWR_NA0030_1_c_2012_18		
Action/Comments			
Inspector Comments: Monitor erosion during high flows.

View of the moderate erosion on both banks.

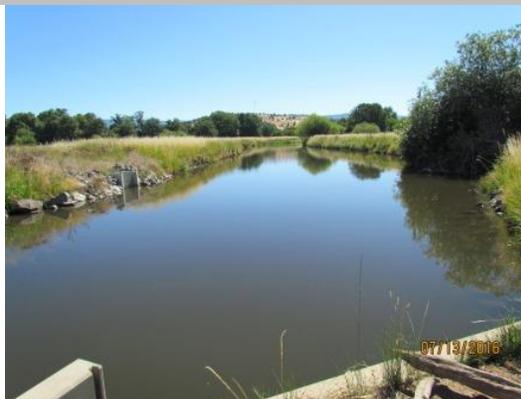
Photo 1 of 1 : CH_2016_NA0030_1_31_20160726_00013.jpg

Check Point / View			
Downstream limit/fish ladder & walkway / Up			
Rating **	A	Issue No. 31	GPS Lat/Long
Issue Type +	Ma	Location *	41.192990 °
Category	Rivers, Channels & Designated Flood		-120.954530 °
Item	Vegetation & Obstructions		
DWR ID	DWR_NA0030_1_c_2012_31		
Action/Comments			
Inspector Comments: The channel is clear of vegetation & obstructions.

View of the upstream side of the weir.

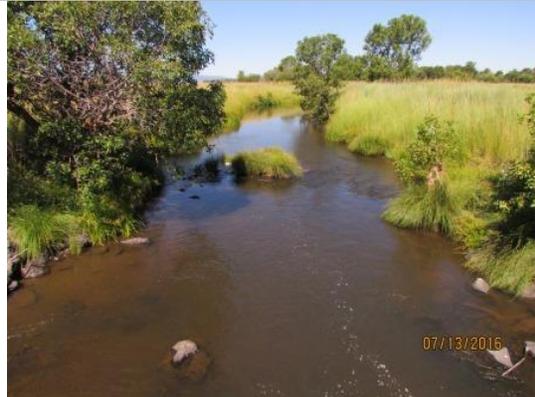
Photo 1 of 2 : CH_2016_NA0030_1_36_20160726_00014.jpg

Check Point / View			
Downstream limit/fish ladder & walkway / Down			
Rating **	A	Issue No.	36
Issue Type +	Ma	Location *	41.192990°
Category	Rivers, Channels & Designated Flood		-120.954530°
Item	Vegetation & Obstructions		
DWR ID	DWR_NA0030_1_c_2012_36		
Action/Comments			
Inspector Comments: The channel is clear of vegetation & obstructions.

View of the downstream side of the dam.

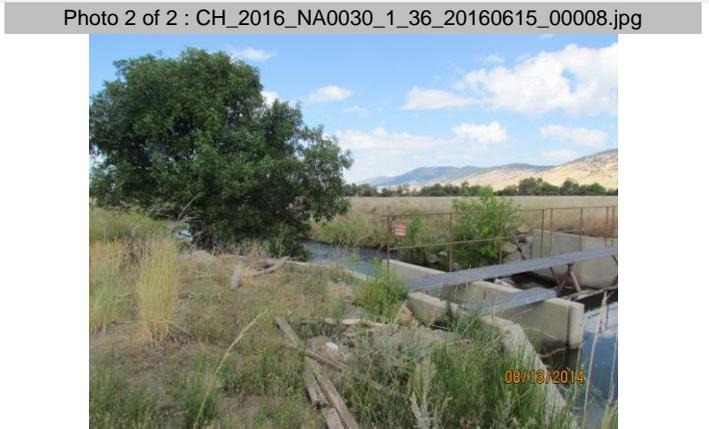
Check Point / View				
Downstream limit/fish ladder & walkway / Down (cont)				
Rating **	A	Issue No.	36 (cont)	GPS Lat/Long
Issue Type +	Ma	Location *		41.192990 °
Category	Rivers, Channels & Designated Flood			-120.954530 °
Item	Vegetation & Obstructions			
DWR ID	DWR_NA0030_1_c_2012_36			
Action/Comments				
Inspector Comments: The channel is clear of vegetation & obstructions.

View of the downstream side of the dam, fish ladder constructed by Dept. of Fish and Game in October 1999.

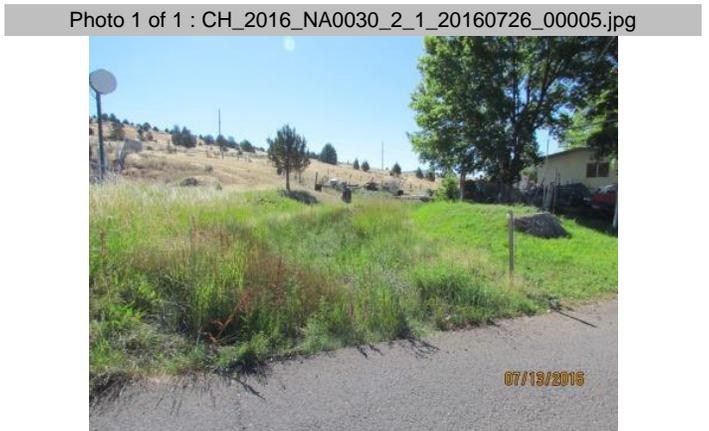
Check Point / View			
Adin Street / Up			
Rating **	A	Issue No.	1
Issue Type +	Ma	Location *	41.195370 °
Category	Rivers, Channels & Designated Flood		-120.943190 °
Item	Vegetation & Obstructions		
DWR ID	DWR_NA0030_2_c_2012_1		
Action/Comments			
Inspector Comments: Remove all vegetation in channel before winter. Mike Williamson said they will remove the vegetation before winter.

Upstream at Adin Street. Minimal vegetation in channel.

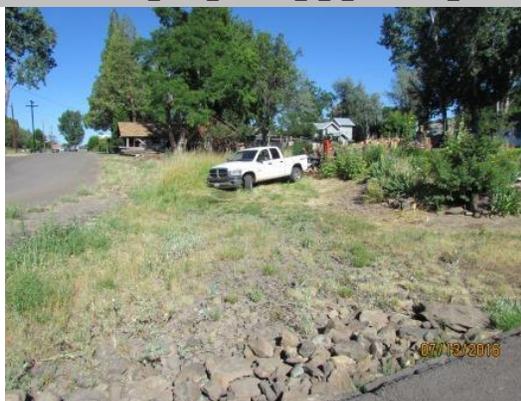
Photo 1 of 1 : CH_2016_NA0030_2_6_20160726_00006.jpg

Check Point / View			
Adin Street / Down			
Rating **	A	Issue No. 6	GPS Lat/Long
Issue Type +	Ma	Location *	41.195370 °
Category	Rivers, Channels & Designated Flood		-120.943190 °
Item	Vegetation & Obstructions		
DWR ID	DWR_NA0030_2_c_2012_6		
Action/Comments			
Inspector Comments: Remove volunteer woody vegetation in channel before blockage occurs.

Downstream from Adin Street. Minimal vegetation in channel.

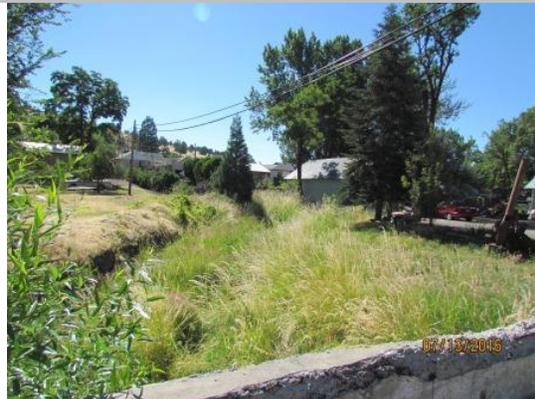
Photo 1 of 1 : CH_2016_NA0030_2_11_20160726_00007.jpg

Check Point / View				
Main Street / Up				
Rating **	M	Issue No.	11	GPS Lat/Long
Issue Type +	Ma	Location *		41.196350 °
Category	Rivers, Channels & Designated Flood			-120.944250 °
Item	Vegetation & Obstructions			
DWR ID	DWR_NA0030_2_c_2012_11			
Action/Comments				
Inspector Comments: Remove all woody vegetation in channel before winter.

Upstream from Main Street. Minimal vegetation in channel.

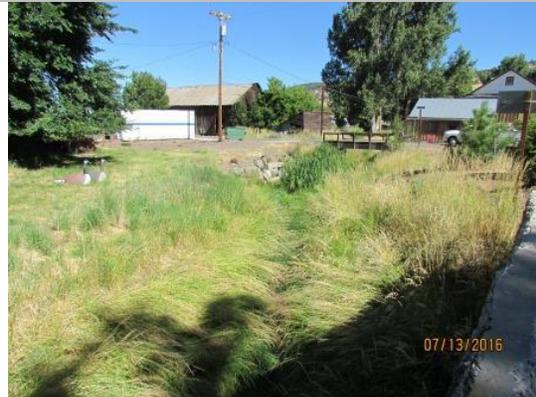
Photo 1 of 1 : CH_2016_NA0030_2_16_20160726_00008.jpg

Check Point / View				
Main Street / Down				
Rating **	A	Issue No.	16	GPS Lat/Long
Issue Type +	Ma	Location *		41.196350 °
Category	Rivers, Channels & Designated Flood			-120.944250 °
Item	Vegetation & Obstructions			
DWR ID	DWR_NA0030_2_c_2012_16			
Action/Comments				
Inspector Comments: Remove volunteer woody vegetation in channel before blockage occurs. The grass should be mowed before flood season.

View from Main Street looking downstream at minimal vegetation in channel.
