**Flood Control Project Maintenance
Levee Inspections**

2010 Channel Summary Report

Fairfield Suisun Sewer District

2010 Channel Inspection Results

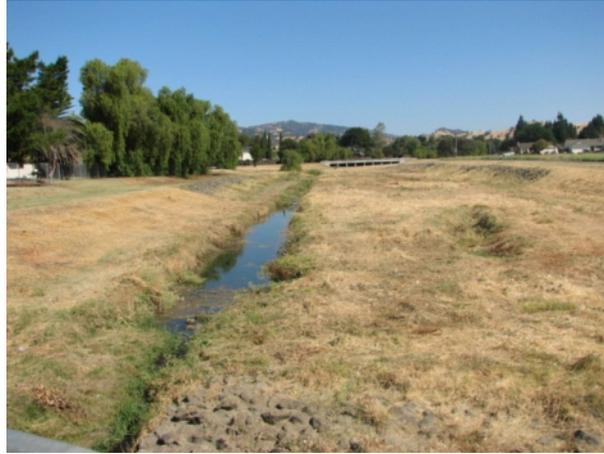
Levee Mile Report Line	1
Start Levee Mile	0.00
End Levee Mile	0.00
Location	
Category	Channels
Item	Vegetation & Obstructions
Upstream view at Cement Hill Rd.	
johngw_c_20100805_080.jpg

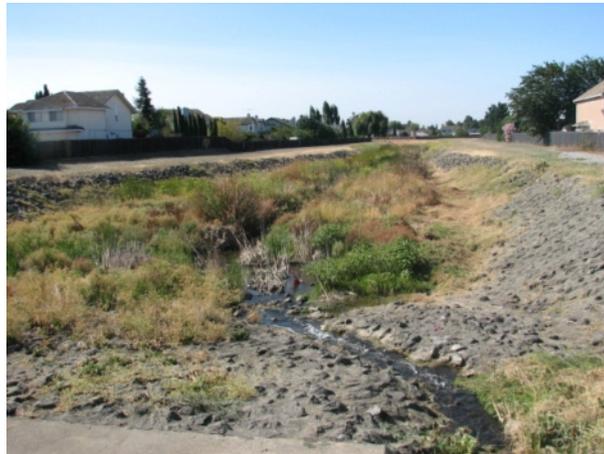
Levee Mile Report Line	6
Start Levee Mile	0.00
End Levee Mile	0.00
Location	
Category	Channels
Item	Vegetation & Obstructions
Downstream view at Cement Hill Rd.	
johngw_c_20100805_081.jpg

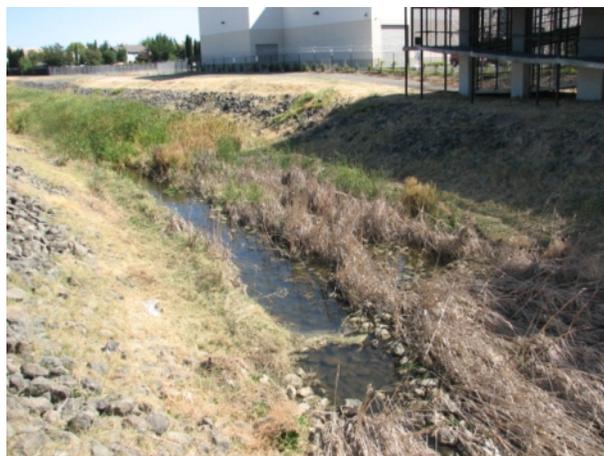
Levee Mile Report Line	11
Start Levee Mile	0.00
End Levee Mile	0.00
Location	
Category	Channels
Item	Vegetation & Obstructions
Upstream view at Airbase Parkway	
johngw_c_20100805_082.jpg

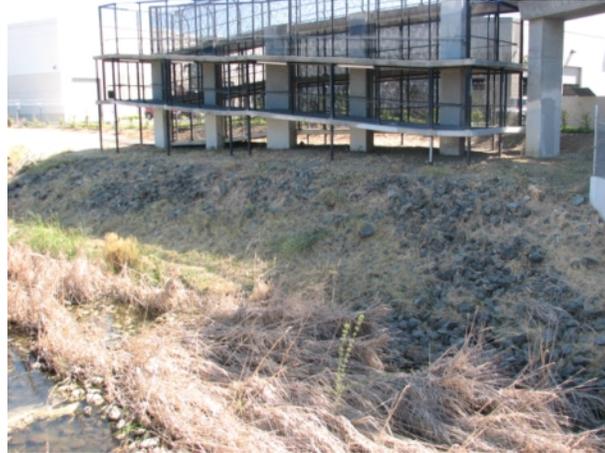
Levee Mile Report Line	14
Start Levee Mile	0.00
End Levee Mile	0.00
Location	
Category	Channels
Item	Revetments
Rip rap by walk over Airbase Parkway	
johngw_c_20100805_088.jpg

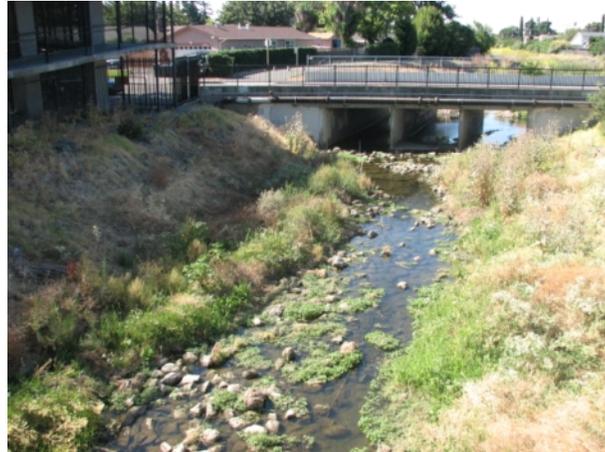
Levee Mile Report Line	16
Start Levee Mile	0.00
End Levee Mile	0.00
Location	
Category	Channels
Item	Vegetation & Obstructions
Downstream view at Airbase Parkway Nightgale Dr. in background	
johngw_c_20100805_083.jpg

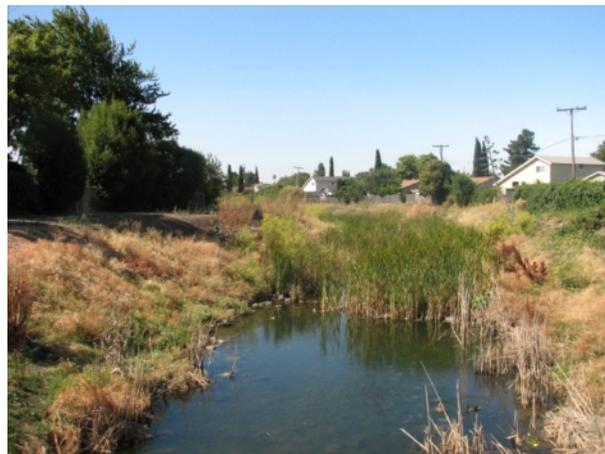
Levee Mile Report Line	16
Start Levee Mile	0.00
End Levee Mile	0.00
Location	
Category	Channels
Item	Vegetation & Obstructions
Downstream view at Nightgale Dr.	
johngw_c_20100805_084.jpg

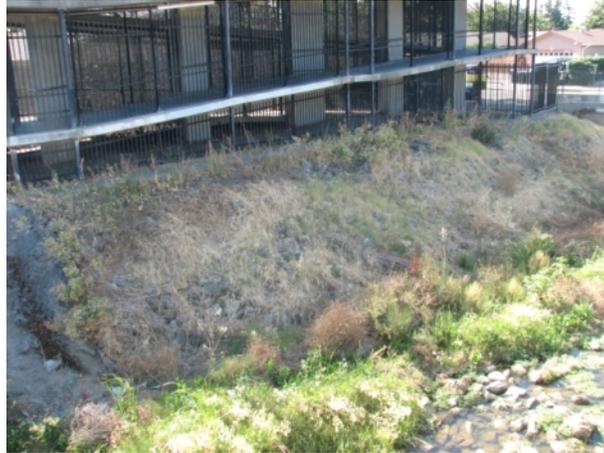
Levee Mile Report Line	19
Start Levee Mile	0.00
End Levee Mile	0.00
Location	
Category	Channels
Item	Revetments
Rip rap by walk over Airbase Parkway	
johngw_c_20100805_087.jpg

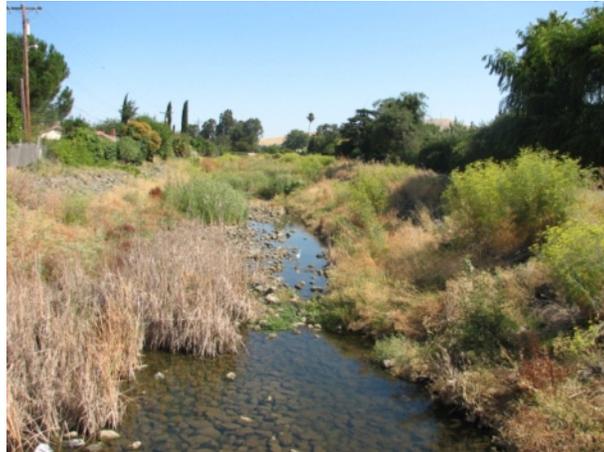
Levee Mile Report Line	21
Start Levee Mile	0.00
End Levee Mile	0.00
Location	
Category	Channels
Item	Vegetation & Obstructions
Upstream view at Meadowlark Dr.	
johngw_c_20100805_085.jpg

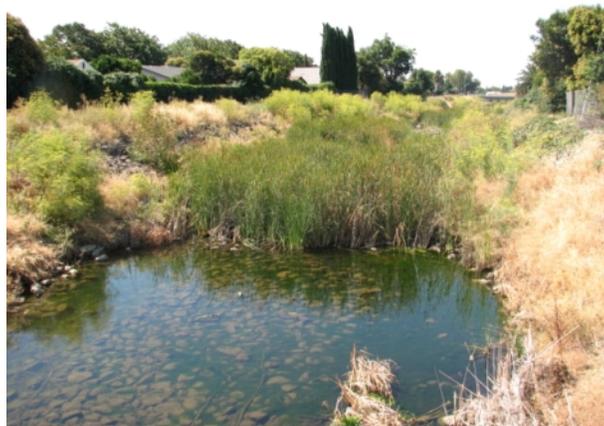
Levee Mile Report Line	26
Start Levee Mile	0.00
End Levee Mile	0.00
Location	
Category	Channels
Item	Vegetation & Obstructions
Downstream view at Meadowlark Dr.	
johngw_c_20100805_086.jpg

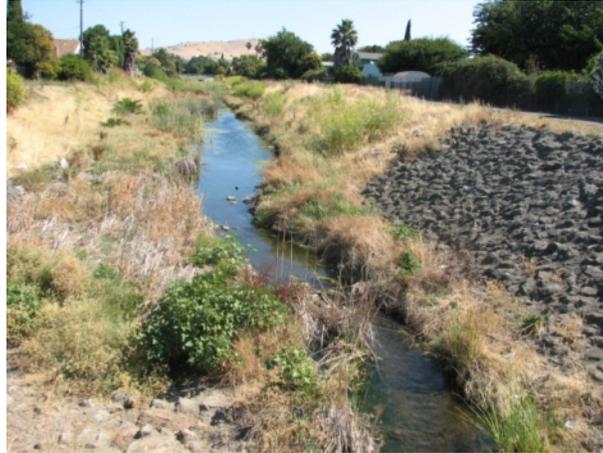
Levee Mile Report Line	31
Start Levee Mile	0.00
End Levee Mile	0.00
Location	
Category	Channels
Item	Vegetation & Obstructions
Upstream view at E. Tabor Ave.	
johngw_c_20100805_089.jpg

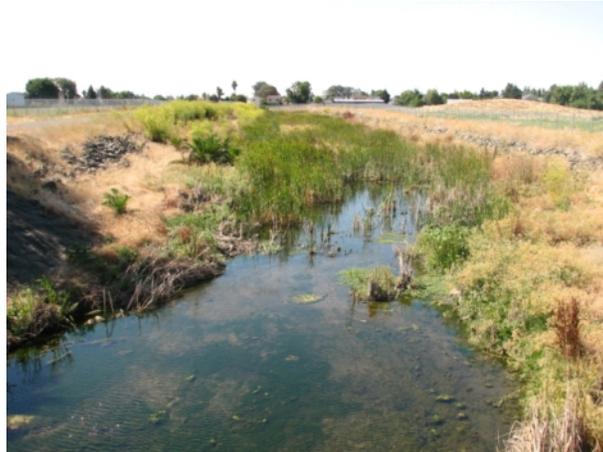
Levee Mile Report Line	36
Start Levee Mile	0.00
End Levee Mile	0.00
Location	
Category	Channels
Item	Vegetation & Obstructions
Downstream view at E. Tabor Ave.	
johngw_c_20100805_090.jpg

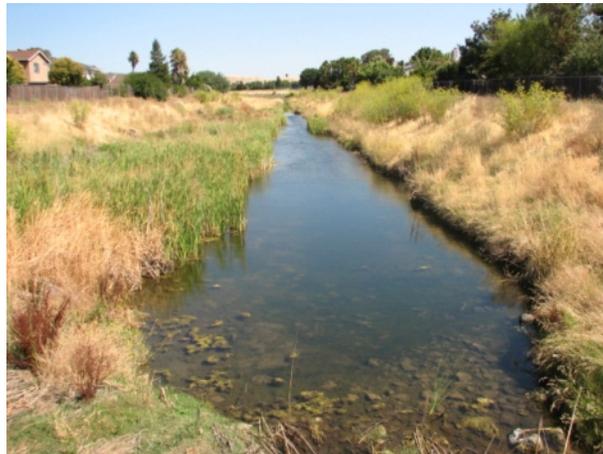
Levee Mile Report Line	41
Start Levee Mile	0.00
End Levee Mile	0.00
Location	
Category	Channels
Item	Vegetation & Obstructions
Upstream view at Matthew Rd.	
johngw_c_20100805_091.jpg

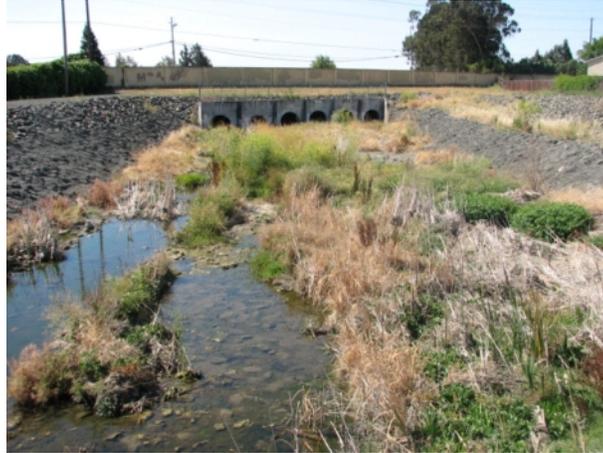
Levee Mile Report Line	46
Start Levee Mile	0.00
End Levee Mile	0.00
Location	
Category	Channels
Item	Vegetation & Obstructions
<p>Downstream view from Matthew Rd. looking towards railroad tracks. This is the end of the City of Fairfield's maintenance of the channel. The City of Suisun takes over for the remainder.</p>	
<p>johngw_c_20100805_092.jpg</p>

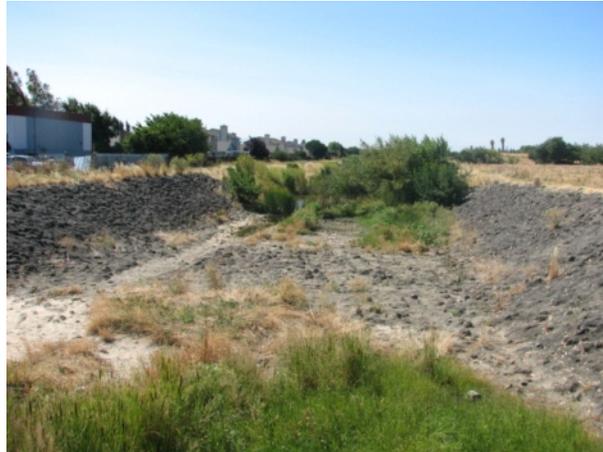
Levee Mile Report Line	51
Start Levee Mile	
End Levee Mile	
Location	
Category	Channels
Item	Vegetation & Obstructions
<p>View is looking downstream, upstream is piped under railroad tracks and Railroad Ave.</p>	
<p>johngw_c_20100809_104.jpg</p>

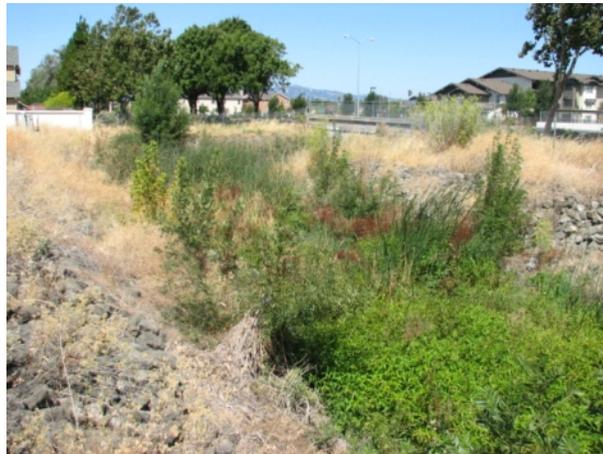
Levee Mile Report Line	56
Start Levee Mile	
End Levee Mile	
Location	
Category	Channels
Item	Vegetation & Obstructions
<p>View is looking upstream and curves to right.</p>	
<p>johngw_c_20100809_105.jpg</p>

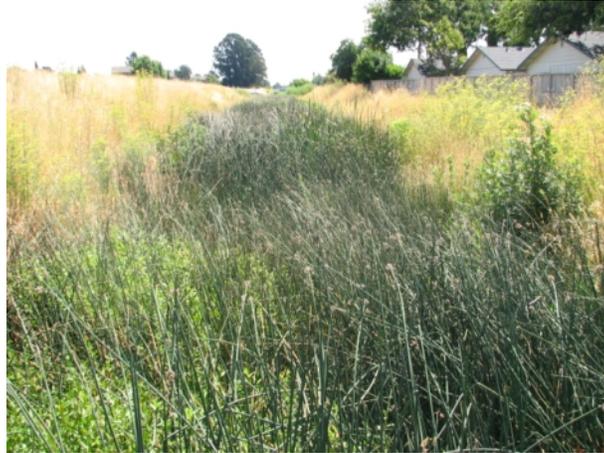
Levee Mile Report Line	61
Start Levee Mile	
End Levee Mile	
Location	
Category	Channels
Item	Vegetation & Obstructions
View is looking downstream, cattails need to be sprayed at least 50' from bridge.	
johngw_c_20100809_106.jpg

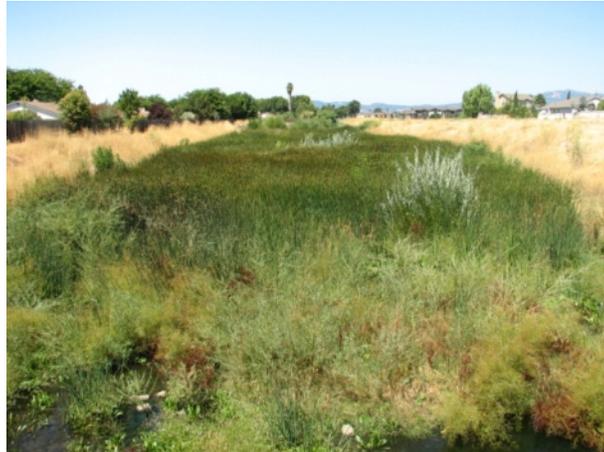
65		Down	Revetments		A		38.253409 ° -122.020114 °		85
66	Blossom Rd	Up	Vegetation & Obstructions		M	Inspector Comments: The bridge is clear. Need to cut and spray small trees. Larger trees upstream need to be cut from channel. Cattails are starting to clogg the channel.	38.253382 ° -122.014862 °	Y	51
67		Up	Shoaling / Sedimentation		A		38.253382 ° -122.014862 °		52
68		Up	Erosion / Bank Caving		A		38.253382 ° -122.014862 °		53

Levee Mile Report Line	66
Start Levee Mile	0.00
End Levee Mile	0.00
Location	
Category	Channels
Item	Vegetation & Obstructions
Upstream view at Blossom Rd.	
johngw_c_20100805_093.jpg

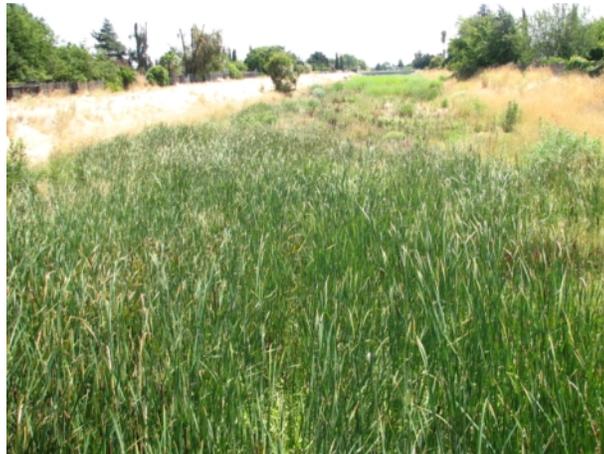
Levee Mile Report Line	71
Start Levee Mile	0.00
End Levee Mile	0.00
Location	
Category	Channels
Item	Vegetation & Obstructions
Downstream view at Blossom Rd.	
johngw_c_20100805_094.jpg

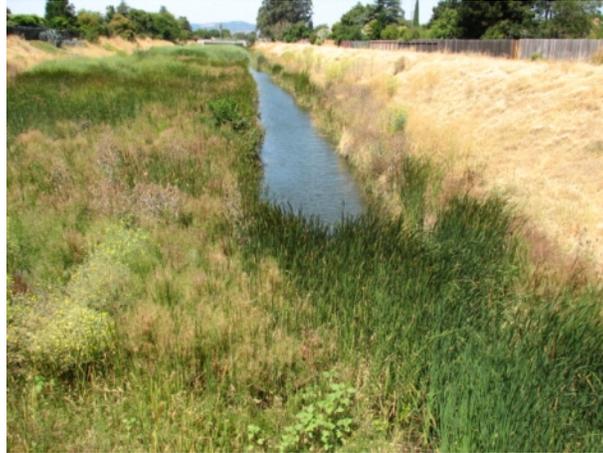
Levee Mile Report Line	76
Start Levee Mile	0.00
End Levee Mile	0.00
Location	
Category	Channels
Item	Vegetation & Obstructions
Upstream view at Worley Rd.	
johngw_c_20100805_095.jpg

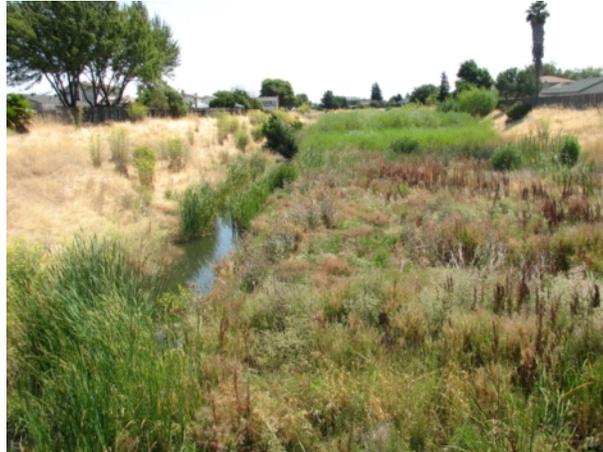
79		Up	Revetments		A		38.253248 ° -122.009732 °		64
80		Up	Encroachments		A		38.253248 ° -122.009732 °		65
81		Down	Vegetation & Obstructions		M	Inspector Comments: Cut and spray small trees, spray cattails back from bridge at least 50'.	38.253248 ° -122.009732 °	Y	66
82		Down	Shoaling / Sedimentation		A		38.253248 ° -122.009732 °		67
83		Down	Erosion / Bank Caving		A		38.253248 ° -122.009732 °		68
84		Down	Revetments		A		38.253248 ° -122.009732 °		69

Levee Mile Report Line	81
Start Levee Mile	0.00
End Levee Mile	0.00
Location	
Category	Channels
Item	Vegetation & Obstructions
Downstream view at Worley Rd.	
johngw_c_20100805_096.jpg
