**Flood Control Project Maintenance
Levee Inspections**

2012 Channel Summary Report

Fairfield Suisun Sewer District

2012 Channel Inspection Results

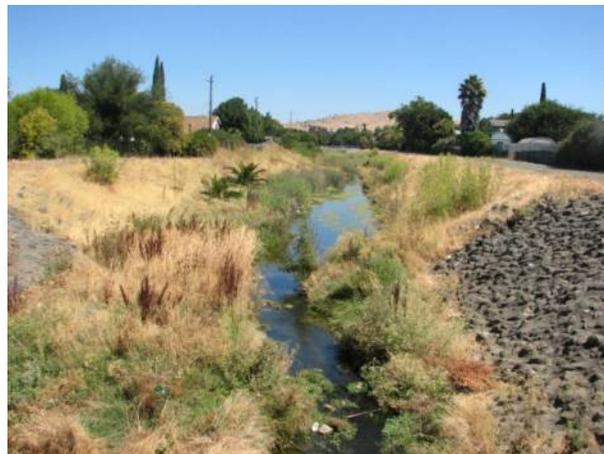
Levee Mile Report Line	31
Start Levee Mile	0.00
End Levee Mile	0.00
Location	
Category	Channels
Item	Vegetation & Obstructions
Looking upstream from E. Tabor Ave. The palm trees should be cut out. (2012)	
johngw_c_20120806_102.jpg

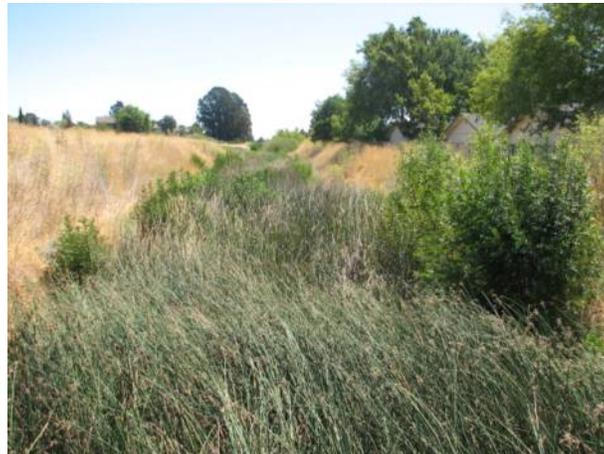
Levee Mile Report Line	66
Start Levee Mile	0.00
End Levee Mile	0.00
Location	
Category	Channels
Item	Vegetation & Obstructions
Looking downstream from Sunset Ave. Trees and brush should be removed. (2012)	
johngw_c_20120806_108.jpg

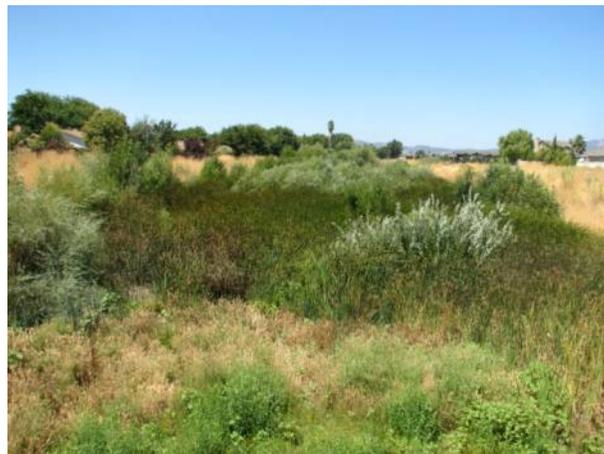
Levee Mile Report Line	71
Start Levee Mile	0.00
End Levee Mile	0.00
Location	
Category	Channels
Item	Vegetation & Obstructions
Looking upstream from Blossom Rd. Trees and brush should be cut and removed. (2012)	
johngw_c_20120806_109.jpg

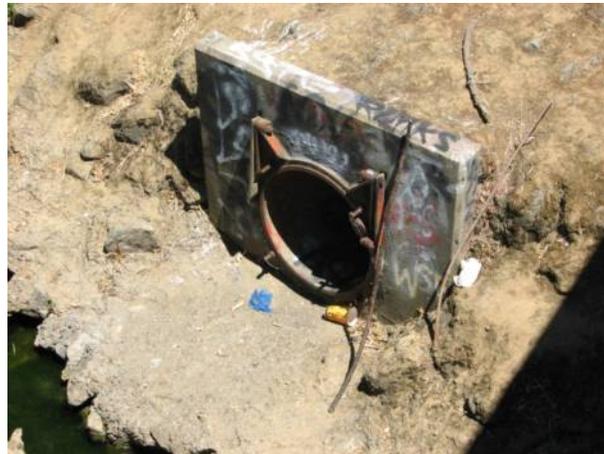
Levee Mile Report Line	25
Start Levee Mile	0.00
End Levee Mile	0.00
Location	
Category	Channels
Item	Gates

The flap gate has not been replaced. Should have a new one installed. (2012)

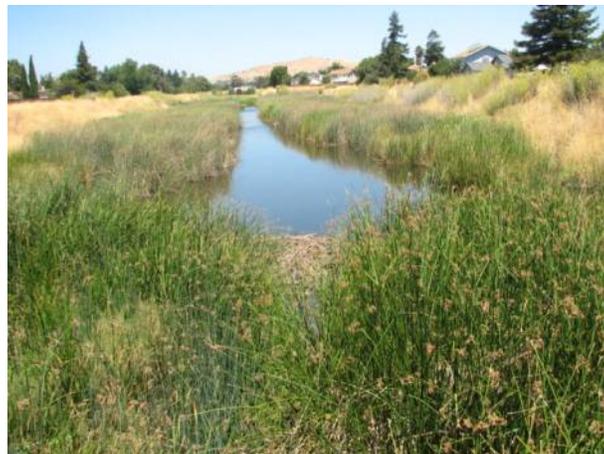
Levee Mile Report Line	21
Start Levee Mile	0.00
End Levee Mile	0.00
Location	
Category	Channels
Item	Vegetation & Obstructions
Looking upstream at Pintail Dr. A dam of cattails is in the channel. (2012)	
johngw_c_20120807_117.jpg
