**Flood Control Project Maintenance
Levee Inspections
2014 Channel Summary Report
Overall Unit and Item Ratings**

Fairfield Suisun Sewer District

Flood Control Project Maintenance
Unit Cover Sheet
2014 Channel Inspection Results

Levee Inspection Report By Mile - Channel 2014

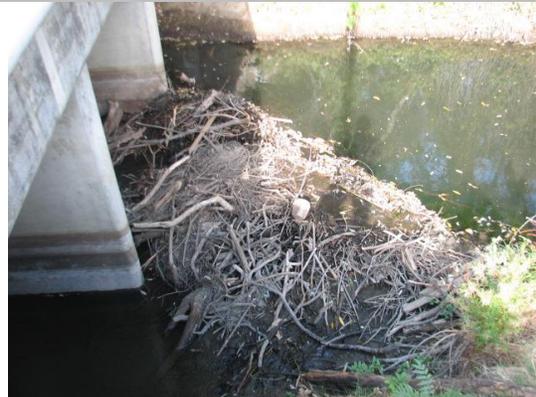
Photo 7 of 8 : CH_2014_NA0035_15_1_20140723_00033.jpg

Debris collecting at the upstream side of bridge at Manual Campos Parkway. Need to remove and look for other debris dams downstream.
Summer 2014

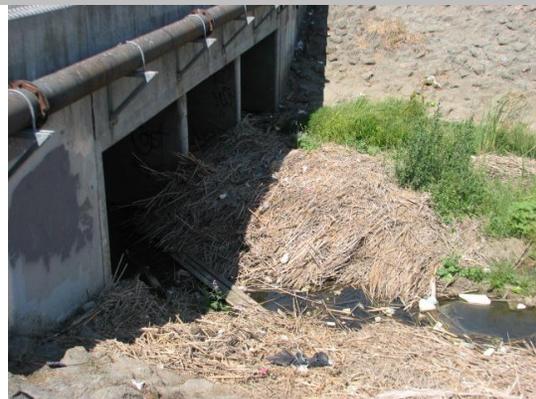
Photo 1 of 3 : CH_2014_NA0035_15_31_20140723_00040.jpg

Dried vegetation collecting at E. Tabor Bridge. Will not impede flow. Summer 2014

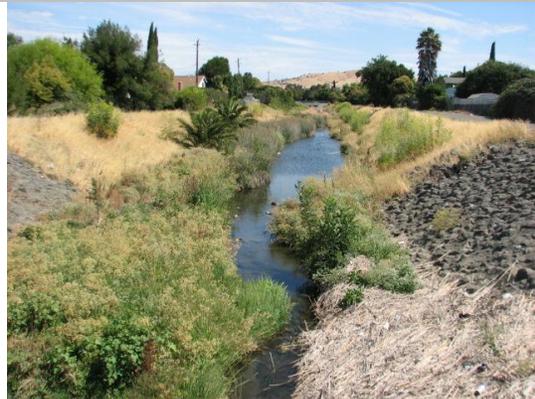
Photo 2 of 3 : CH_2014_NA0035_15_31_20140723_00039.jpg

A view looking upstream from E. Tabor Ave. Summer 2014 Woody vegetation needs to be removed.

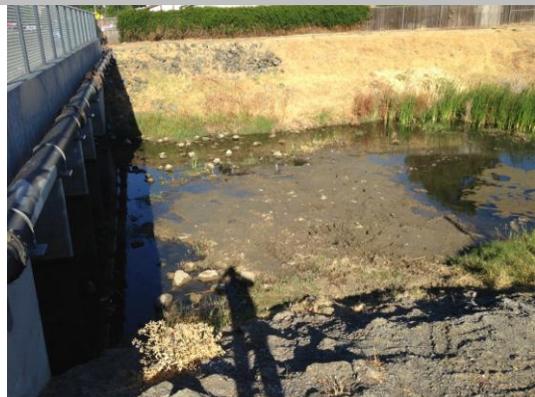
Photo 1 of 3 : CH_2014_NA0035_15_42_20140827_00052.jpg

Corrected view of sedimentation at Matthew Rd. 8-27-2014

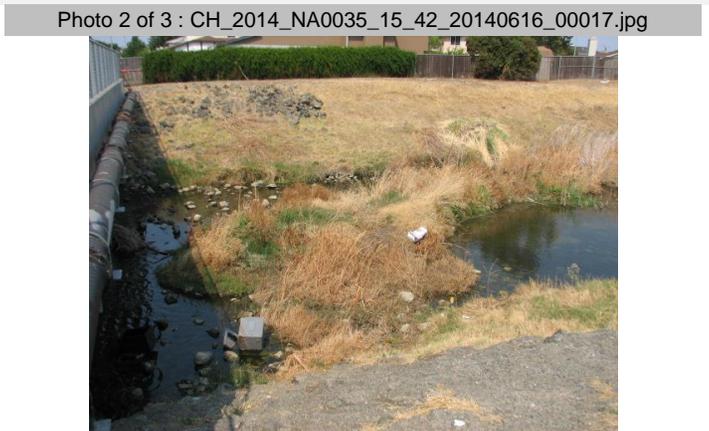
Check Point / View				
Matthew Rd / Up (cont)				
Rating **	A	Issue No.	42 (cont)	GPS Lat/Long
Issue Type +	Ma	Location *		38.259272 °
Category	Rivers, Channels & Designated Flood			-122.017533 °
Item	Shoaling / Sedimentation			
DWR ID	DWR_NA0035_15_c_2012_42			
Action/Comments				
Inspector Comments: Some shoaling or sedimentation present.

A build up of sedimentation upstream; suggest removing it. (Summer 2013)

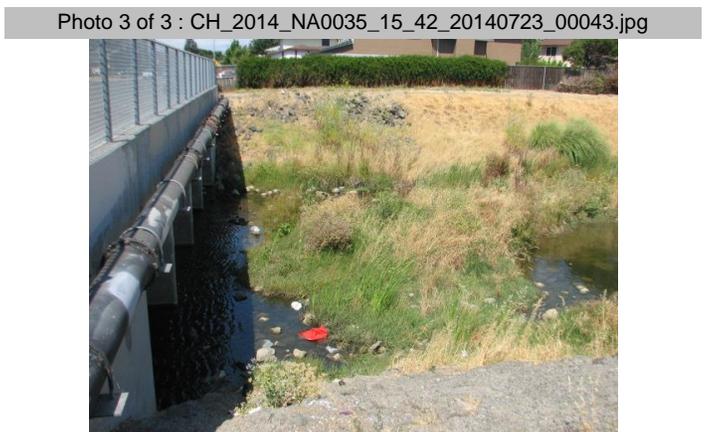
Sedimentation blocks flow and needs to be removed. Summer 2014

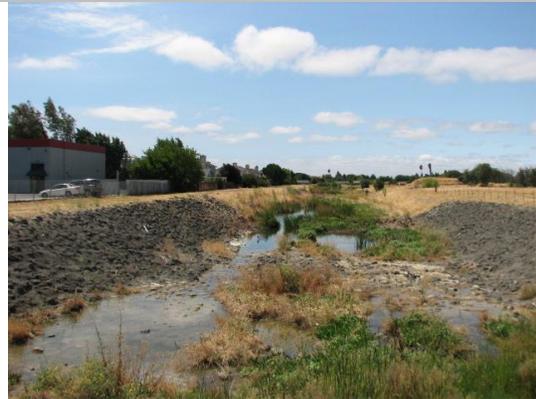
Photo 2 of 2 : CH_2014_NA0035_15_56_20140723_00045.jpg

Looking downstream from Railroad Ave. Woody vegetation has been removed. Summer 2014

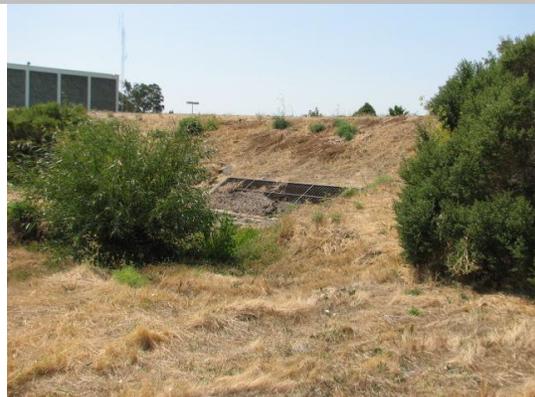
Photo 2 of 6 : CH_2014_NA0035_17_1_20140616_00001.jpg

Looking at the inlet in the retention basin. Suggest removal of willow in front of grate. (Summer 2013)

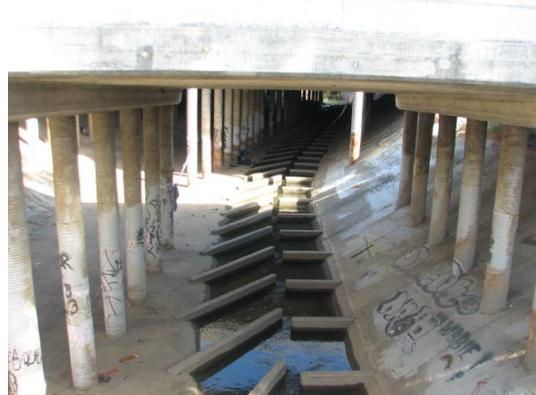
Photo 1 of 2 : CH_2014_NA0035_17_31_20140724_00038.jpg

Upstream view from Auto Mall Pkwy. Under I-80 and homeless camp. Summer 2014

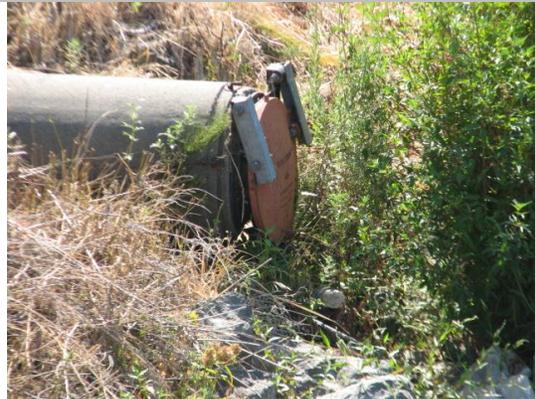
Photo 2 of 3 : CH_2014_NA0035_17_36_20140616_00014.jpg

A flap gate downstream at Auto Mall Parkway needs to be cleaned out and checked. (Summer 2013) Item corrected.

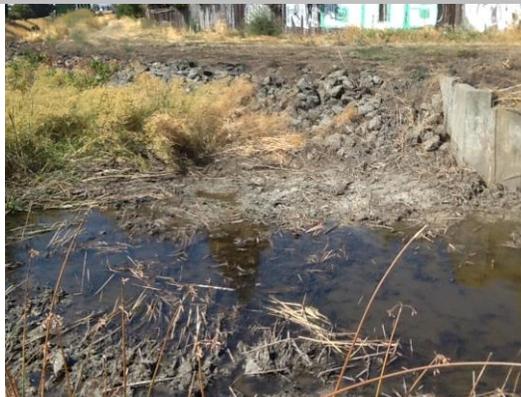
Photo 3 of 4 : CH_2014_NA0035_14_1_20140829_00021.jpg

View upstream after the LMA cleared vegetation, summer 2014.

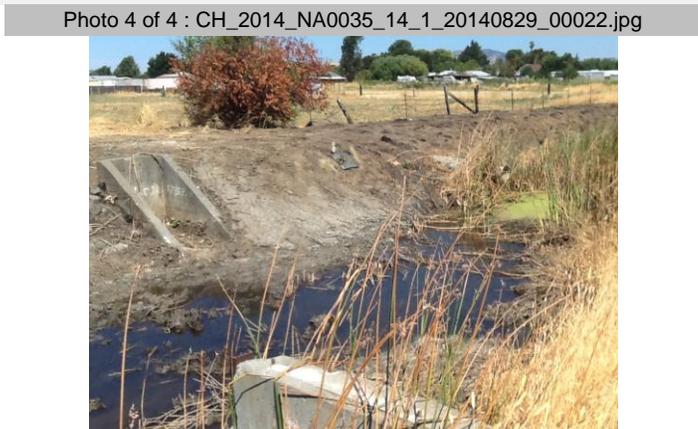
Check Point / View			
Bella Vista Dr / Up (cont)			
Rating **	M	Issue No.	1 (cont)
Issue Type +	Ma	Location *	GPS Lat/Long
Category	Rivers, Channels & Designated Flood		38.253220 °
Item	Vegetation & Obstructions		-122.000589 °
DWR ID	DWR_NA0035_14_c_2012_1		
Action/Comments			
Inspector Comments: Vegetation growth (such as cat tails, bull rushes, bushes or saplings) or other obstructions block approximately 25% of the FCW.

Additional view upstream after the LMA cleared vegetation, summer 2014.

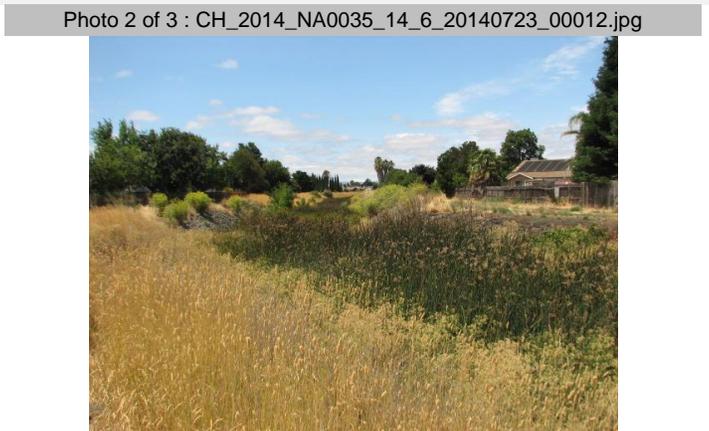
Check Point / View				
Bella Vista Dr / Down (cont)				
Rating **	M	Issue No.	6 (cont)	GPS Lat/Long
Issue Type +	Ma	Location *		38.253219 °
Category	Rivers, Channels & Designated Flood			-122.000587 °
Item	Vegetation & Obstructions			
DWR ID	DWR_NA0035_14_c_2012_6			
Action/Comments				
Inspector Comments: Vegetation growth (such as cat tails, bull rushes, bushes or saplings) or other obstructions block approximately 50% of the FCW.

Looking downstream at Bella Vista Ave. Woody vegetation is getting larger; need to remove. Summer 2014

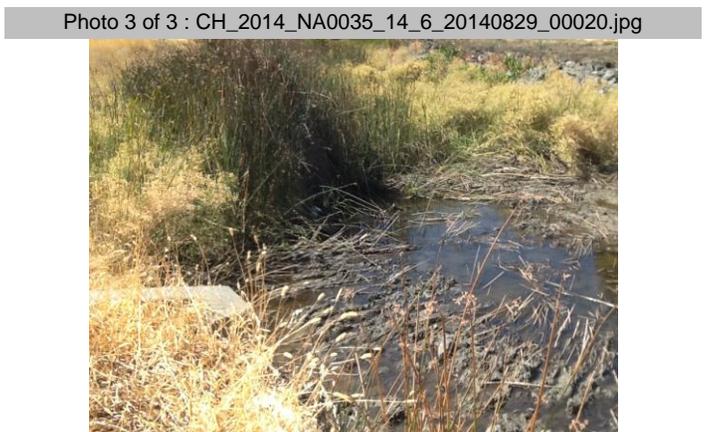
View of the channel downstream during the summer 2014 after the LMA has cleared vegetation.

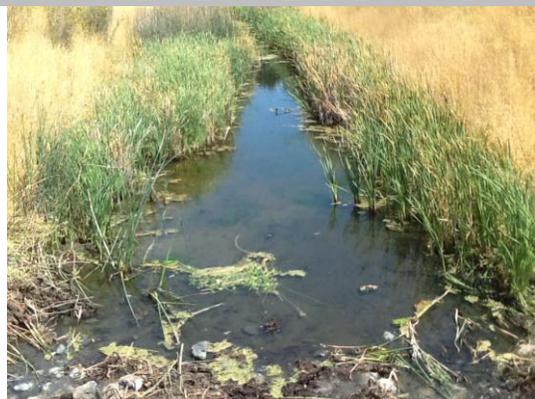
Photo 3 of 4 : CH_2014_NA0035_14_11_20140829_00023.jpg

View upstream after the LMA cleared vegetation, summer 2014. The LMA found and removed a beaver dam.

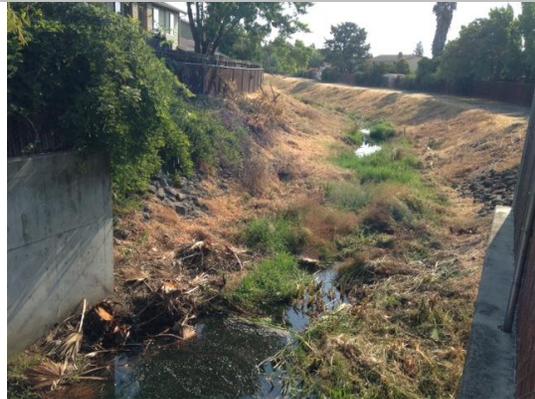
Photo 1 of 3 : CH_2014_NA0035_16_6_20140827_00015.jpg

Corrected issue at N. Texas St. 8-27-2014

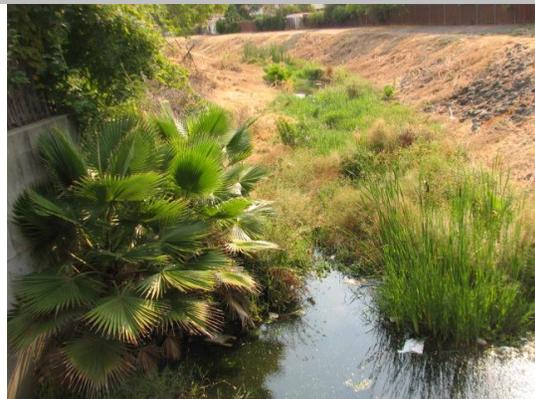
Looking downstream at N. Texas Street. Suggest removal of the palms. (Summer 2013)

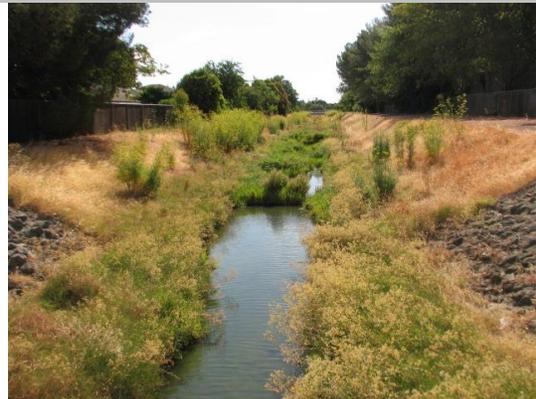
Looking downstream from Dover Ave. Summer 2014. Remove small woody vegetation.

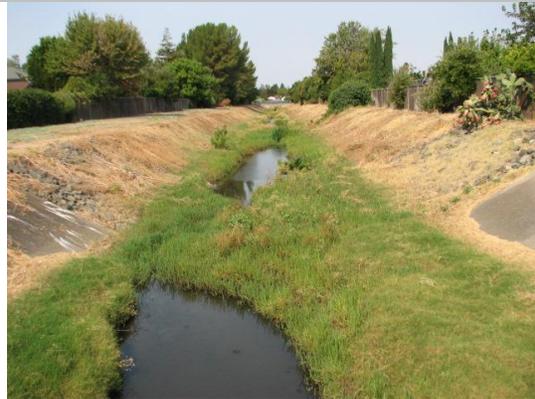
Looking upstream at Gulf Drive. Sedimentation starting to obstruct low flow channel. (Summer 2013)
