**Flood Control Project Maintenance
Levee Inspections**

2012 Channel Summary Report

Placer County

Truckee River

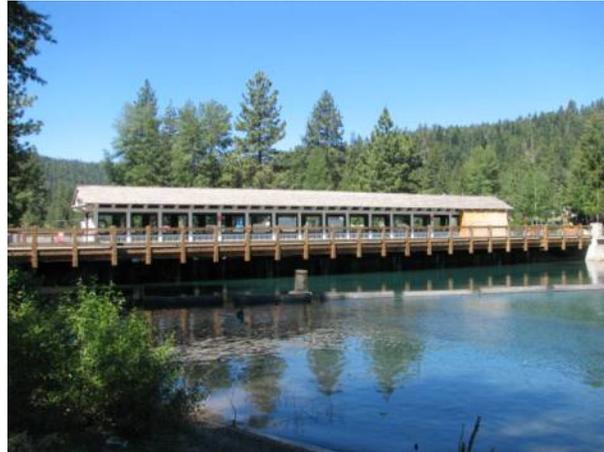
Levee Mile Report Line	1
Start Levee Mile	0.00
End Levee Mile	0.00
Location	
Category	Channels
Item	Vegetation & Obstructions
Looking from Lake Tahoe to the outlet structure 2012.	
johngw_c_20120711_081.jpg

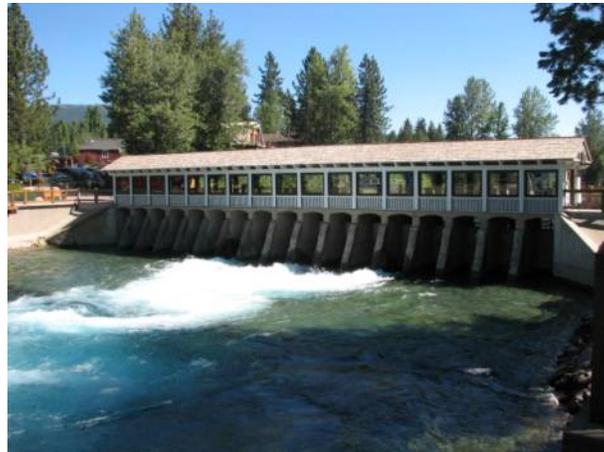
Levee Mile Report Line	6
Start Levee Mile	0.00
End Levee Mile	0.00
Location	
Category	Channels
Item	Vegetation & Obstructions
The outlet structure at the start of the Truckee River. 2012	
johngw_c_20120711_080.jpg

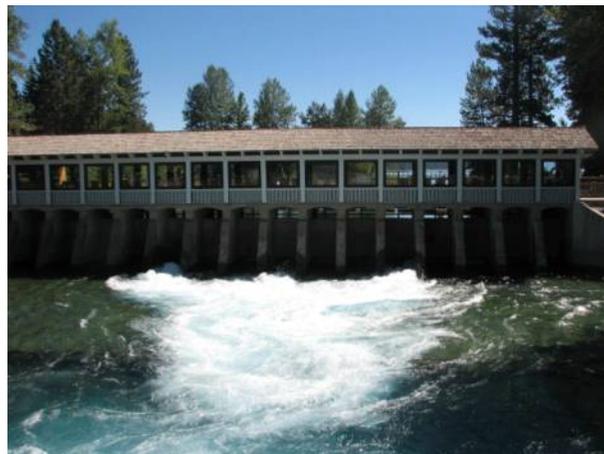
Levee Mile Report Line	11
Start Levee Mile	0.00
End Levee Mile	0.00
Location	
Category	Channels
Item	Vegetation & Obstructions
Looking at the outlet structure upstream from Highway 89 , 2012.	
johngw_c_20120711_079.jpg

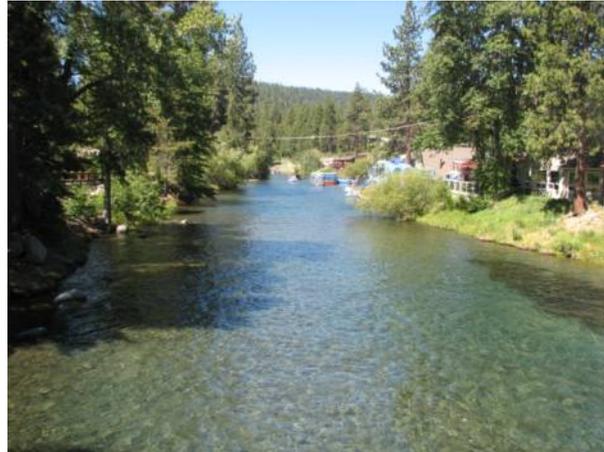
Levee Mile Report Line	16
Start Levee Mile	0.00
End Levee Mile	0.00
Location	
Category	Channels
Item	Vegetation & Obstructions
Looking downstream from the bridge at Highway 89, 2012.	
johngw_c_20120711_078.jpg

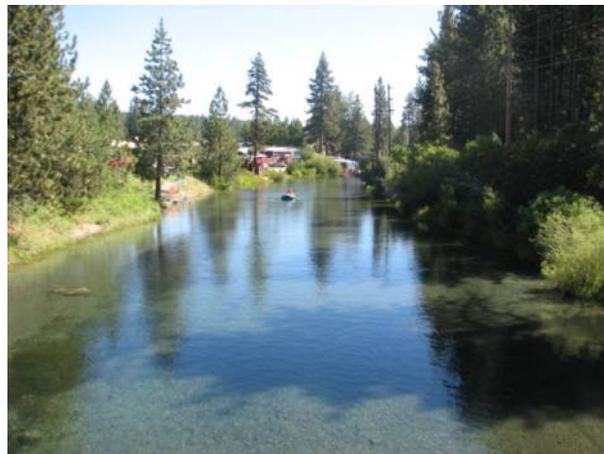
Levee Mile Report Line	21
Start Levee Mile	0.00
End Levee Mile	0.00
Location	
Category	Channels
Item	Vegetation & Obstructions
Looking upstream from the bike bridge 2012.	
johngw_c_20120711_077.jpg

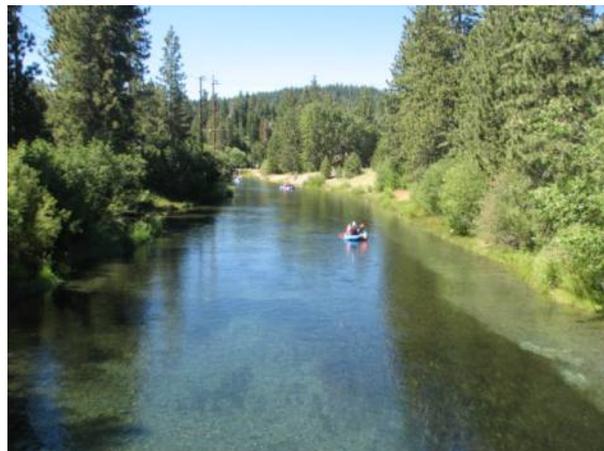
Levee Mile Report Line	26
Start Levee Mile	0.00
End Levee Mile	0.00
Location	
Category	Channels
Item	Vegetation & Obstructions
The view looking downstream from the bike bridge 2012.	
johngw_c_20120711_076.jpg

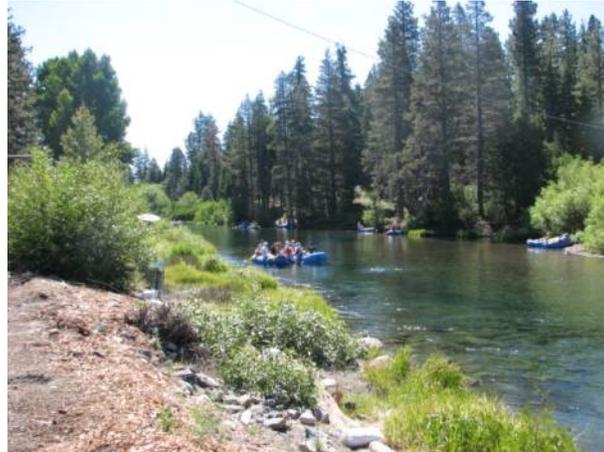
Levee Mile Report Line	31
Start Levee Mile	0.00
End Levee Mile	0.00
Location	
Category	Channels
Item	Vegetation & Obstructions
The view looking upstream at Tahoe Lumber Yard 2012.	
johngw_c_20120711_073.jpg

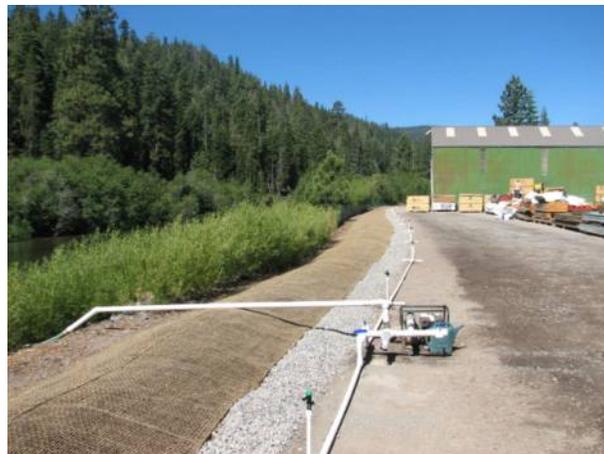
Levee Mile Report Line	31
Start Levee Mile	0.00
End Levee Mile	0.00
Location	
Category	Channels
Item	Vegetation & Obstructions
The yard has been planting willows and installing a drain system. The berm will be hydro seeded with native grasses. 2012.	
johngw_c_20120711_074.jpg

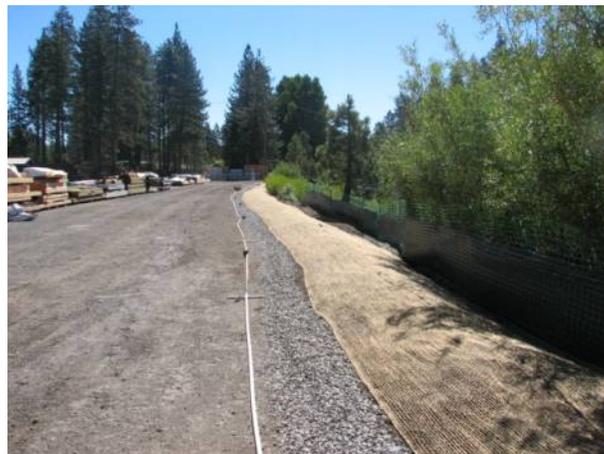
Levee Mile Report Line	31
Start Levee Mile	0.00
End Levee Mile	0.00
Location	
Category	Channels
Item	Vegetation & Obstructions
A good view of the drain and filter fence along the willows. 2012	
johngw_c_20120711_075.jpg

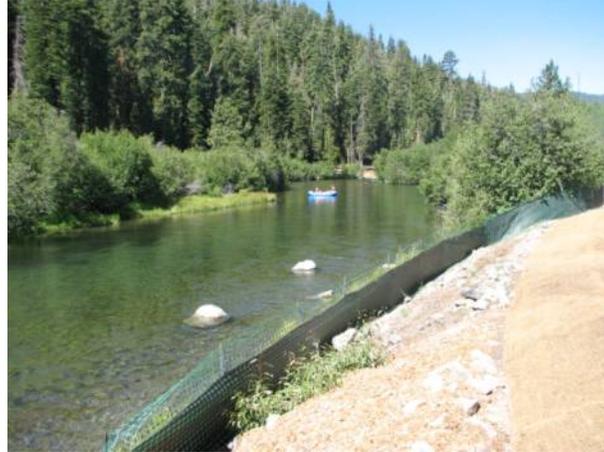
Levee Mile Report Line	36
Start Levee Mile	0.00
End Levee Mile	0.00
Location	
Category	Channels
Item	Vegetation & Obstructions

The view looking downstream 2012.
