**Flood Control Project Maintenance  
Levee Inspections**

**2015 Channel Summary Report**

**Placer County**

**Truckee River**

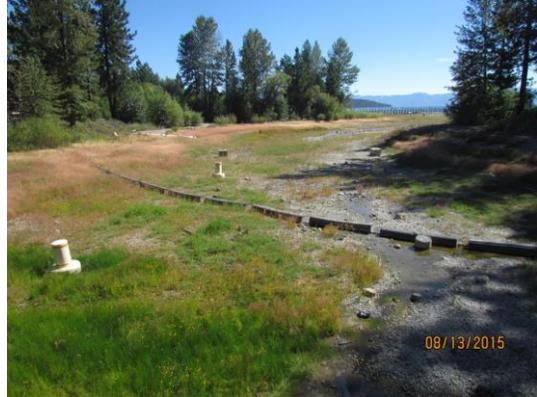
Photo 1 of 3 : CH\_2015\_NA0045\_13\_1\_20150817\_00020.jpg

Check Point / View				
<b>Outlet Structure / Up</b>				
Rating **	A	Issue No.	1	GPS Lat/Long
Issue Type +	Ma	Location *		39.167101 °
Category	Rivers, Channels & Designated Flood			-120.144002 °
Item	Vegetation & Obstructions			
DWR ID	DWR_NA0045_13_c_2012_1			
Action/Comments				
Inspector Comments: Minimal, scattered obstructions or vegetation. The flow is not impeded.

Looking upstream from the outlet structure. Summer 2015.

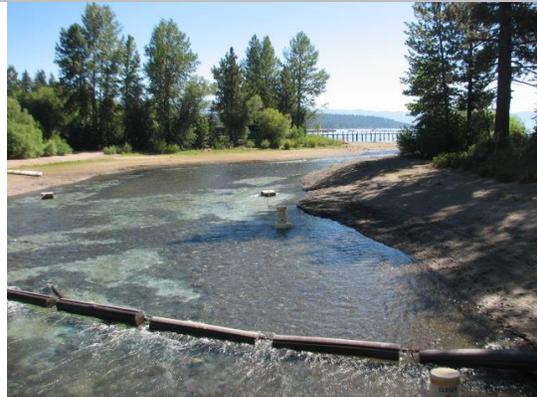
Photo 2 of 3 : CH\_2015\_NA0045\_13\_1\_20150612\_00001.jpg

Standing on the walkway looking upstream at Lake Tahoe. Summer 2014

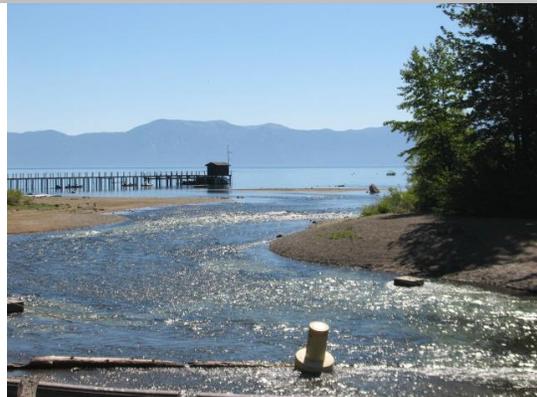
Photo 3 of 3 : CH\_2015\_NA0045\_13\_1\_20150612\_00003.jpg

Looking upstream at the very low flow out of Lake Tahoe. Summer 2014

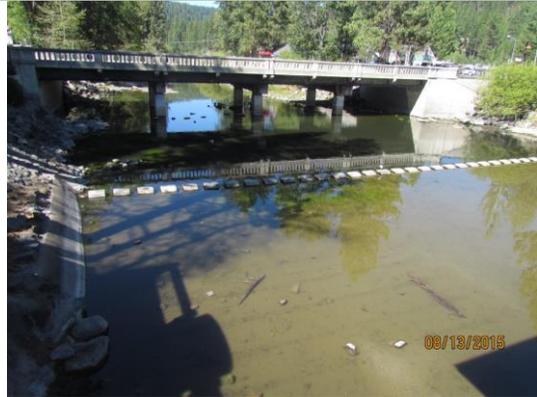
Photo 1 of 3 : CH\_2015\_NA0045\_13\_6\_20150817\_00021.jpg

Check Point / View				
<b>Outlet Structure / Down</b>				
Rating **	A	Issue No.	6	GPS Lat/Long
Issue Type +	Ma	Location *		39.167101 °
Category	Rivers, Channels & Designated Flood			-120.144002 °
Item	Vegetation & Obstructions			
DWR ID	DWR_NA0045_13_c_2012_6			
Action/Comments				
Inspector Comments: Minimal, scattered obstructions or vegetation. The flow is not impeded.

Looking downstream from the outlet structure. Summer 2015.

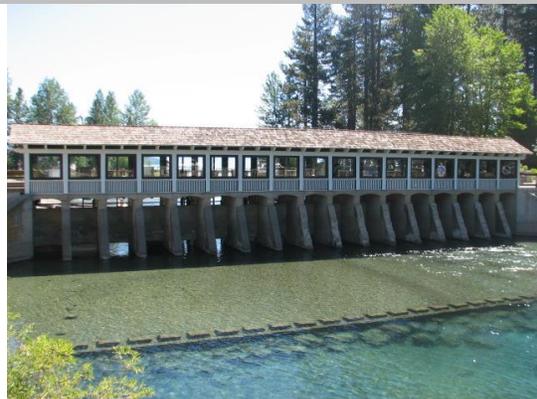
Photo 2 of 3 : CH\_2015\_NA0045\_13\_6\_20150612\_00004.jpg

Looking at the outlet structure from Highway 89. Summer 2014

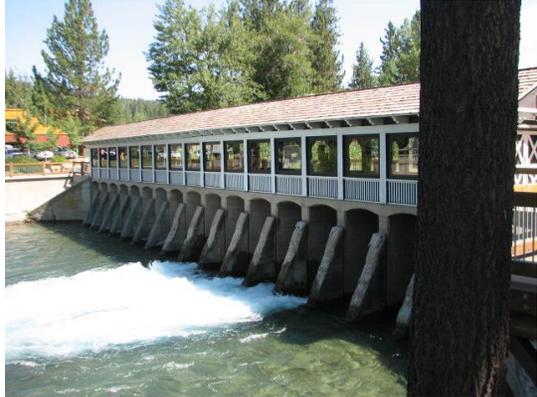
Photo 3 of 3 : CH\_2015\_NA0045\_13\_6\_20150612\_00005.jpg

A side view of the downstream side of the structure. Summer 2013

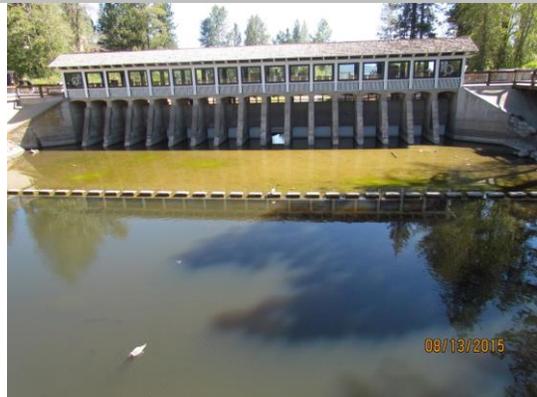
Photo 1 of 2 : CH\_2015\_NA0045\_13\_11\_20150817\_00022.jpg

Check Point / View			
<b>Hwy 89 / Up</b>			
Rating **	A	Issue No.	11
Issue Type +	Ma	Location *	GPS Lat/Long
Category	Rivers, Channels & Designated Flood		39.166845 °
Item	Vegetation & Obstructions		-120.144424 °
DWR ID	DWR_NA0045_13_c _ 2012_11		
Action/Comments			
Inspector Comments: The flow going out the control structure is very low. Minimal, scattered obstructions or vegetation. The flow is not impeded.

Looking upstream from Highway 89. Summer 2015.

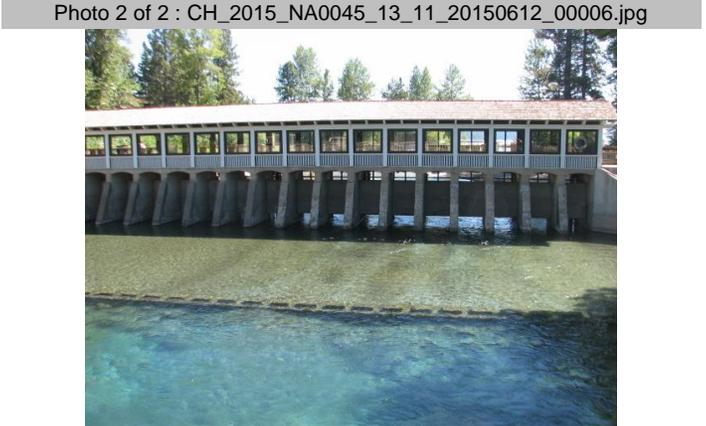
Looking upstream from Highway 89 at the outlet structure. Summer 2014

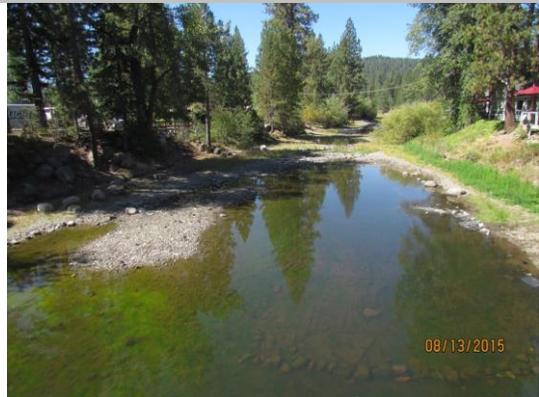
Photo 1 of 2 : CH\_2015\_NA0045\_13\_16\_20150817\_00023.jpg

Check Point / View			
<b>Hwy 89 / Down</b>			
Rating **	A	Issue No. <b>16</b>	GPS Lat/Long
Issue Type +	Ma	Location *	39.166845 °
Category	Rivers, Channels & Designated Flood		-120.144424 °
Item	Vegetation & Obstructions		
DWR ID	DWR_NA0045_13_c _ 2012_16		
Action/Comments			
Inspector Comments: Minimal, scattered obstructions or vegetation. The flow is not impeded.

Looking downstream from Highway 89. Summer 2015.

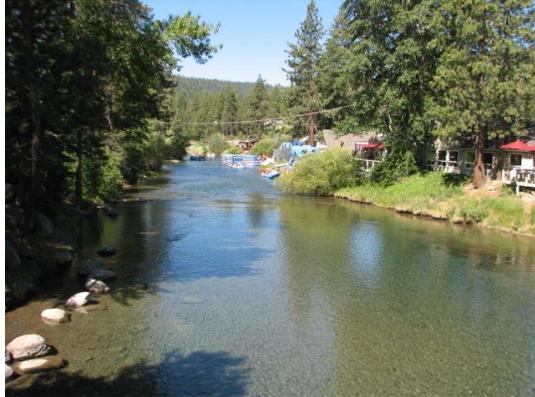
Photo 2 of 2 : CH\_2015\_NA0045\_13\_16\_20150612\_00008.jpg

Looking downstream from Highway 89. Summer 2014

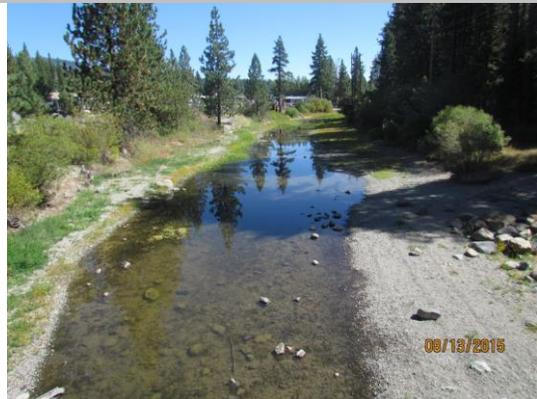
Photo 1 of 2 : CH\_2015\_NA0045\_13\_21\_20150817\_00024.jpg

Check Point / View			
<b>bike bridge / Up</b>			
Rating **	A	Issue No.	21
Issue Type +	Ma	Location *	39.165170 °
Category	Rivers, Channels & Designated Flood		120.147590 °
Item	Vegetation & Obstructions		
DWR ID	DWR_NA0045_13_c_2012_21		
Action/Comments			
Inspector Comments: Minimal, scattered obstructions or vegetation. The flow is not impeded.

Looking upstream from the bike bridge. Summer 2015.

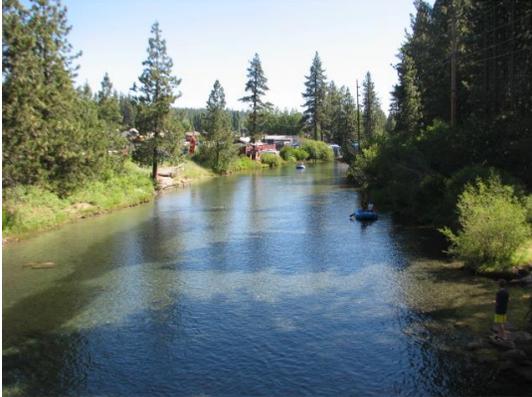
Photo 2 of 2 : CH\_2015\_NA0045\_13\_21\_20150612\_00010.jpg

Looking upstream from the bike bridge. Summer 2014

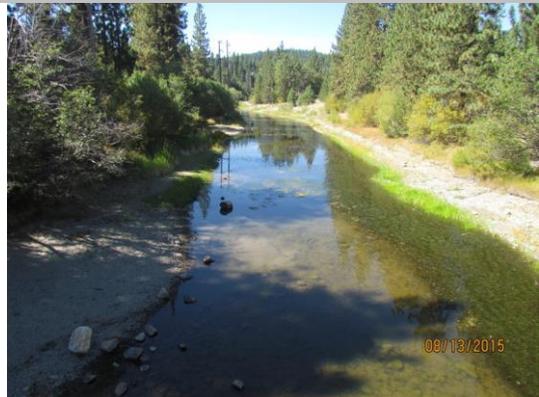
Photo 1 of 2 : CH\_2015\_NA0045\_13\_26\_20150817\_00025.jpg

Check Point / View			
<b>bike bridge / Down</b>			
Rating **	A	Issue No. <b>26</b>	GPS Lat/Long
Issue Type +	Ma	Location *	39.165170 °
Category	Rivers, Channels & Designated Flood		120.147590 °
Item	Vegetation & Obstructions		
DWR ID	DWR_NA0045_13_c_2012_26		
Action/Comments			
Inspector Comments: Minimal, scattered obstructions or vegetation. The flow is not impeded.

Looking downstream from the bike bridge. Summer 2015.

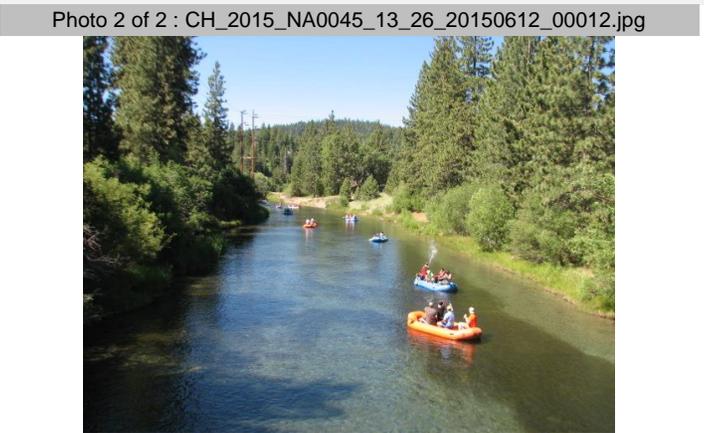
Looking downstream from the bike bridge. Summer 2014

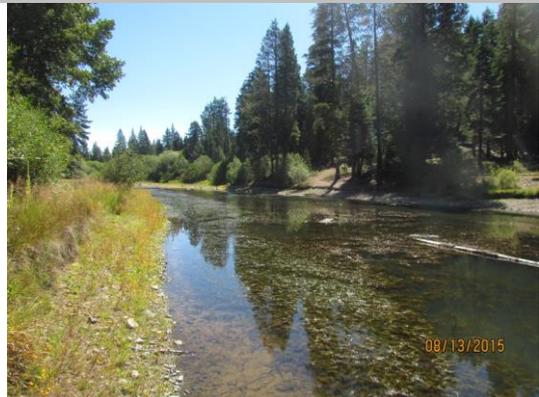
Photo 1 of 3 : CH\_2015\_NA0045\_13\_31\_20150817\_00026.jpg

Check Point / View				
<b>Tahoe City lumber yard / Up</b>				
Rating **	A	Issue No.	31	GPS Lat/Long
Issue Type +	Ma	Location *		39.162480 °
Category	Rivers, Channels & Designated Flood			-120.151900 °
Item	Vegetation & Obstructions			
DWR ID	DWR_NA0045_13_c_2012_31			
Action/Comments				
Inspector Comments: Minimal, scattered obstructions or vegetation. The flow is not impeded.

Looking upstream from Tahoe City Lumber Yard ( 39.162628, - 120.151856). Summer 2015.

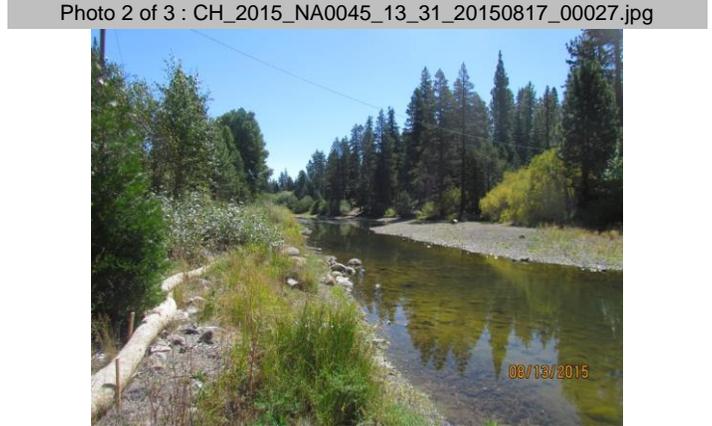
Looking upstream from Tahoe City Lumber Yard ( 39.162634, -120.152646). Summer 2015.

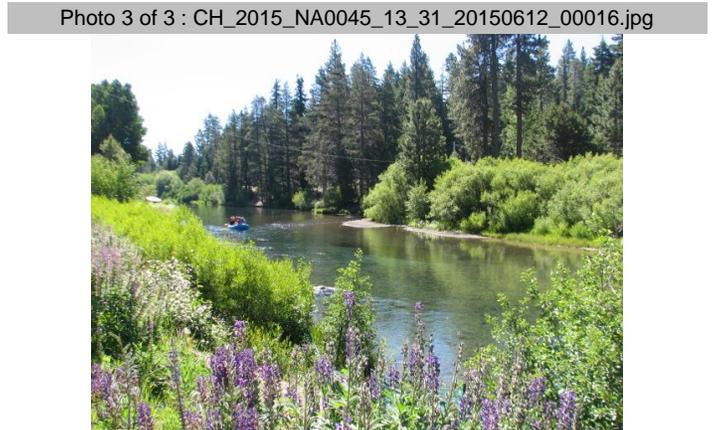
Looking upstream from Tahoe City Lumber Yard. Summer 2014

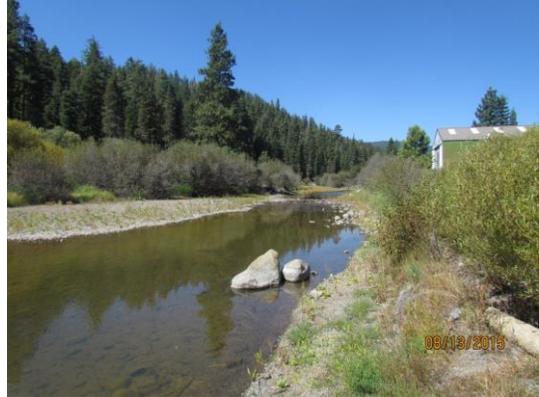
Photo 1 of 3 : CH\_2015\_NA0045\_13\_36\_20150817\_00030.jpg

Check Point / View				
<b>Tahoe City lumber yard / Down</b>				
Rating **	A	Issue No.	<b>36</b>	GPS Lat/Long
Issue Type +	Ma	Location *		39.162480 °
Category	Rivers, Channels & Designated Flood			-120.151900 °
Item	Vegetation & Obstructions			
DWR ID	DWR_NA0045_13_c_2012_36			
Action/Comments				
Inspector Comments: Minimal, scattered obstructions or vegetation. The flow is not impeded.

Alternate view of downstream from Tahoe City Lumber Yard (39.162634, -120.152646). Summer 2015.

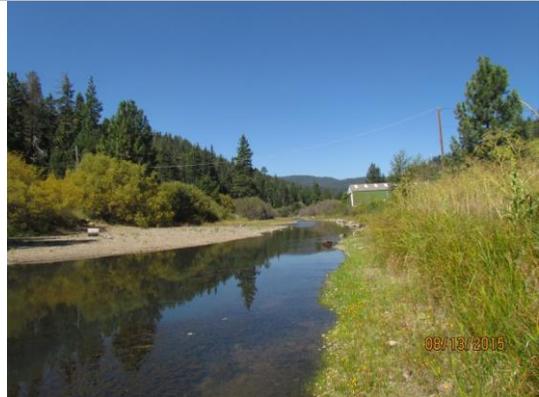
Photo 2 of 3 : CH\_2015\_NA0045\_13\_36\_20150817\_00029.jpg

Looking downstream from Tahoe City Lumber Yard (39.162628, -120.151856). Summer 2015.

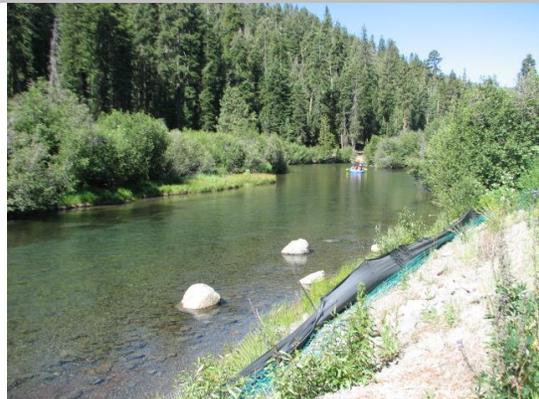
Photo 3 of 3 : CH\_2015\_NA0045\_13\_36\_20150612\_00018.jpg

Looking downstream From Tahoe City Lumber Yard. Summer 2014
