Flood Control Project Maintenance
2010 Structure Summary Report
Overall Unit and Item Ratings

Sacramento County

American River Pumping Plant No. 1 Howe Avenue Storm Drain D - 05

Flood Control Project Maintenance
Unit Cover Sheet
2010 Pumping Plant Inspection Results

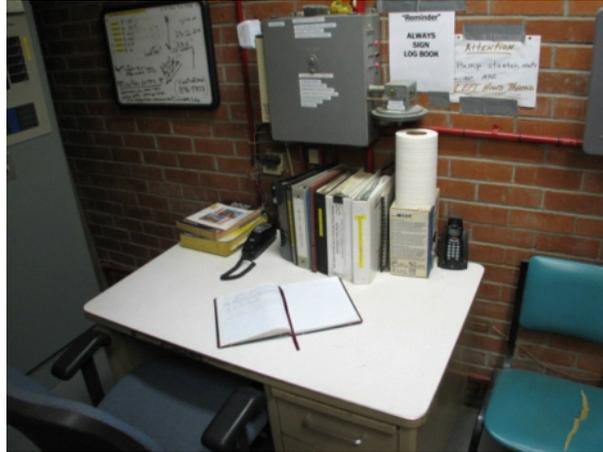
Levee Mile Report Line	2
Start Levee Mile	0.00
End Levee Mile	0.00
Location	
Category	Pump Stations
Item	Operation & Maintenance Manual
Operation and Maintenance manuals for facility are onsite.	
jpaasch_t_20100817_063.jpg

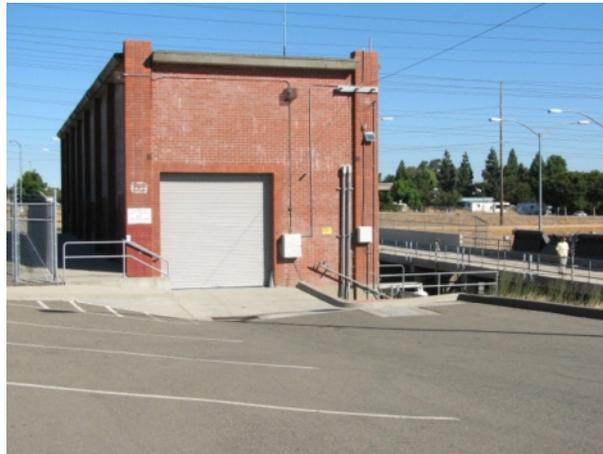
Levee Mile Report Line	3
Start Levee Mile	0.00
End Levee Mile	0.00
Location	
Category	Pump Stations
Item	Plant Building
Photo of pumping plant building.	
jpaasch_t_20100817_064.jpg

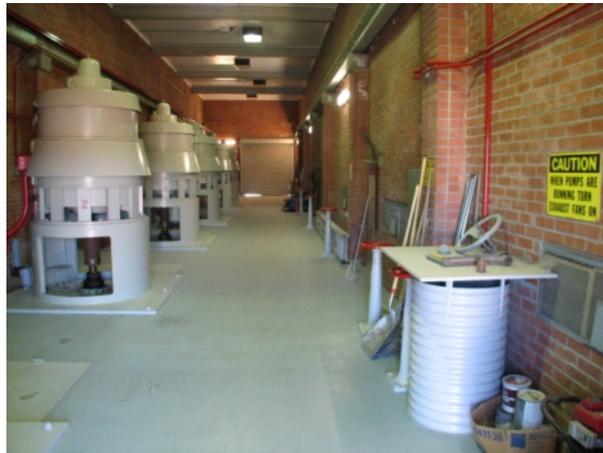
Levee Mile Report Line	7
Start Levee Mile	0.00
End Levee Mile	0.00
Location	
Category	Pump Stations
Item	Pumps
Photo of building interior with five of six pump motors in view.	
jhirabay_t_20100916_074.jpg

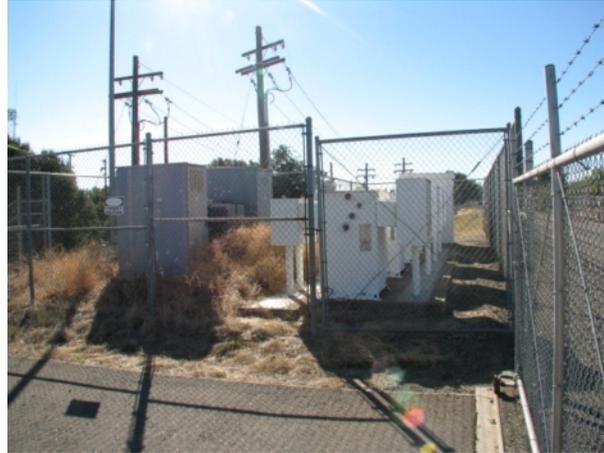
Levee Mile Report Line	8
Start Levee Mile	0.00
End Levee Mile	0.00
Location	
Category	Pump Stations
Item	Power
Photo of commercial power and backup power. Weeds present around transformer pads.	
jpaasch_t_20100817_065.jpg

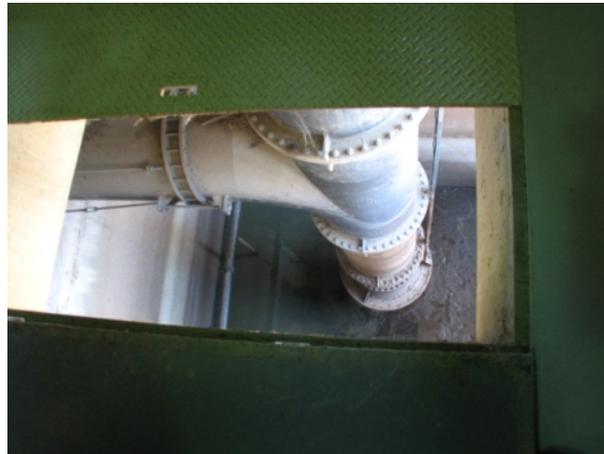
Levee Mile Report Line	11
Start Levee Mile	0.00
End Levee Mile	0.00
Location	
Category	Pump Stations
Item	Sumps/Wet Well
Wet well appears free of obstructive debris.	
jpaasch_t_20100817_067.jpg

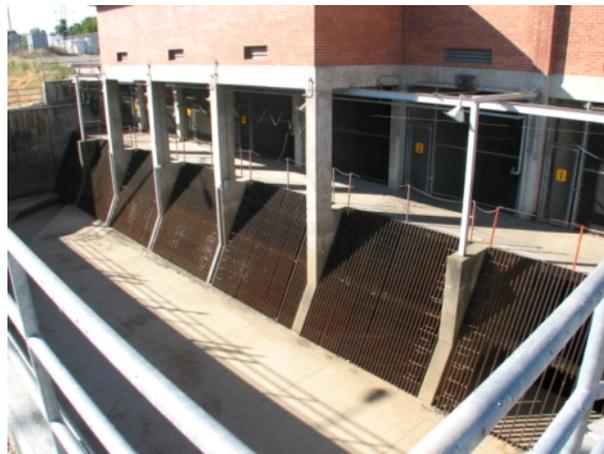
Levee Mile Report Line	11
Start Levee Mile	0.00
End Levee Mile	0.00
Location	
Category	Pump Stations
Item	Sumps/Wet Well
Wet well appears free of obstructive debris. Second set of trash racks prevent debris from entering sump.	
jpaasch_t_20100817_070.jpg

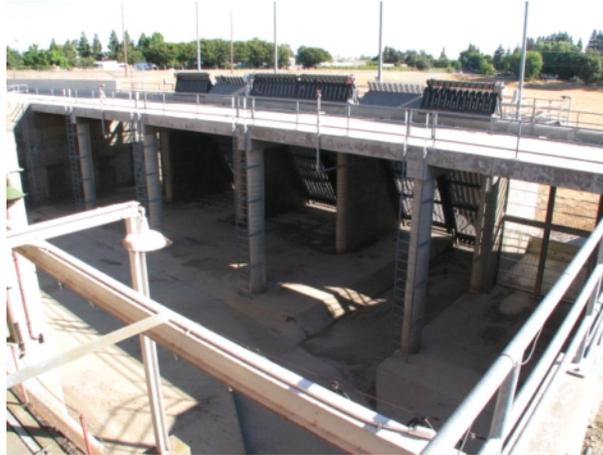
Levee Mile Report Line	12
Start Levee Mile	0.00
End Levee Mile	0.00
Location	
Category	Pump Stations
Item	Trash Racks
Trash racks and rakes are free of debris.	
jpaasch_t_20100817_068.jpg

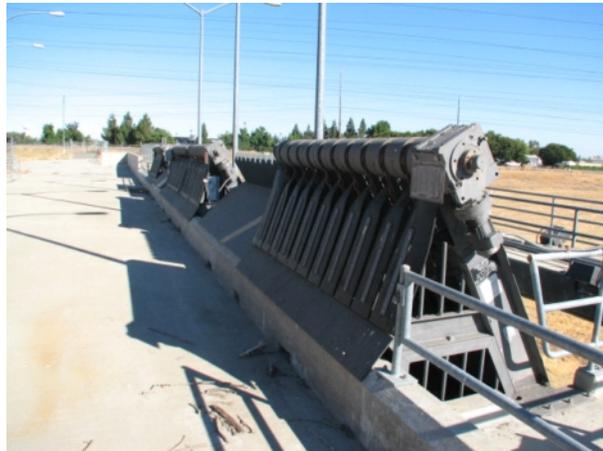
Levee Mile Report Line	13
Start Levee Mile	0.00
End Levee Mile	0.00
Location	
Category	Pump Stations
Item	Trash Rakes
Mechanical trash rakes and controls appear in good working condition.	
jpaasch_t_20100817_069.jpg

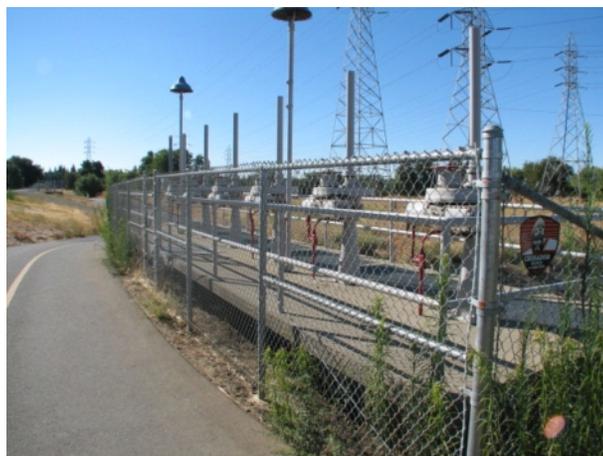
Levee Mile Report Line	16
Start Levee Mile	0.00
End Levee Mile	0.00
Location	
Category	Pump Stations
Item	Manual Gate Operators
Electrical and manual gate operators appear to be in good working condition.	
jpaasch_t_20100817_071.jpg

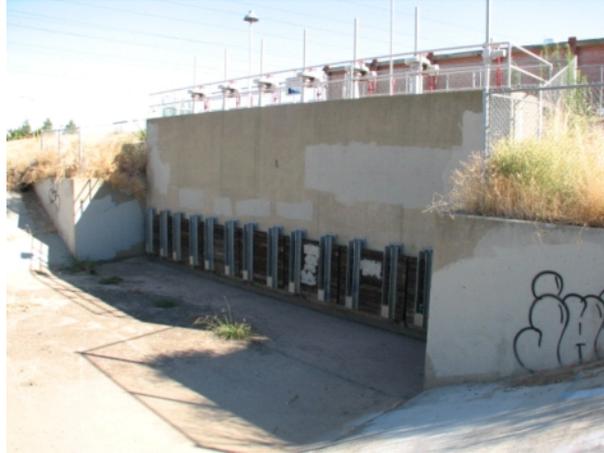
Levee Mile Report Line	18
Start Levee Mile	0.00
End Levee Mile	0.00
Location	
Category	Pump Stations
Item	Flap Gates
Photo of outfall structure, flap gates and gate operators.	
jpaasch_t_20100817_072.jpg

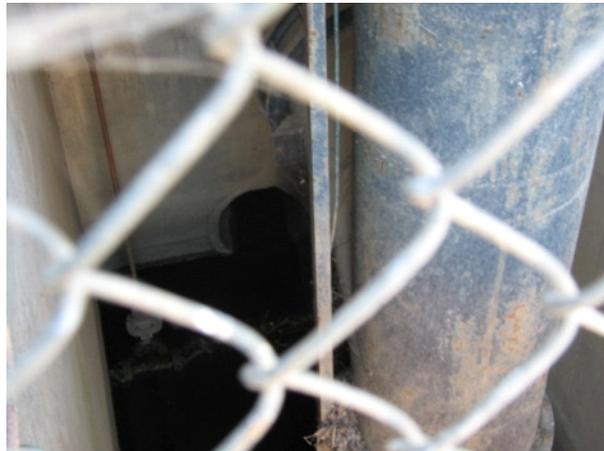
Levee Mile Report Line	22
Start Levee Mile	0.00
End Levee Mile	0.00
Location	
Category	Pump Stations
Item	Pressurized Pipe
Photo looking down into the wet well. Pipe appears to be in good condition.	
jpaasch_t_20100817_073.jpg

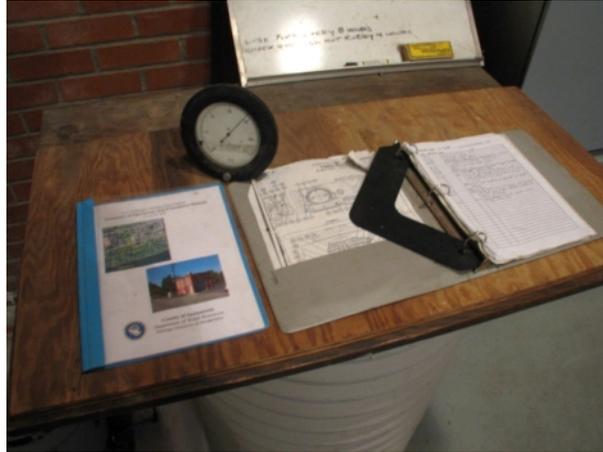
Levee Mile Report Line	2
Start Levee Mile	0.00
End Levee Mile	0.00
Location	
Category	Pump Stations
Item	Operation & Maintenance Manual
Photo of operation manual and maintenance logs.	
jpaasch_t_20100817_074.jpg

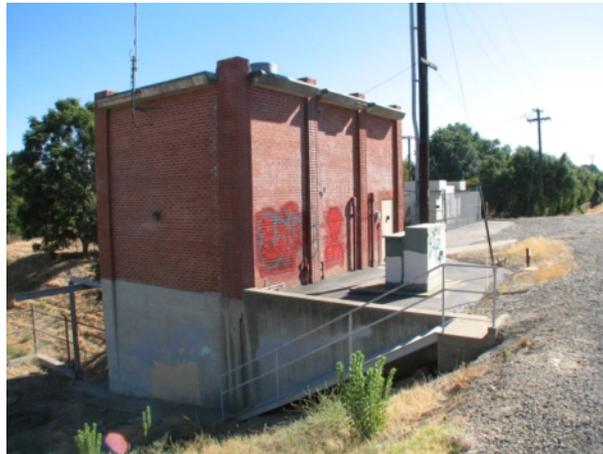
Levee Mile Report Line	3
Start Levee Mile	0.00
End Levee Mile	0.00
Location	
Category	Pump Stations
Item	Plant Building
Photo of pumping plant building.	
jpaasch_t_20100817_075.jpg

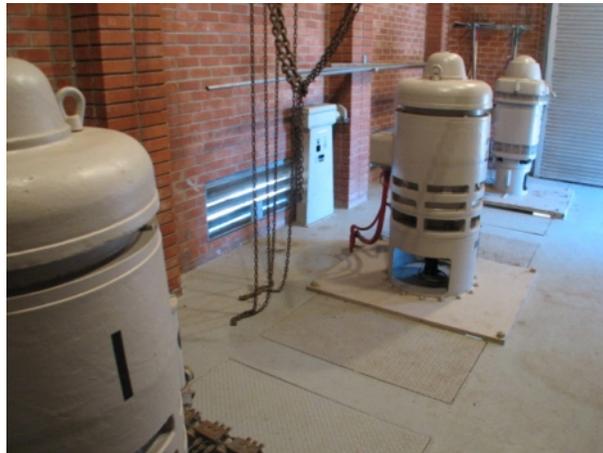
Levee Mile Report Line	7
Start Levee Mile	0.00
End Levee Mile	0.00
Location	
Category	Pump Stations
Item	Pumps
Photo of three pump motors.	
jhirabay_t_20100916_083.jpg

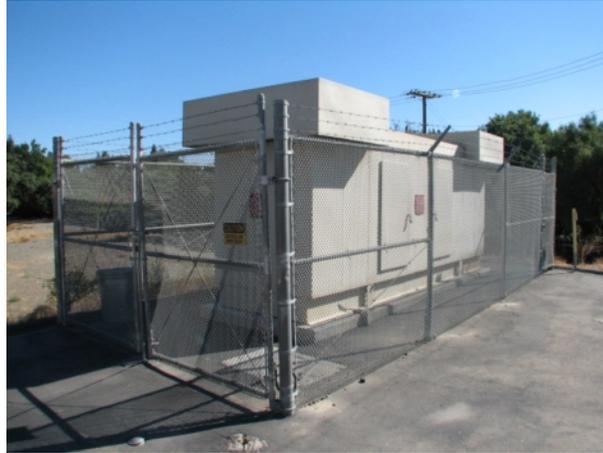
Levee Mile Report Line	8
Start Levee Mile	0.00
End Levee Mile	0.00
Location	
Category	Pump Stations
Item	Power
Photo of generator backup.	
jpaasch_t_20100817_076.jpg

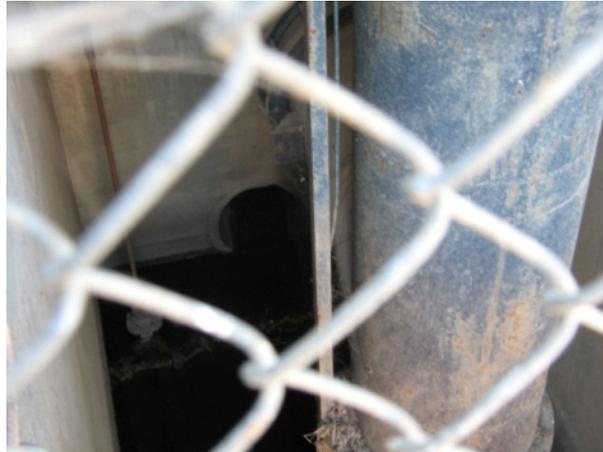
Levee Mile Report Line	11
Start Levee Mile	0.00
End Levee Mile	0.00
Location	
Category	Pump Stations
Item	Sumps/Wet Well
Wet well appears free of debris and sediment.	
jpaasch_t_20100817_078.jpg

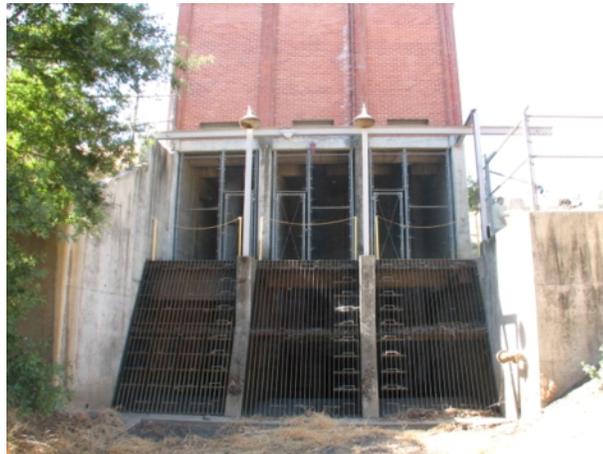
Levee Mile Report Line	12
Start Levee Mile	0.00
End Levee Mile	0.00
Location	
Category	Pump Stations
Item	Trash Racks
Photo of trash racks and exterior of building.	
jpaasch_t_20100817_079.jpg

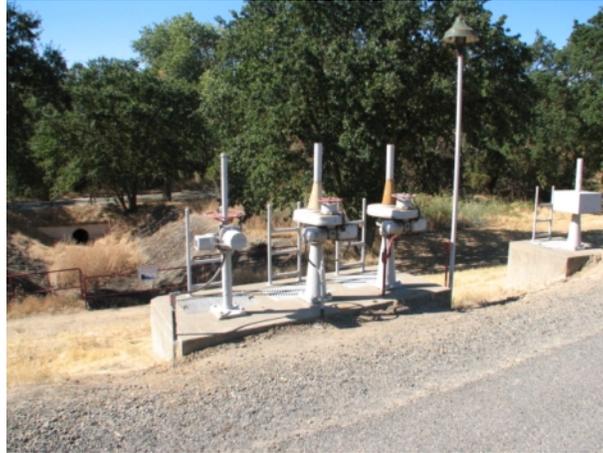
Levee Mile Report Line	15
Start Levee Mile	0.00
End Levee Mile	0.00
Location	
Category	Pump Stations
Item	Electric Gate Operators
Photo of electric and manual gate operators for gates between pumps and the outfall.	
jpaasch_t_20100817_080.jpg

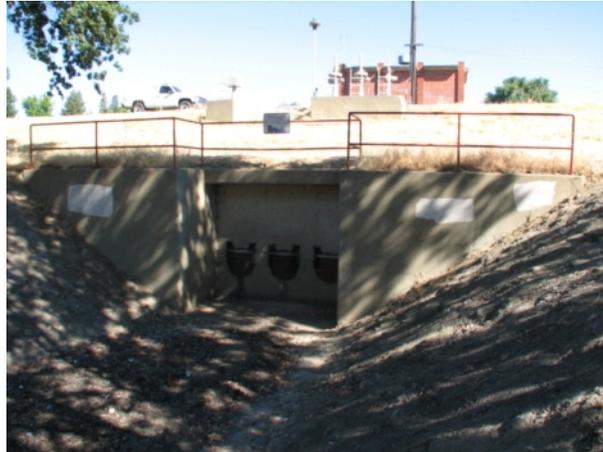
Levee Mile Report Line	18
Start Levee Mile	0.00
End Levee Mile	0.00
Location	
Category	Pump Stations
Item	Flap Gates
Photo of flap gates and the outfall structure.	
jpaasch_t_20100817_081.jpg

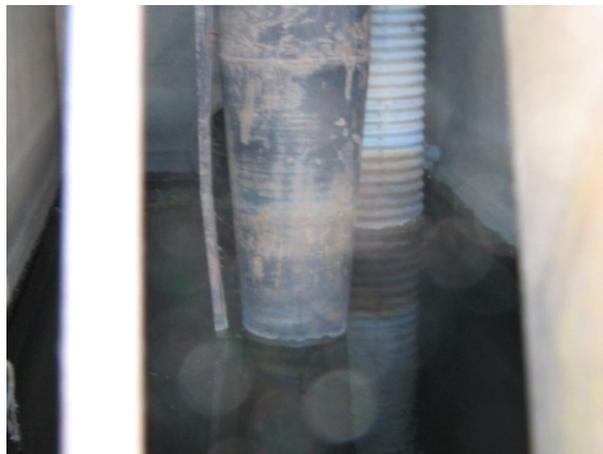
Levee Mile Report Line	22
Start Levee Mile	0.00
End Levee Mile	0.00
Location	
Category	Pump Stations
Item	Pressurized Pipe
Metal pipe appears free of corrosion and leaks.	
jpaasch_t_20100817_082.jpg
