Flood Control Project Maintenance
2014 Structure Summary Report
Overall Unit and Item Ratings

Sacramento County

American River Pumping Plant No. 1 Howe Avenue Storm Drain D - 05

Levee Inspection Report By Mile - Structure 2014

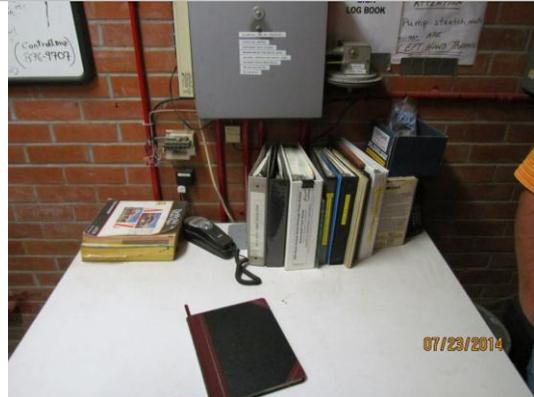
Photo 1 of 1 : ST_2014_NA0050_13_1_20140729_00016.jpg

LM Start	0.00	Rating **	A	Issue No.	1
LM End	0.00	Issue Type +	Ma	Location *	
Category	Pump Stations		GPS Latitude/Longitude		
			Start	End	
Item	Operating Log		38.584600 °	38.584600 °	
			-121.421417 °	-121.421417 °	
DWR ID	DWR_NA0050_13_t_2012_1				
Action/Comments					
Inspector Comments: Maintenance log is present on site at the pump station and is being used and updated.

Photo shows desk with maintenance log and O & M manuals on site.

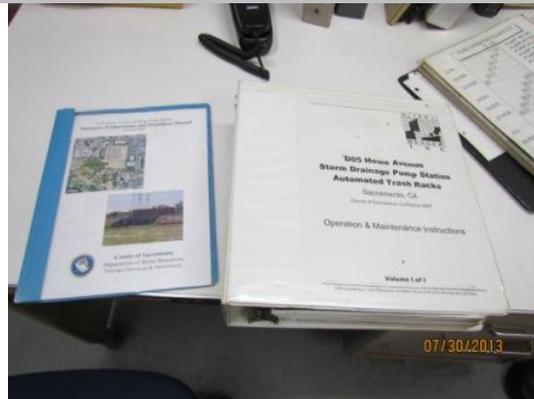
Photo 1 of 1 : ST_2014_NA0050_13_2_20140630_00002.jpg

LM Start	0.00	Rating **	A	Issue No.	2
LM End	0.00	Issue Type +	Ma	Location *	
Category	Pump Stations		GPS Latitude/Longitude		
			Start	End	
Item	Operation & Maintenance Manual		38.584600 °	38.584600 °	
			-121.421417 °	-121.421417 °	
DWR ID	DWR_NA0050_13_t_2012_2				
Action/Comments					
Inspector Comments: O & M manuals are located on site. Stored in same location as Operating Log.

View of the O&M manual.

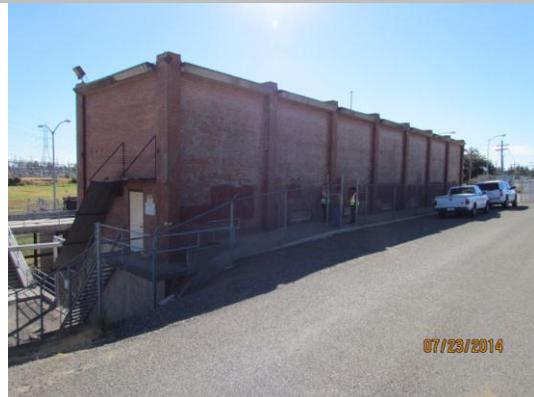
Photo 1 of 2 : ST_2014_NA0050_13_3_20140729_00017.jpg

LM Start	0.00	Rating **	A	Issue No.	3
LM End	0.00	Issue Type +	Ma	Location *	
Category	Pump Stations		GPS Latitude/Longitude		
			Start	End	
Item	Plant Building		38.584600 °	38.584600 °	
			-121.421417 °	-121.421417 °	
DWR ID	DWR_NA0050_13_t_2012_3				
Action/Comments					
Inspector Comments: Plant building appears to be in sound structural condition.

View of the pump building.

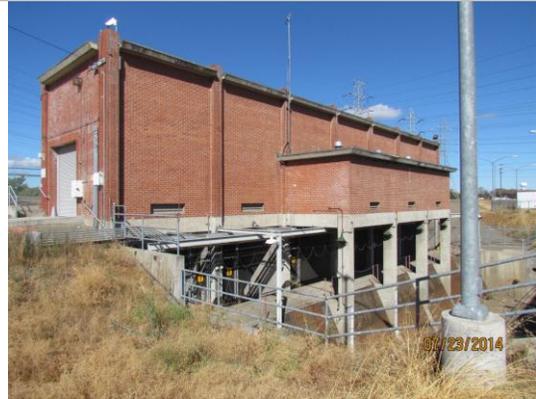
Photo 2 of 2 : ST_2014_NA0050_13_3_20140729_00030.jpg

LM Start	0.00	Rating **	A	Issue No.	3 (cont)
LM End	0.00	Issue Type +	Ma	Location *	
Category	Pump Stations			GPS Latitude/Longitude	
				Start	End
Item	Plant Building			38.584600 °	38.584600 °
				-121.421417 °	-121.421417 °
DWR ID	DWR_NA0050_13_t_2012_3				
Action/Comments					
Inspector Comments: Plant building appears to be in sound structural condition.

Another view of the pump building.

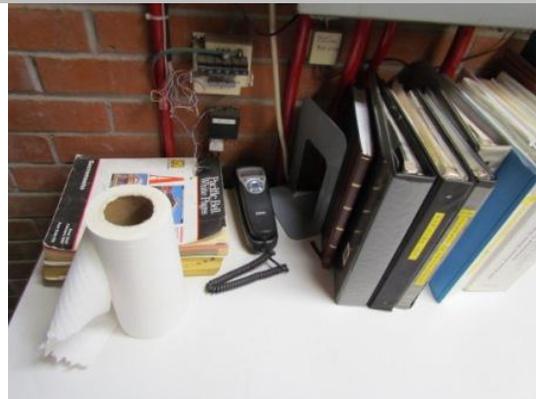
Photo 1 of 1 : ST_2014_NA0050_13_4_20140630_00004.jpg

LM Start	0.00	Rating **	A	Issue No.	4
LM End	0.00	Issue Type +	Ma	Location *	
Category	Pump Stations			GPS Latitude/Longitude	
				Start	End
Item	Communications			38.584600 °	38.584600 °
				-121.421417 °	-121.421417 °
DWR ID	DWR_NA0050_13_t_2012_4				
Action/Comments					
Inspector Comments: Cellular service is available to pump station personnel.

View of the landline telephone on site

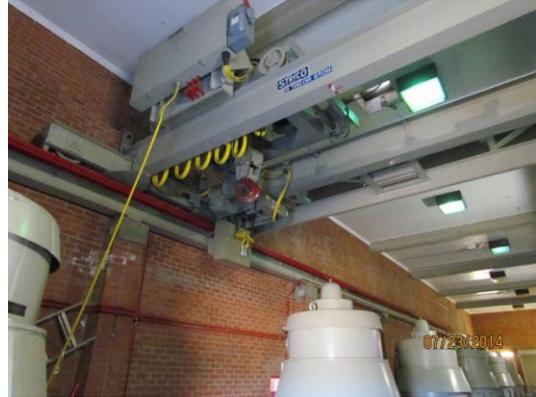
Photo 1 of 1 : ST_2014_NA0050_13_6_20140729_00018.jpg

LM Start	0.00	Rating **	A	Issue No.	6
LM End	0.00	Issue Type +	Ma	Location *	
Category	Pump Stations		GPS Latitude/Longitude		
			Start	End	
Item	Cranes		38.584600 °	38.584600 °	
			-121.421417 °	-121.421417 °	
DWR ID	DWR_NA0050_13_t_2012_6				
Action/Comments					
Inspector Comments: Cranes appear to be in operational condition.

View of the cranes inside the building.

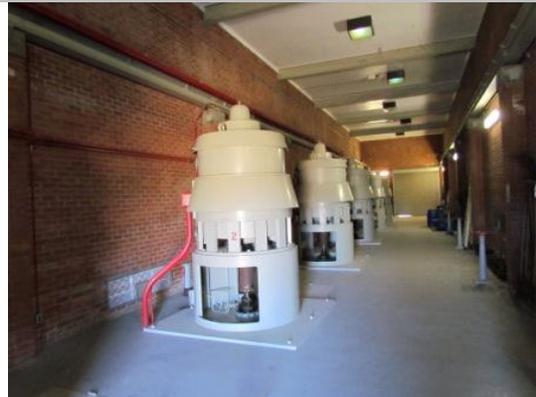
Photo 1 of 1 : ST_2014_NA0050_13_7_20140630_00006.jpg

LM Start	0.00	Rating **	A	Issue No.	7
LM End	0.00	Issue Type +	Ma	Location *	
Category	Pump Stations		GPS Latitude/Longitude		
			Start	End	
Item	Pumps		38.584600 °	38.584600 °	
			-121.421417 °	-121.421417 °	
DWR ID	DWR_NA0050_13_t_2012_7				
Action/Comments					
Inspector Comments: Pumps appear to be properly maintained and in proper working order.

View of the pumps.

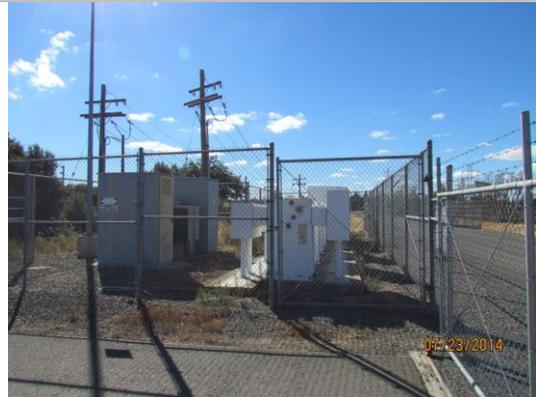
Photo 1 of 1 : ST_2014_NA0050_13_8_20140729_00019.jpg

LM Start	0.00	Rating **	A	Issue No.	8
LM End	0.00	Issue Type +	Ma	Location *	
Category	Pump Stations		GPS Latitude/Longitude		
			Start	End	
Item	Power		38.584600 °	38.584600 °	
			-121.421417 °	-121.421417 °	
DWR ID	DWR_NA0050_13_t_2012_8				
Action/Comments					
Inspector Comments: Backup generators are on site.

Photo shows security fencing and power source.

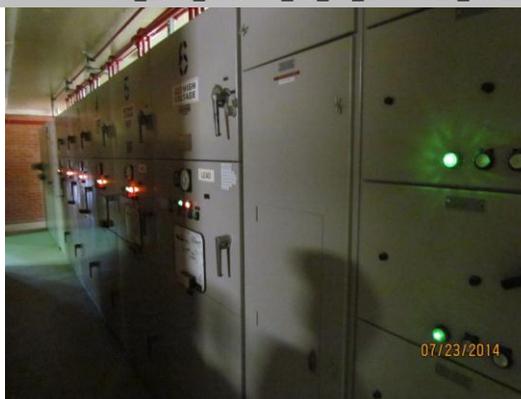
Photo 1 of 1 : ST_2014_NA0050_13_11_20140729_00020.jpg

View of the pump control panel.

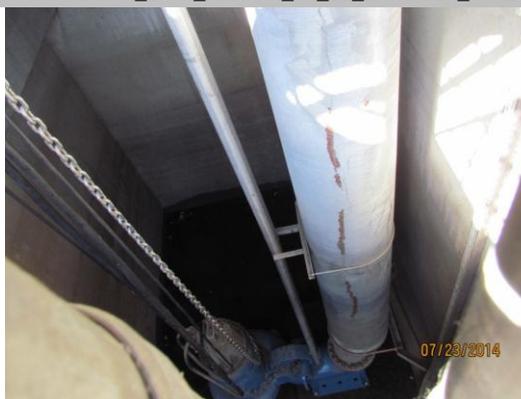
Photo 1 of 2 : ST_2014_NA0050_13_12_20140729_00021.jpg

LM Start	0.00	Rating **	A	Issue No.	12
LM End	0.00	Issue Type +	Ma	Location *	
Category	Pump Stations			GPS Latitude/Longitude	
				Start	End
Item	Sumps/Wet Well			38.584600 °	38.584600 °
				-121.421417 °	-121.421417 °
DWR ID	DWR_NA0050_13_t_2012_12				
Action/Comments					
Inspector Comments: Sumps and wet wells are free of sediment and debris.

View of the well with adjustable pump height.

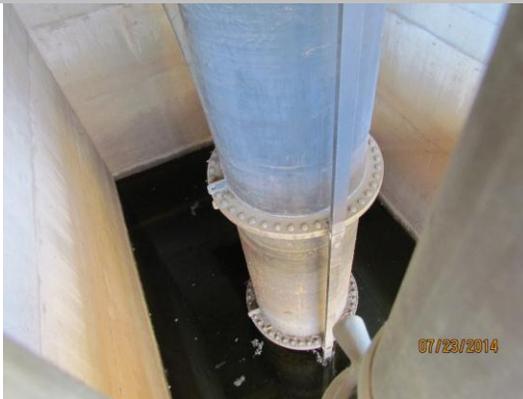
Photo 2 of 2 : ST_2014_NA0050_13_12_20140729_00022.jpg

Typical view of the wet well.

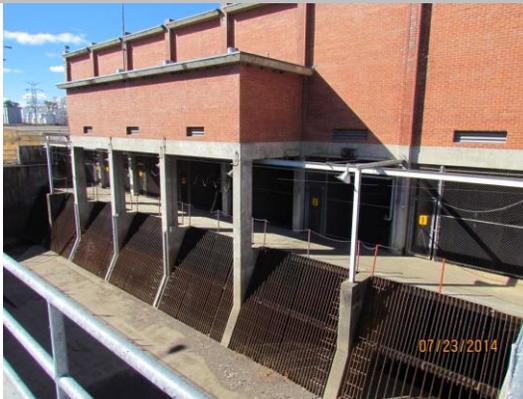
Photo 1 of 2 : ST_2014_NA0050_13_13_20140729_00023.jpg

LM Start	0.00	Rating **	A	Issue No.	13
LM End	0.00	Issue Type +	Ma	Location *	
Category	Pump Stations			GPS Latitude/Longitude	
				Start	End
Item	Trash Racks			38.584600 °	38.584600 °
				-121.421417 °	-121.421417 °
DWR ID	DWR_NA0050_13_t_2012_13				
Action/Comments					
Inspector Comments: Trash racks are in place, properly maintained and clear of any debris.

View of the trash racks protecting the wells.

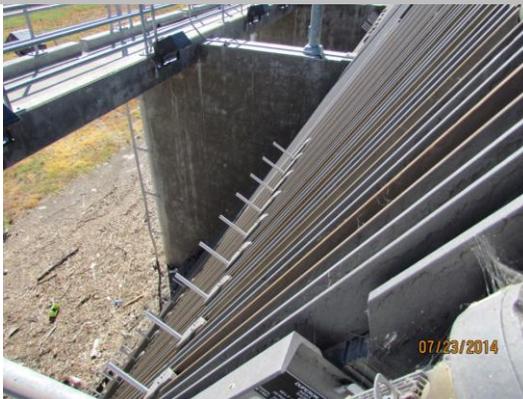
Photo 2 of 2 : ST_2014_NA0050_13_13_20140729_00024.jpg

View of the trash racks and rakes.

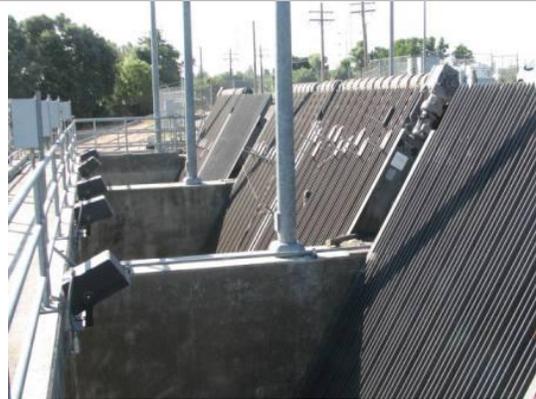
Photo 1 of 2 : ST_2014_NA0050_13_14_20140630_00011.jpg

Extended photo of trash rakes.

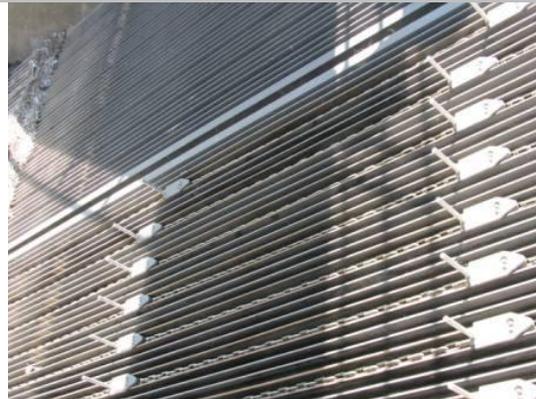
Photo 2 of 2 : ST_2014_NA0050_13_14_20140630_00012.jpg

Close up photo of trash rake, note cleanliness and free of debris.

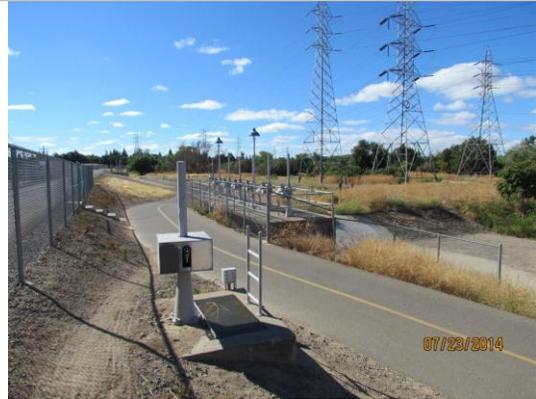
Photo 1 of 1 : ST_2014_NA0050_13_16_20140729_00025.jpg

LM Start	0.00	Rating **	A	Issue No.	16
LM End	0.00	Issue Type +	Ma	Location *	
Category	Pump Stations		GPS Latitude/Longitude		
			Start	End	
Item	Electric Gate Operators		38.584600 °	38.584600 °	
			-121.421417 °	-121.421417 °	
DWR ID	DWR_NA0050_13_t_2012_16				
Action/Comments					
Inspector Comments: Electric gate operators appear to be in proper operating condition.

View of the gate operators

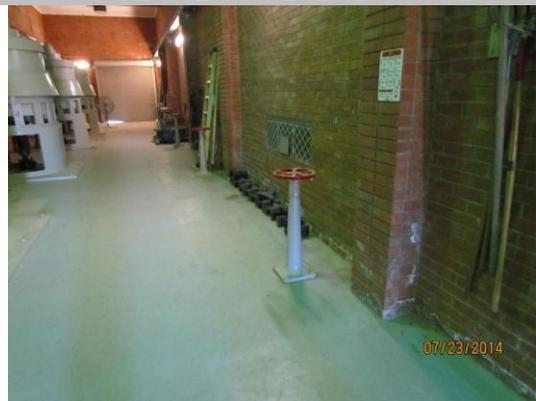
Photo 1 of 1 : ST_2014_NA0050_13_17_20140729_00026.jpg

LM Start	0.00	Rating **	A	Issue No.	17
LM End	0.00	Issue Type +	Ma	Location *	
Category	Pump Stations		GPS Latitude/Longitude		
			Start	End	
Item	Manual Gate Operators		38.584600 °	38.584600 °	
			-121.421417 °	-121.421417 °	
DWR ID	DWR_NA0050_13_t_2012_17				
Action/Comments					
Inspector Comments: Manual gate operators appear to be in good working condition.

View of the manual gate operator.

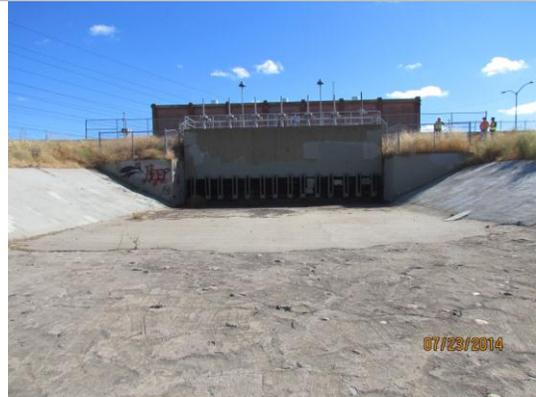
Photo 1 of 2 : ST_2014_NA0050_13_19_20140729_00027.jpg

View of the flap gates on the waterside.

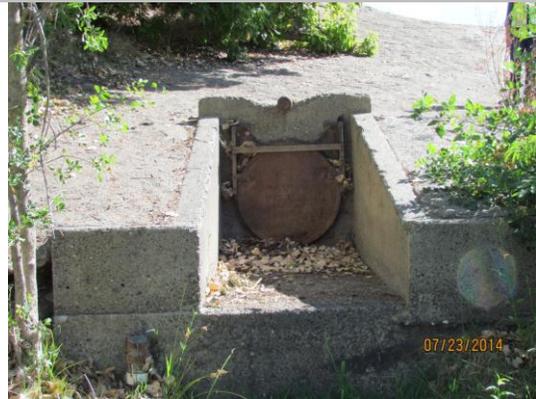
Photo 2 of 2 : ST_2014_NA0050_13_19_20140729_00028.jpg

View of the low flow flap gate.

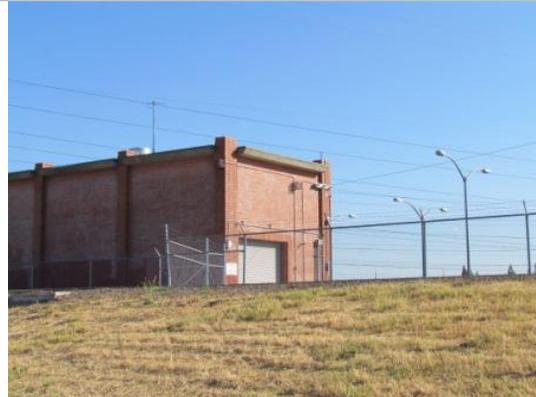
Photo 1 of 2 : ST_2014_NA0050_13_21_20140630_00015.jpg

View of the security fencing around the pumping facility.

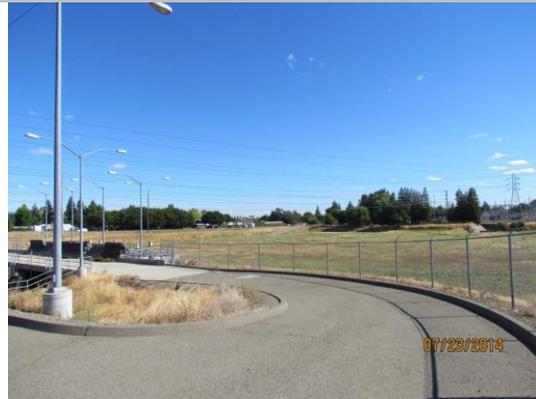
Photo 2 of 2 : ST_2014_NA0050_13_21_20140729_00029.jpg

View of the security fencing.

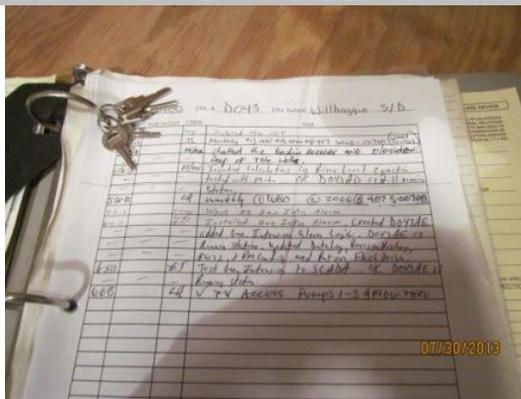
Photo 1 of 1 : ST_2014_NA0050_14_1_20140630_00001.jpg

Photo shows operating log on site.

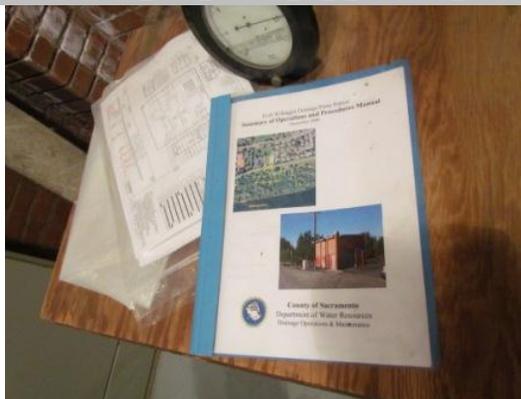
Photo 1 of 1 : ST_2014_NA0050_14_2_20140630_00002.jpg

LM Start	0.00	Rating **	A	Issue No.	2
LM End	0.00	Issue Type +	Ma	Location *	
Category	Pump Stations		GPS Latitude/Longitude		
			Start	End	
Item	Operation & Maintenance Manual		38.584904 °	38.584904 °	
			-121.421534 °	-121.421534 °	
DWR ID	DWR_NA0050_14_t_2012_2				
Action/Comments					
Inspector Comments: O & M Manual is kept on site, posted instructions are also written on dry erase board.

Photo shows O&M manual on site.

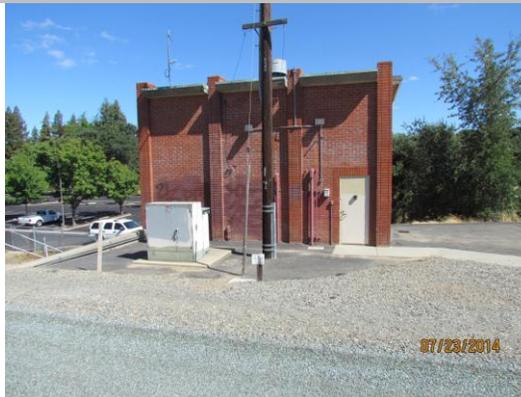
Photo 1 of 1 : ST_2014_NA0050_14_3_20140729_00013.jpg

LM Start	0.00	Rating **	A	Issue No.	3
LM End	0.00	Issue Type +	Ma	Location *	
Category	Pump Stations		GPS Latitude/Longitude		
			Start	End	
Item	Plant Building		38.584904 °	38.584904 °	
			-121.421534 °	-121.421534 °	
DWR ID	DWR_NA0050_14_t_2012_3				
Action/Comments					
Inspector Comments: Building appears to be in sound structural condition.

View of the pumping plant building.

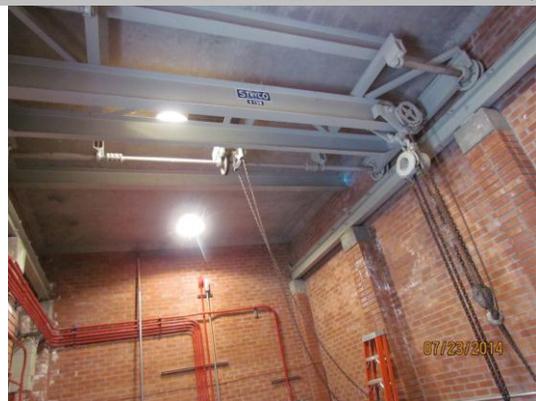
Photo 1 of 1 : ST_2014_NA0050_14_6_20140729_00011.jpg

LM Start	0.00	Rating **	A	Issue No.	6
LM End	0.00	Issue Type +	Ma	Location *	
Category	Pump Stations		GPS Latitude/Longitude		
			Start	End	
Item	Cranes		38.584904 °	38.584904 °	
			-121.421534 °	-121.421534 °	
DWR ID	DWR_NA0050_14_t_2012_6				
Action/Comments					
Inspector Comments: Crane appears to be in good working condition.

View of the crane above the pumps inside the building.

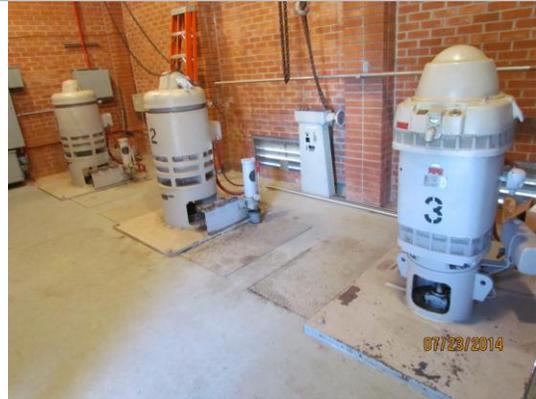
Photo 1 of 1 : ST_2014_NA0050_14_7_20140729_00012.jpg

View of the pump motors.

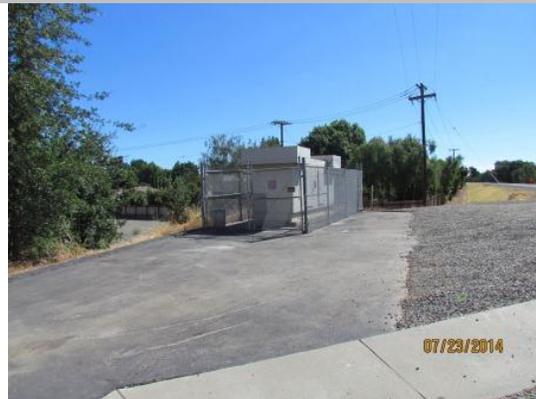
Photo 1 of 1 : ST_2014_NA0050_14_8_20140729_00015.jpg

LM Start	0.00	Rating **	A	Issue No.	8
LM End	0.00	Issue Type +	Ma	Location *	
Category	Pump Stations		GPS Latitude/Longitude		
			Start	End	
Item	Power		38.584904 °	38.584904 °	
			-121.421534 °	-121.421534 °	
DWR ID	DWR_NA0050_14_t_2012_8				
Action/Comments					
Inspector Comments: No visible deficiencies, backup generator is on site.

View of the backup generator.

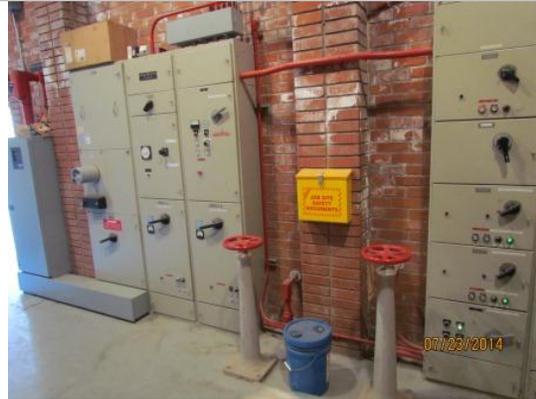
Photo 1 of 1 : ST_2014_NA0050_14_11_20140729_00016.jpg

LM Start	0.00	Rating **	A	Issue No.	11
LM End	0.00	Issue Type +	Ma	Location *	
Category	Pump Stations		GPS Latitude/Longitude		
			Start	End	
Item	Pump Control Systems		38.584904 °	38.584904 °	
			-121.421534 °	-121.421534 °	
DWR ID	DWR_NA0050_14_t_2012_11				
Action/Comments					
Inspector Comments: Controls appear well maintained and free of corrosion.

View of the pump controls panel.

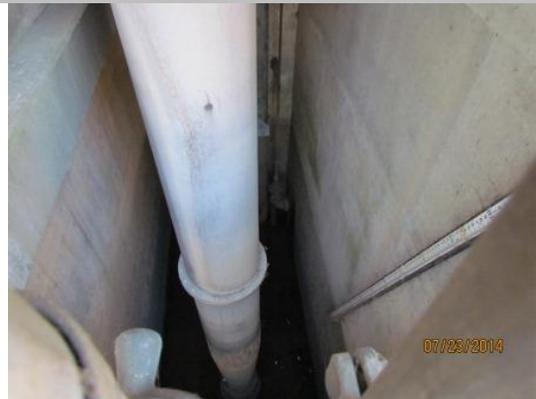
Photo 1 of 1 : ST_2014_NA0050_14_12_20140729_00017.jpg

LM Start	0.00	Rating **	A	Issue No.	12
LM End	0.00	Issue Type +	Ma	Location *	
Category	Pump Stations		GPS Latitude/Longitude		
			Start	End	
Item	Sumps/Wet Well		38.584904 °	38.584904 °	
			-121.421534 °	-121.421534 °	
DWR ID	DWR_NA0050_14_t_2012_12				
Action/Comments					
Inspector Comments: Wet well is clear of debris.

View of the wet well.

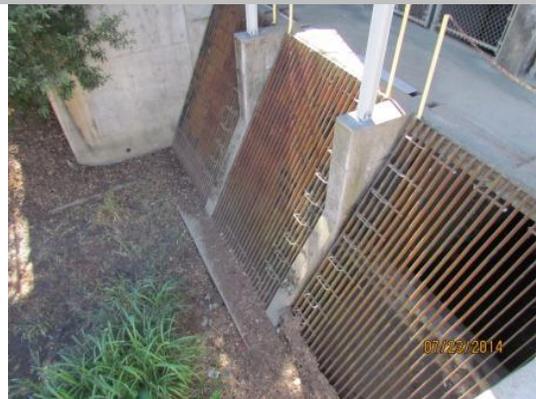
Photo 1 of 1 : ST_2014_NA0050_14_13_20140729_00018.jpg

LM Start	0.00	Rating **	A	Issue No.	13
LM End	0.00	Issue Type +	Ma	Location *	
Category	Pump Stations		GPS Latitude/Longitude		
			Start	End	
Item	Trash Racks		38.584904 °	38.584904 °	
			-121.421534 °	-121.421534 °	
DWR ID	DWR_NA0050_14_t_2012_13				
Action/Comments					
Inspector Comments: Trash rack is in place and free of debris.

Photo shows properly maintained trash rack free of debris.

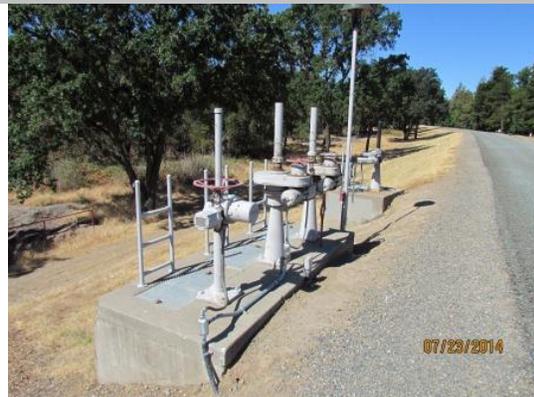
Photo 1 of 1 : ST_2014_NA0050_14_16_20140729_00019.jpg

View of the gate controls.

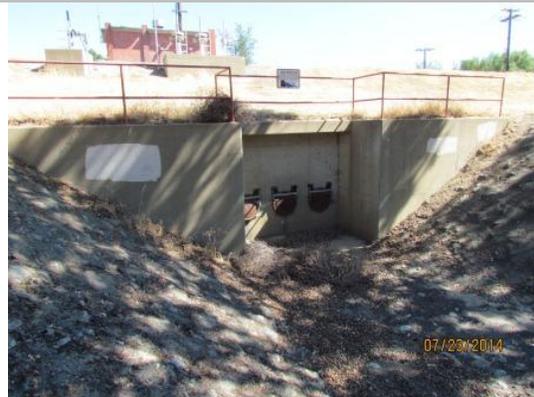
Photo 1 of 1 : ST_2014_NA0050_14_19_20140729_00020.jpg

LM Start	0.00	Rating **	A	Issue No.	19
LM End	0.00	Issue Type +	Ma	Location *	
Category	Pump Stations		GPS Latitude/Longitude		
			Start	End	
Item	Flap Gates		38.584904 °	38.584904 °	
			-121.421534 °	-121.421534 °	
DWR ID	DWR_NA0050_14_t_2012_19				
Action/Comments					
Inspector Comments: Flap gates are visible and appear to be in working order, there was no flow to test for leakage.

View of the flap gates.

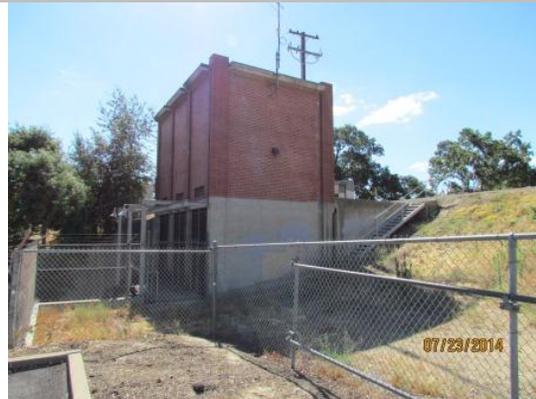
Photo 1 of 1 : ST_2014_NA0050_14_21_20140729_00021.jpg

View of the security fencing.

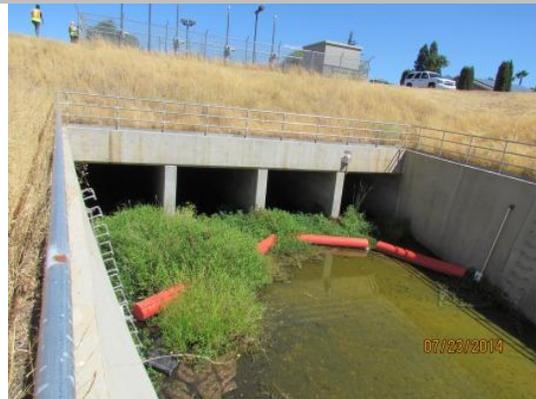
Photo 1 of 1 : ST_2014_NA0050_220_7_20140805_00001.jpg

View of the structure inlet.

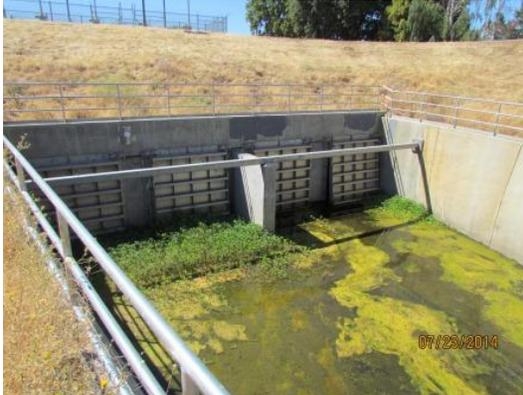
Photo 1 of 3 : ST_2014_NA0050_220_11_20140805_00002.jpg

View of the flap gates. Counting from right to left, first and third flap gates were partially open due to lodged debris.

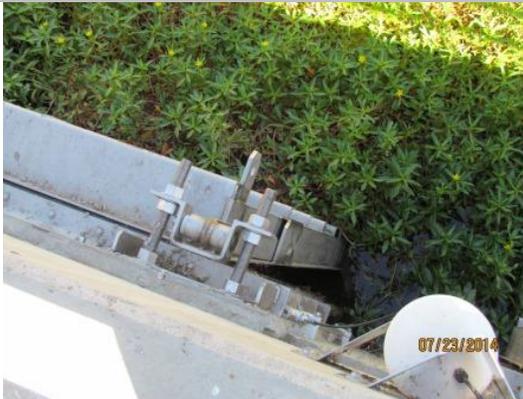
Photo 2 of 3 : ST_2014_NA0050_220_11_20140805_00003.jpg

View of the third flap gate partially propped open by debris.

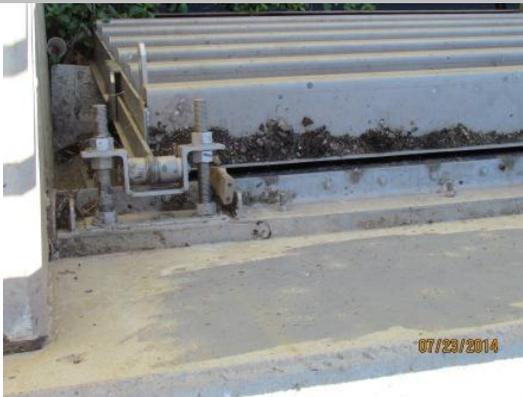
Photo 3 of 3 : ST_2014_NA0050_220_11_20140805_00004.jpg

View of the first flap gate partially propped open by debris.

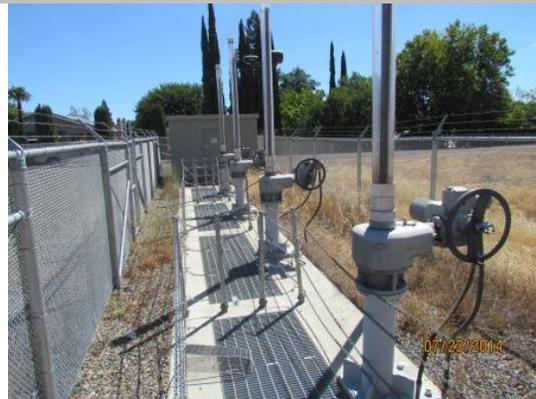
Photo 1 of 1 : ST_2014_NA0050_220_13_20140805_00005.jpg

LM Start	0.00	Rating **	A	Issue No.	13
LM End	0.00	Issue Type +	Ma	Location *	
Category	Structures & Concrete Lined Channels		GPS Latitude/Longitude		
			Start	End	
Item	Electric Gate Operators		38.569898 °	38.569898 °	
			-121.353360 °	-121.353360 °	
DWR ID	DWR_NA0050_220_t_2014_13				
Action/Comments					
Inspector Comments: Electric gate operators appear to be in working condition with manual controls installed.

View of the gate mechanism controls.

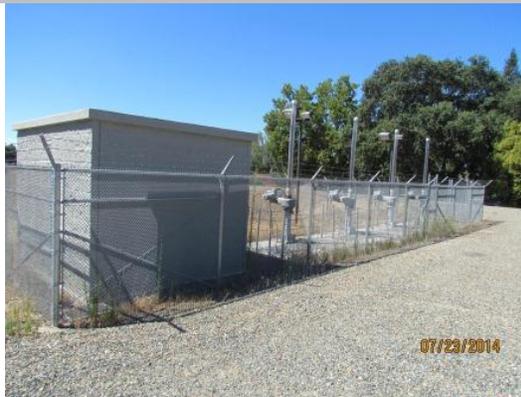
Photo 1 of 1 : ST_2014_NA0050_220_18_20140805_00006.jpg

View of the security fencing around the facility.
