**Flood Control Project Maintenance**  
**2015 Structure Summary Report**  
**Overall Unit and Item Ratings**

**American River Pumping Plant No. 1 Howe Avenue Storm Drain D - 05**

**Flood Control Project Maintenance**  
**Unit Cover Sheet**  
**2015 Pumping Plant Inspection Results**

**Levee Inspection Report By Mile - Structure 2015**

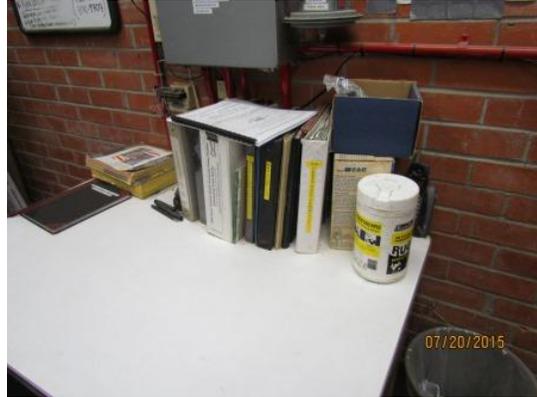
Photo 1 of 1 : ST\_2015\_NA0050\_13\_1\_20150731\_00022.jpg

Photo shows desk with maintenance log and O & M manuals on site.

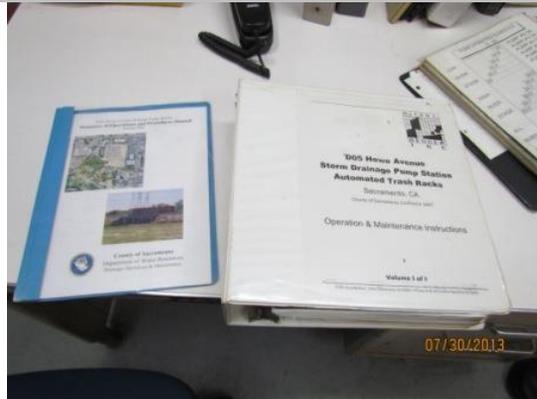
Photo 1 of 1 : ST\_2015\_NA0050\_13\_2\_20150709\_00002.jpg

LM Start	<b>0.00</b>	Rating **	A	Issue No.	<b>2</b>
LM End	<b>0.00</b>	Issue Type +	Ma	Location *	
Category	Pump Stations		GPS Latitude/Longitude		
			Start	End	
Item	Operation & Maintenance Manual		38.584600 °	38.584600 °	
			-121.421417 °	-121.421417 °	
DWR ID	DWR_NA0050_13_t_2012_2				
Action/Comments					
Inspector Comments: O & M manuals are located on site. Stored in same location as Operating Log.

View of the O&M manual.

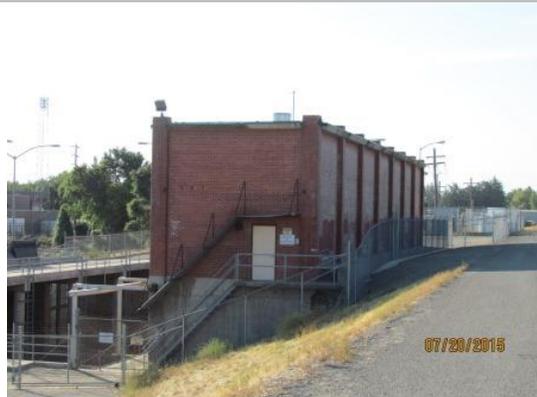
Photo 1 of 2 : ST\_2015\_NA0050\_13\_3\_20150731\_00023.jpg

LM Start	<b>0.00</b>	Rating **	A	Issue No.	<b>3</b>
LM End	<b>0.00</b>	Issue Type +	Ma	Location *	
Category	Pump Stations		GPS Latitude/Longitude		
			Start	End	
Item	Plant Building		38.584600 °	38.584600 °	
			-121.421417 °	-121.421417 °	
DWR ID	DWR_NA0050_13_t_2012_3				
Action/Comments					
Inspector Comments: Plant building appears to be in sound structural condition.

View of the pump building.

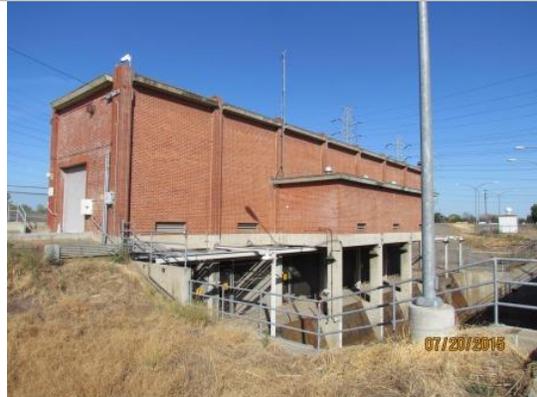
Photo 2 of 2 : ST\_2015\_NA0050\_13\_3\_20150731\_00024.jpg

LM Start	<b>0.00</b>	Rating **	A	Issue No.	<b>3 (cont)</b>
LM End	<b>0.00</b>	Issue Type +	Ma	Location *	
Category	Pump Stations		GPS Latitude/Longitude		
			Start	End	
Item	Plant Building		38.584600 °	38.584600 °	
			-121.421417 °	-121.421417 °	
DWR ID	DWR_NA0050_13_t_2012_3				
Action/Comments					
Inspector Comments: Plant building appears to be in sound structural condition.

Another view of the pump building.

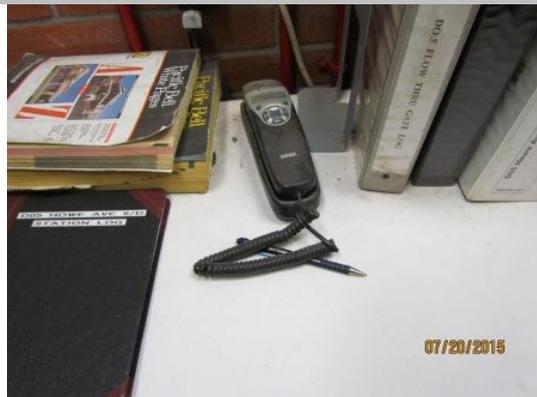
Photo 1 of 1 : ST\_2015\_NA0050\_13\_4\_20150731\_00025.jpg

LM Start	<b>0.00</b>	Rating **	A	Issue No.	<b>4</b>
LM End	<b>0.00</b>	Issue Type +	Ma	Location *	
Category	Pump Stations		GPS Latitude/Longitude		
			Start	End	
Item	Communications		38.584600 °	38.584600 °	
			-121.421417 °	-121.421417 °	
DWR ID	DWR_NA0050_13_t_2012_4				
Action/Comments					
Inspector Comments: Cellular service is available to pump station personnel.

View of the landline telephone on site.

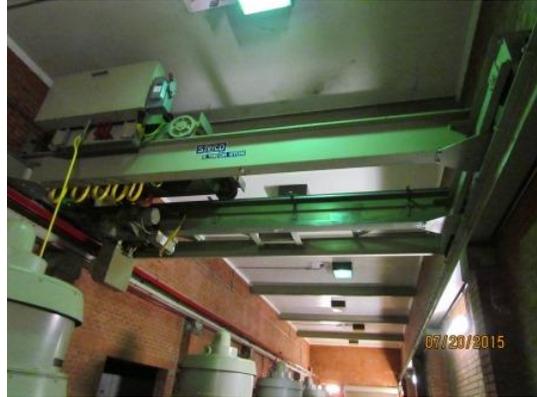
Photo 1 of 1 : ST\_2015\_NA0050\_13\_6\_20150731\_00026.jpg

LM Start	<b>0.00</b>	Rating **	A	Issue No.	<b>6</b>
LM End	<b>0.00</b>	Issue Type +	Ma	Location *	
Category	Pump Stations		GPS Latitude/Longitude		
			Start	End	
Item	Cranes		38.584600 °	38.584600 °	
			-121.421417 °	-121.421417 °	
DWR ID	DWR_NA0050_13_t_2012_6				
Action/Comments					
Inspector Comments: Cranes appear to be in operational condition.

View of the cranes inside the building.

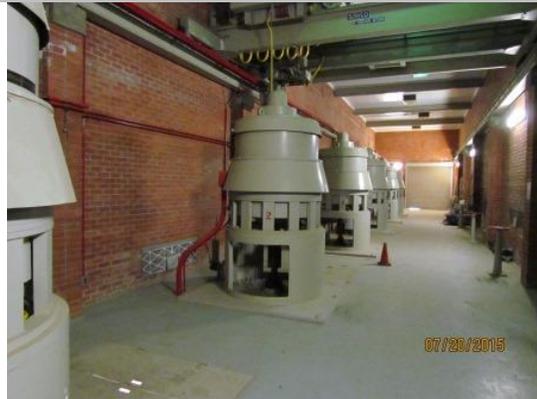
Photo 1 of 1 : ST\_2015\_NA0050\_13\_7\_20150731\_00027.jpg

LM Start	<b>0.00</b>	Rating **	A	Issue No.	<b>7</b>
LM End	<b>0.00</b>	Issue Type +	Ma	Location *	
Category	Pump Stations		GPS Latitude/Longitude		
			Start	End	
Item	Pumps		38.584600 °	38.584600 °	
			-121.421417 °	-121.421417 °	
DWR ID	DWR_NA0050_13_t_2012_7				
Action/Comments					
Inspector Comments: Pumps appear to be properly maintained and in proper working order.

View of the pump motors.

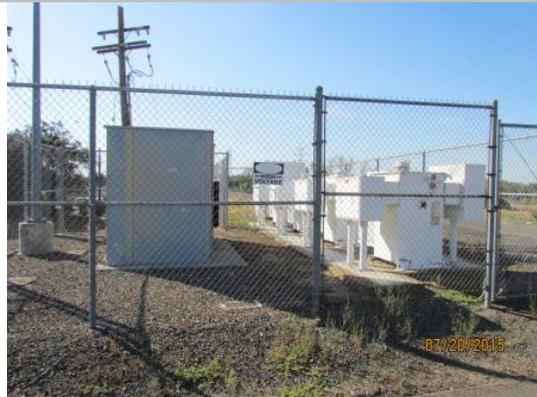
Photo 1 of 1 : ST\_2015\_NA0050\_13\_8\_20150731\_00028.jpg

LM Start	<b>0.00</b>	Rating **	A	Issue No.	<b>8</b>
LM End	<b>0.00</b>	Issue Type +	Ma	Location *	
Category	Pump Stations		GPS Latitude/Longitude		
			Start	End	
Item	Power		38.584600 °	38.584600 °	
			-121.421417 °	-121.421417 °	
DWR ID	DWR_NA0050_13_t_2012_8				
Action/Comments					
Inspector Comments: Backup power generator is shared with the wastewater facility.

Photo shows security fencing and power source.

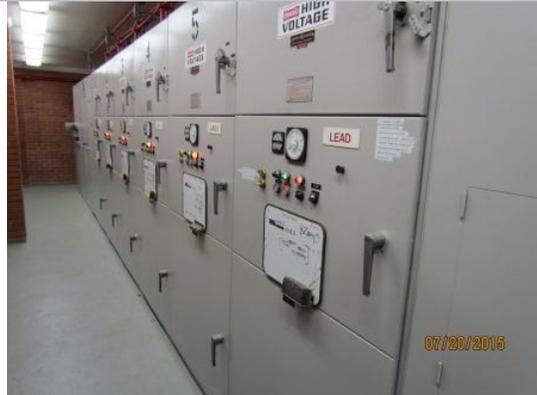
Photo 1 of 2 : ST\_2015\_NA0050\_13\_11\_20150731\_00029.jpg

View of the pump manual pump switches.

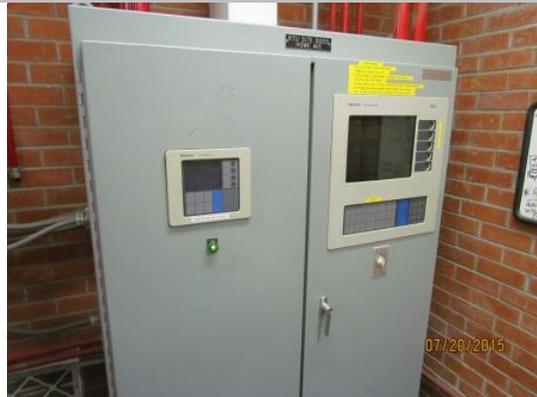
Photo 2 of 2 : ST\_2015\_NA0050\_13\_11\_20150731\_00030.jpg

View of the pump control panel.

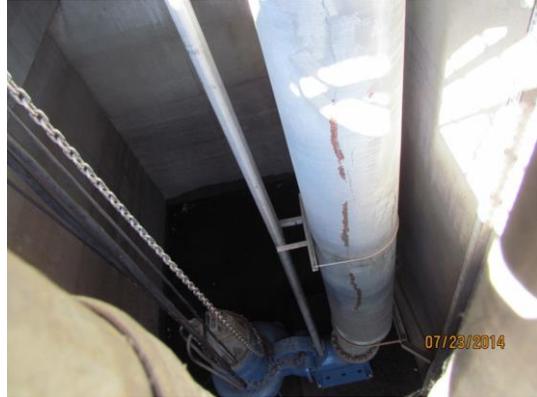
Photo 1 of 2 : ST\_2015\_NA0050\_13\_12\_20150709\_00010.jpg

View of the well with adjustable pump height.

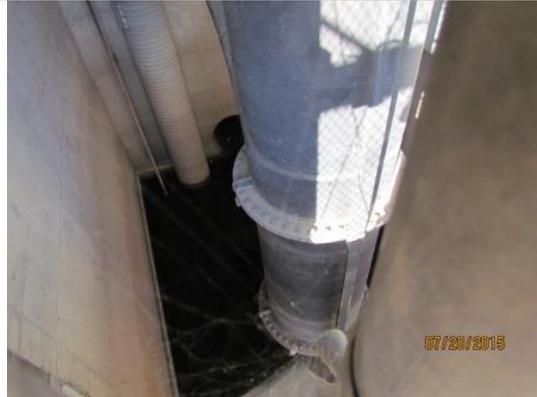
Photo 2 of 2 : ST\_2015\_NA0050\_13\_12\_20150731\_00031.jpg

Typical view of the wet well.

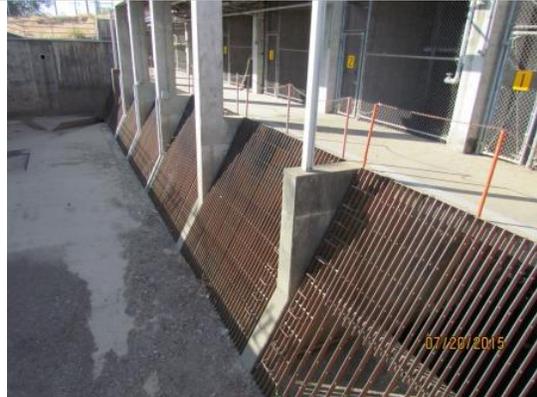
Photo 1 of 2 : ST\_2015\_NA0050\_13\_13\_20150731\_00032.jpg

LM Start	<b>0.00</b>	Rating **	A	Issue No.	<b>13</b>
LM End	<b>0.00</b>	Issue Type +	Ma	Location *	
Category	Pump Stations			GPS Latitude/Longitude	
				Start	End
Item	Trash Racks			38.584600 °	38.584600 °
				-121.421417 °	-121.421417 °
DWR ID	DWR_NA0050_13_t_2012_13				
Action/Comments					
Inspector Comments: Trash racks are in place, properly maintained and clear of any debris.

View of the trash racks protecting the wells.

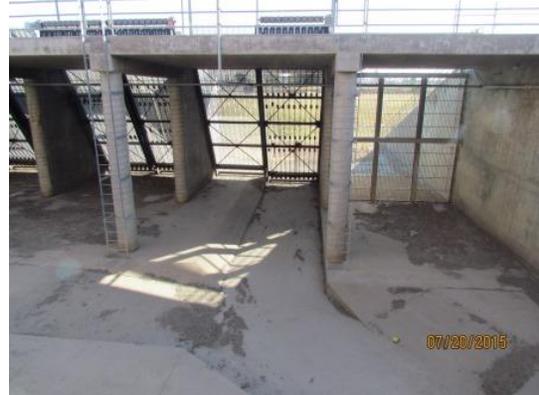
Photo 2 of 2 : ST\_2015\_NA0050\_13\_13\_20150731\_00033.jpg

View of the trash racks at the inlet.

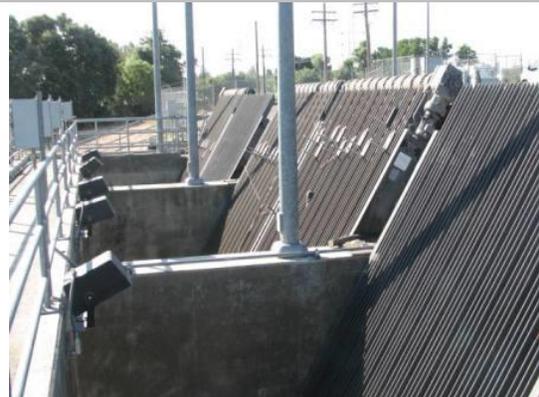
Photo 1 of 2 : ST\_2015\_NA0050\_13\_14\_20150709\_00014.jpg

LM Start	<b>0.00</b>	Rating **	A	Issue No.	<b>14</b>
LM End	<b>0.00</b>	Issue Type +	Ma	Location *	
Category	Pump Stations		GPS Latitude/Longitude		
			Start	End	
Item	Trash Rakes		38.584600 °	38.584600 °	
			-121.421417 °	-121.421417 °	
DWR ID	DWR_NA0050_13_t_2012_14				
Action/Comments					
Inspector Comments: Trash rake appears to be properly maintained and in operational condition.

Extended photo of trash rakes.

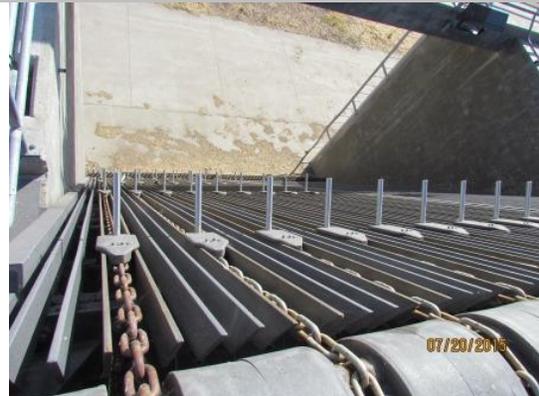
Photo 2 of 2 : ST\_2015\_NA0050\_13\_14\_20150731\_00034.jpg

Close up photo of trash rake, note cleanliness and free of debris.

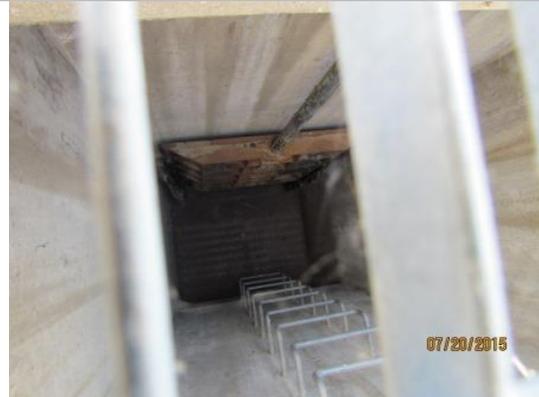
Photo 1 of 1 : ST\_2015\_NA0050\_13\_15\_20150731\_00035.jpg

LM Start	<b>0.00</b>	Rating **	A	Issue No.	<b>15</b>
LM End	<b>0.00</b>	Issue Type +	Ma	Location *	
Category	Pump Stations		GPS Latitude/Longitude		
			Start	End	
Item	Sluice / Slide Gates		38.584600 °	38.584600 °	
			-121.421417 °	-121.421417 °	
DWR ID	DWR_NA0050_13_t_2012_15				
Action/Comments					
Inspector Comments: Slide gates appear to be in good operational condition.

View of the slide gate, typical.

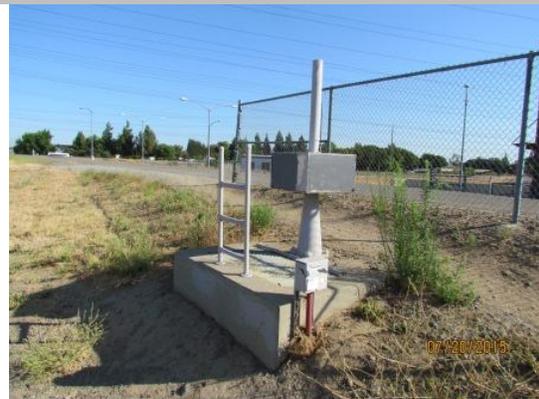
Photo 1 of 2 : ST\_2015\_NA0050\_13\_16\_20150731\_00036.jpg

LM Start	<b>0.00</b>	Rating **	A	Issue No.	<b>16</b>
LM End	<b>0.00</b>	Issue Type +	Ma	Location *	
Category	Pump Stations		GPS Latitude/Longitude		
			Start	End	
Item	Electric Gate Operators		38.584600 °	38.584600 °	
			-121.421417 °	-121.421417 °	
DWR ID	DWR_NA0050_13_t_2012_16				
Action/Comments					
Inspector Comments: Electric gate operators appear to be in proper operating condition.

View of the gravity flow gate operator.

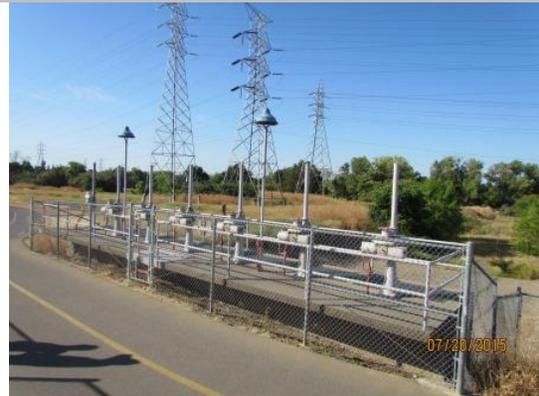
Photo 2 of 2 : ST\_2015\_NA0050\_13\_16\_20150731\_00037.jpg

View of the gate operators

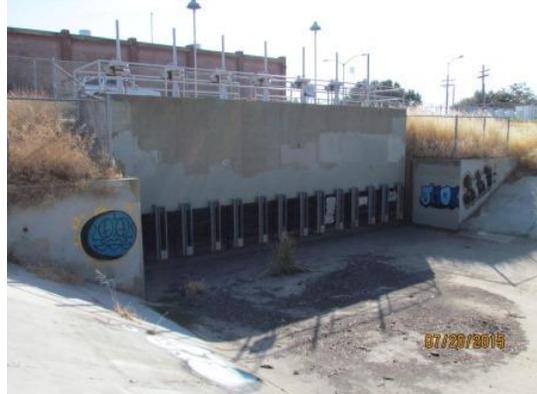
Photo 1 of 2 : ST\_2015\_NA0050\_13\_19\_20150731\_00038.jpg

View of the flap gates on the waterside.

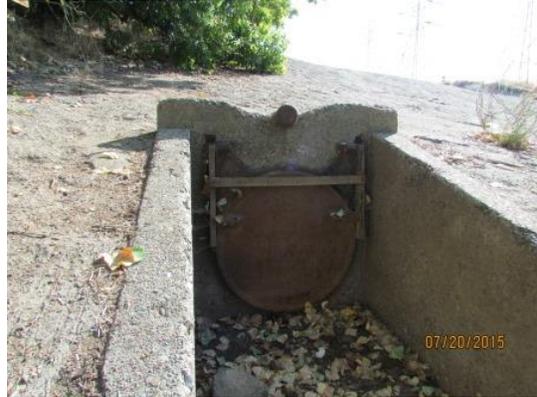
Photo 2 of 2 : ST\_2015\_NA0050\_13\_19\_20150731\_00039.jpg

View of the low flow flap gate.

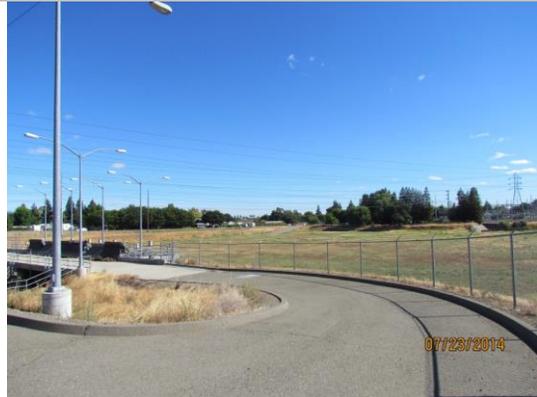
Photo 1 of 2 : ST\_2015\_NA0050\_13\_21\_20150709\_00020.jpg

View of the security fencing.

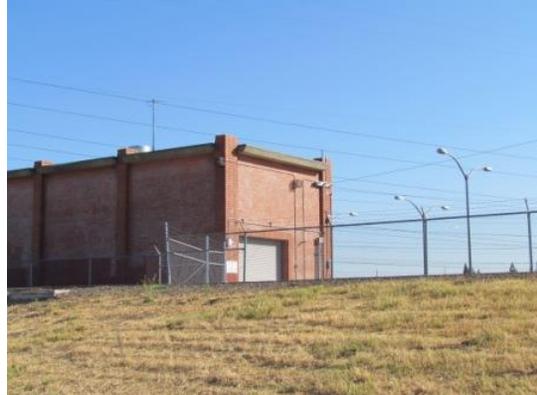
Photo 2 of 2 : ST\_2015\_NA0050\_13\_21\_20150709\_00021.jpg

View of the security fencing around the pumping facility.

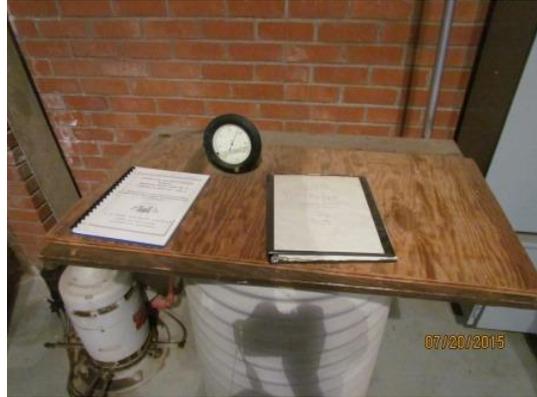
Photo 1 of 1 : ST\_2015\_NA0050\_14\_1\_20150731\_00013.jpg

Photo shows operating log on site.

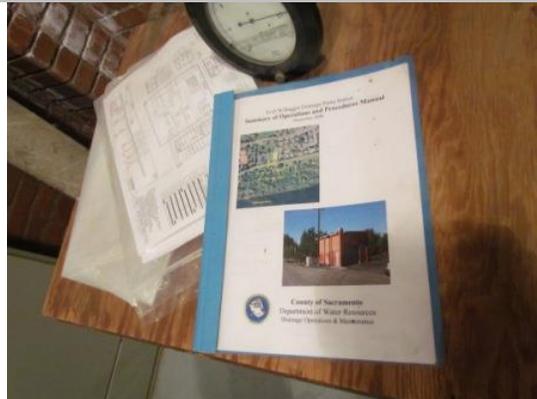
Photo 1 of 1 : ST\_2015\_NA0050\_14\_2\_20150709\_00002.jpg

LM Start	<b>0.00</b>	Rating **	A	Issue No.	<b>2</b>
LM End	<b>0.00</b>	Issue Type +	Ma	Location *	
Category	Pump Stations		GPS Latitude/Longitude		
			Start	End	
Item	Operation & Maintenance Manual		38.569692 °	38.569692 °	
			-121.374816 °	-121.374816 °	
DWR ID	DWR_NA0050_14_t_2012_2				
Action/Comments					
Inspector Comments: O & M Manual is kept on site, posted instructions are also written on dry erase board.

Photo shows O&M manual on site.

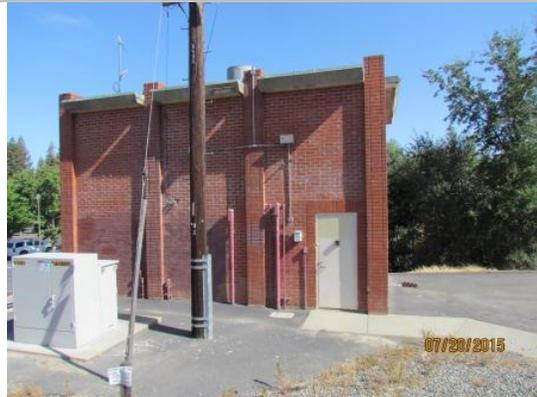
Photo 1 of 1 : ST\_2015\_NA0050\_14\_3\_20150731\_00014.jpg

LM Start	<b>0.00</b>	Rating **	A	Issue No.	<b>3</b>
LM End	<b>0.00</b>	Issue Type +	Ma	Location *	
Category	Pump Stations		GPS Latitude/Longitude		
			Start	End	
Item	Plant Building		38.569692 °	38.569692 °	
			-121.374816 °	-121.374816 °	
DWR ID	DWR_NA0050_14_t_2012_3				
Action/Comments					
Inspector Comments: Building appears to be in sound structural condition.

View of the pumping plant building.

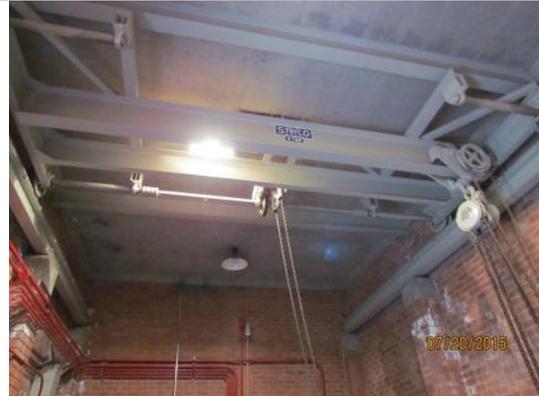
Photo 1 of 1 : ST\_2015\_NA0050\_14\_6\_20150731\_00015.jpg

LM Start	<b>0.00</b>	Rating **	A	Issue No.	<b>6</b>
LM End	<b>0.00</b>	Issue Type +	Ma	Location *	
Category	Pump Stations		GPS Latitude/Longitude		
			Start	End	
Item	Cranes		38.569692 °	38.569692 °	
			-121.374816 °	-121.374816 °	
DWR ID	DWR_NA0050_14_t_2012_6				
Action/Comments					
Inspector Comments: Crane appears to be in good working condition.

View of the crane above the pumps inside the building.

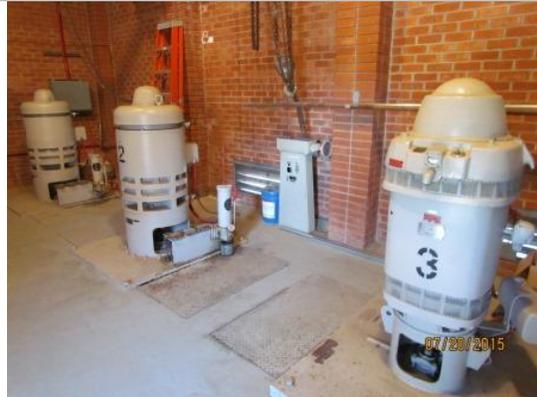
Photo 1 of 1 : ST\_2015\_NA0050\_14\_7\_20150731\_00016.jpg

View of the pump motors.

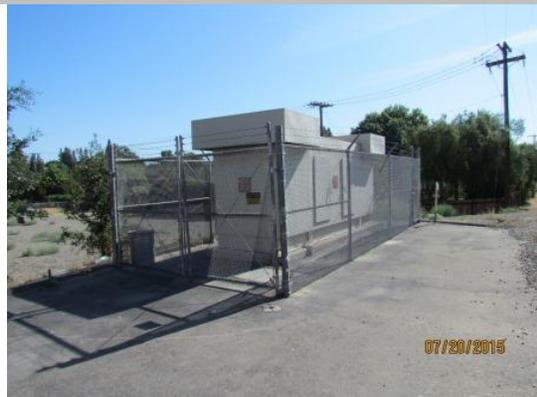
Photo 1 of 1 : ST\_2015\_NA0050\_14\_8\_20150731\_00017.jpg

LM Start	<b>0.00</b>	Rating **	A	Issue No.	<b>8</b>
LM End		Issue Type +	Ma	Location *	
Category	Pump Stations		GPS Latitude/Longitude		
			Start	End	
Item	Power		38.569692 °	38.569692 °	
			-121.374816 °	-121.374816 °	
DWR ID	DWR_NA0050_14_t_2012_8				
Action/Comments					
Inspector Comments: No visible deficiencies, backup generator is on site.

View of the backup generator.

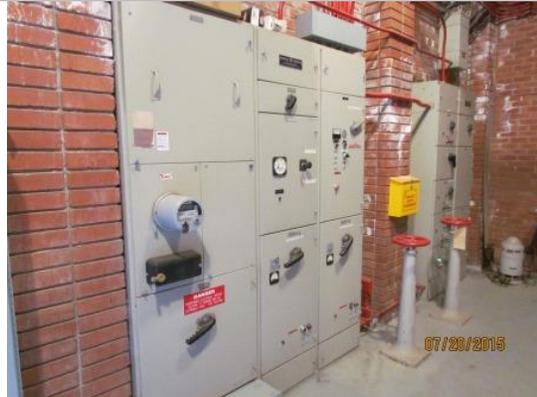
Photo 1 of 2 : ST\_2015\_NA0050\_14\_11\_20150731\_00018.jpg

LM Start	<b>0.00</b>	Rating **	A	Issue No.	<b>11</b>
LM End	<b>0.00</b>	Issue Type +	Ma	Location *	
Category	Pump Stations		GPS Latitude/Longitude		
			Start	End	
Item	Pump Control Systems		38.569692 °	38.569692 °	
			-121.374816 °	-121.374816 °	
DWR ID	DWR_NA0050_14_t_2012_11				
Action/Comments					
Inspector Comments: Controls appear well maintained and free of corrosion.

View of the manual pump controls switches.

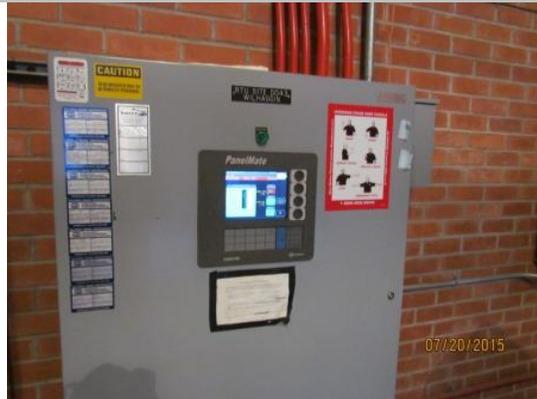
Photo 2 of 2 : ST\_2015\_NA0050\_14\_11\_20150731\_00019.jpg

View of the pump controls panel.

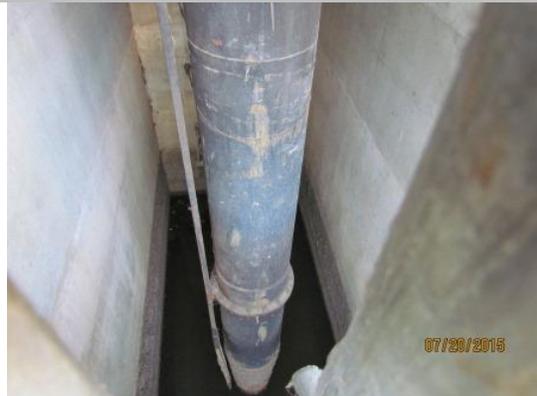
Photo 1 of 1 : ST\_2015\_NA0050\_14\_12\_20150731\_00020.jpg

LM Start	<b>0.00</b>	Rating **	A	Issue No.	<b>12</b>
LM End	<b>0.00</b>	Issue Type +	Ma	Location *	
Category	Pump Stations		GPS Latitude/Longitude		
			Start	End	
Item	Sumps/Wet Well		38.569692 °	38.569692 °	
			-121.374816 °	-121.374816 °	
DWR ID	DWR_NA0050_14_t_2012_12				
Action/Comments					
Inspector Comments: Wet well is clear of debris.

View of the wet well.

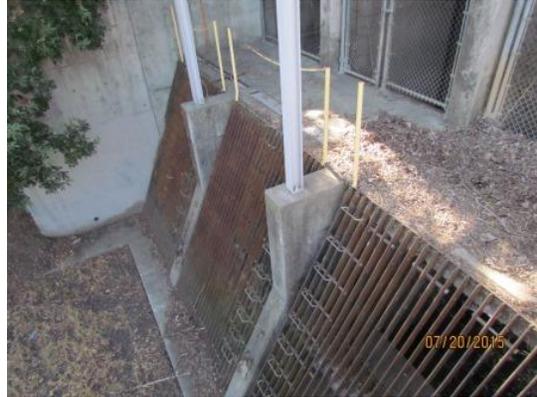
Photo 1 of 1 : ST\_2015\_NA0050\_14\_13\_20150731\_00021.jpg

Photo shows properly maintained trash rack free of debris.

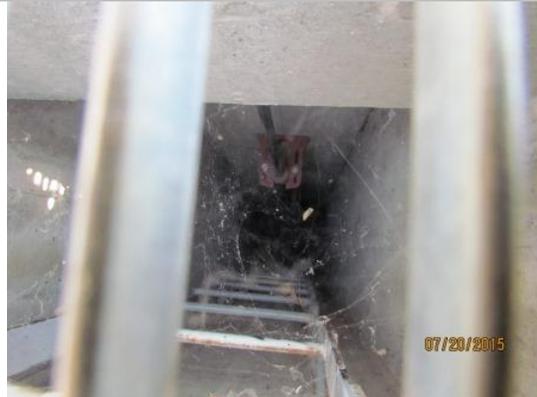
Photo 1 of 1 : ST\_2015\_NA0050\_14\_15\_20150731\_00022.jpg

View of the slide gate.

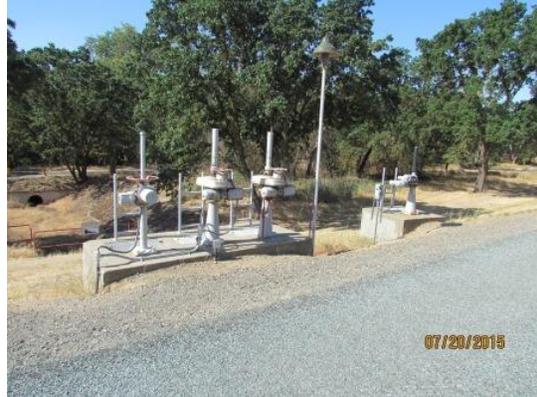
Photo 1 of 1 : ST\_2015\_NA0050\_14\_16\_20150731\_00023.jpg

View of the gate controls.

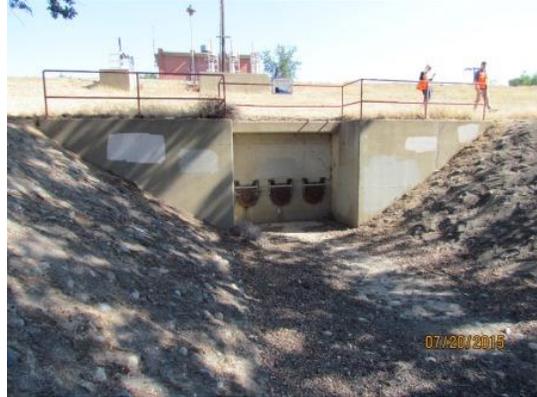
Photo 1 of 1 : ST\_2015\_NA0050\_14\_19\_20150731\_00024.jpg

LM Start	<b>0.00</b>	Rating **	A	Issue No.	<b>19</b>
LM End	<b>0.00</b>	Issue Type +	Ma	Location *	
Category	Pump Stations		GPS Latitude/Longitude		
			Start	End	
Item	Flap Gates		38.569692 °	38.569692 °	
			-121.374816 °	-121.374816 °	
DWR ID	DWR_NA0050_14_t_2012_19				
Action/Comments					
Inspector Comments: Flap gates are visible and appear to be in working order, there was no flow to test for leakage.

View of the flap gates.

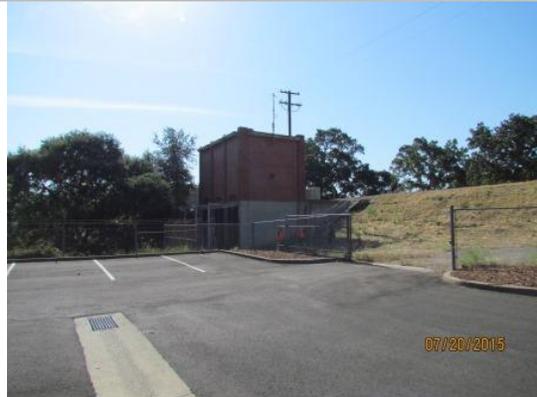
Photo 1 of 1 : ST\_2015\_NA0050\_14\_21\_20150731\_00025.jpg

View of the security fencing.

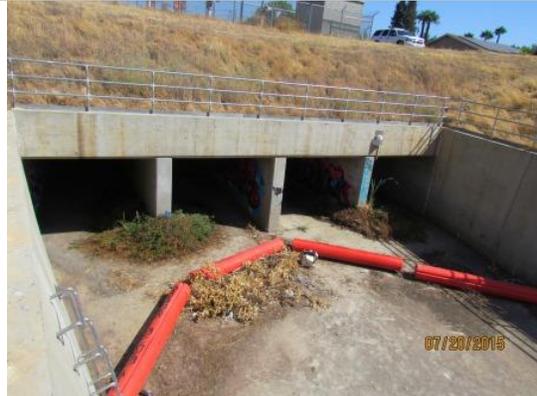
Photo 1 of 1 : ST\_2015\_NA0050\_220\_7\_20150731\_00007.jpg

View of the structure inlet.

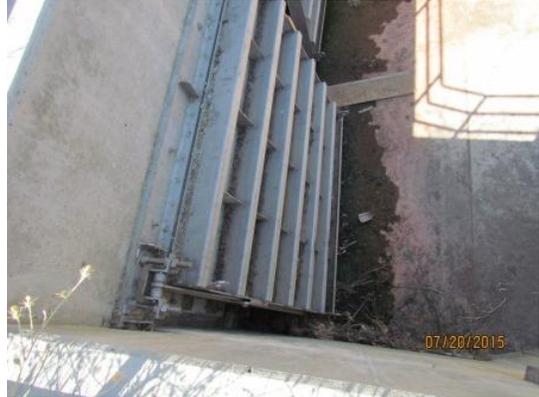
Photo 1 of 3 : ST\_2015\_NA0050\_220\_11\_20150731\_00008.jpg

Close up view of the flap gate.

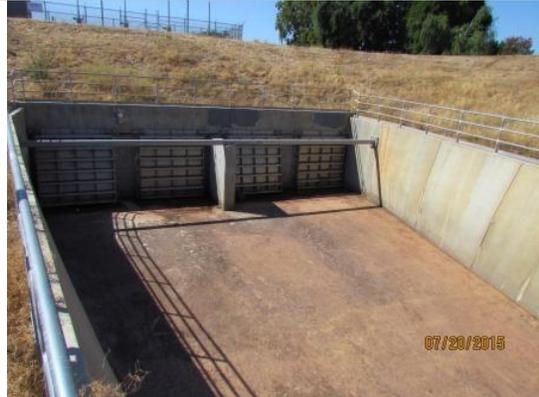
Photo 2 of 3 : ST\_2015\_NA0050\_220\_11\_20150731\_00009.jpg

View of the flap gates.

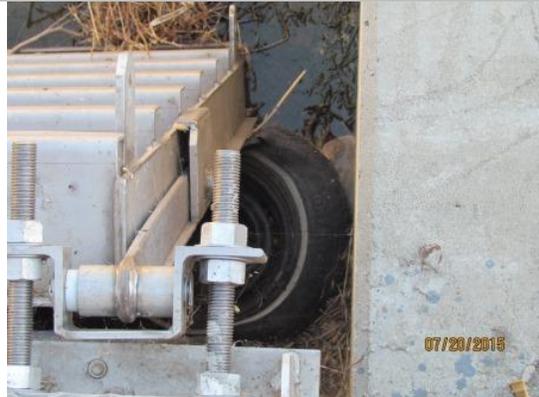
Photo 3 of 3 : ST\_2015\_NA0050\_220\_11\_20150731\_00010.jpg

View of a flap gate with debris propping the gate open.

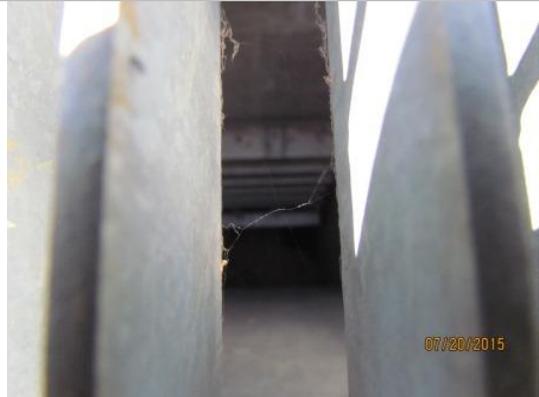
Photo 1 of 1 : ST\_2015\_NA0050\_220\_12\_20150731\_00011.jpg

View of a slide gate.

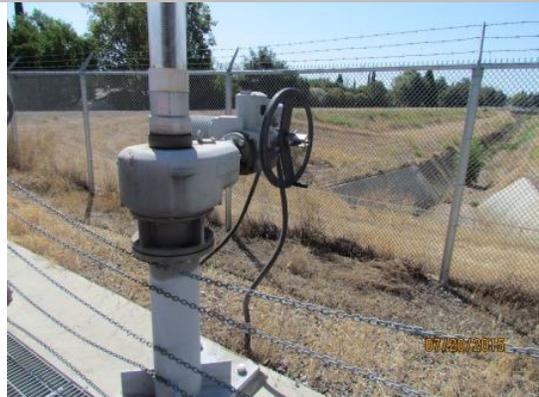
Photo 1 of 1 : ST\_2015\_NA0050\_220\_13\_20150731\_00012.jpg

View of the gate mechanism controls.

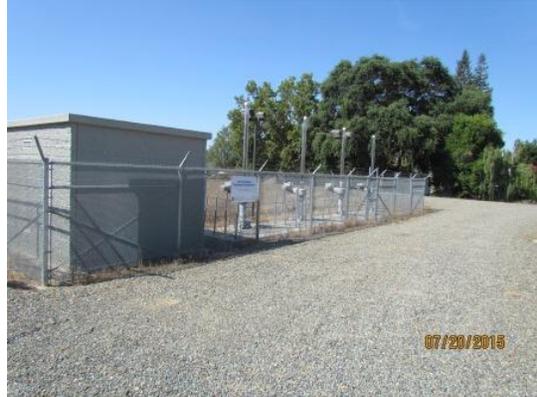
Photo 1 of 1 : ST\_2015\_NA0050\_220\_18\_20150731\_00013.jpg

View of the security fencing around the facility.
