Flood Control Project Maintenance
2008 Structure Summary Report
Overall Unit and Item Ratings

DWR Sacramento Maintenance Yard

2008 Structure Inspection Results

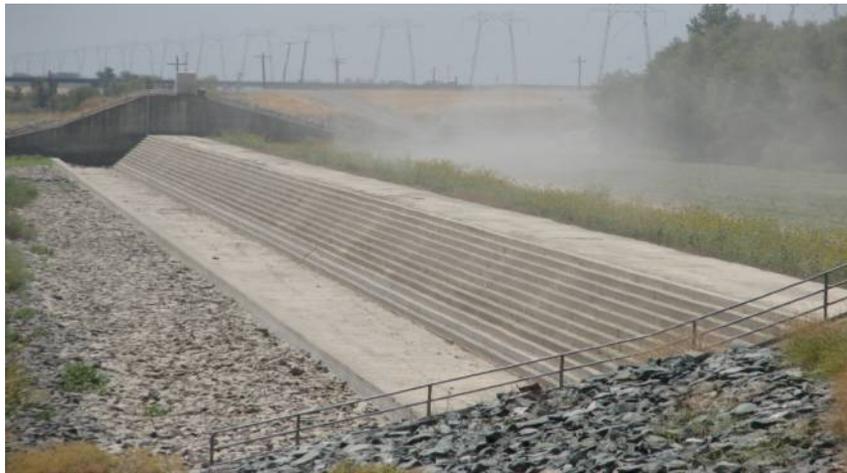
Report Line	4
Location	
Category	Structures & Concrete Lined Channels
Item	Concrete Surfaces
View of Cache Weir and stilling basin rip rap on north side GPS center of weir 38.68457 - 121.67326

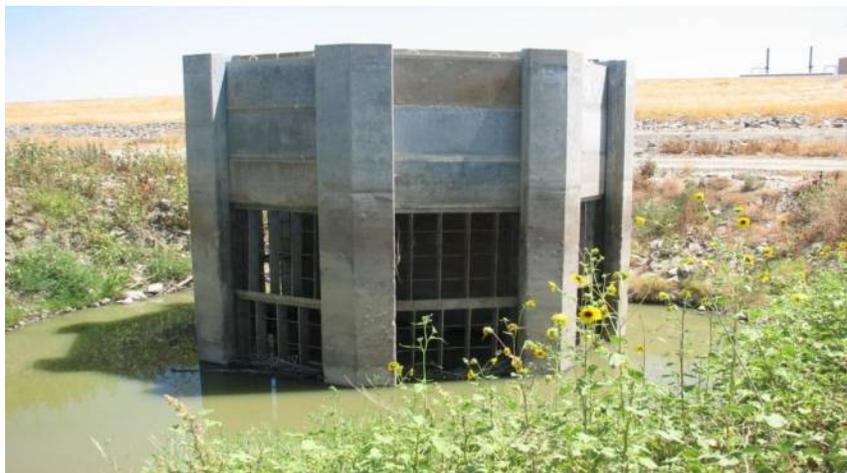
Report Line	4
Location	
Category	Structures & Concrete Lined Channels
Item	Concrete Surfaces
View of low flow inlet structure located southeast corner of settling basin closure gates upper right corner of picture GPS at gates on levee 38.67844 -121.67294

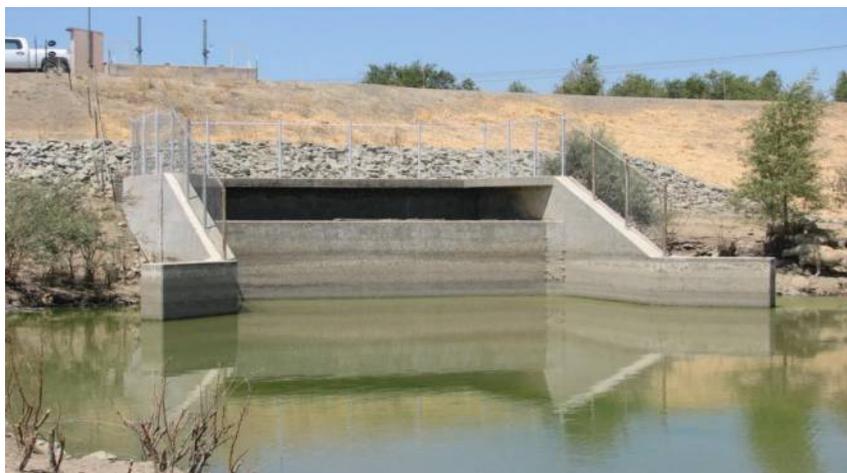
Report Line	4
Location	
Category	Structures & Concrete Lined Channels
Item	Concrete Surfaces
View of outlet of low flow channel

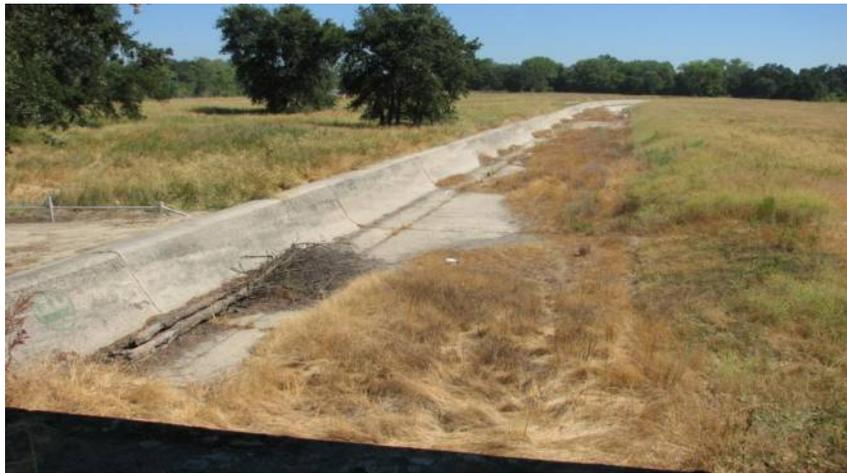
Report Line	3
Location	
Category	Structures & Concrete Lined Channels
Item	Concrete Surfaces
View of weir and stilling basin from abutment unit 1GPS 38.75907 -121.66541

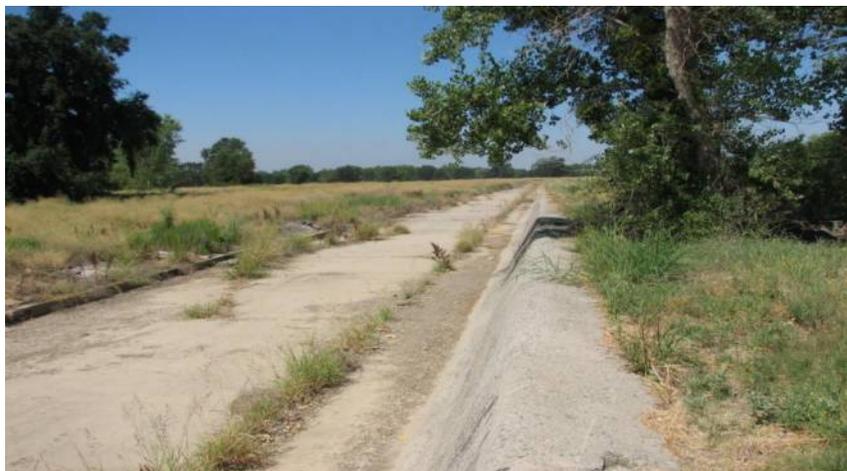
Report Line	3
Location	
Category	Structures & Concrete Lined Channels
Item	Concrete Surfaces
View from fish ladder looking west GPS 38.76424 -121.64689

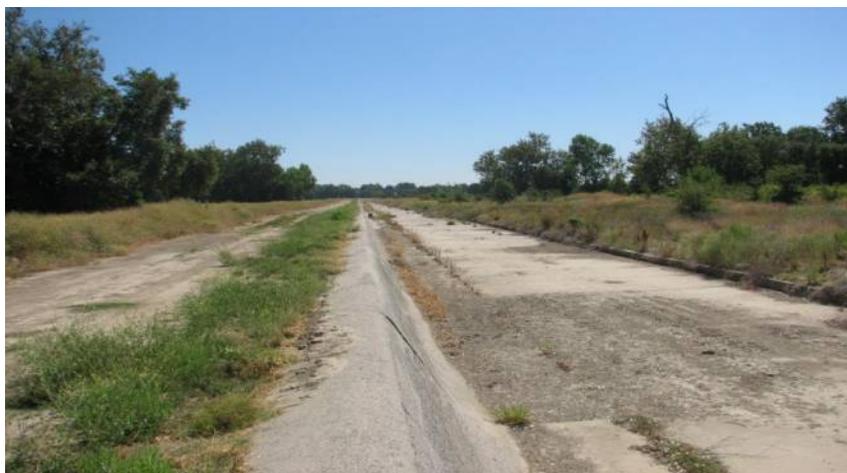
Report Line	3
Location	
Category	Structures & Concrete Lined Channels
Item	Concrete Surfaces
View from fish ladder looking east

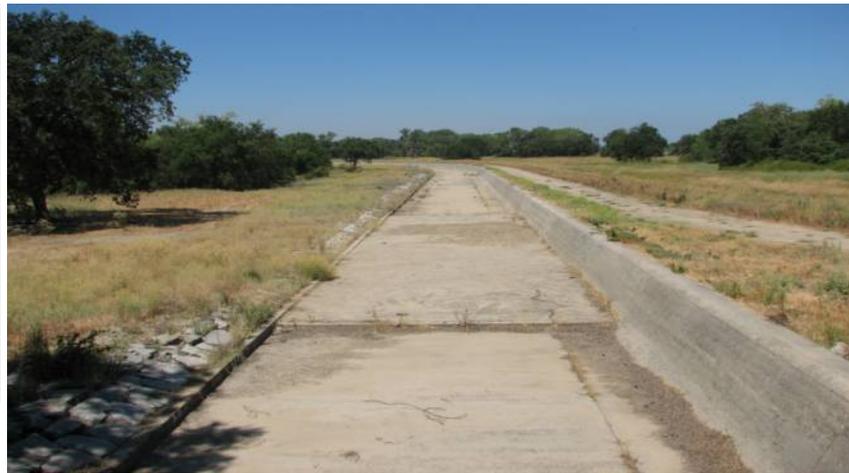
Report Line	3
Location	
Category	Structures & Concrete Lined Channels
Item	Concrete Surfaces

View looking west from abutment East Levee Yolo Bypass

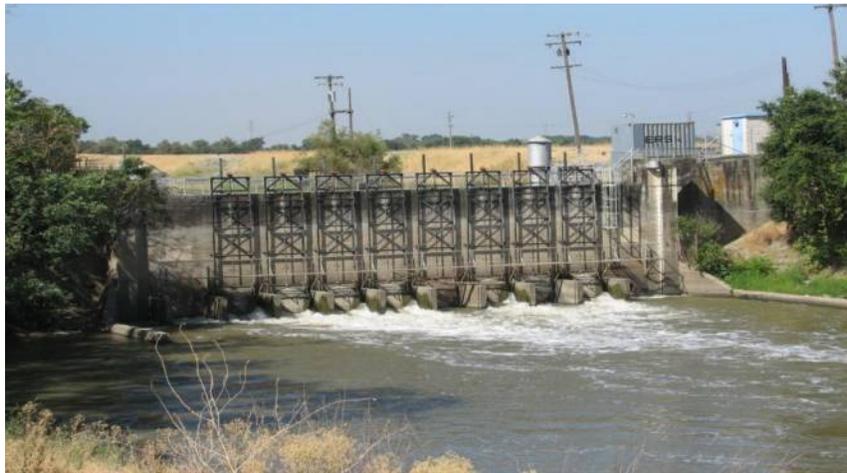
Report Line	3
Location	
Category	Structures & Concrete Lined Channels
Item	Flap Gates

Downstream side of the structure from right bank

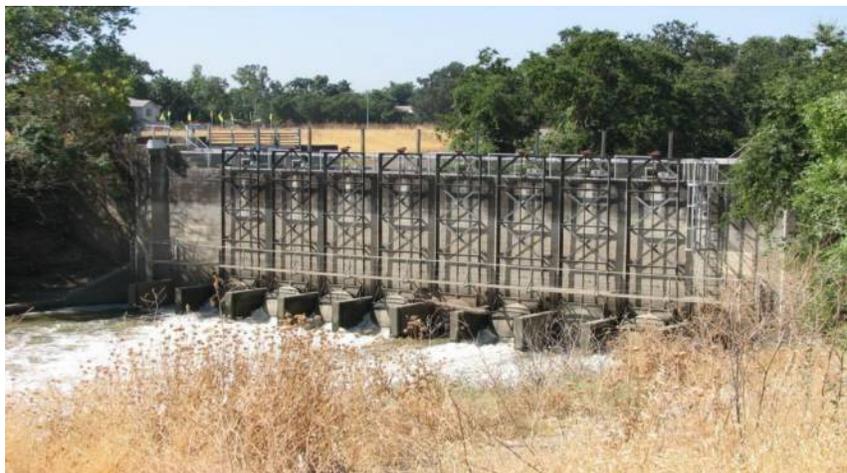
Report Line	3
Location	
Category	Structures & Concrete Lined Channels
Item	Flap Gates

Downstream side view from left bank

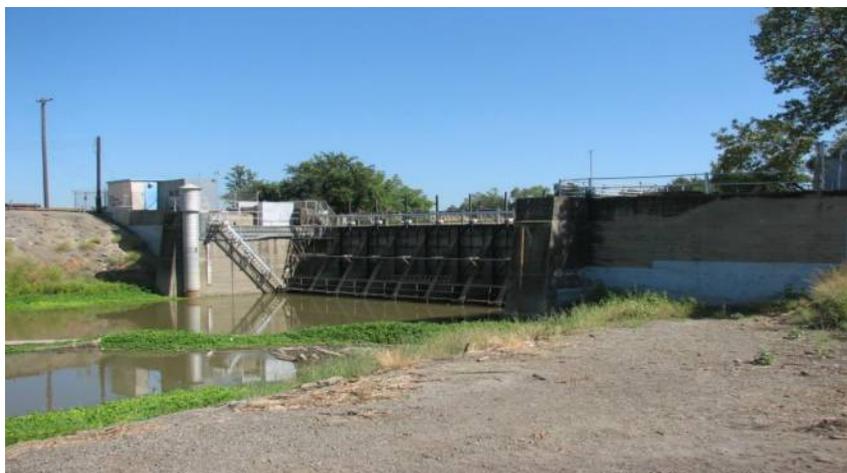
Report Line	11
Location	
Category	Structures & Concrete Lined Channels
Item	Trash Rakes

10	Structures & Concrete Lined Channels	Security Fencing		A			o	8
11	Structures & Concrete Lined Channels	Trash Rakes		A	The trash rake is a log boom with debris against it minimal		o Y	9

Upstream side of structure from right bank log boom in place

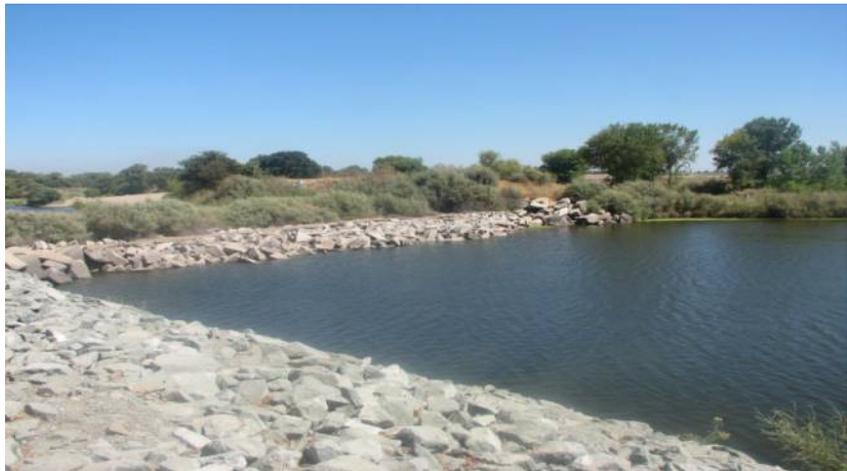
Report Line	1
Location	
Category	Structures & Concrete Lined Channels
Item	Vegetation & Obstructions
Looking at downstream side of dam

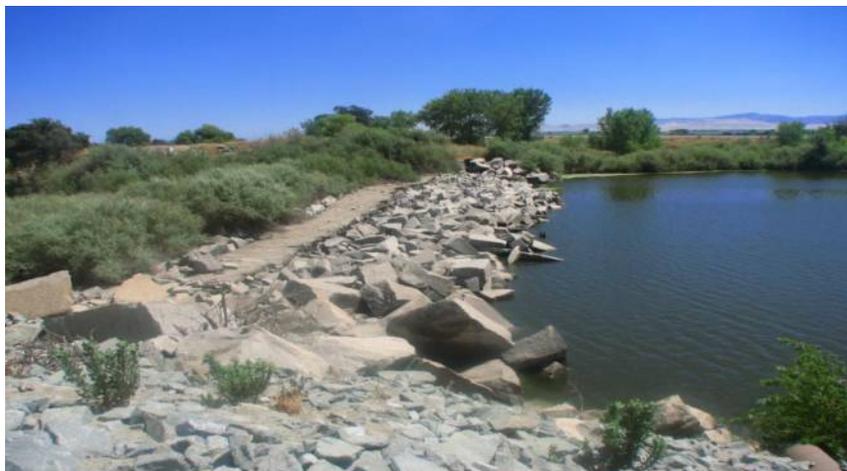
RptLine	Category	Item	Location *	Rating **	Comment	GPS	Photo	Issue
1	Structures & Concrete Lined Channels	Vegetation & Obstructions		M	Start Lat & Long is the southside of the structure RD 2095 & 2058 End Lat & Long is the northside of the structure at RD 2107. The overgrowth of the willow are on the upstream side of the dam.	37.759900 ° -121.309340 °	Y	1
2	Structures & Concrete Lined Channels	Encroachments		A			Y	3
3	Structures & Concrete Lined Channels	Erosion Areas		M			Y	2

Report Line	1
Location	
Category	Structures & Concrete Lined Channels
Item	Vegetation & Obstructions
Looking at overgrowth of willow on the downstream side of the Dam

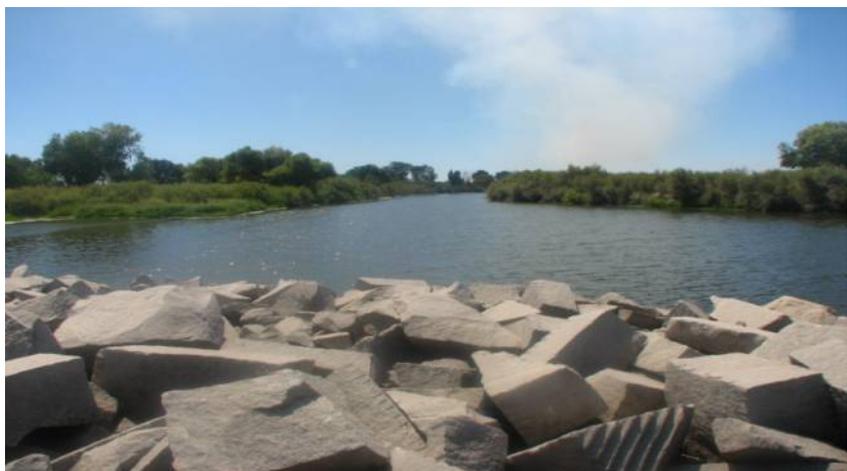
Report Line	2
Location	
Category	Structures & Concrete Lined Channels
Item	Encroachments
Looking downstream from Dam structure at channel

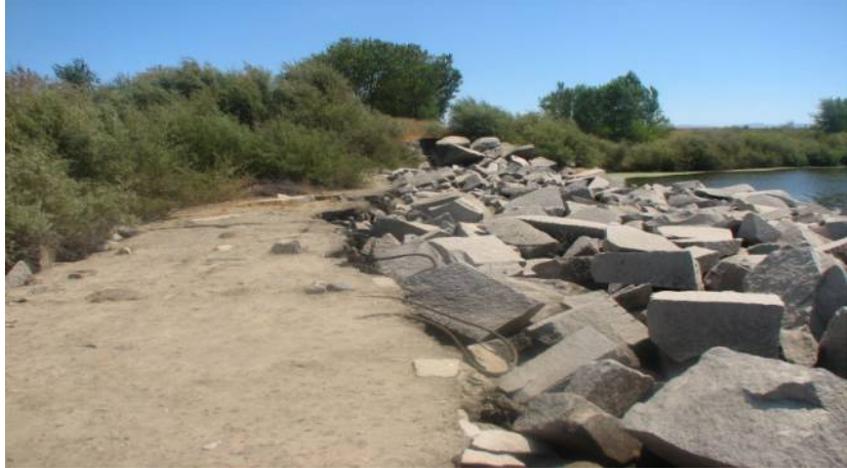
Report Line	3
Location	
Category	Structures & Concrete Lined Channels
Item	Erosion Areas

Looking at minor tilting/settlement/erosion on the upstream & downstream side of the Dam

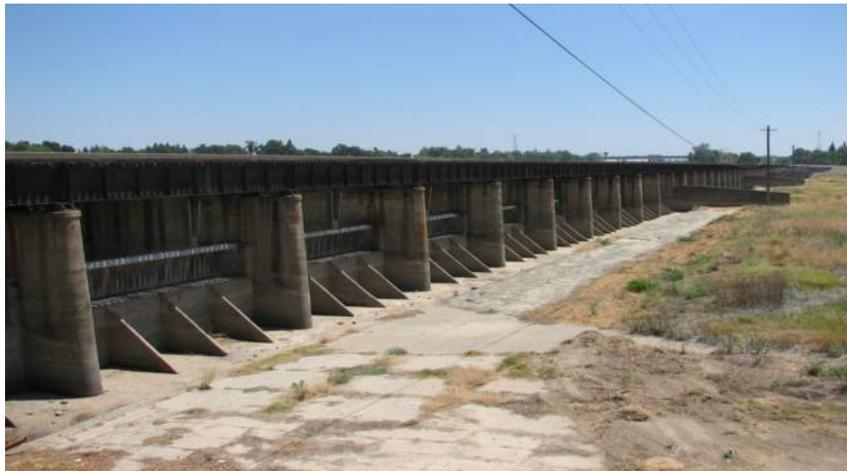
RptLine	Category	Item	Location *	Rating **	Comment	GPS	Photo	Issue
1	Structures & Concrete Lined Channels	Vegetation & Obstructions		A	There is no vegetation and no debris in the spilling basin		° °	1
2	Structures & Concrete Lined Channels	Manual Operations		A	needle boards, batting and hinges aare in good condition. Metal stop logs cables and clamps are in good condition. Sacramento Maintenance Yard does an annual inspections and repair before flood season. Tripping mechanism are locked and working.		° °	2
3	Structures & Concrete Lined Channels	Concrete Surfaces		A	concrete weir,stilling basin and bulkheads are in good condition minor spalling and scaling monitor and repair as necessary.		° °	Y 3

Report Line	3
Location	
Category	Structures & Concrete Lined Channels
Item	Concrete Surfaces
View of weir and stilling basin downstream side north end GPS 38.60718 -121.56005 center point GPS 38.60466 -121.55733

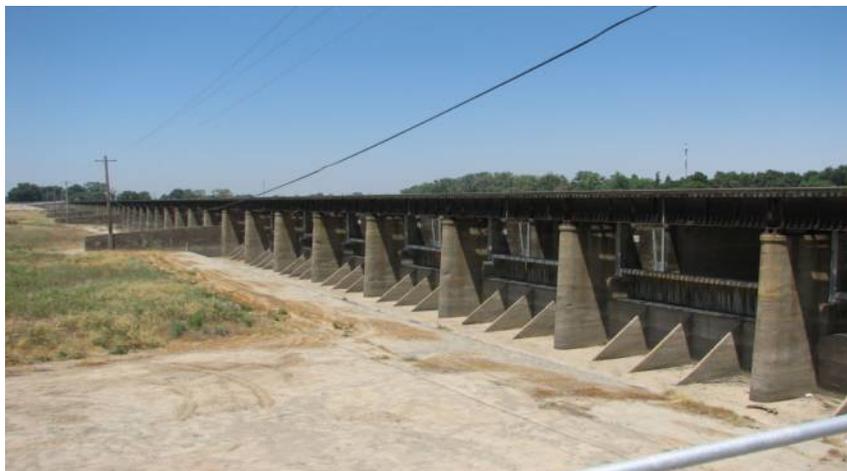
Report Line	3
Location	
Category	Structures & Concrete Lined Channels
Item	Concrete Surfaces
View of weir and stilling basin south end GPS 38.60281 -121.55577

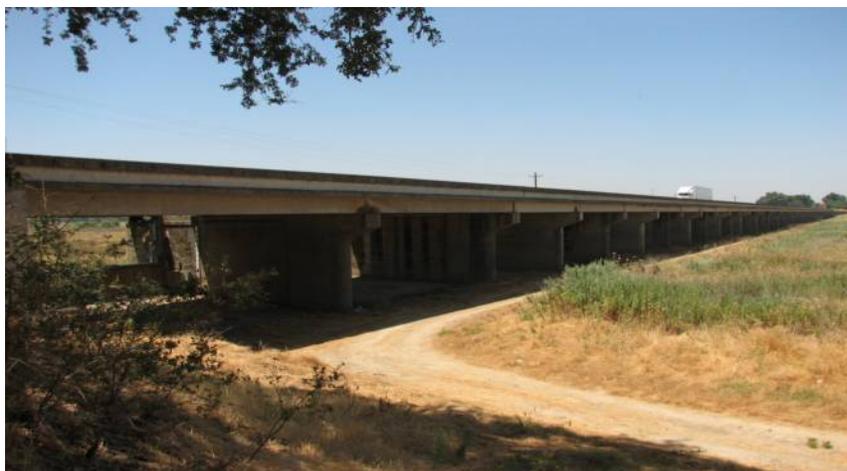
Report Line	3
Location	
Category	Structures & Concrete Lined Channels
Item	Concrete Surfaces
southend looking north upstream side of weir
