Flood Control Project Maintenance
2009 Structure Summary Report
Overall Unit and Item Ratings

DWR Sacramento Maintenance Yard

Levee Inspection Report By Mile - Structure 2009

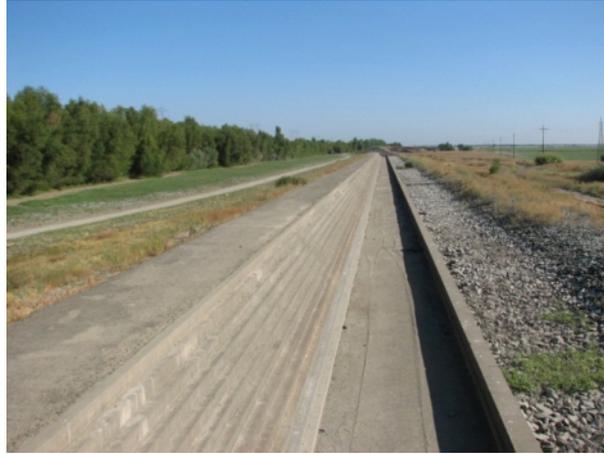
| johngw_20090716_10.jpg | |

| Look from the southern end Cache Weir 38.68246 -121.67293 | |

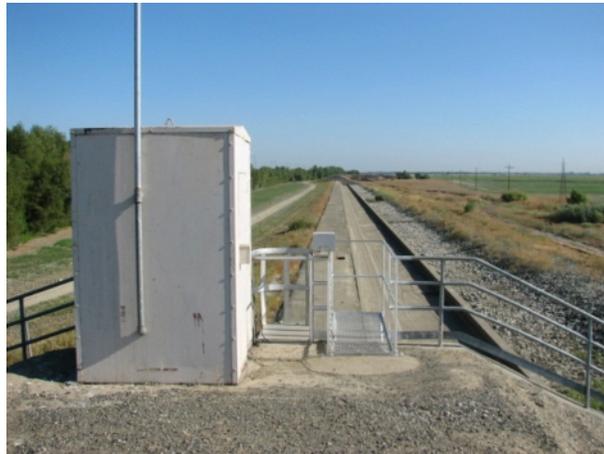
| johngw_20090716_11.jpg | |

| Another view southern end with recorder can 38.68246 -121.67293 | |

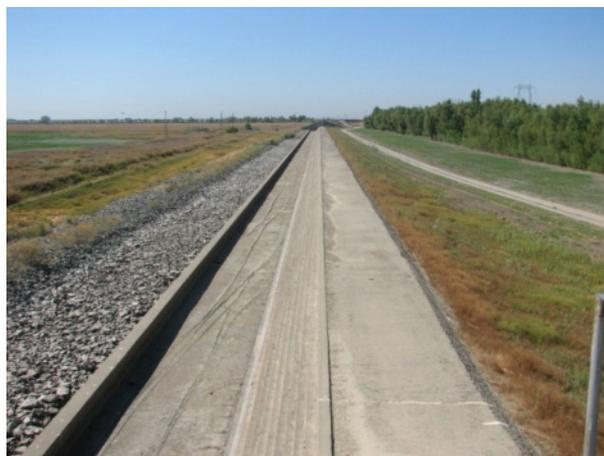
| johngw_20090716_12.jpg | |

| view from the northern end of Cache Weir 38.68735 -121.67374 | |

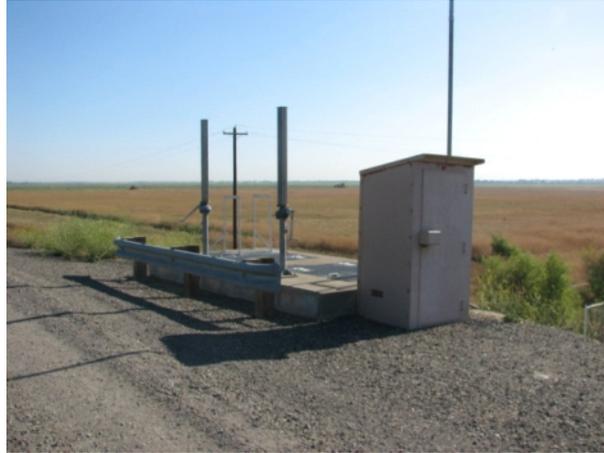
| johngw_20090716_13.jpg | |

| LMR No. | Levee Mile | | Category | Item | Location* | Rating** | Action/Comment | GPS Latitude/Longitude | | Photo | Issue No. |
|---|---|---|---|---|---|---|---|---|---|---|---|
| 14 | 0.00 | 0.00 | Structures | Manual Gate Operators | | A | Inspector Comments: 38.67848 -121.67294 gates are tested once a year with safety and dams. Gates are open for the flood season every year. | 38.678480 ° 121.672940 ° | 38.678480 ° 121.672940 ° | Y | 14 |

| Manual gates | 38.67848 121.67294 |

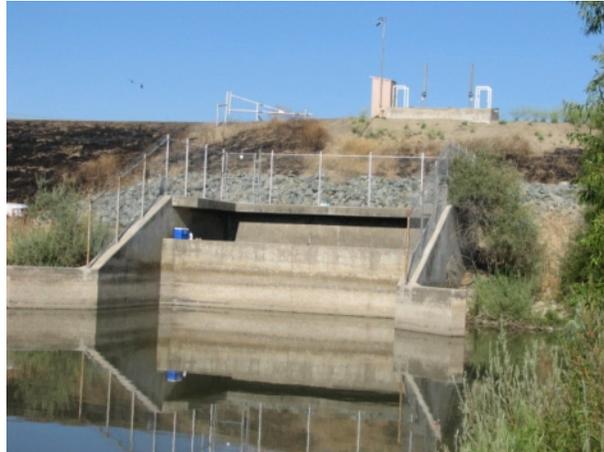
| johngw_20090716_14.jpg | |

| out flow structure gates on top of levee | |

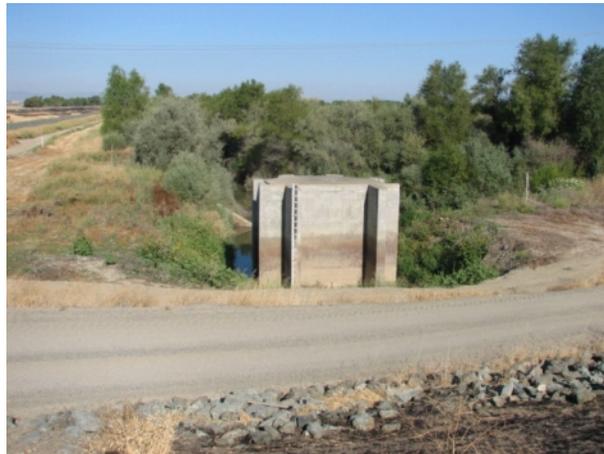
| johngw_20090716_15.jpg | |

| intake structure | |

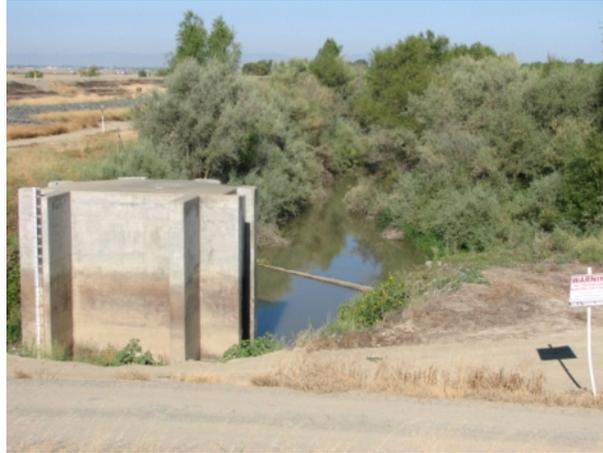
| johngw_20090716_16.jpg | |

| intake structure and stop logs | |

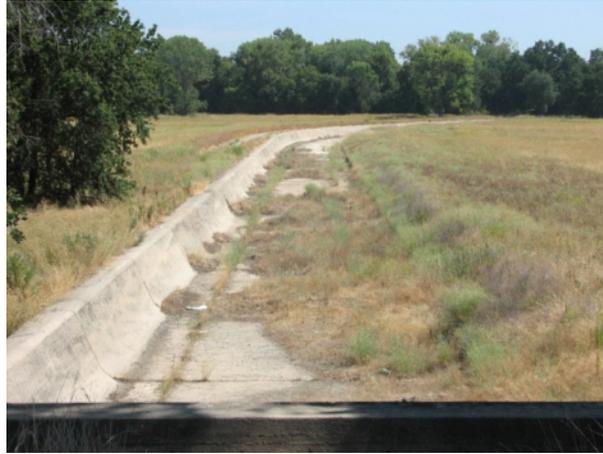
| johngw_20090709_6.jpg | |

| west end of weir 38.75888 -121.66538 | |

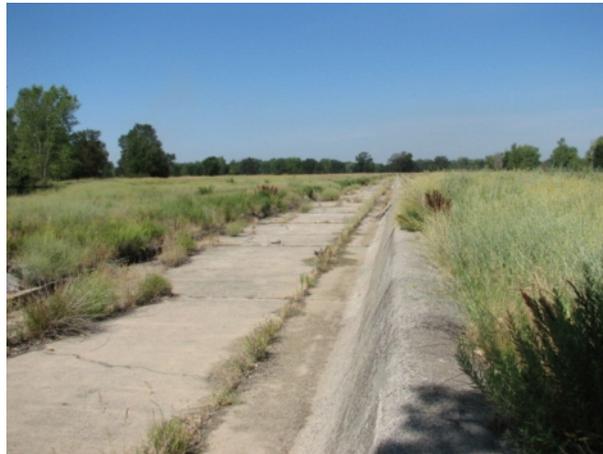
| johngw_20090709_7.jpg | |

| standing at fish ladder looking west 38.764318 - 121.64669 | |

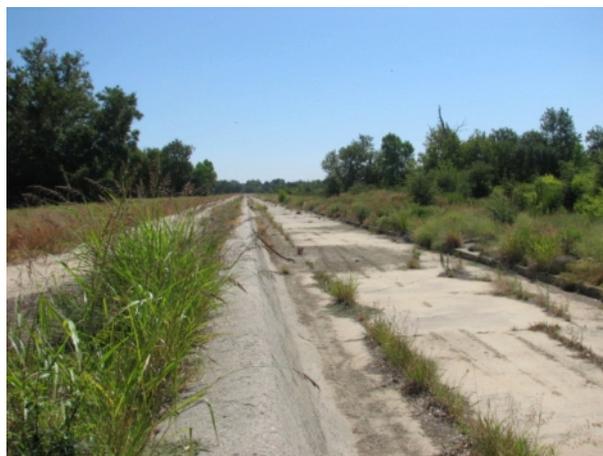
| johngw_20090709_8.jpg | |

| standing at fish ladder looking east 38.764318 - 121.64669 | |

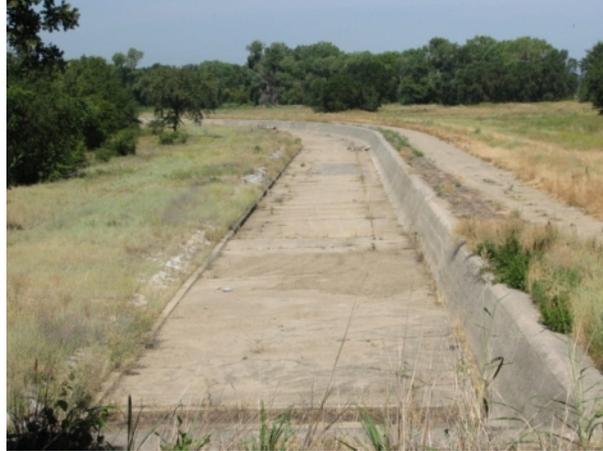
| johngw_20090709_9.jpg | |

| east end of weir 38.76468 -121.63543 | |

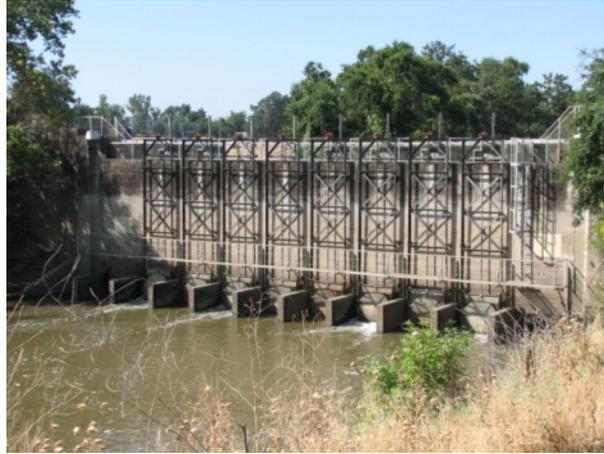
| johngw_20090720_31.jpg | |

| view from the north side of Syamore Slough | |

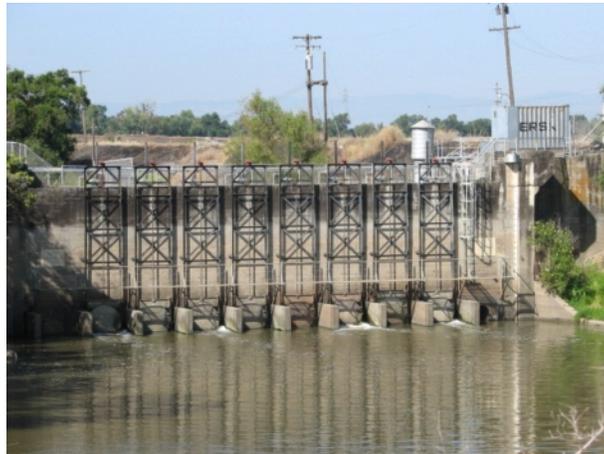
| johngw_20090720_32.jpg | |

| view from the South side | |

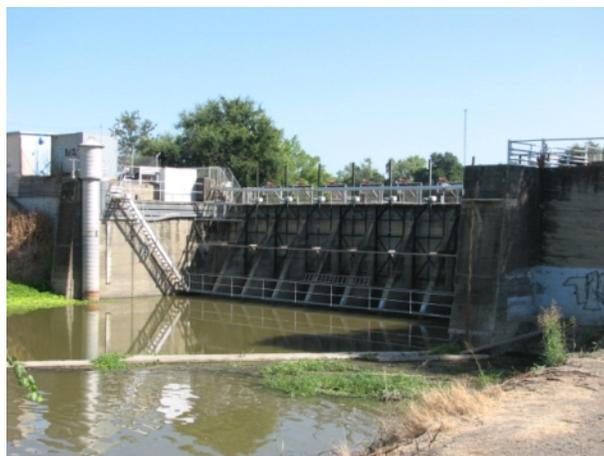
| johngw_20090720_33.jpg | |

| Backside view from the Southside | |

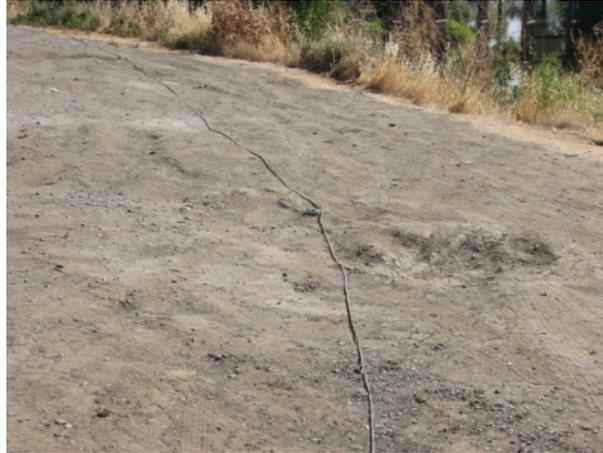
| johngw_20090720_34.jpg | |

| Telephone cable laying on ground running towards control room | |

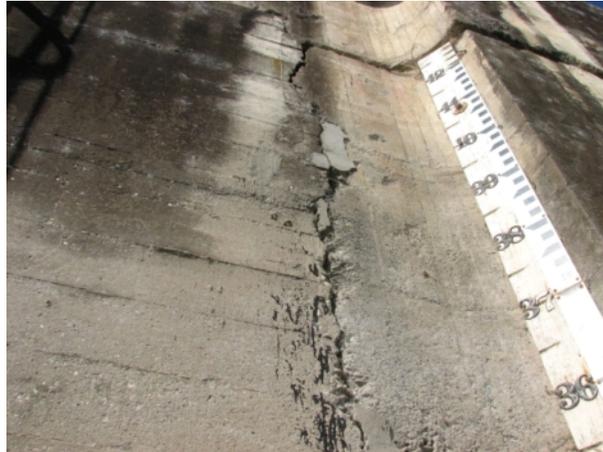
| johngw_20090720_36.jpg | |

| LMR No. | Levee Mile | | Category | Item | Location* | Rating** | Action/Comment | GPS Latitude/Longitude | | Photo | Issue No. |
|---|---|---|---|---|---|---|---|---|---|---|---|
| 15 | 0.00 | 0.00 | Structures | Concrete Surfaces | | A | Inspector Comments: vertical crack on north side has not changed from pass year continue to monitor and repair as necessary. Small vertical crack south side continue to monitor. | ° | ° | ° | Y 15 |

| vertical crack Northside has not changed from pervious inspection | |

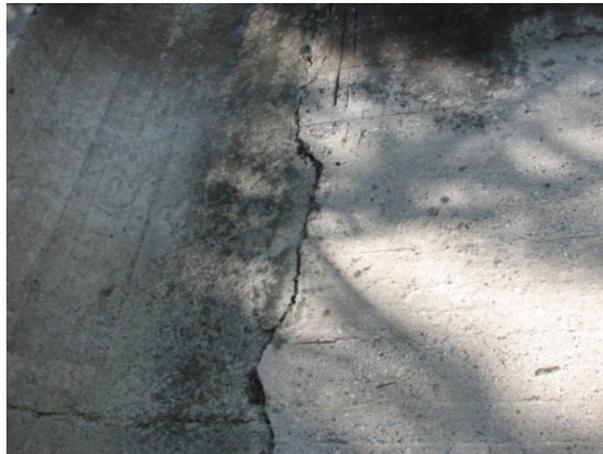
| johngw_20090720_37.jpg | |

| vertical crack Southside montior | |

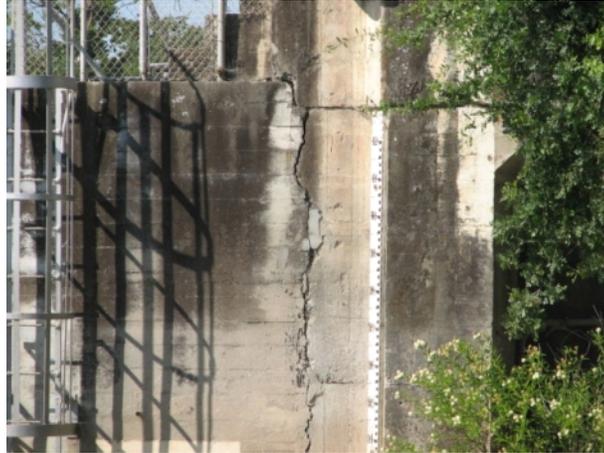
| johngw_20090720_38.jpg | |

| view from the bank downstream | |

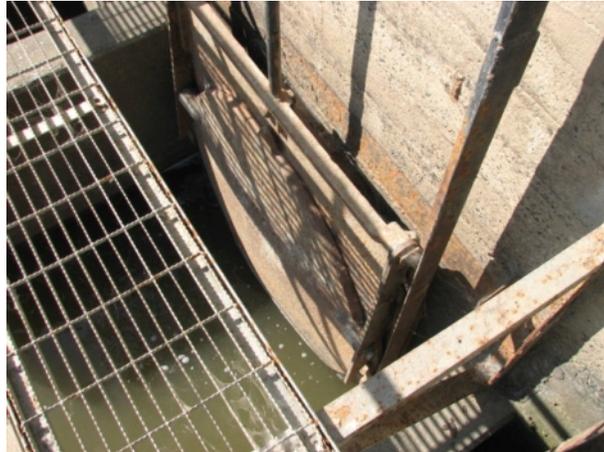
| johngw_20090720_35.jpg | |

| flap gate outlet side some rust on metal surfaces | |

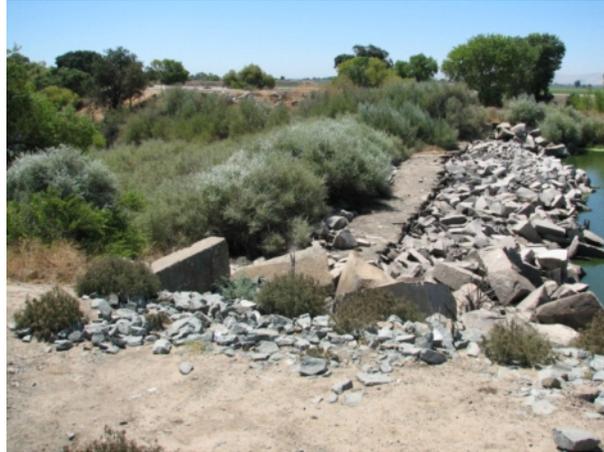
| jpaasch_20090722_8.jpg | |

| Paradise Dam as viewed from RD 2107. Paradise Cut to right, San Joaquin River to left (beyond extents of photo). | |

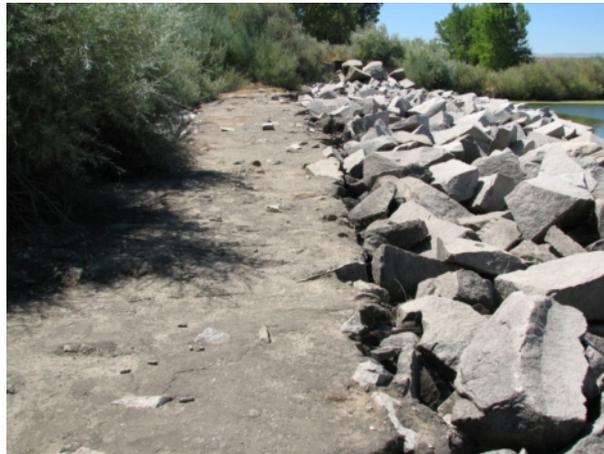
| jpaasch_20090722_9.jpg | |

| LMR No. | Levee Mile | | Category | Item | Location * | Rating ** | Action/Comment | GPS Latitude/Longitude | | Photo | Issue No. |
|---|---|---|---|---|---|---|---|---|---|---|---|
| 17 | 0.00 | 0.00 | Structures | Concrete Foundations | | M | Inspector Comments: Minor scouring beneath asphalt dam surface evident. | ° | ° | Y | 17 |

| Close up of dam surface shows asphalt and large granite rip-rap. | |

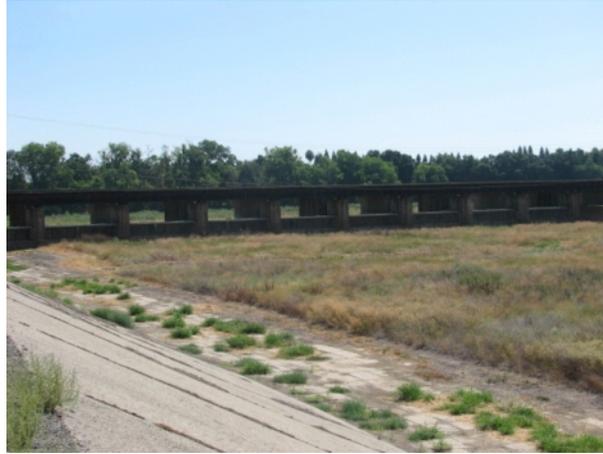
| johngw_20090716_17.jpg | |

| view downstream north side of weie bays 1-10, 38.60712 -121.56010 | |

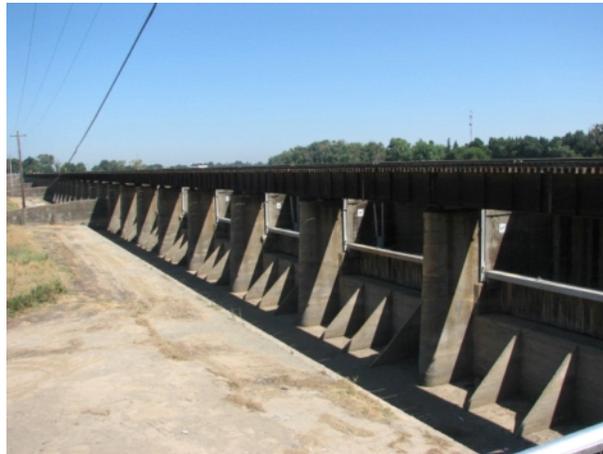
| johngw_20090716_18.jpg | |

| view south end bays 39-47 38.60285 - 121.55579 | |

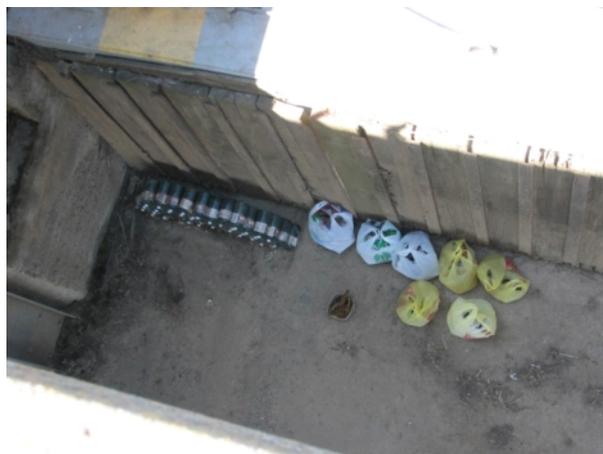
| johngw_20090716_19.jpg | |

| propane bottles and trash bay 10 | |

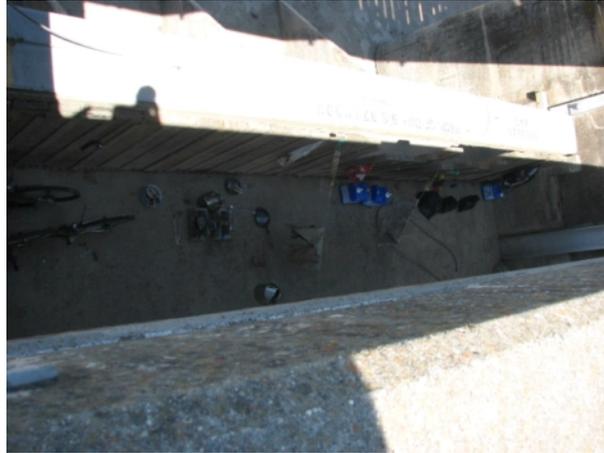
| johngw_20090716_20.jpg | |

| homeless camp bay 9 | |

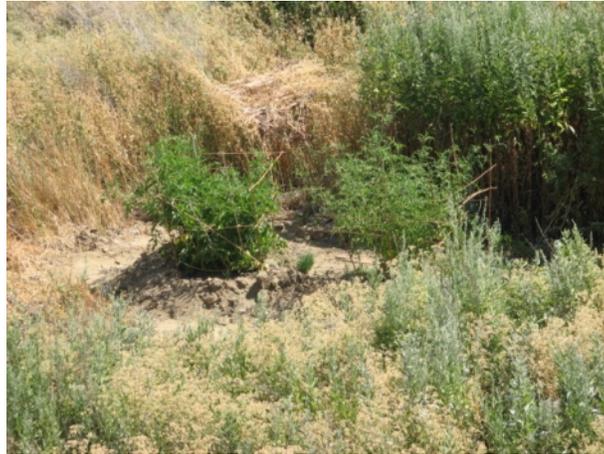
| johngw_20090716_21.jpg | |

| garden on water side | |

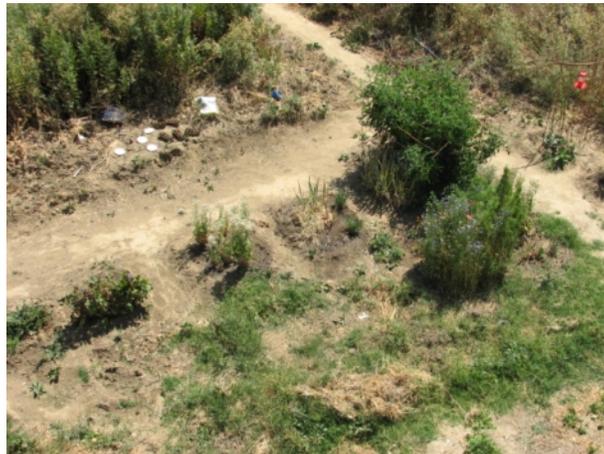
| johngw_20090716_22.jpg | |

| more of the garden waterside | |
