**Flood Control Project Maintenance**  
**2015 Structure Summary Report**  
**Overall Unit and Item Ratings**

## DWR Sacramento Maintenance Yard

### Cache Creek Settling Basin Weir And Drainage Structure

**Flood Control Project Maintenance**

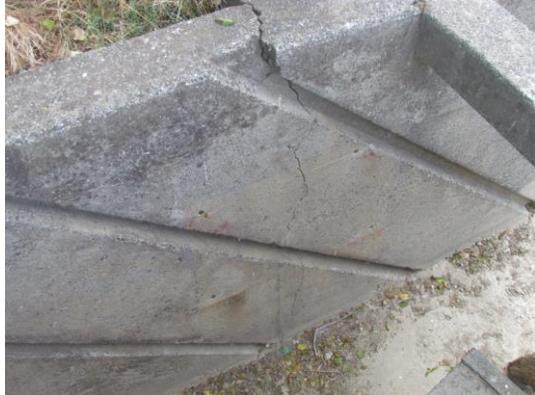
Photo 1 of 3 : ST\_2015\_NA0055\_2\_15\_20150819\_00021.jpg

LM Start	<b>0.00</b>	Rating **	A	Issue No.	<b>15</b>
LM End	<b>0.00</b>	Issue Type +	Ma	Location *	CR
Category	Structures & Concrete Lined Channels		GPS Latitude/Longitude		
			Start	End	
Item	Concrete Surfaces		38.758880 °	38.764680 °	
			-121.665380 °	-121.635430 °	
DWR ID	DWR_NA0055_2_t_2012_15				
Action/Comments					
Inspector Comments: Crack runs from the top to the bottom on the downstream side at the West end of the weir. The crack appears to be about 1" at the top of the wall and about 1/2" near the bottom. This does not affect the function of the weir. It is minor but needs to be repaired. (see photo in photo documation)

View of the crack on the wall of the fish ladder. Summer 2015.

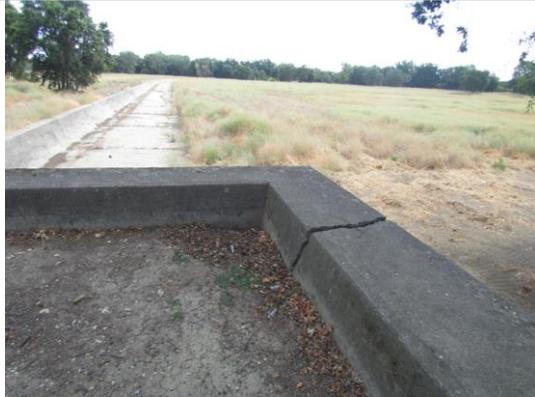
Photo 2 of 3 : ST\_2015\_NA0055\_2\_15\_20150819\_00022.jpg

View of the crack at the end of the weir. Summer 2015.

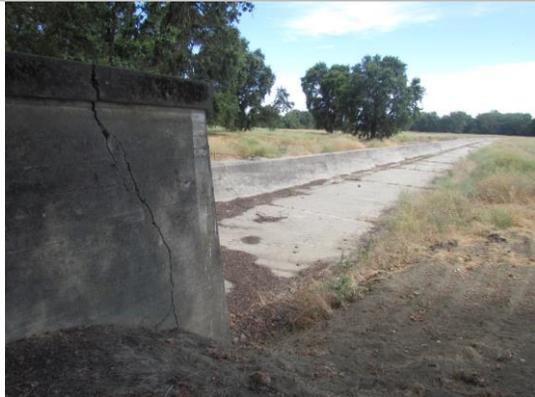
Photo 3 of 3 : ST\_2015\_NA0055\_2\_15\_20150819\_00023.jpg

Perspective view of the crack at the end of the weir. Summer 2015.

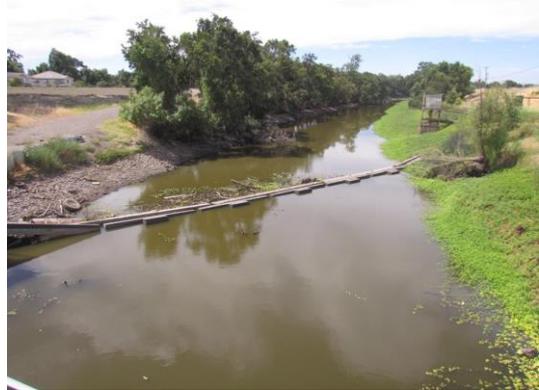
Photo 4 of 4 : ST\_2015\_NA0055\_41\_1\_20150707\_00012.jpg

View of the stop log and channel looking upstream. Summer 2015.

LM Start	<b>0.00</b>	Rating **	A	Issue No.	<b>2</b>
LM End	<b>0.00</b>	Issue Type +	Ma	Location *	
Category	Structures & Concrete Lined Channels		GPS Latitude/Longitude		
			Start	End	
Item	Vegetation & Obstructions		38.799560 °	38.799320 °	
			-121.725530 °	-121.724850 °	
DWR ID	DWR_NA0055_41_t_2012_2				
Action/Comments					
Inspector Comments: Minimal, scattered obstructions or vegetation. The flow is not impeded. Aquatic weeds are increasing on the stop logs and upstream of the structure.

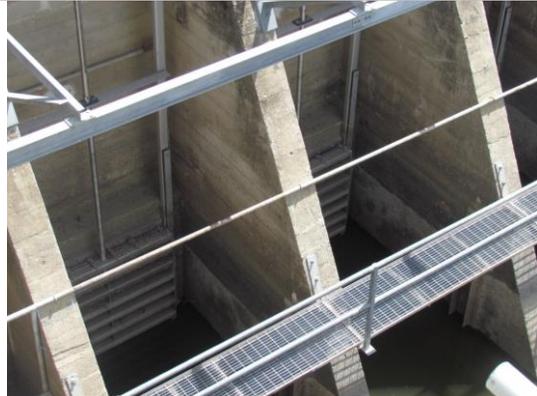
Photo 1 of 1 : ST\_2015\_NA0055\_41\_12\_20150819\_00013.jpg

View of the unopened slide gate on the inlet side of the structure. Summer 2015.

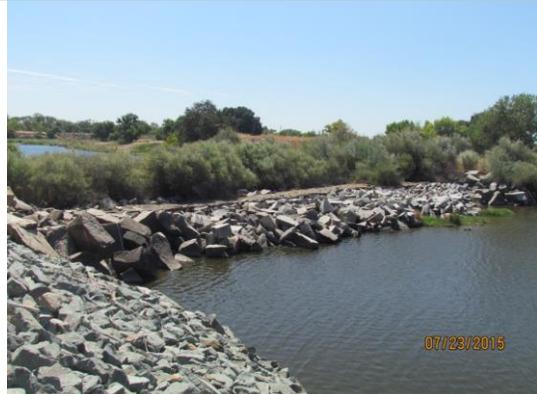
Photo 1 of 2 : ST\_2015\_XX0000\_52\_2\_20150724\_00004.jpg

LM Start	<b>0.00</b>	Rating **	M	Issue No.	<b>2</b>
LM End	<b>0.00</b>	Issue Type +	Ma	Location *	CR
Category	Structures & Concrete Lined Channels		GPS Latitude/Longitude		
			Start	End	
Item	Vegetation & Obstructions		37.760584 °	37.760584 °	
			-121.309450 °	-121.309450 °	
DWR ID	DWR_NA0055_52_t_2012_2				
Action/Comments					
Inspector Comments: Vegetation growth (such as dense vegetation (willows) obstructions block the upstream side (San Joaquin River) of the FCW.

View of the willows on the structure looking upstream. Summer 2015.

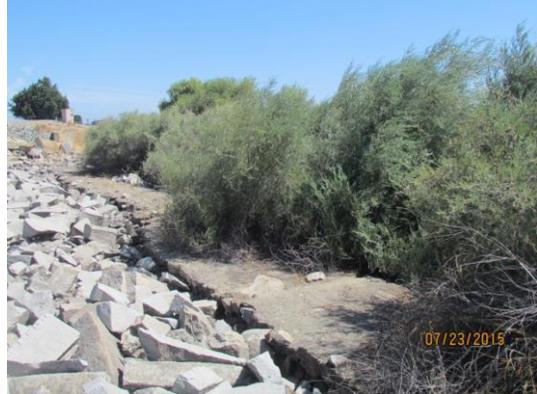
Photo 2 of 2 : ST\_2015\_XX0000\_52\_2\_20150724\_00011.jpg

View of the photos on the structure looking to the north. Summer 2015.

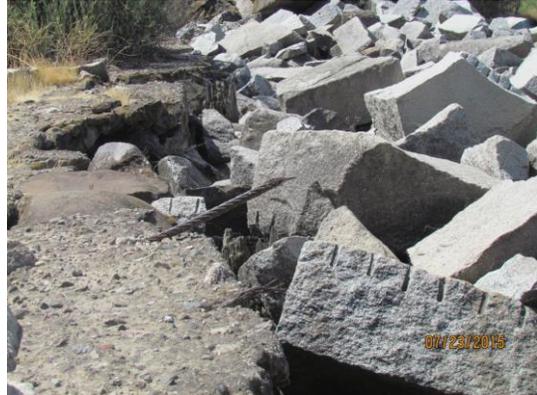
Photo 1 of 1 : ST\_2015\_XX0000\_52\_23\_20150724\_00005.jpg

Exposed cables on the structure looking to the south. Summer 2015.

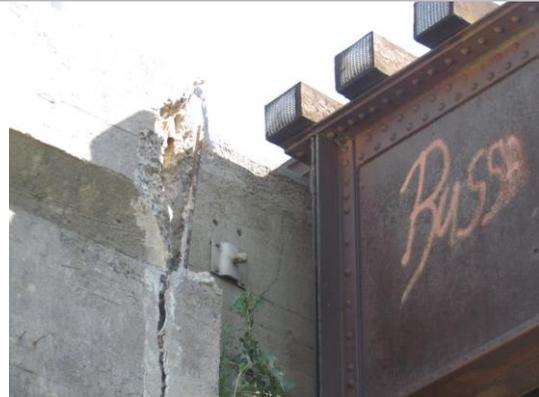
Photo 1 of 7 : ST\_2015\_NA0055\_1\_15\_20150708\_00014.jpg

View of the exposure of the rebar at the top of the structure on the north end of the structure. Summer 2015.

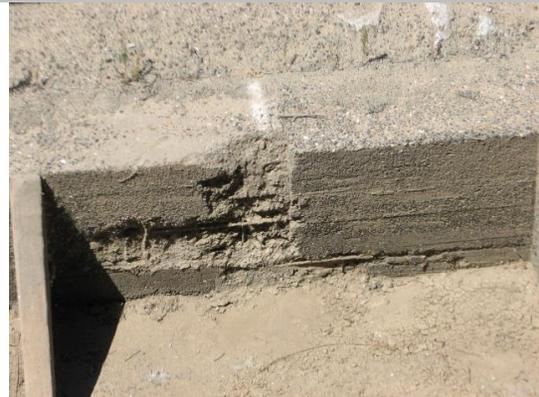
Photo 2 of 7 : ST\_2015\_NA0055\_1\_15\_20150819\_00017.jpg

( Bay 14) Rebar is exposed on the defusion wall. Summer 2014

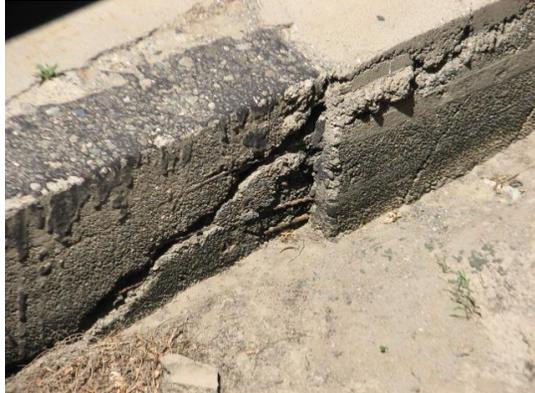
Photo 3 of 7 : ST\_2015\_NA0055\_1\_15\_20150819\_00018.jpg

(Bay1) Small cracking and rebar is exposed. Summer 2014

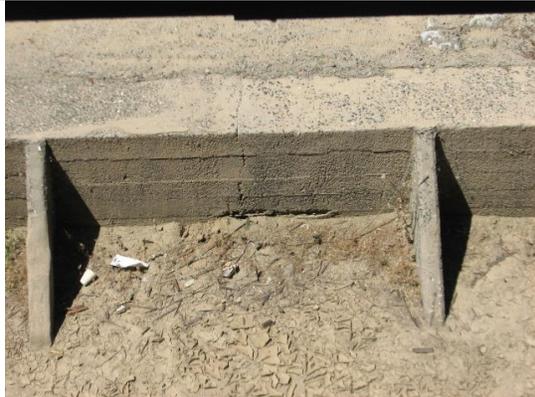
Photo 4 of 7 : ST\_2015\_NA0055\_1\_15\_20150819\_00019.jpg

(Bay11) A small amount of scouring at the base of the wall. Summer 2014

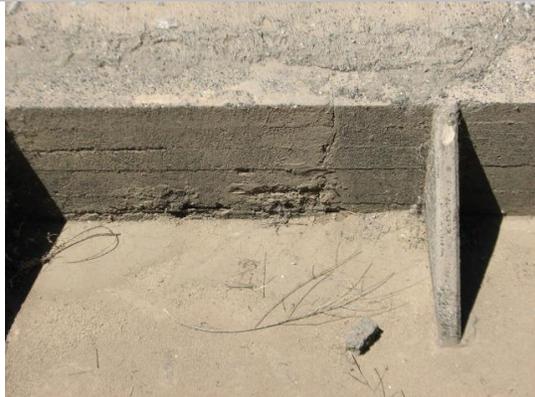
Photo 5 of 7 : ST\_2015\_NA0055\_1\_15\_20150819\_00020.jpg

(Bay 6) Scouring on the defusion wall. Summer 2014

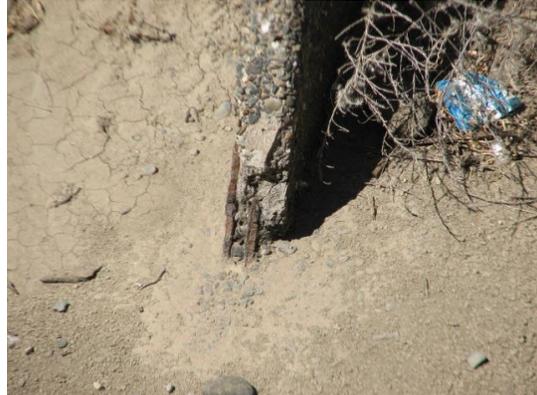
Photo 6 of 7 : ST\_2015\_NA0055\_1\_15\_20150819\_00021.jpg

(Bay3) Some rebar is exposed. Summer 2014

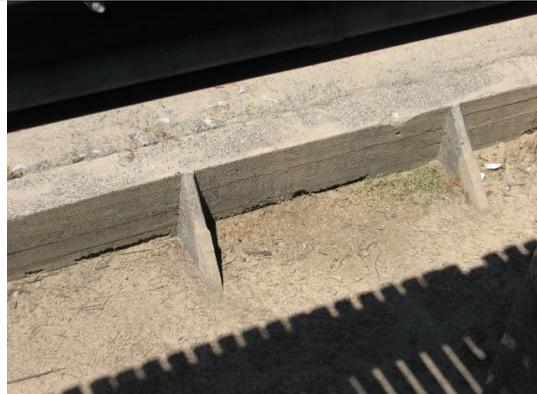
Photo 7 of 7 : ST\_2015\_NA0055\_1\_15\_20150819\_00022.jpg

(Bay 12) A small amount of scouring at the base of the wall. Summer 2014

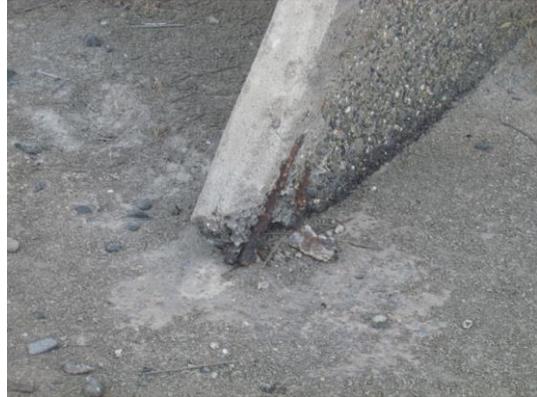
Photo 1 of 1 : ST\_2015\_NA0055\_1\_17\_20150819\_00016.jpg

View of the concrete erosion at the bottom of the wing wall for base 3 of the structure. Summer 2015.
