**Flood Control Project Maintenance  
Levee Inspections**

**2010 Channel Summary Report**

**DWR Sutter Maintenance Yard**

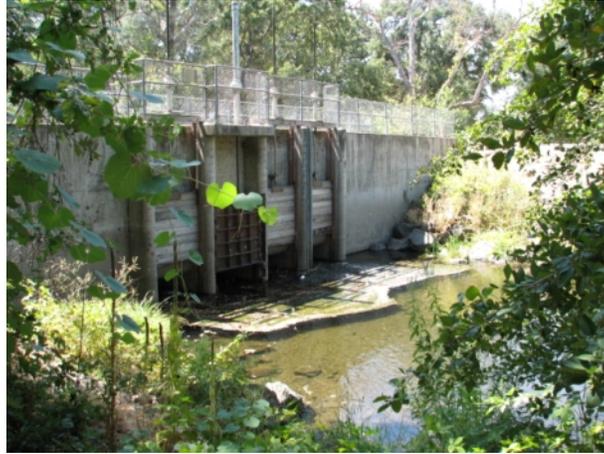
Levee Mile Report Line	1
Start Levee Mile	0.00
End Levee Mile	0.00
Location	
Category	Channels
Item	Vegetation & Obstructions
Big Chico Creek Control Structure.	
cathom_c_20100916_001.jpg

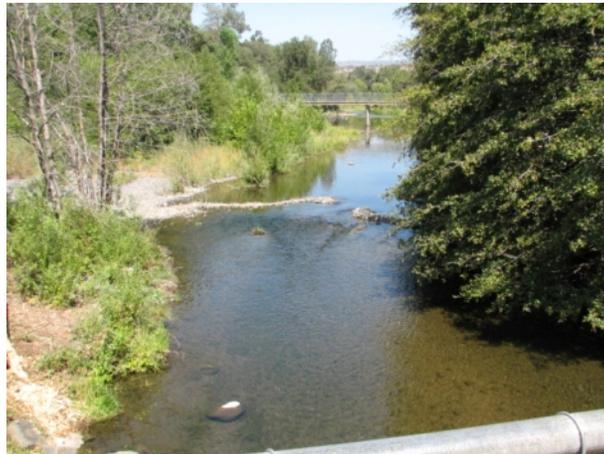
Levee Mile Report Line	1
Start Levee Mile	0.00
End Levee Mile	0.00
Location	
Category	Channels
Item	Vegetation & Obstructions
Up stream from Big Chico Creek Control Structure.	
cathom_c_20100916_002.jpg

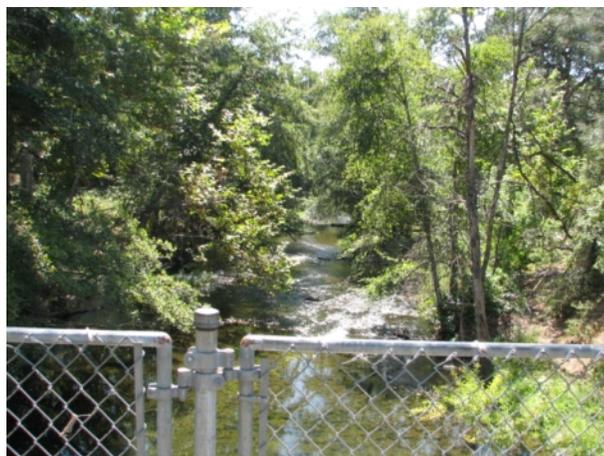
Levee Mile Report Line	6
Start Levee Mile	0.00
End Levee Mile	0.00
Location	
Category	Channels
Item	Vegetation & Obstructions
Downstream from Big Chico Creek Control Structure, growth along both banks.	
cathom_c_20100916_003.jpg

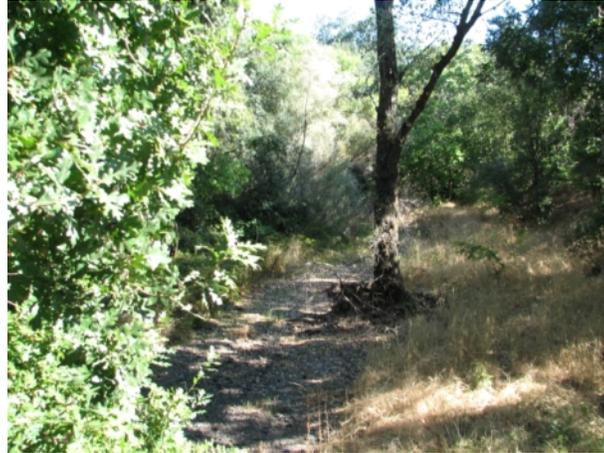
Levee Mile Report Line	11
Start Levee Mile	0.00
End Levee Mile	0.00
Location	
Category	Channels
Item	Vegetation & Obstructions
<p>This photo is looking up stream on Highway 32 bridge, near Forrest Avenue.</p>	
<p>cathom_c_20100916_072.jpg</p>

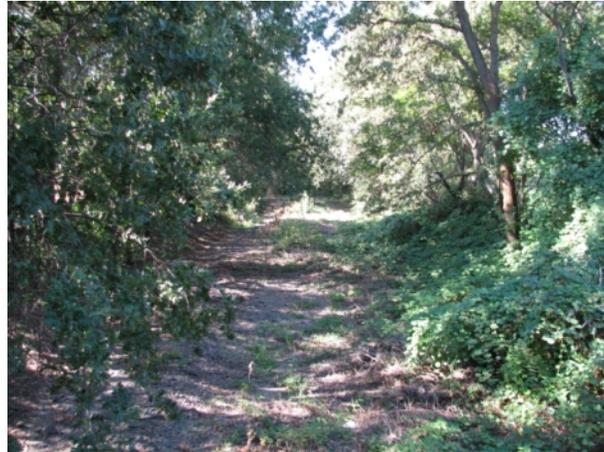
Levee Mile Report Line	16
Start Levee Mile	0.00
End Levee Mile	0.00
Location	
Category	Channels
Item	Vegetation & Obstructions
<p>This view is looking down stream on Highway 32 bridge, near Forrest Avenue.</p>	
<p>cathom_c_20100916_073.jpg</p>

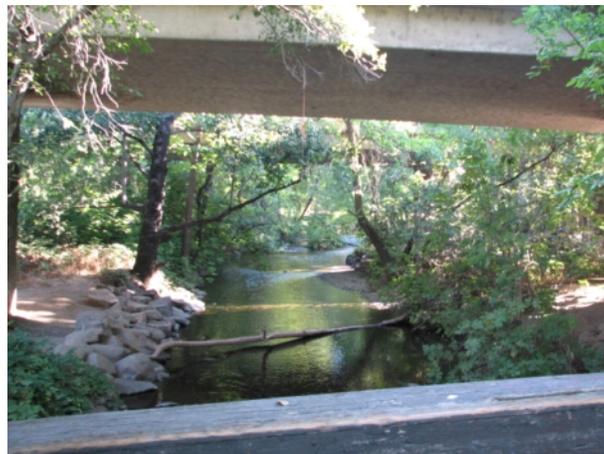
Levee Mile Report Line	21
Start Levee Mile	0.00
End Levee Mile	0.00
Location	
Category	Channels
Item	Vegetation & Obstructions
<p>This photo is looking up stream from Highway 99 bike path bridge. Near Villombrosa Avenue.</p>	
<p>cathom_c_20100916_074.jpg</p>

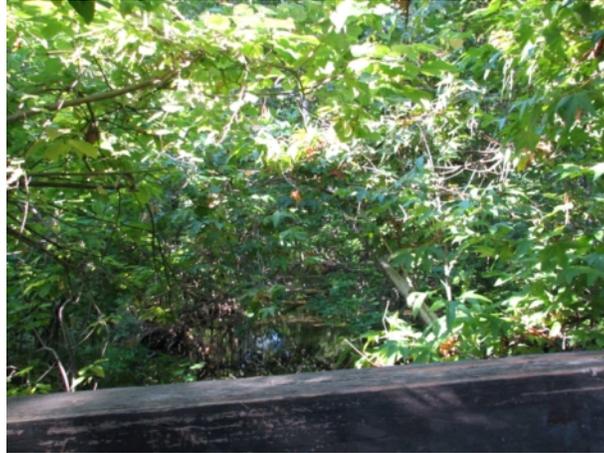
Levee Mile Report Line	26
Start Levee Mile	0.00
End Levee Mile	0.00
Location	
Category	Channels
Item	Vegetation & Obstructions
<p>This photo is looking down stream from the Highway 99 bike path. Near Villombrosa Avenue.</p>	
<p>cathom_c_20100916_075.jpg</p>

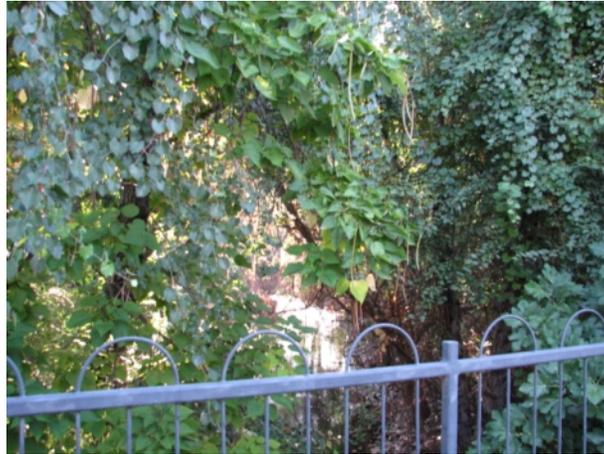
Levee Mile Report Line	31
Start Levee Mile	0.00
End Levee Mile	0.00
Location	
Category	Channels
Item	Vegetation & Obstructions
<p>This photo is looking up stream from Esplanade Avenue, near the Bidwell Mansion.</p>	
<p>cathom_c_20100916_076.jpg</p>

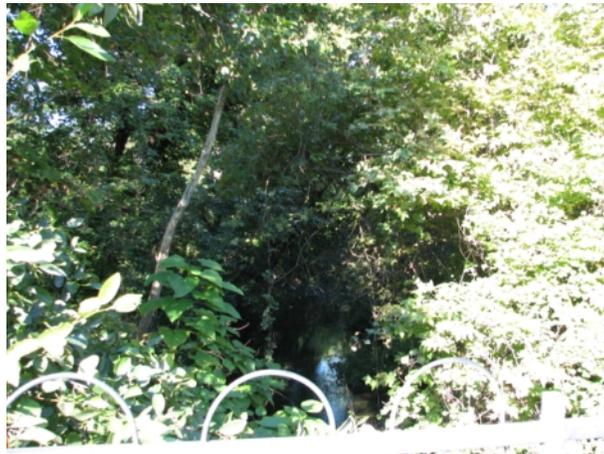
Levee Mile Report Line	36
Start Levee Mile	0.00
End Levee Mile	0.00
Location	
Category	Channels
Item	Vegetation & Obstructions
<p>This view is looking down stream from Esplanade Avenue.</p>	
<p>cathom_c_20100916_077.jpg</p>

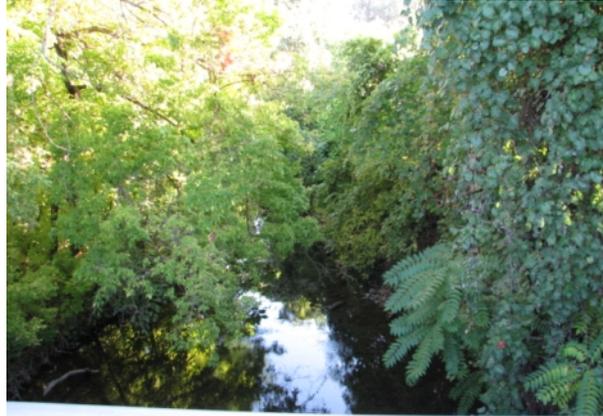
Levee Mile Report Line	41
Start Levee Mile	0.00
End Levee Mile	0.00
Location	
Category	Channels
Item	Vegetation & Obstructions
This view is looking up stream from Highway 32.	
cathom_c_20100916_078.jpg

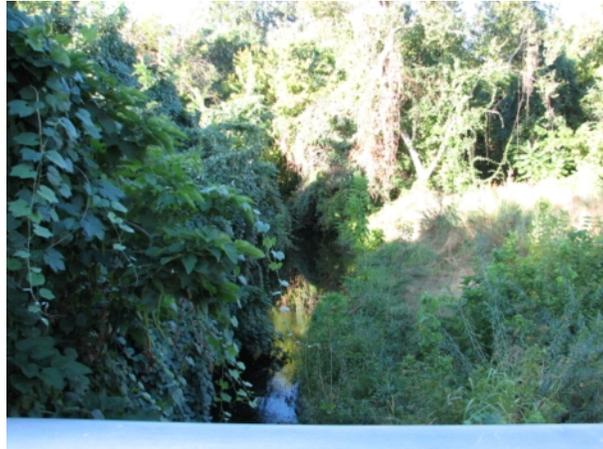
Levee Mile Report Line	46
Start Levee Mile	0.00
End Levee Mile	0.00
Location	
Category	Channels
Item	Vegetation & Obstructions
This photo is looking down stream from Highway 32.	
cathom_c_20100916_079.jpg

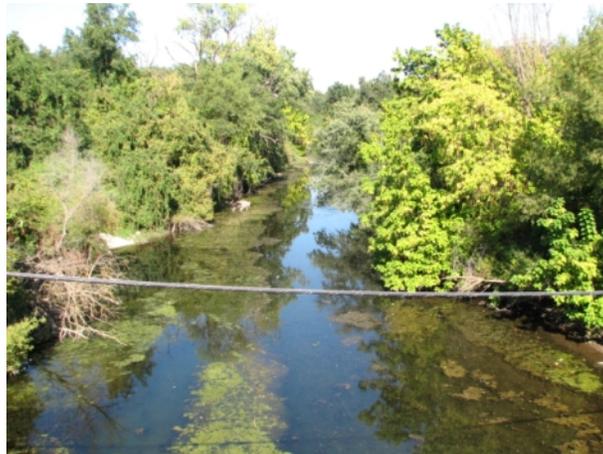
Levee Mile Report Line	51
Start Levee Mile	0.00
End Levee Mile	0.00
Location	
Category	Channels
Item	Vegetation & Obstructions
This photo is looking up stream from River Road at Mud Creek, near the confluence with the Sacramento River.	
cathom_c_20100916_080.jpg

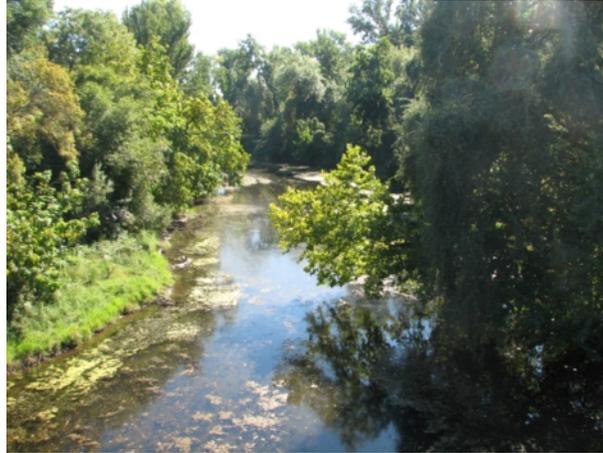
Levee Mile Report Line	56
Start Levee Mile	0.00
End Levee Mile	0.00
Location	
Category	Channels
Item	Vegetation & Obstructions
<p>This photo is looking down stream from the River Road bridge, near the confluence of the Sacramento River.</p>	
<p>cathom_c_20100916_081.jpg</p>

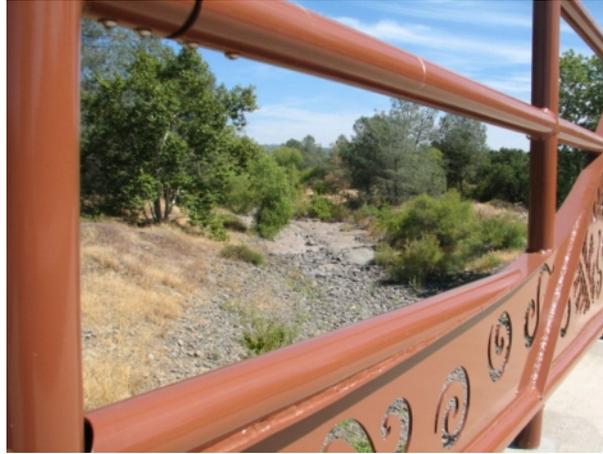
Levee Mile Report Line	11
Start Levee Mile	0.00
End Levee Mile	0.00
Location	
Category	Channels
Item	Vegetation & Obstructions
This view is looking up stream from Manzanita Avenue, new bridge is in place.	
cathom_c_20100916_060.jpg

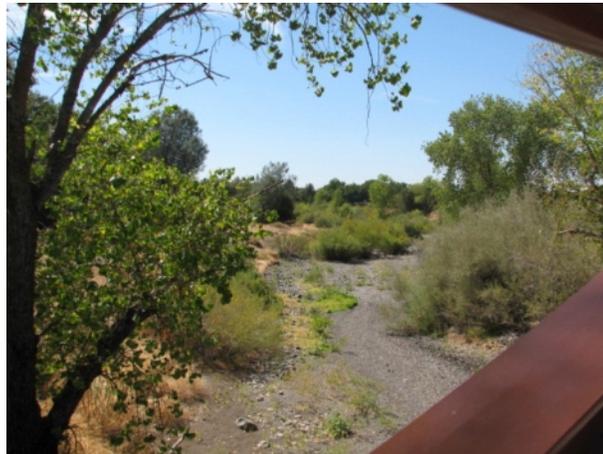
Levee Mile Report Line	16
Start Levee Mile	0.00
End Levee Mile	0.00
Location	
Category	Channels
Item	Vegetation & Obstructions
This view is looking down stream from Manzanita Avenue, note new bridge.	
cathom_c_20100916_064.jpg

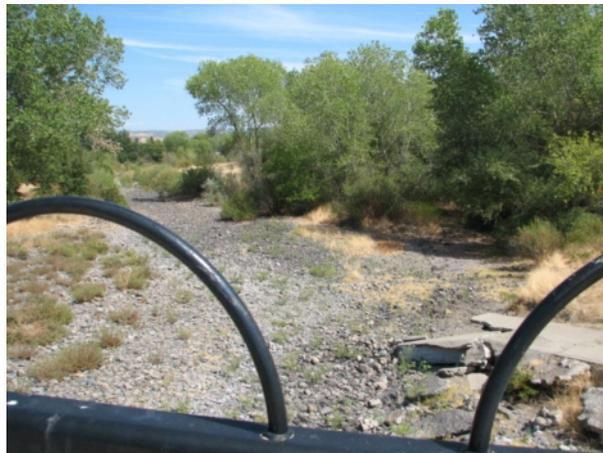
Levee Mile Report Line	21
Start Levee Mile	0.00
End Levee Mile	0.00
Location	
Category	Channels
Item	Vegetation & Obstructions
This view is looking up stream from the bike path bridge at the extension of Madrone Avenue.	
cathom_c_20100916_062.jpg

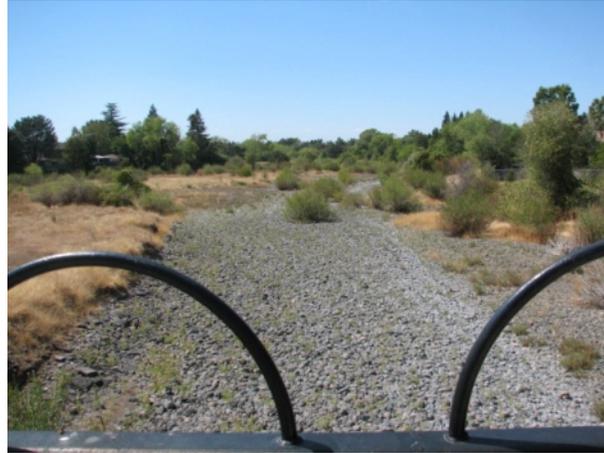
Levee Mile Report Line	26
Start Levee Mile	0.00
End Levee Mile	0.00
Location	
Category	Channels
Item	Vegetation & Obstructions
<p>This photo is looking down stream from the bike path at the extension of Madrone Avenue.</p>	
<p>cathom_c_20100916_065.jpg</p>

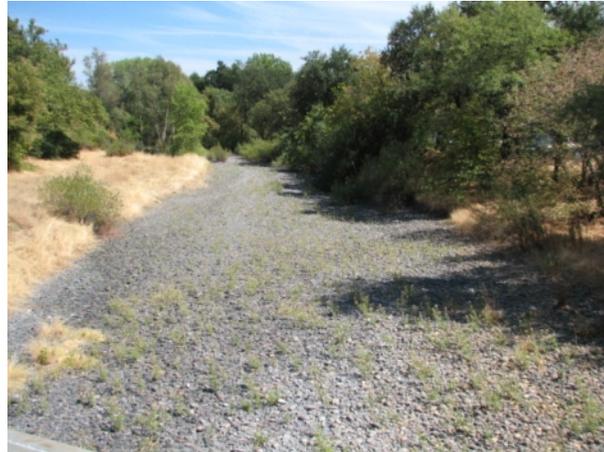
Levee Mile Report Line	31
Start Levee Mile	0.00
End Levee Mile	0.00
Location	
Category	Channels
Item	Vegetation & Obstructions
<p>This view is looking up stream from the bridge at Mariposa Avenue.</p>	
<p>cathom_c_20100916_066.jpg</p>

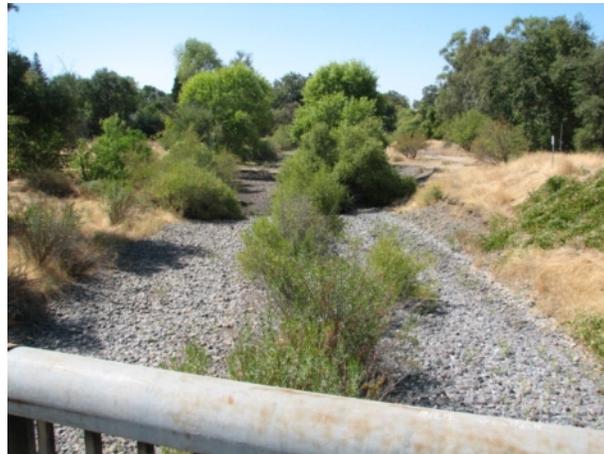
Levee Mile Report Line	36
Start Levee Mile	0.00
End Levee Mile	0.00
Location	
Category	Channels
Item	Vegetation & Obstructions
<p>This photo is looking down stream from the Mariposa Avenue bridge.</p>	
<p>cathom_c_20100916_067.jpg</p>

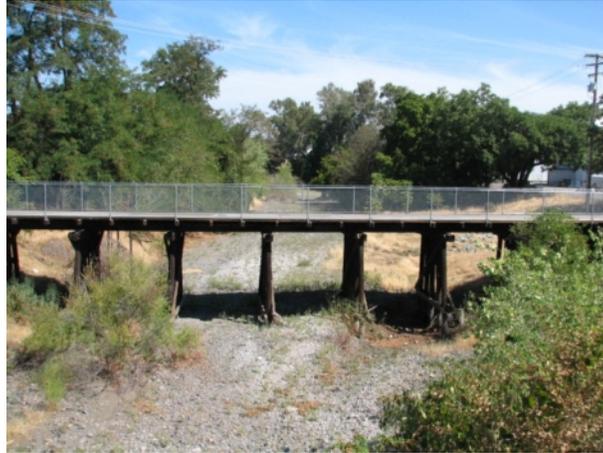
Levee Mile Report Line	51
Start Levee Mile	0.00
End Levee Mile	0.00
Location	
Category	Channels
Item	Vegetation & Obstructions
This view is looking up stream from Esplanade Avenue bridge.	
cathom_c_20100916_068.jpg

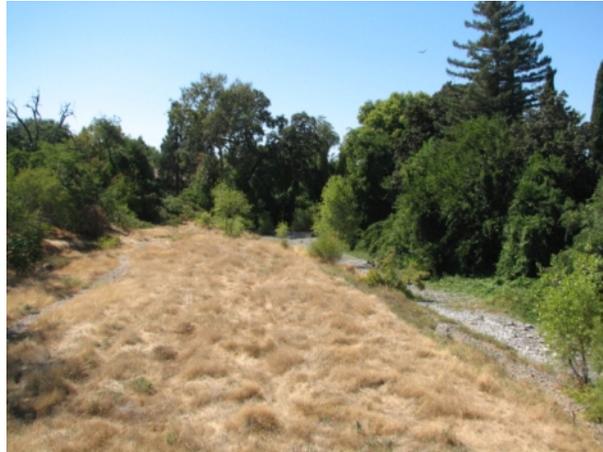
Levee Mile Report Line	56
Start Levee Mile	0.00
End Levee Mile	0.00
Location	
Category	Channels
Item	Vegetation & Obstructions
This photo is looking down stream from Esplanade Avenue bridge.	
cathom_c_20100916_069.jpg

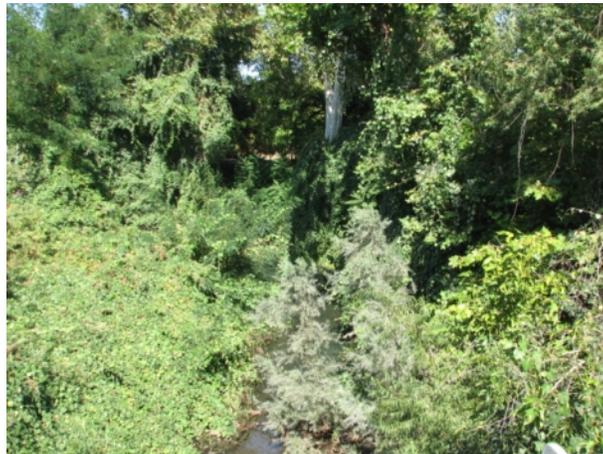
Levee Mile Report Line	61
Start Levee Mile	0.00
End Levee Mile	0.00
Location	
Category	Channels
Item	Vegetation & Obstructions
This view is looking up stream from the Highway 32, Nord Avenue bridge.	
cathom_c_20100916_070.jpg

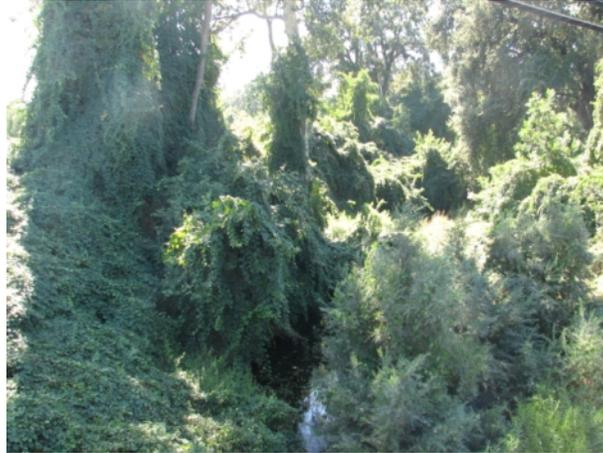
Levee Mile Report Line	66
Start Levee Mile	0.00
End Levee Mile	0.00
Location	
Category	Channels
Item	Vegetation & Obstructions
This photo is looking down stream from Highway 32, Nord Avenue bridge.	
cathom_c_20100916_071.jpg

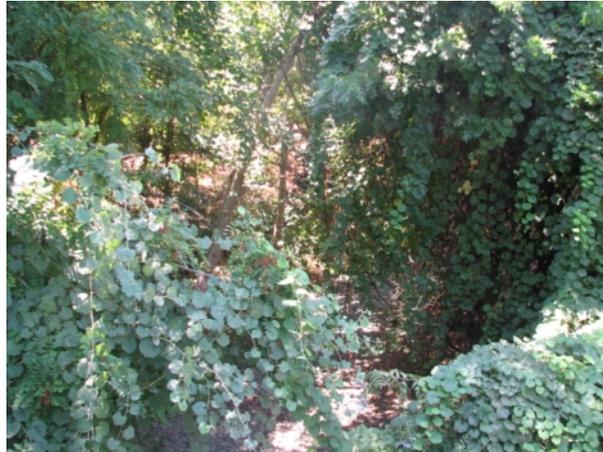
Levee Mile Report Line	78
Start Levee Mile	0.00
End Levee Mile	0.00
Location	
Category	Channels
Item	Erosion / Bank Caving
Down stream at Oak Avenue.	
cathom_c_20100916_038.jpg

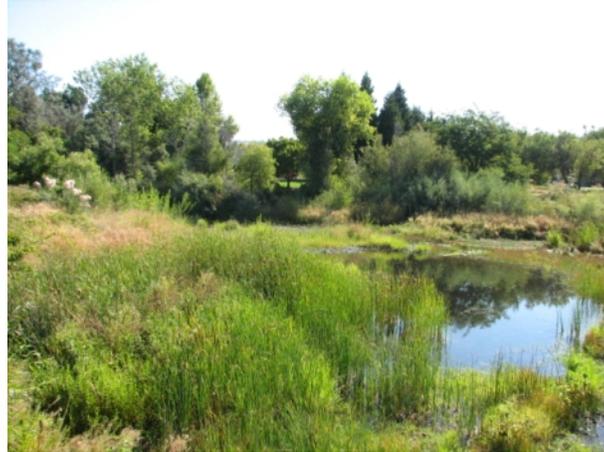
Levee Mile Report Line	1
Start Levee Mile	0.00
End Levee Mile	0.00
Location	
Category	Channels
Item	Vegetation & Obstructions
<p>This photo is looking up stream from the control structure near Stilson Road.</p>	
<p>cathom_c_20100916_082.jpg</p>

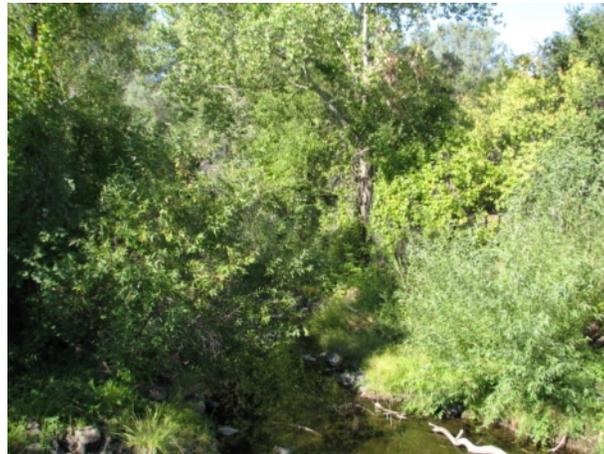
Levee Mile Report Line	6
Start Levee Mile	0.00
End Levee Mile	0.00
Location	
Category	Channels
Item	Vegetation & Obstructions
<p>This photo is looking down stream from the control structure.</p>	
<p>cathom_c_20100916_083.jpg</p>

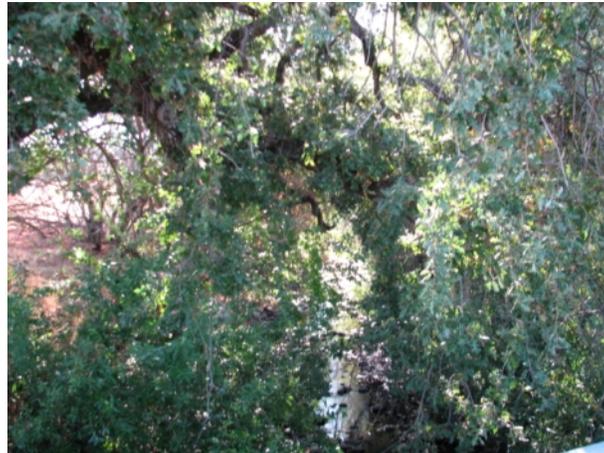
Levee Mile Report Line	11
Start Levee Mile	0.00
End Levee Mile	0.00
Location	
Category	Channels
Item	Vegetation & Obstructions
<p>This photo is looking up stream from Bruce Road bridge.</p>	
<p>cathom_c_20100916_084.jpg</p>

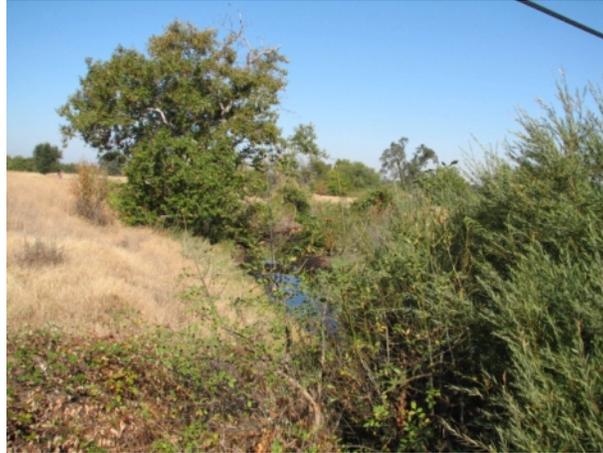
Levee Mile Report Line	16
Start Levee Mile	0.00
End Levee Mile	0.00
Location	
Category	Channels
Item	Vegetation & Obstructions
This photo is looking down stream from Bruce Road bridge.	
cathom_c_20100916_085.jpg

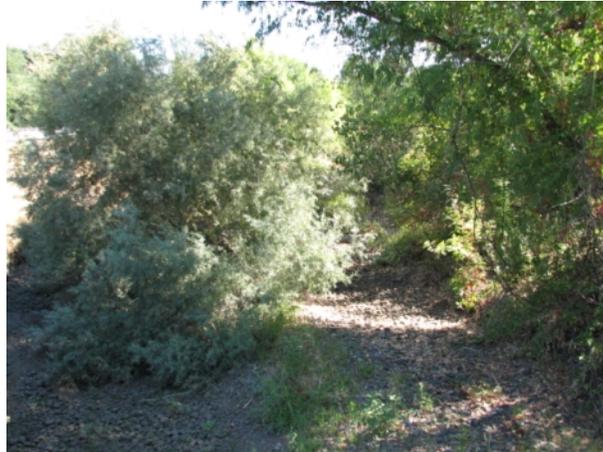
Levee Mile Report Line	21
Start Levee Mile	0.00
End Levee Mile	0.00
Location	
Category	Channels
Item	Vegetation & Obstructions
This photo is looking up stream from Forrest Avenue bridge.	
cathom_c_20100916_086.jpg

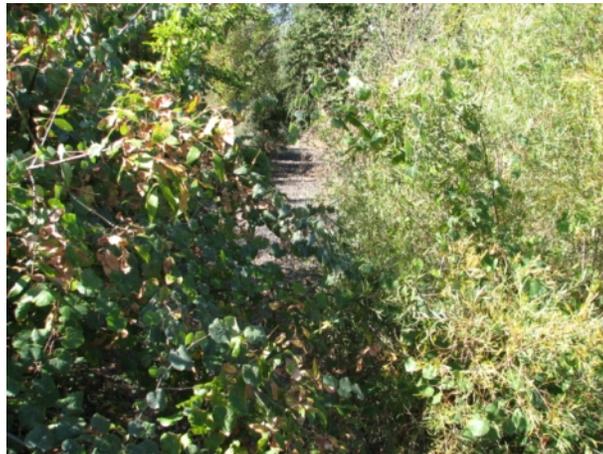
Levee Mile Report Line	26
Start Levee Mile	0.00
End Levee Mile	0.00
Location	
Category	Channels
Item	Vegetation & Obstructions
This photo is looking down stream from the Forrest Avenue bridge.	
cathom_c_20100916_087.jpg

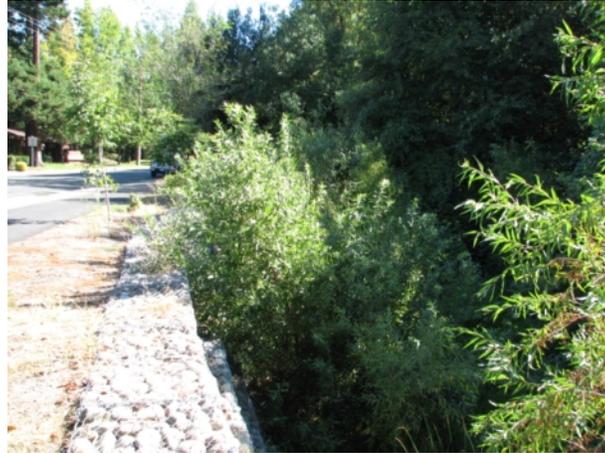
Levee Mile Report Line	31
Start Levee Mile	0.00
End Levee Mile	0.00
Location	
Category	Channels
Item	Vegetation & Obstructions
<p>This photo is looking up stream at the erosion repair site, up stream from Highway 99 on Humbolt Road.</p>	
<p>cathom_c_20100916_088.jpg</p>

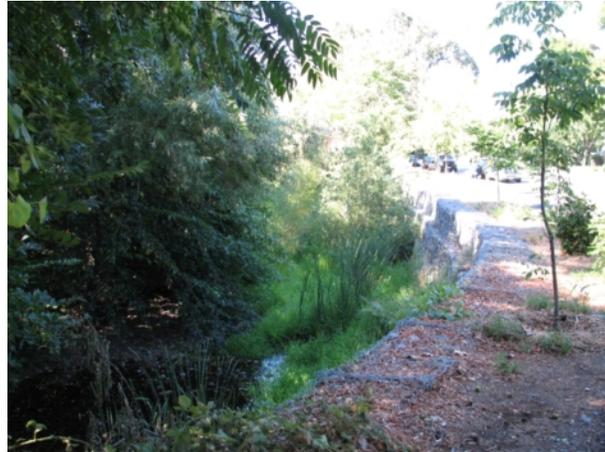
Levee Mile Report Line	36
Start Levee Mile	0.00
End Levee Mile	0.00
Location	
Category	Channels
Item	Vegetation & Obstructions
<p>This photo is looking down stream at the erosion repair site, down stream of Highway 99 on Humbolt Road.</p>	
<p>cathom_c_20100916_089.jpg</p>

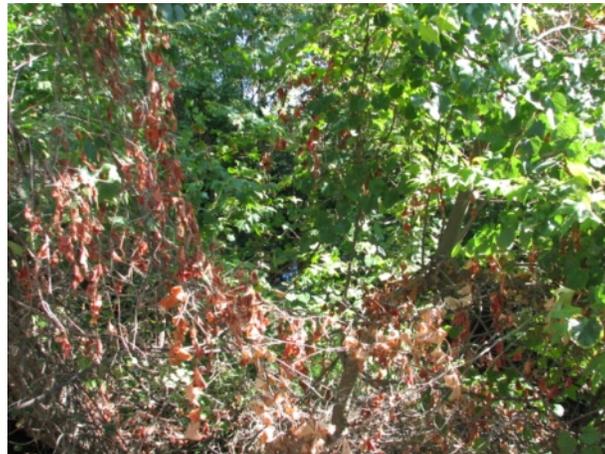
Levee Mile Report Line	41
Start Levee Mile	0.00
End Levee Mile	0.00
Location	
Category	Channels
Item	Vegetation & Obstructions
<p>This photo is looking up stream from Boucher Street bridge.</p>	
<p>cathom_c_20100916_090.jpg</p>

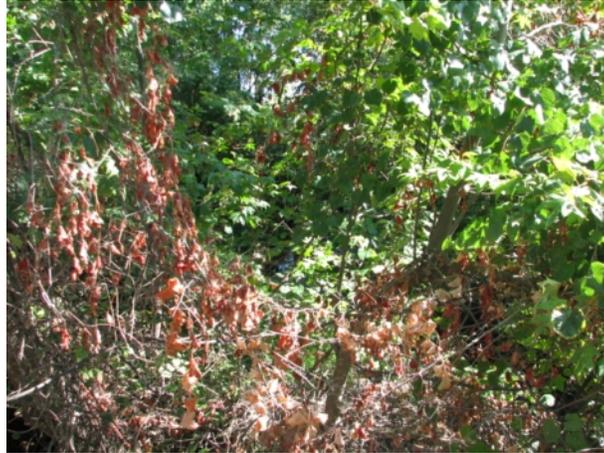
Levee Mile Report Line	46
Start Levee Mile	0.00
End Levee Mile	0.00
Location	
Category	Channels
Item	Vegetation & Obstructions
This photo is looking down stream from Boucher Street bridge.	
cathom_c_20100916_091.jpg

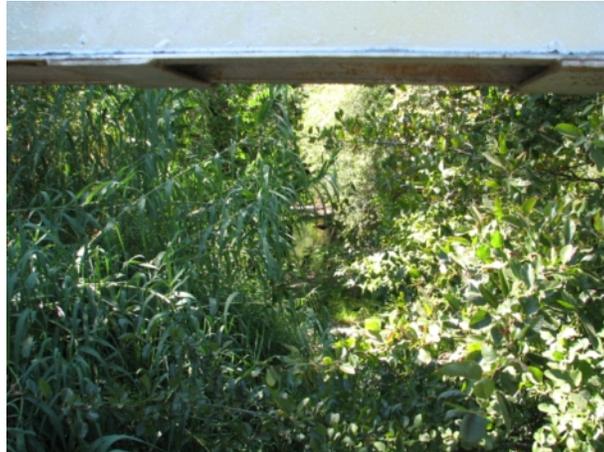
Levee Mile Report Line	51
Start Levee Mile	0.00
End Levee Mile	0.00
Location	
Category	Channels
Item	Vegetation & Obstructions
This photo is looking up stream from Olive Street bridge.	
cathom_c_20100916_092.jpg

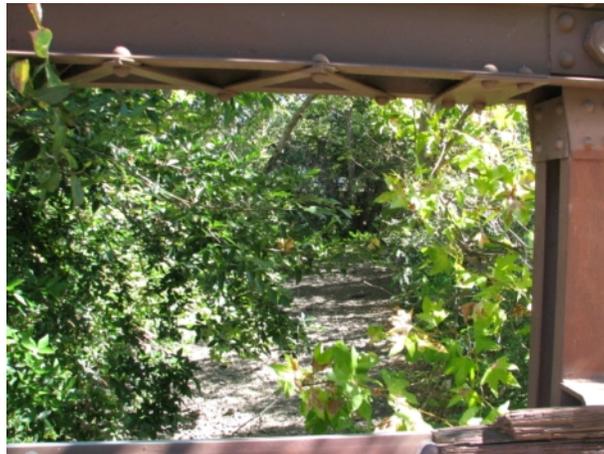
Levee Mile Report Line	56
Start Levee Mile	0.00
End Levee Mile	0.00
Location	
Category	Channels
Item	Vegetation & Obstructions
This photo is looking down stream from the Olive Street bridge.	
cathom_c_20100916_093.jpg

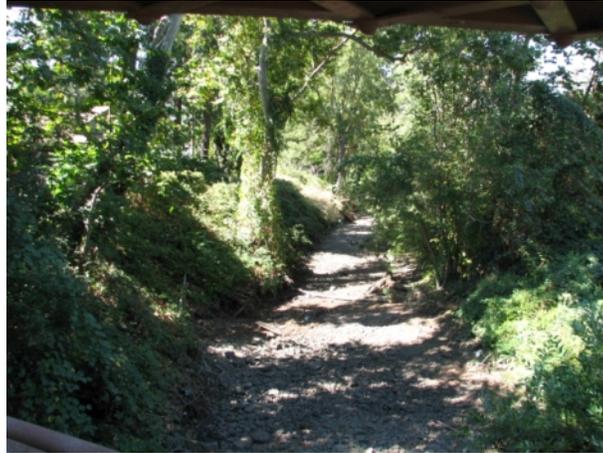
Levee Mile Report Line	71
Start Levee Mile	0.00
End Levee Mile	0.00
Location	
Category	Channels
Item	Vegetation & Obstructions
This photo is looking up stream from Lone Pine Avenue.	
cathom_c_20100916_094.jpg

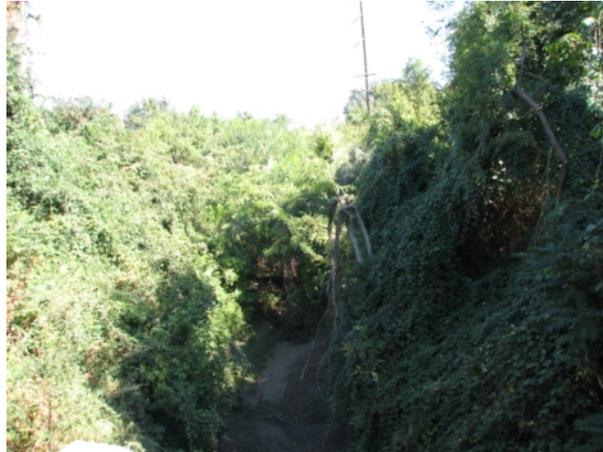
Levee Mile Report Line	76
Start Levee Mile	0.00
End Levee Mile	0.00
Location	
Category	Channels
Item	Vegetation & Obstructions
This photo is looking down stream from Lone Pine Avenue bridge.	
cathom_c_20100916_095.jpg
