**Flood Control Project Maintenance
Levee Inspections**

2011 Channel Summary Report

DWR Sutter Maintenance Yard

Flood Control Project Maintenance
Unit Cover Sheet
2011 Channel Inspection Results

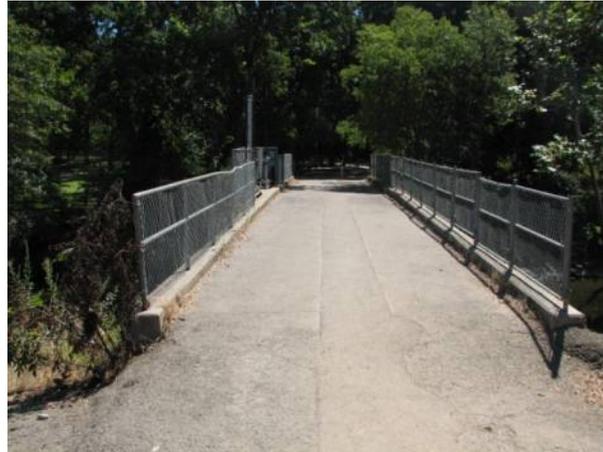
Levee Mile Report Line	1
Start Levee Mile	0.00
End Levee Mile	0.00
Location	
Category	Channels
Item	Vegetation & Obstructions
Upstream from Big Chico Creek Control Structure.	
cathom_c_20110831_066.jpg

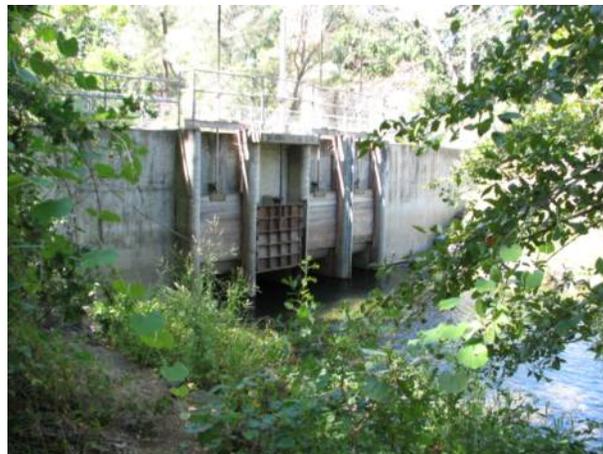
Levee Mile Report Line	6
Start Levee Mile	0.00
End Levee Mile	0.00
Location	
Category	Channels
Item	Vegetation & Obstructions
Downstream from Big Chico Creek Control Structure,	
cathom_c_20110831_067.jpg

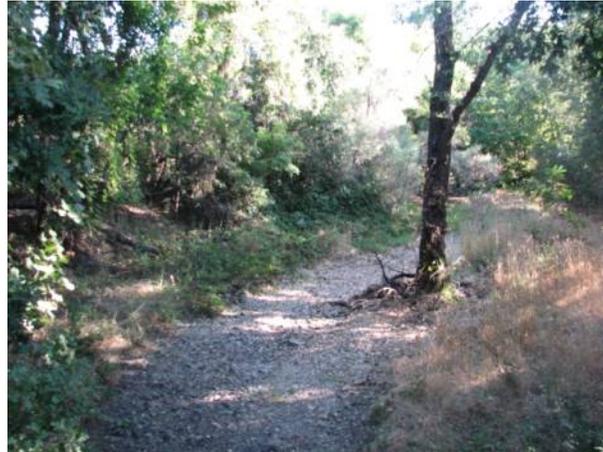
Levee Mile Report Line	16
Start Levee Mile	0.00
End Levee Mile	0.00
Location	
Category	Channels
Item	Vegetation & Obstructions
<p>This view is looking downstream on Highway 32 bridge, near Forrest Avenue.</p>	
<p>cathom_c_20110831_064.jpg</p>

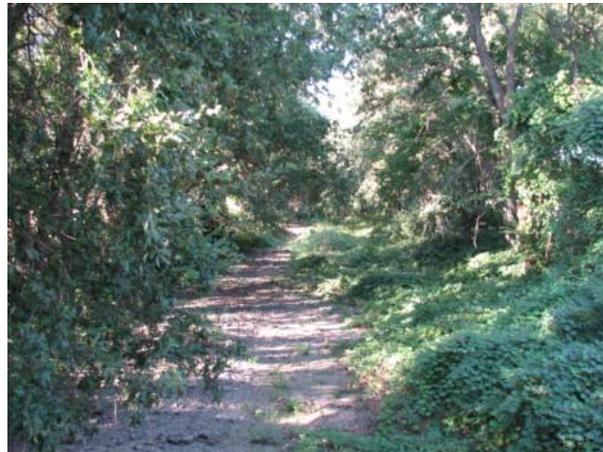
Levee Mile Report Line	21
Start Levee Mile	0.00
End Levee Mile	0.00
Location	
Category	Channels
Item	Vegetation & Obstructions
<p>This photo is looking upstream from Highway 99 bike path bridge. Near Villombrosa Avenue.</p>	
<p>cathom_c_20110831_068.jpg</p>

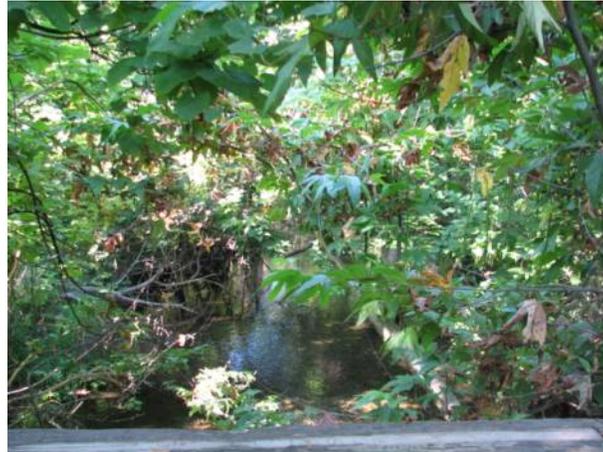
Levee Mile Report Line	31
Start Levee Mile	0.00
End Levee Mile	0.00
Location	
Category	Channels
Item	Vegetation & Obstructions
<p>This photo is looking upstream from Esplanade Avenue.</p>	
<p>cathom_c_20110831_070.jpg</p>

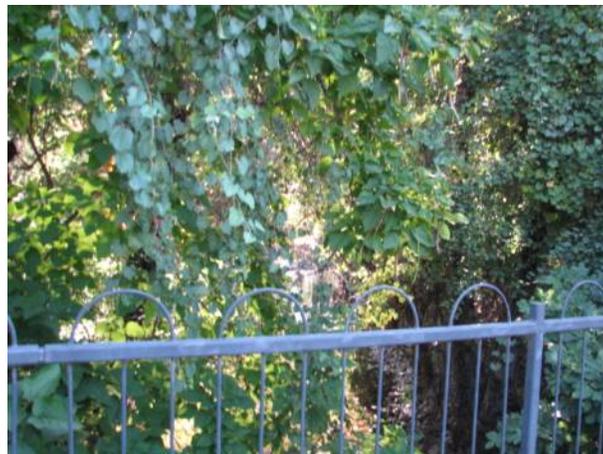
Levee Mile Report Line	36
Start Levee Mile	0.00
End Levee Mile	0.00
Location	
Category	Channels
Item	Vegetation & Obstructions
<p>This view is looking downstream from Esplanade Avenue.</p>	
<p>cathom_c_20110824_009.jpg</p>

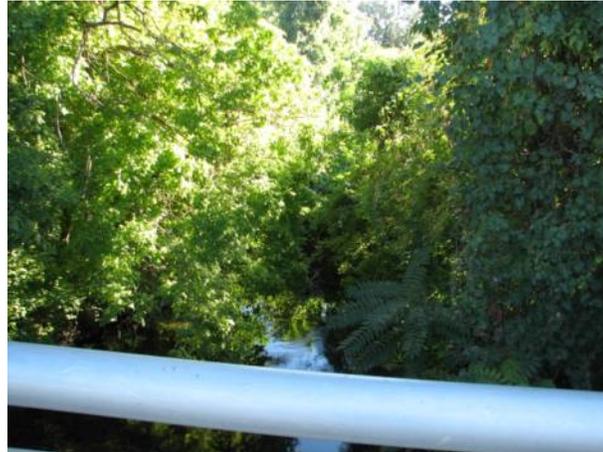
Levee Mile Report Line	46
Start Levee Mile	0.00
End Levee Mile	0.00
Location	
Category	Channels
Item	Vegetation & Obstructions
<p>This photo is looking downstream from Highway 32. The vegetation obstructs the view for revetment inspection.</p>	
<p>cathom_c_20110831_072.jpg</p>

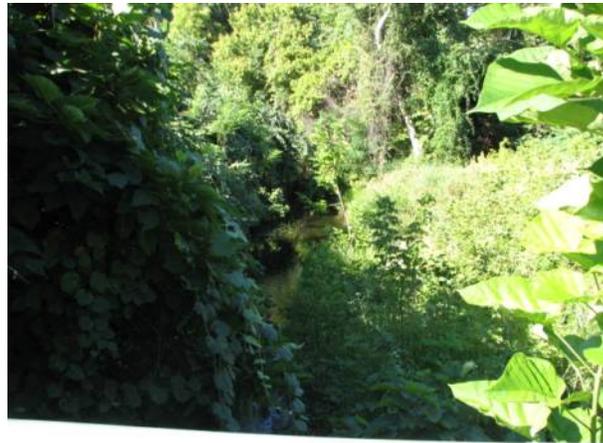
Levee Mile Report Line	51
Start Levee Mile	0.00
End Levee Mile	0.00
Location	
Category	Channels
Item	Vegetation & Obstructions
<p>This photo is looking upstream from River Road at Mud Creek, near the confluence with the Sacramento River.</p>	
<p>cathom_c_20110831_073.jpg</p>

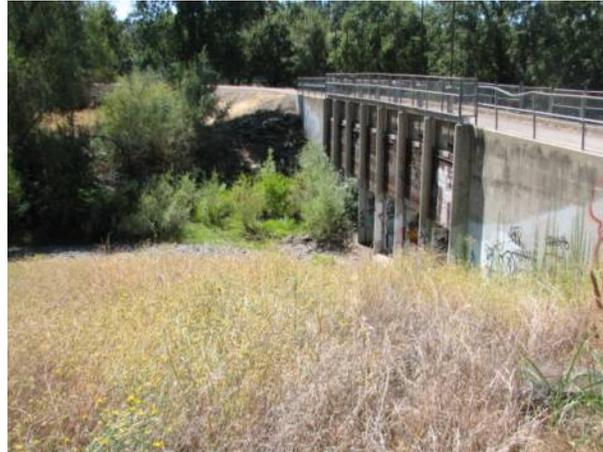
Levee Mile Report Line	6
Start Levee Mile	0.00
End Levee Mile	0.00
Location	
Category	Channels
Item	Vegetation & Obstructions
<p>This view is of the downstream side of the control structure.</p>	
<p>cathom_c_20110825_040.jpg</p>

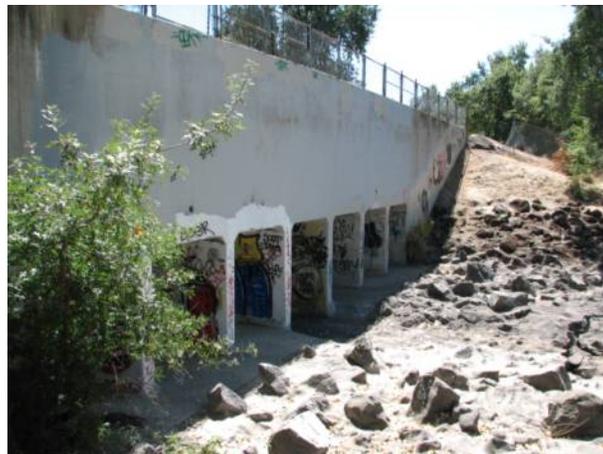
Levee Mile Report Line	11
Start Levee Mile	0.00
End Levee Mile	0.00
Location	
Category	Channels
Item	Vegetation & Obstructions
<p>This view is looking up stream from Manzanita Avenue, new bridge is in place.</p>	
<p>cathom_c_20110829_041.jpg</p>

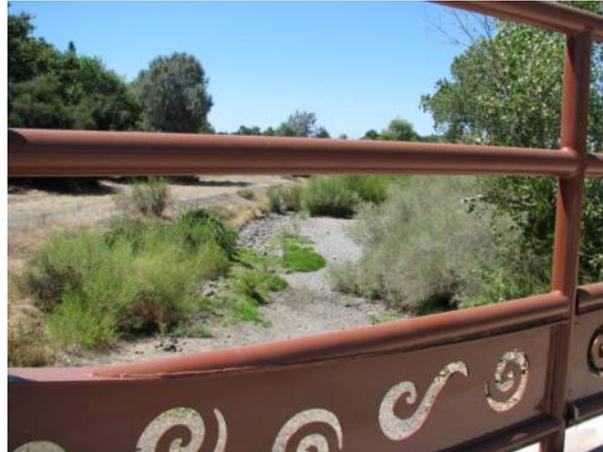
Levee Mile Report Line	21
Start Levee Mile	0.00
End Levee Mile	0.00
Location	
Category	Channels
Item	Vegetation & Obstructions
<p>This view is looking up stream from the bike path bridge at the extension of Madrone Avenue.</p>	
<p>cathom_c_20110829_043.jpg</p>

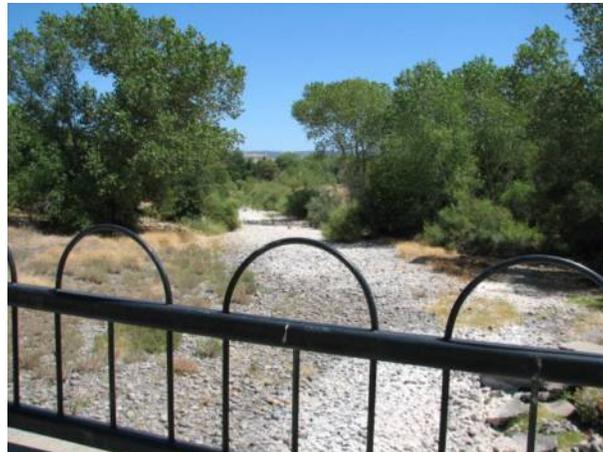
Levee Mile Report Line	26
Start Levee Mile	0.00
End Levee Mile	0.00
Location	
Category	Channels
Item	Vegetation & Obstructions
<p>This photo is looking down stream from the bike path at the extension of Madrone Avenue.</p>	
<p>cathom_c_20110829_044.jpg</p>

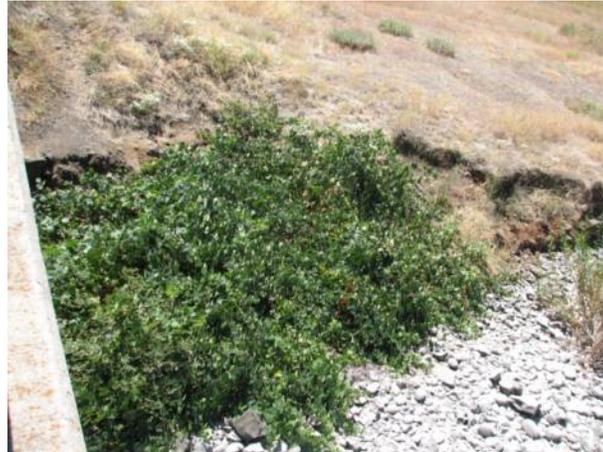
Levee Mile Report Line	31
Start Levee Mile	0.00
End Levee Mile	0.00
Location	
Category	Channels
Item	Vegetation & Obstructions
<p>This view is looking up stream from the bridge at Mariposa Avenue.</p>	
<p>cathom_c_20110830_046.jpg</p>

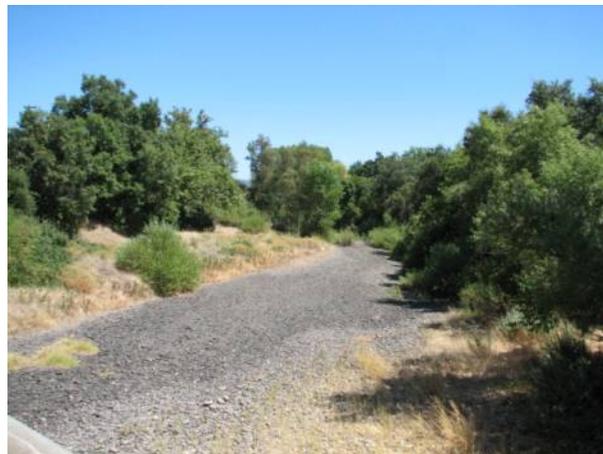
Levee Mile Report Line	36
Start Levee Mile	0.00
End Levee Mile	0.00
Location	
Category	Channels
Item	Vegetation & Obstructions
<p>This photo is looking down stream from the Mariposa Avenue bridge.</p>	
<p>cathom_c_20110830_047.jpg</p>

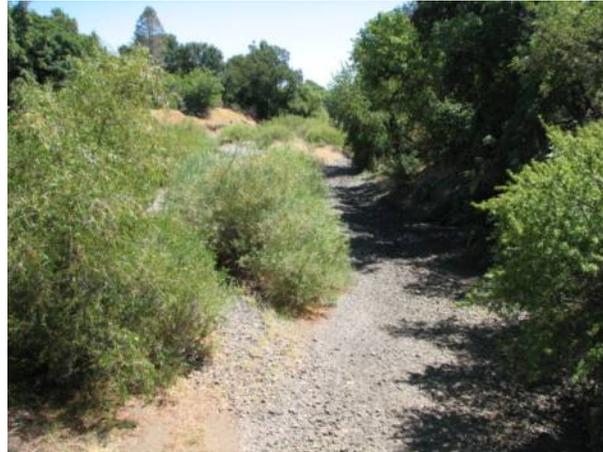
Levee Mile Report Line	46
Start Levee Mile	0.00
End Levee Mile	0.00
Location	
Category	Channels
Item	Vegetation & Obstructions
This photo is looking downstream from 5th Ave.	
cathom_c_20110830_049.jpg

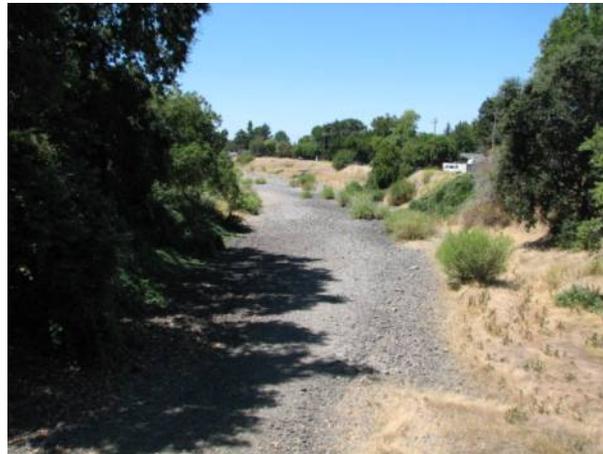
Levee Mile Report Line	51
Start Levee Mile	0.00
End Levee Mile	0.00
Location	
Category	Channels
Item	Vegetation & Obstructions
This view is looking up stream from Esplanade Avenue bridge.	
cathom_c_20110830_050.jpg

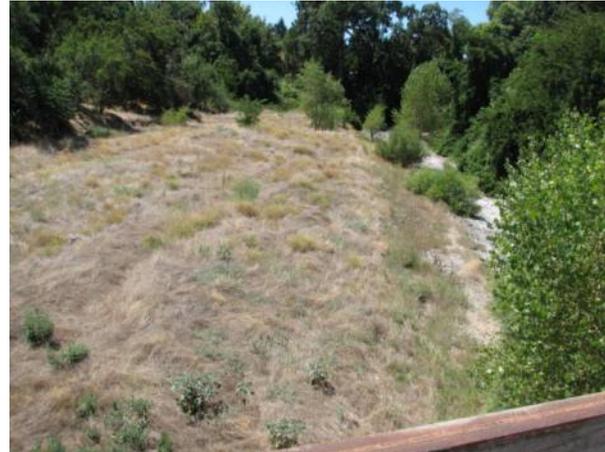
Levee Mile Report Line	61
Start Levee Mile	0.00
End Levee Mile	0.00
Location	
Category	Channels
Item	Vegetation & Obstructions
<p>This view is looking up stream from the Highway 32, Nord Avenue bridge.</p>	
<p>cathom_c_20110830_052.jpg</p>

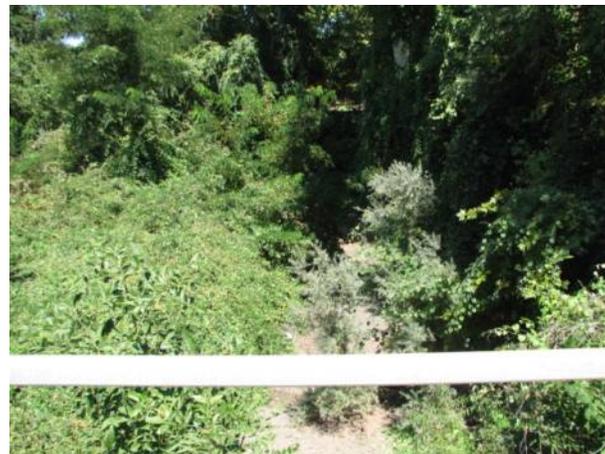
Levee Mile Report Line	66
Start Levee Mile	0.00
End Levee Mile	0.00
Location	
Category	Channels
Item	Vegetation & Obstructions
<p>This photo is looking down stream from Highway 32, Nord Avenue bridge.</p>	
<p>cathom_c_20110830_053.jpg</p>

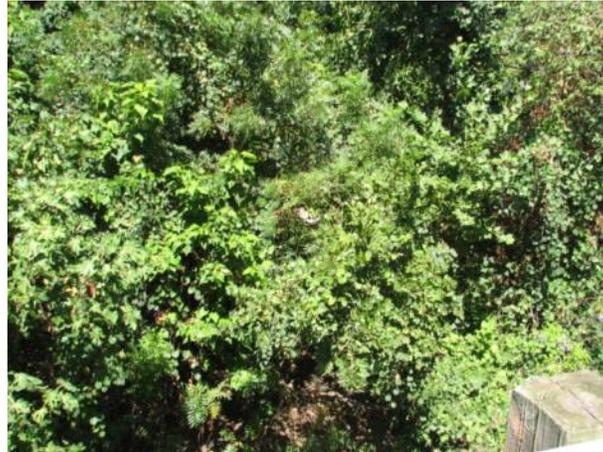
Levee Mile Report Line	76
Start Levee Mile	0.00
End Levee Mile	0.00
Location	
Category	Channels
Item	Vegetation & Obstructions
This is a view of the channel from the downstream side of the Oak Ave. bridge.	
cathom_c_20110830_056.jpg

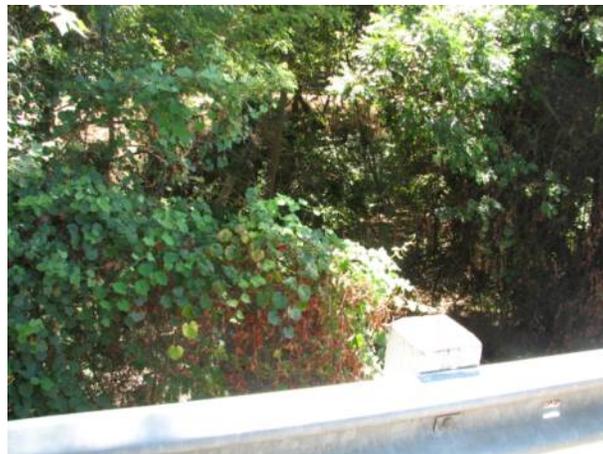
Levee Mile Report Line	78
Start Levee Mile	0.00
End Levee Mile	0.00
Location	
Category	Channels
Item	Erosion / Bank Caving
Down stream at Oak Avenue.	
cathom_c_20110824_024.jpg

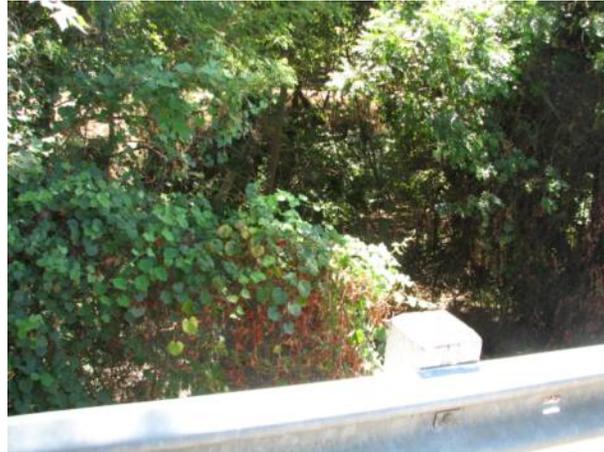
Levee Mile Report Line	84
Start Levee Mile	0.00
End Levee Mile	0.00
Location	
Category	Channels
Item	Revetments
<p>This photo is looking upstream at the channel from the Grape Way bridge. Vegetation obstructing the view should be removed.</p>	
<p>cathom_c_20110830_060.jpg</p>

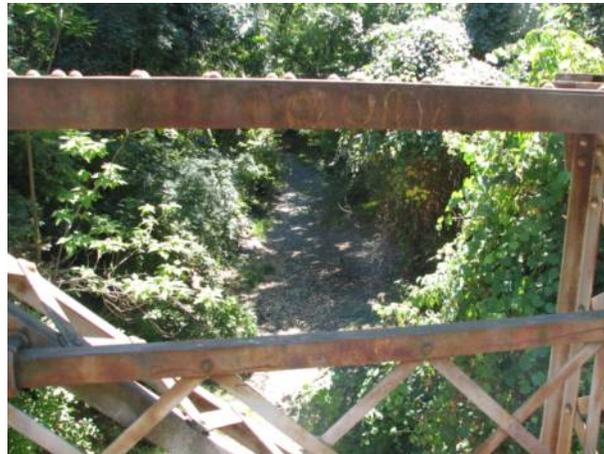
Levee Mile Report Line	89
Start Levee Mile	0.00
End Levee Mile	0.00
Location	
Category	Channels
Item	Revetments
<p>This view is looking downstream at the channel at the Grape Way bridge. Vegetation obstructing the view of revetment should be removed.</p>	
<p>cathom_c_20110830_062.jpg</p>

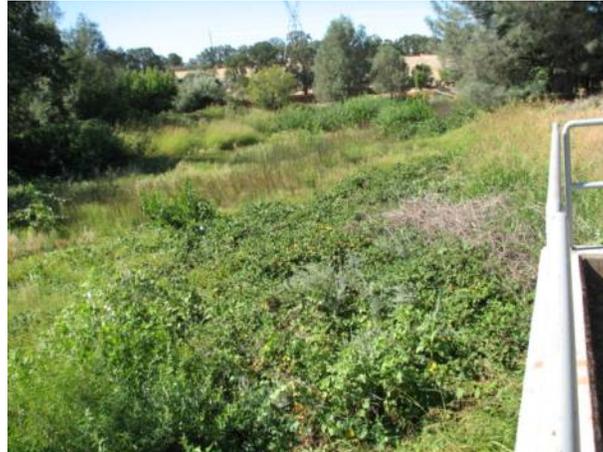
Levee Mile Report Line	1
Start Levee Mile	0.00
End Levee Mile	0.00
Location	
Category	Channels
Item	Vegetation & Obstructions
<p>This photo is of the control structure.</p>	
<p>cathom_c_20110831_076.jpg</p>

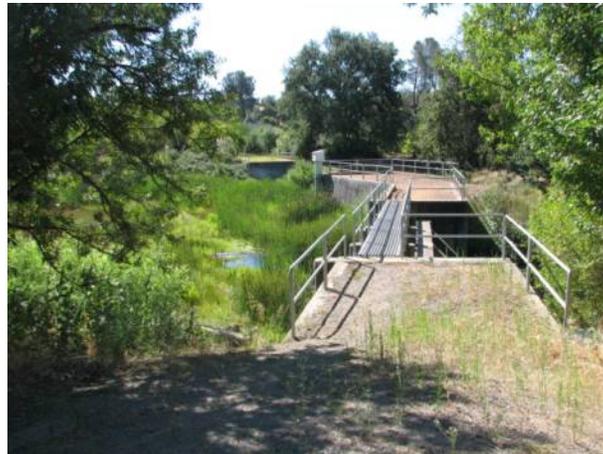
Levee Mile Report Line	6
Start Levee Mile	0.00
End Levee Mile	0.00
Location	
Category	Channels
Item	Vegetation & Obstructions
<p>This photo is looking downstream from the control structure.</p>	
<p>cathom_c_20110831_077.jpg</p>

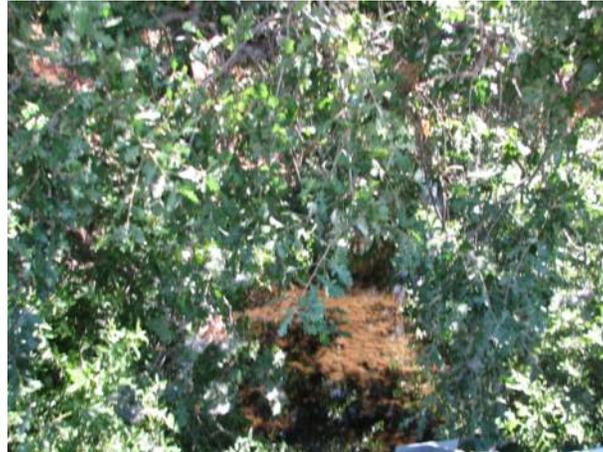
Levee Mile Report Line	16
Start Levee Mile	0.00
End Levee Mile	0.00
Location	
Category	Channels
Item	Vegetation & Obstructions
<p>This photo is looking downstream from Bruce Road bridge. Vegetation obstructed the view of the channel.</p>	
<p>cathom_c_20110901_079.jpg</p>

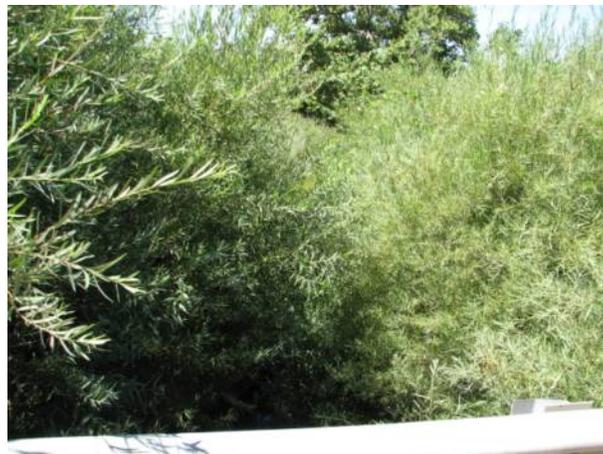
Levee Mile Report Line	21
Start Levee Mile	0.00
End Levee Mile	0.00
Location	
Category	Channels
Item	Vegetation & Obstructions
<p>This photo is looking upstream from Forrest Avenue bridge. Shoaling and vegetation in the channel.</p>	
<p>cathom_c_20110901_080.jpg</p>

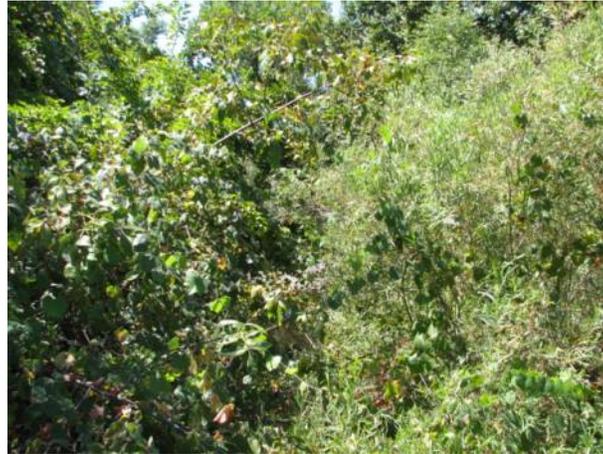
Levee Mile Report Line	31
Start Levee Mile	0.00
End Levee Mile	0.00
Location	
Category	Channels
Item	Vegetation & Obstructions
<p>This photo is looking up stream at the erosion repair site, up stream from Highway 99 on Humbolt Road. There is vegetation in the channel, the flow in the channel does not appear to be impeded.</p>	
<p>cathom_c_20110901_082.jpg</p>

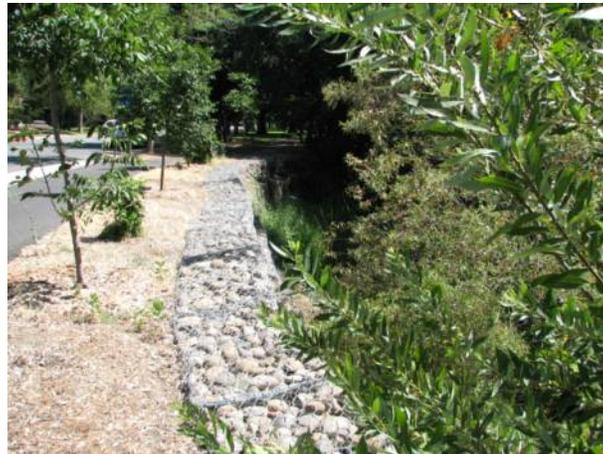
Levee Mile Report Line	36
Start Levee Mile	0.00
End Levee Mile	0.00
Location	
Category	Channels
Item	Vegetation & Obstructions
<p>This photo is looking downstream at the erosion repair site, down stream of Highway 99 on Humbolt Road. There is vegetation in the channel, the flow does not appear impeded.</p>	
<p>cathom_c_20110901_083.jpg</p>

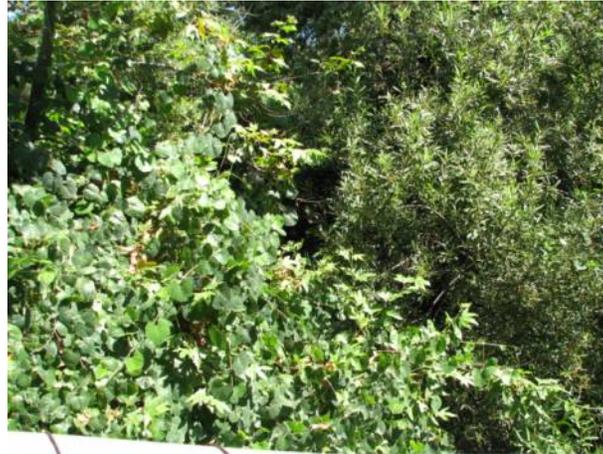
Levee Mile Report Line	46
Start Levee Mile	0.00
End Levee Mile	0.00
Location	
Category	Channels
Item	Vegetation & Obstructions
<p>This photo is looking downstream from Boucher Street bridge.</p>	
<p>cathom_c_20110901_085.jpg</p>

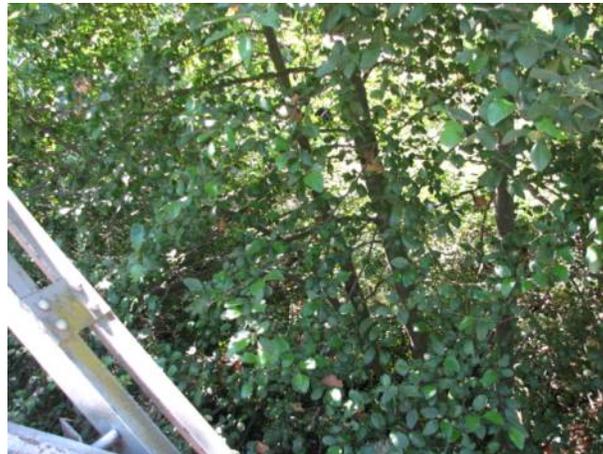
Levee Mile Report Line	51
Start Levee Mile	0.00
End Levee Mile	0.00
Location	
Category	Channels
Item	Vegetation & Obstructions
<p>This photo is looking upstream from Olive Street bridge.</p>	
<p>cathom_c_20110901_086.jpg</p>

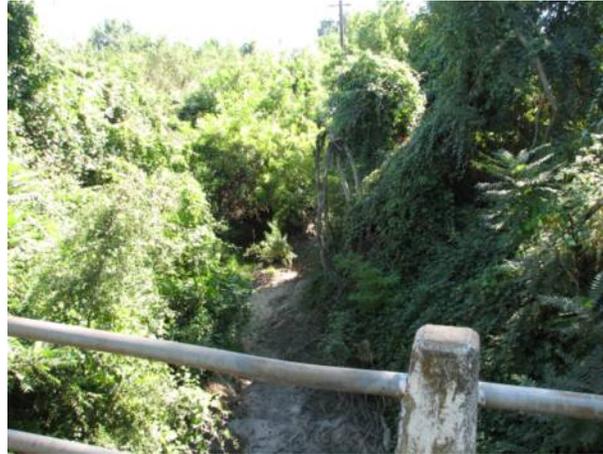
Levee Mile Report Line	76
Start Levee Mile	0.00
End Levee Mile	0.00
Location	
Category	Channels
Item	Vegetation & Obstructions
This photo is looking upstream from Lone Pine Avenue.	
cathom_c_20110901_091.jpg
