**Flood Control Project Maintenance
Levee Inspections**

2015 Channel Summary Report

DWR Sutter Maintenance Yard

2015 Channel Inspection Results

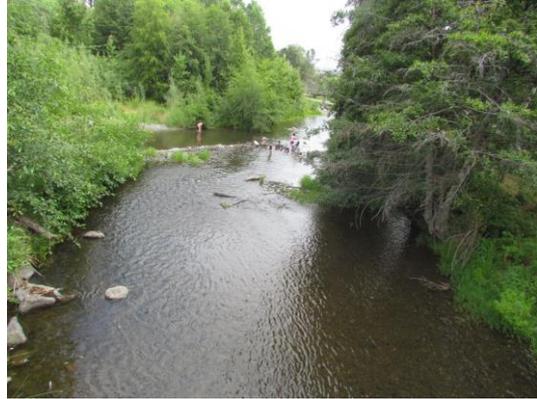
Photo 1 of 1 : CH_2015_NA0060_5_1_20150728_00013.jpg

Check Point / View			
Big Chico Creek Control Structure / Up			
Rating **	A	Issue No.	1
Issue Type +	Ma	Location *	39.761840 °
Category	Rivers, Channels & Designated Flood		-121.792590 °
Item	Vegetation & Obstructions		
DWR ID	DWR_NA0060_5_c_2012_1		
Action/Comments			
Inspector Comments: Minimal, scattered obstructions and vegetation. The flow is not impeded.

View of the channel from the structure facing upstream.

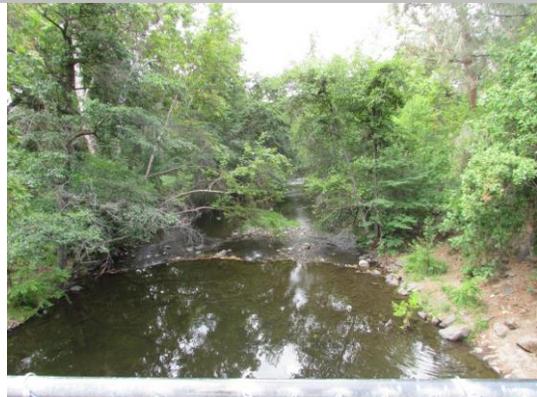
Photo 1 of 1 : CH_2015_NA0060_5_6_20150728_00014.jpg

View of the downstream side of the channel from the structure.

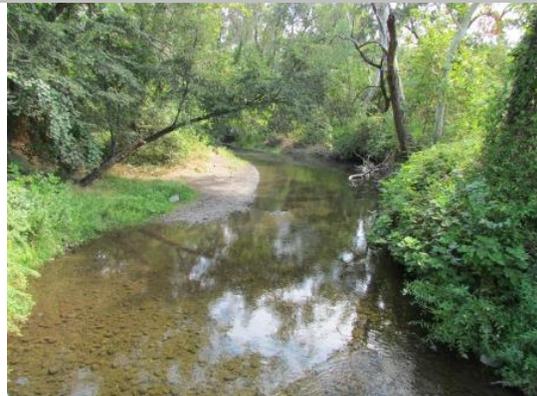
Photo 1 of 1 : CH_2015_NA0060_5_11_20150610_00003.jpg

This photo is looking upstream on Manzanita Ave.

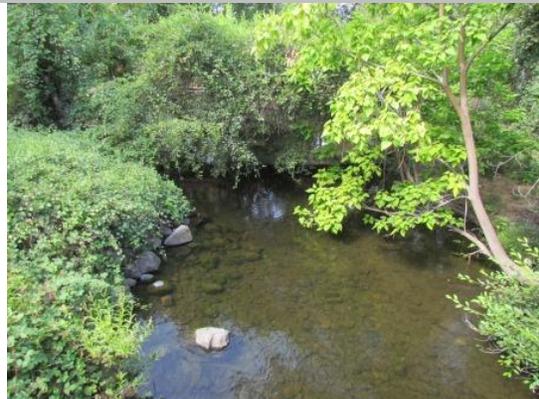
Photo 1 of 1 : CH_2015_NA0060_5_16_20150610_00004.jpg

This photo is looking downstream on Manzanita Ave.

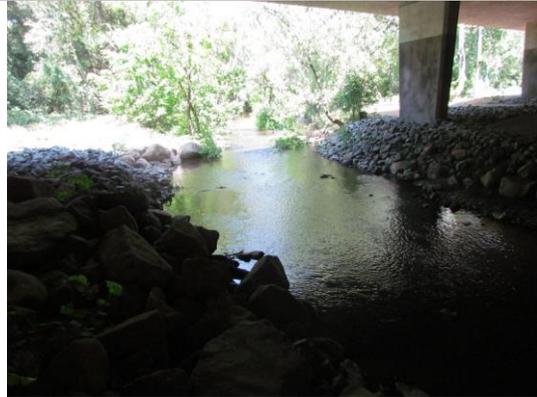
Photo 1 of 1 : CH_2015_NA0060_5_21_20150812_00021.jpg

View of the channel from under Highway 99 facing upstream.

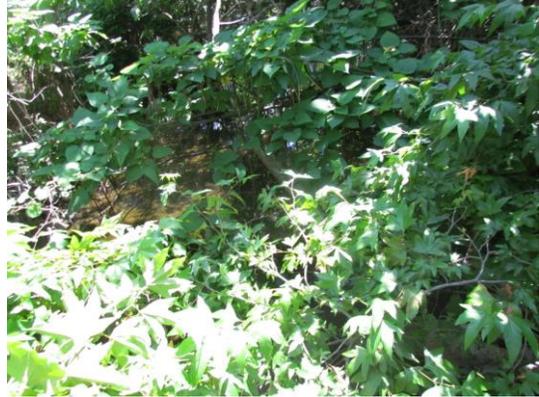
Photo 1 of 1 : CH_2015_NA0060_5_26_20150812_00022.jpg

View of the channel facing downstream.

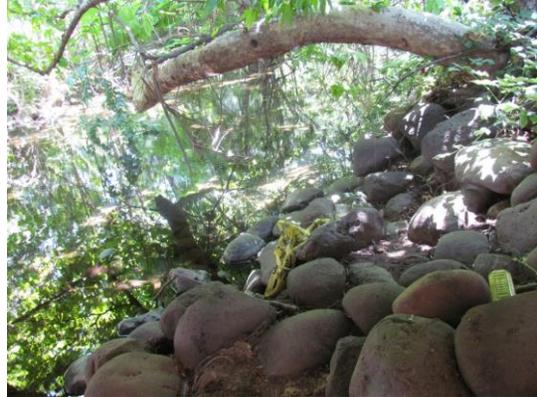
Photo 1 of 1 : CH_2015_NA0060_5_29_20150812_00023.jpg

View of the type of riprap that lines the channel.

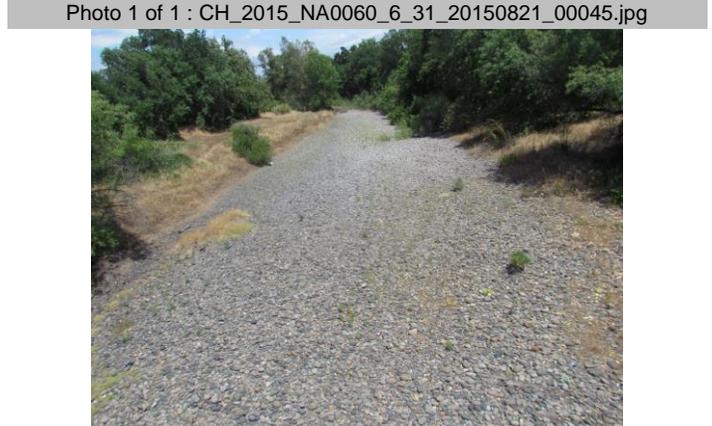
Check Point / View				
Mariposa Ave / Up				
Rating **	A	Issue No.	31	GPS Lat/Long
Issue Type +	Ma	Location *		39.752730 °
Category	Rivers, Channels & Designated Flood			-121.824560 °
Item	Vegetation & Obstructions			
DWR ID	DWR_NA0060_6_c_2012_31			
Action/Comments				
Inspector Comments: Minimal, scattered obstructions or vegetation. The flow is not impeded.

View of the channel facing upstream.

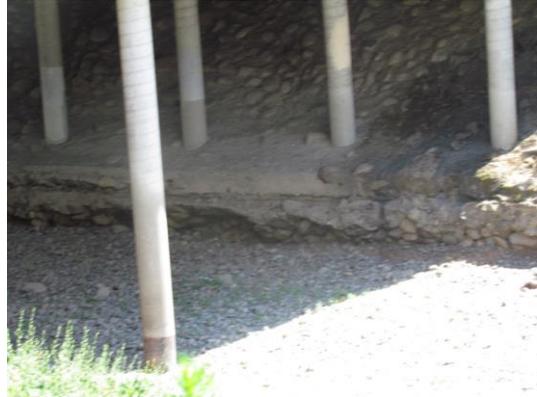
Photo 1 of 1 : CH_2015_NA0060_6_43_20150821_00051.jpg

View of the erosion found under the bridge.

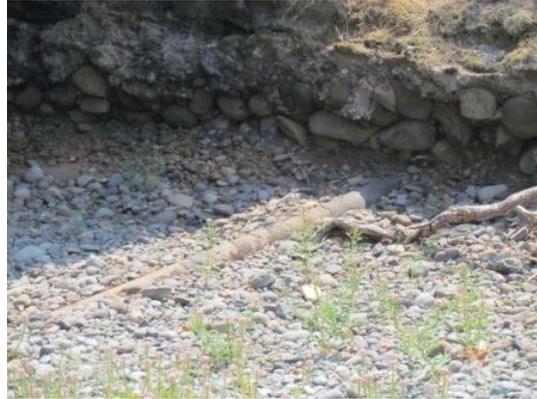
Photo 1 of 2 : CH_2015_NA0060_6_48_20150610_00011.jpg

Erosion around bridge footing and south bank of channel.

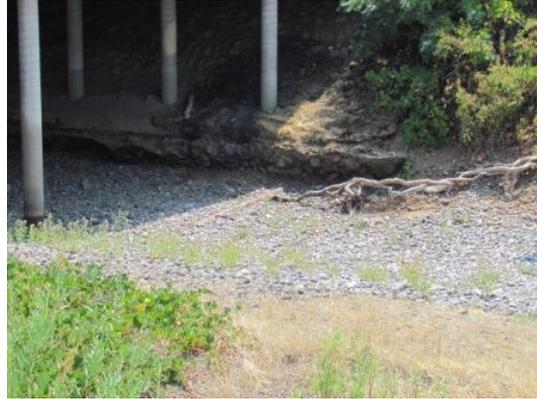
Photo 2 of 2 : CH_2015_NA0060_6_48_20150610_00012.jpg

Erosion around bridge footing and south bank of channel.

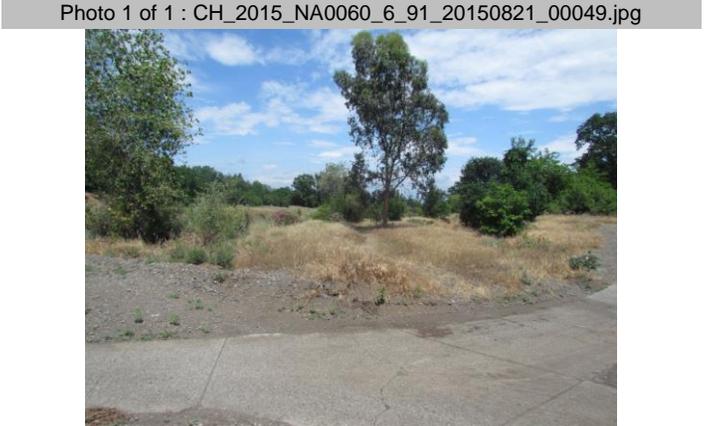
Check Point / View				
Highway 99 / Up				
Rating **	A	Issue No.	91	GPS Lat/Long
Issue Type +	Ma	Location *		39.751220 °
Category	Rivers, Channels & Designated Flood			-121.840042 °
Item	Vegetation & Obstructions			
DWR ID	DWR_NA0060_6_c_2015_91			
Action/Comments				
Inspector Comments: Minimal, scattered obstructions or vegetation. The flow is not impeded.

View of the channel facing upstream.

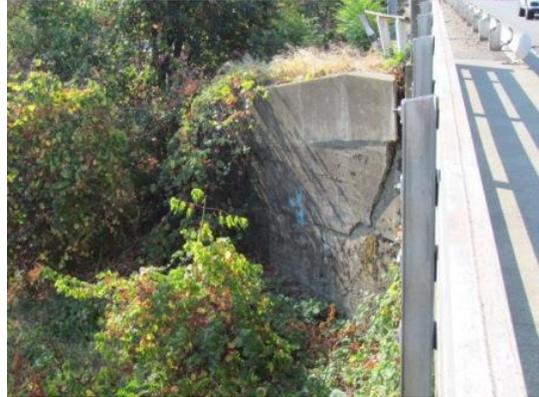
Photo 1 of 1 : CH_2015_NA0060_6_53_20150821_00034.jpg

View of the cracking on south wing wall.

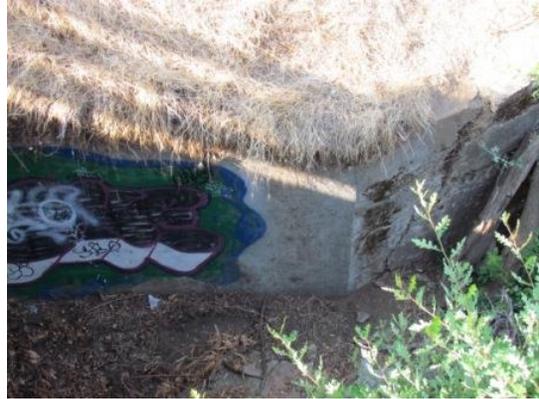
Photo 1 of 1 : CH_2015_NA0060_6_58_20150821_00032.jpg

View of cracks on south wing wall.

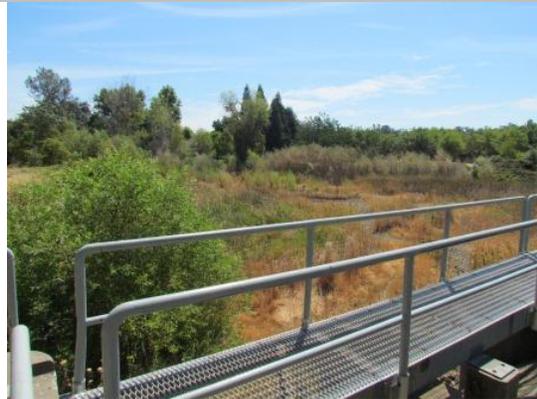
Photo 1 of 1 : CH_2015_NA0060_12_1_20150610_00001.jpg

This is the upstream side at the Little Chico Control Structure.

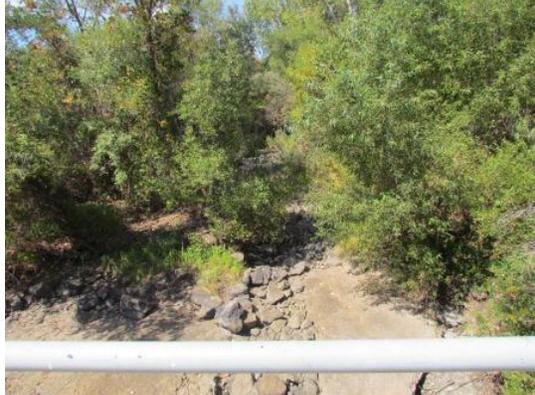
Photo 2 of 2 : CH_2015_NA0060_12_6_20150610_00002.jpg

This photo is looking downstream from the control structure during 2014 inspection.

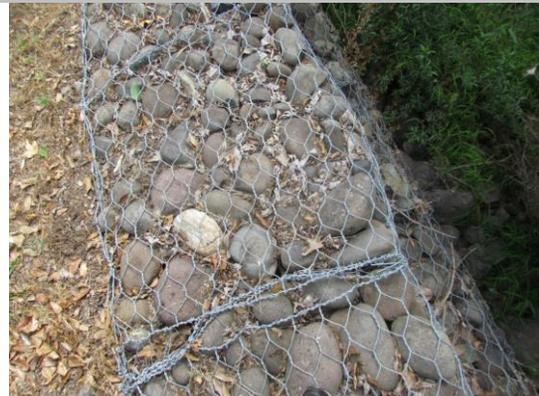
Photo 1 of 2 : CH_2015_NA0060_12_31_20150724_00034.jpg

View of the material used in the erosion repair site.

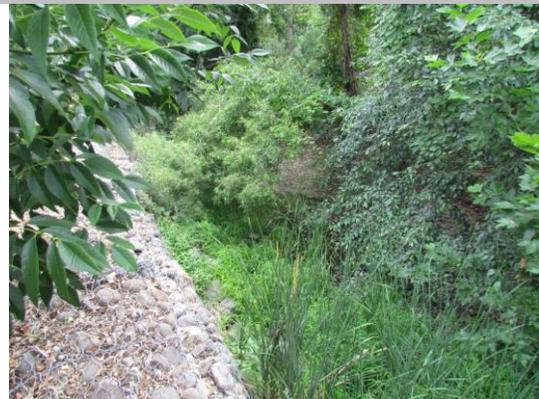
Photo 2 of 2 : CH_2015_NA0060_12_31_20150724_00035.jpg

View of the upstream side of the erosion repair site .

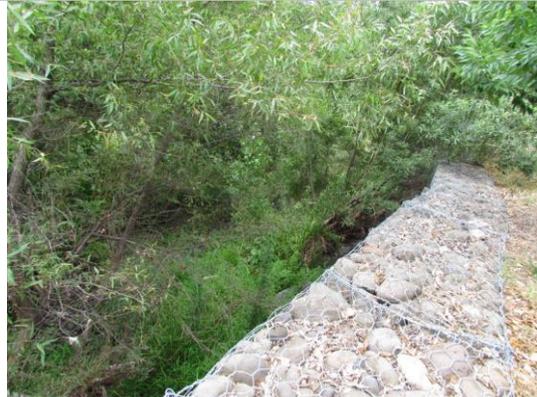
Photo 1 of 1 : CH_2015_NA0060_12_36_20150724_00037.jpg

View of the downstream side of the erosion repair site.
