**Flood Control Project Maintenance
Levee Inspections**
2016 Channel Summary Report
Overall Unit and Item Ratings

2016 Channel Inspection Results

DWR Sutter Maintenance Yard

Channel
Big Chico Creek

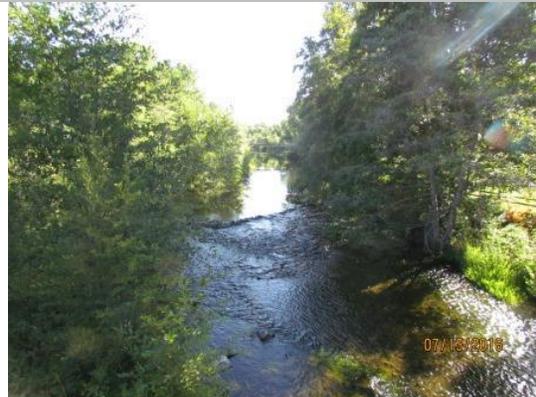
Photo 1 of 1 : CH_2016_NA0060_5_1_20160718_00014.jpg

Check Point / View			
Big Chico Creek Control Structure / Up			
Rating **	A	Issue No.	1
Issue Type +	Ma	Location *	39.761840 °
Category	Rivers, Channels & Designated Flood		-121.792590 °
Item	Vegetation & Obstructions		
DWR ID	DWR_NA0060_5_c_2012_1		
Action/Comments			
Inspector Comments: Minimal, scattered obstructions and vegetation. The flow is not impeded.

View of the channel from the structure facing upstream.

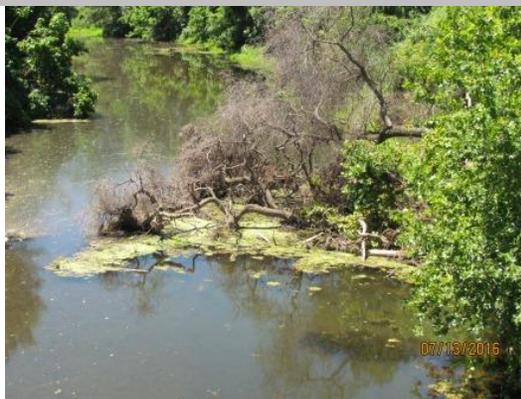
Photo 2 of 2 : CH_2016_NA0060_5_56_20160718_00030.jpg

View of downed tree in Mud Creek at River Road facing downstream. This could impeded flow.

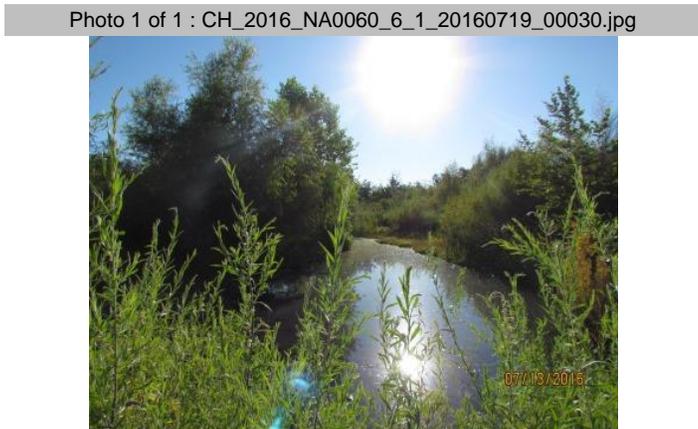
Check Point / View			
Diversion Structure / Up			
Rating **	A	Issue No. 1	GPS Lat/Long
Issue Type +	Ma	Location *	39.761590 °
Category	Rivers, Channels & Designated Flood		-121.797320 °
Item	Vegetation & Obstructions		
DWR ID	DWR_NA0060_6_c_2012_1		
Action/Comments			
Inspector Comments: Minimal, scattered obstructions and small trees. The flow is not impeded.

View of the channel facing upstream.

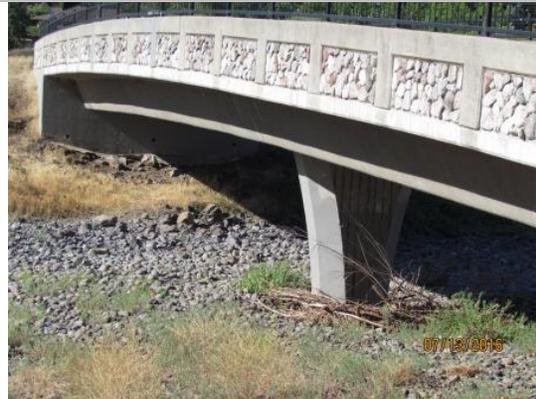
Photo 1 of 1 : CH_2016_NA0060_6_29_20160719_00037.jpg

View looking downstream, no revetment at bridge abutment.

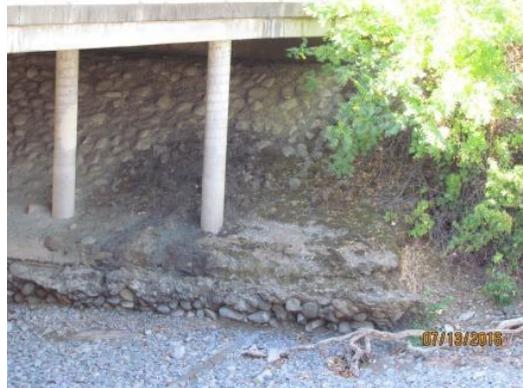
Photo 1 of 1 : CH_2016_NA0060_6_43_20160719_00043.jpg

View of the erosion found under the bridge.

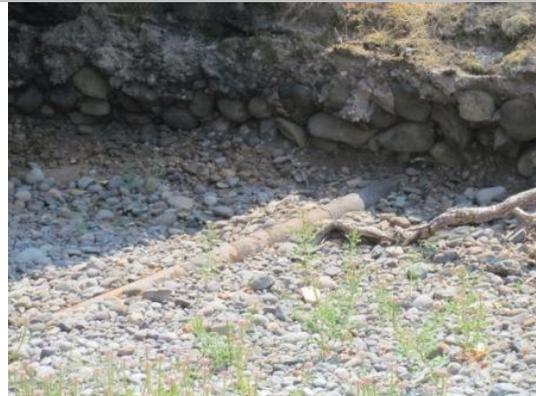
Photo 1 of 2 : CH_2016_NA0060_6_48_20160701_00012.jpg

Erosion around bridge footing and south bank of channel.

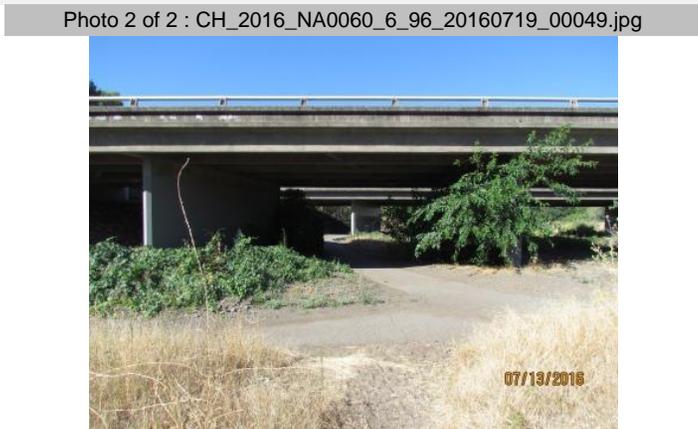
Check Point / View			
Highway 99 / Down (cont)			
Rating **	A	Issue No.	96 (cont)
Issue Type +	Ma	Location *	GPS Lat/Long
Category	Rivers, Channels & Designated Flood		39.751220 °
Item	Vegetation & Obstructions		-121.840042 °
DWR ID	DWR_NA0060_6_c_2015_96		
Action/Comments			
Inspector Comments: Minimal, scattered obstructions or vegetation. The flow is not impeded.

View of a tree growing next to the bridge support that should be removed.

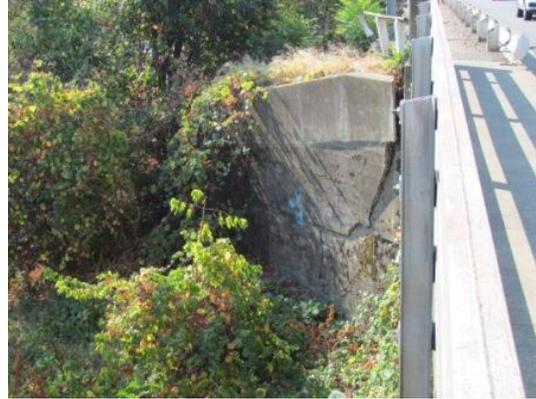
Photo 1 of 2 : CH_2016_NA0060_6_53_20160701_00015.jpg

View of the cracking on south wing wall.

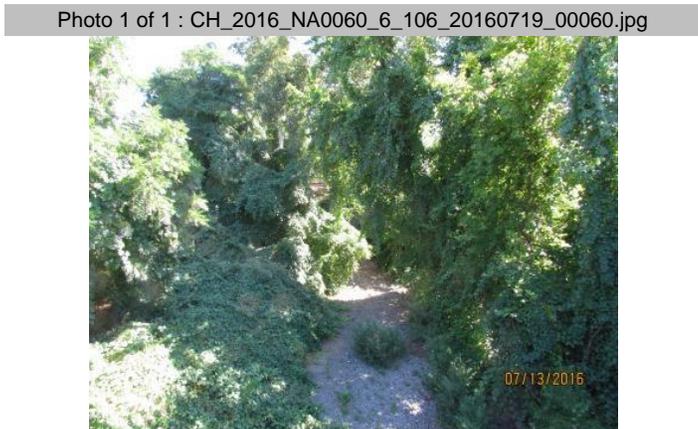
Check Point / View			
Holly Avenue / Down			
Rating **	M	Issue No. 106	GPS Lat/Long
Issue Type +	Ma	Location *	39.749209 °
Category	Rivers, Channels & Designated Flood		-121.865682 °
Item	Vegetation & Obstructions		
DWR ID	DWR_NA0060_6_c_2015_106		
Action/Comments			
Inspector Comments: Minimal, scattered obstructions or vegetation. The flow may be impeded.

View of the channel facing downstream.

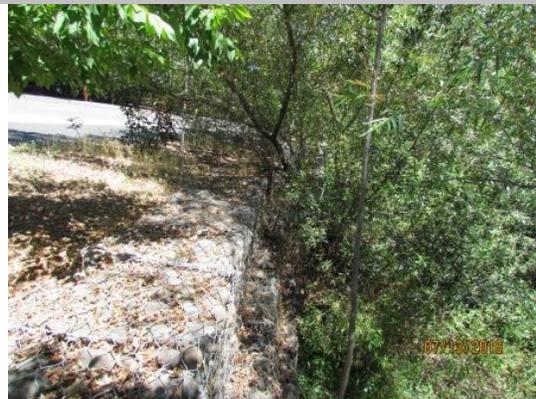
Photo 2 of 2 : CH_2016_NA0060_12_31_20160719_00036.jpg

View of the upstream side of the erosion repair site. The site is approximately 300 yards upstream from bridge.

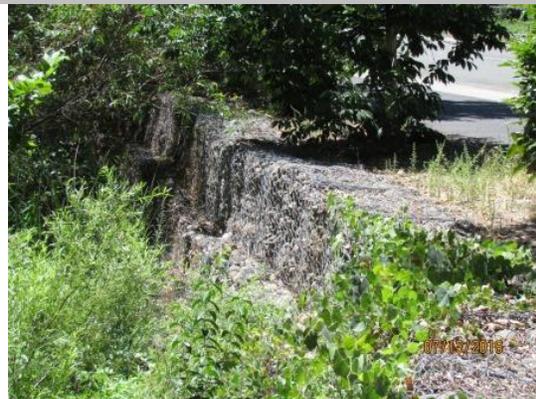
Photo 2 of 2 : CH_2016_NA0060_12_36_20160719_00039.jpg

View looking downstream of the erosion repair site. The repair is approximately 300 yards upstream from the bridge.
