## Flood Control Project Maintenance

## 2011 Structure Summary Report

## DWR Sutter Maintenance Yard

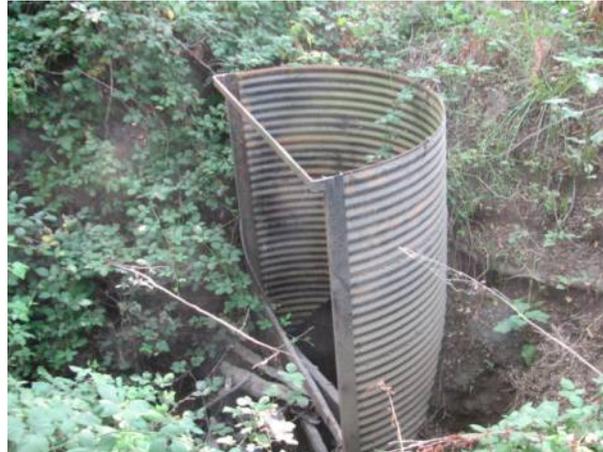
Levee Mile Report Line	1
Start Levee Mile	0.00
End Levee Mile	0.00
Location	
Category	Structures
Item	Photo Documentation
08/04/2011 Butte Slough Drainage structure outfall.	
jeto_t_20110809_011.jpg

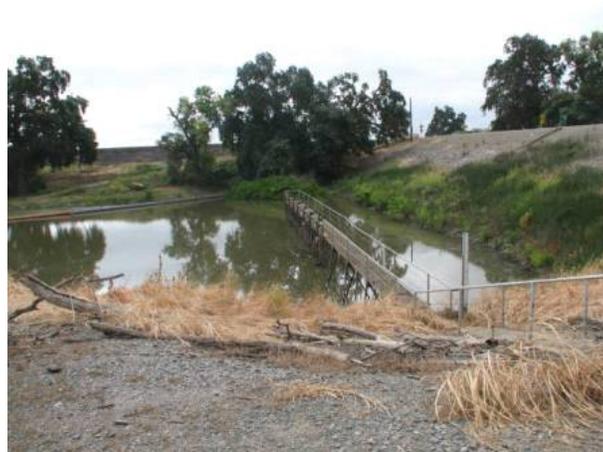
Levee Mile Report Line	1
Start Levee Mile	0.00
End Levee Mile	0.00
Location	
Category	Structures
Item	Photo Documentation
08/04/2011 View of the Butte Slough Outfall Structure on the water side.	
jeto_t_20110809_009.jpg

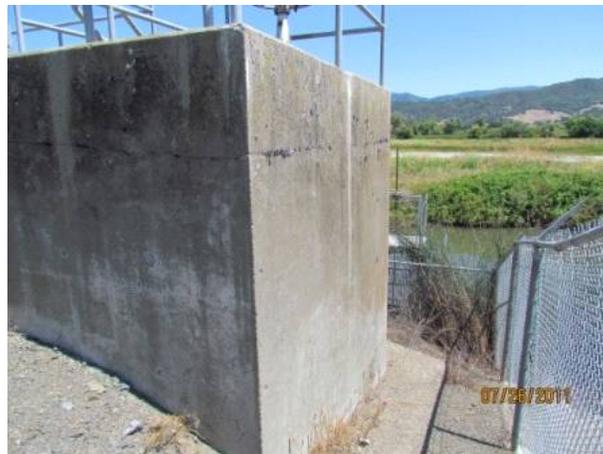
Levee Mile Report Line	3
Start Levee Mile	0.00
End Levee Mile	0.00
Location	
Category	Pump Stations
Item	Plant Building
View of the settlement adjacent to the structure.	
pkazi_t_20110808_039.jpg

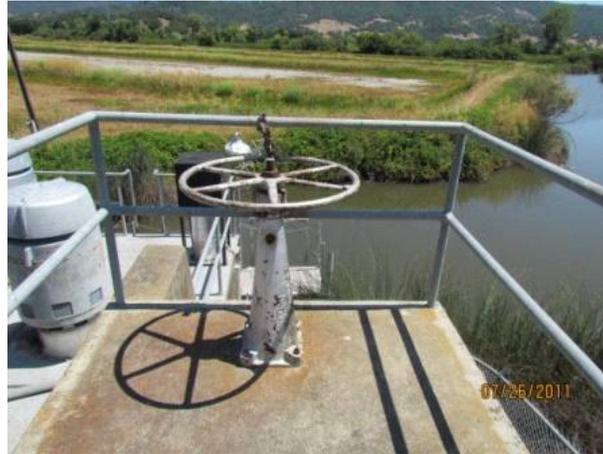
Levee Mile Report Line	18
Start Levee Mile	0.00
End Levee Mile	0.00
Location	
Category	Pump Stations
Item	Flap Gates
Vegetation growth near the flap gate opening.	
pkazi_t_20110808_051.jpg

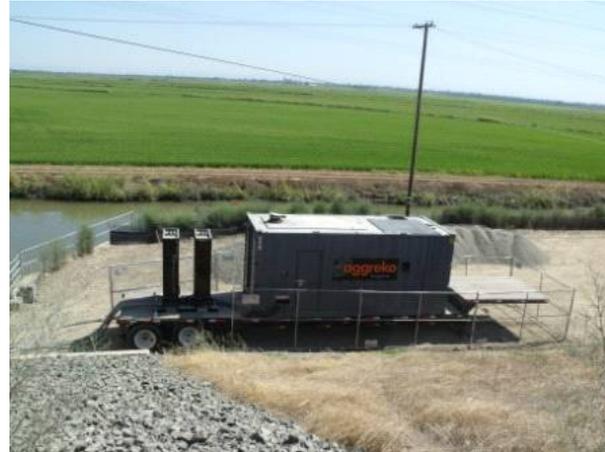
Levee Mile Report Line	9
Start Levee Mile	0.00
End Levee Mile	0.00
Location	
Category	Pump Stations
Item	Motors, Engines, Fans & Gear Reducers
08/24/2011 Photo shows pump motors, which appear to be in operating condition.	
jeto_t_20110829_048.jpg

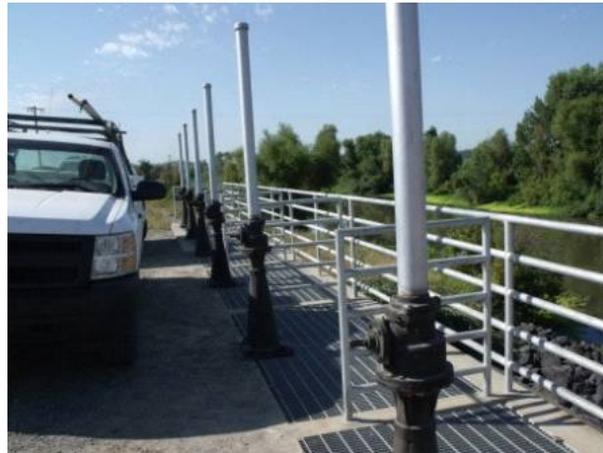
Levee Mile Report Line	18
Start Levee Mile	0.00
End Levee Mile	0.00
Location	
Category	Pump Stations
Item	Flap Gates
08/24/2011 Photo shows flap gates. Note water is the result of the motor/pump testing.	
jeto_t_20110825_046.jpg
