**Flood Control Project Maintenance**  
**2016 Structure Summary Report**  
**Overall Unit and Item Ratings**

**DWR Sutter Maintenance Yard**

**Butte Slough Drainage Structure**

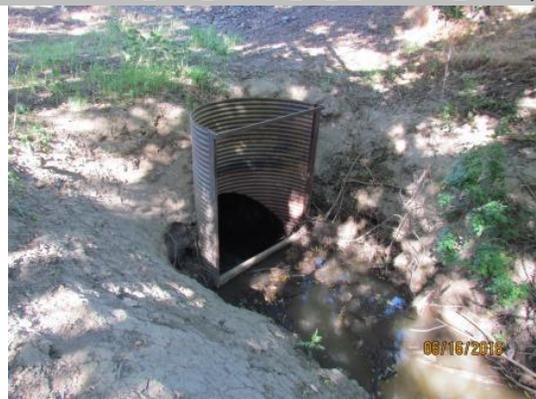
Photo 3 of 6 : ST\_2016\_NA0060\_38\_1\_20160617\_00008.jpg

Butte Slough Drainage structure on the land side.

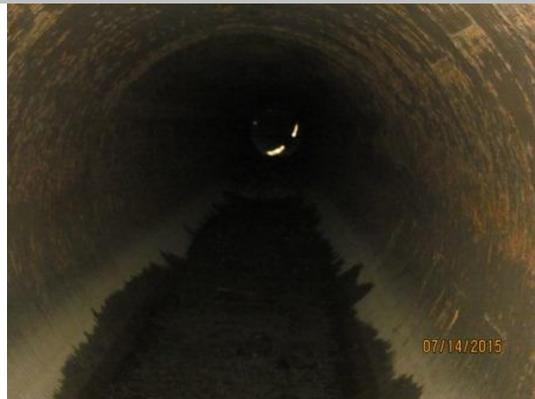
Photo 6 of 6 : ST\_2016\_NA0060\_38\_1\_20160615\_00005.jpg

Zoomed-in view of the pipe from the landside.

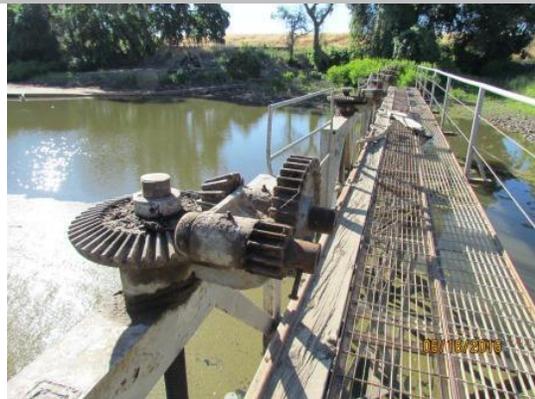
Photo 3 of 6 : ST\_2016\_NA0060\_42\_1\_20160617\_00007.jpg

View of the mechanical gate operation mechanism.

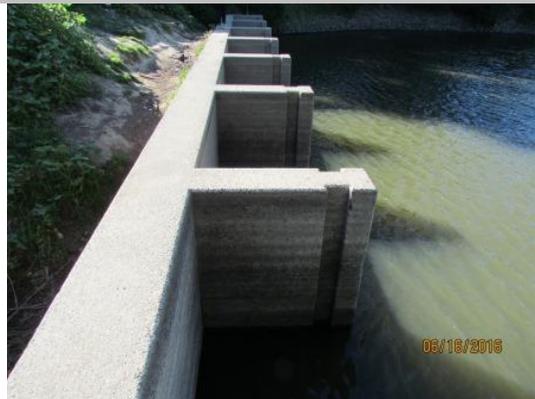
Photo 6 of 6 : ST\_2016\_NA0060\_42\_1\_20160617\_00009.jpg

View of the Butte Slough Outfall Structure on the water side.

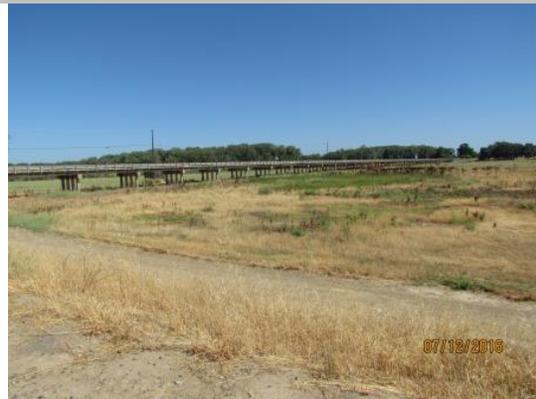
Photo 3 of 4 : ST\_2016\_NA0060\_55\_1\_20160718\_00011.jpg

This is the upstream view of the Colusa Weir structure.

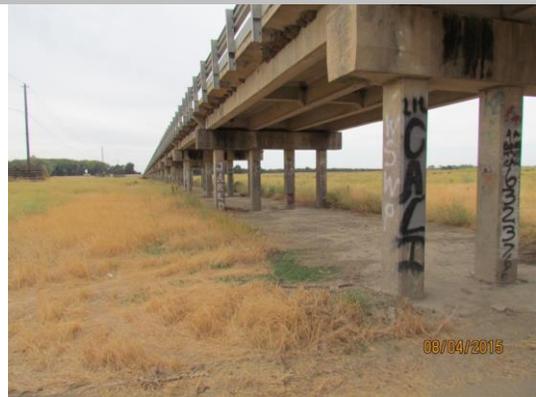
Photo 1 of 1 : ST\_2016\_NA0060\_55\_2\_20160701\_00007.jpg

View of the vegetation found in the weir from the right bank of the channel.

LM Start	<b>0.00</b>	Rating **	M	Issue No.	<b>3</b>
LM End	<b>0.00</b>	Issue Type +	Ma	Location *	
Category	Structures & Concrete Lined Channels			GPS Latitude/Longitude	
				Start	End
Item	Shoaling / Sedimentation			39.232135 °	39.232135 °
				-121.996253 °	-121.996253 °
DWR ID	DWR_NA0060_55_t_2012_3				
Action/Comments					
Inspector Comments: Minimal sedimentation present.

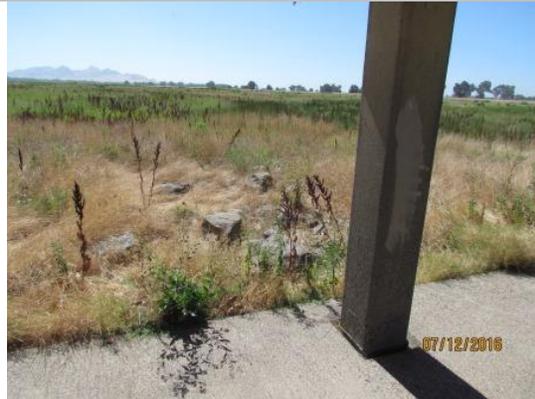
Photo 4 of 4 : ST\_2016\_NA0060\_55\_5\_20160718\_00019.jpg

View of riprap at the columns of the bridge.

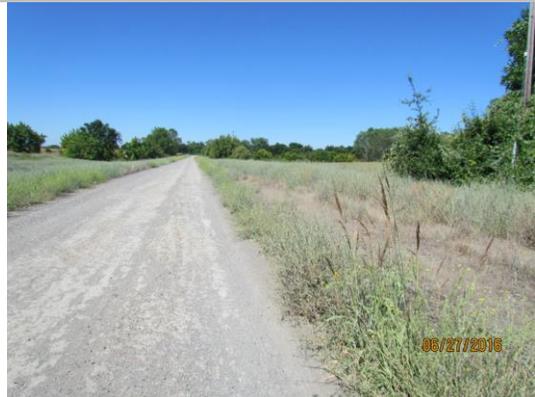
Photo 2 of 2 : ST\_2016\_NA0060\_225\_2\_20160701\_00005.jpg

View of the vegetation on upstream of the weir.

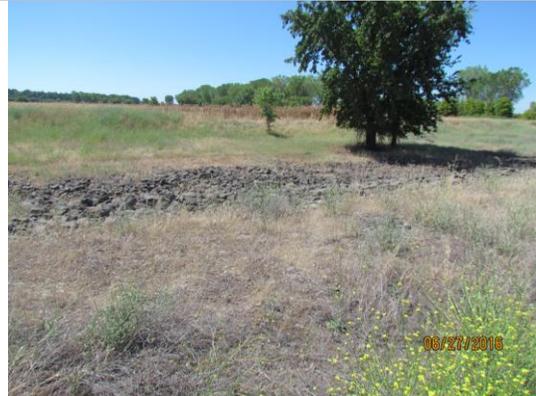
Photo 1 of 1 : ST\_2016\_NA0060\_225\_5\_20160701\_00006.jpg

View of the existing revetments on the downstream of the weir.

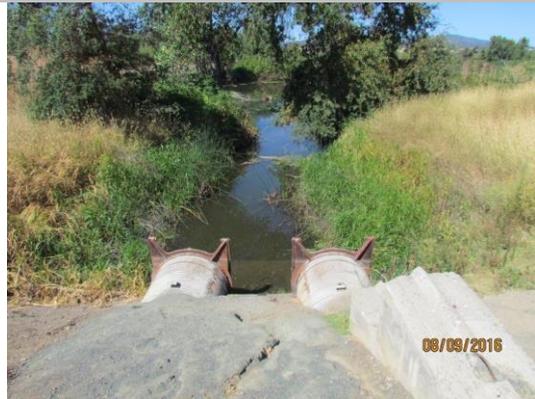
Photo 2 of 2 : ST\_2016\_NA0060\_7\_2\_20160810\_00011.jpg

View of vegetation on the outlet of the structure.

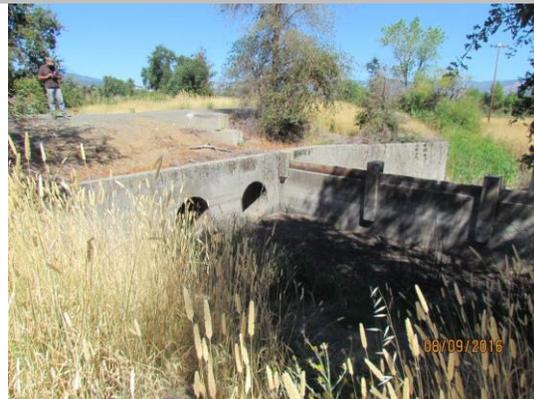
Photo 1 of 2 : ST\_2016\_NA0060\_7\_7\_20160810\_00012.jpg

View of inlet of the culvert.

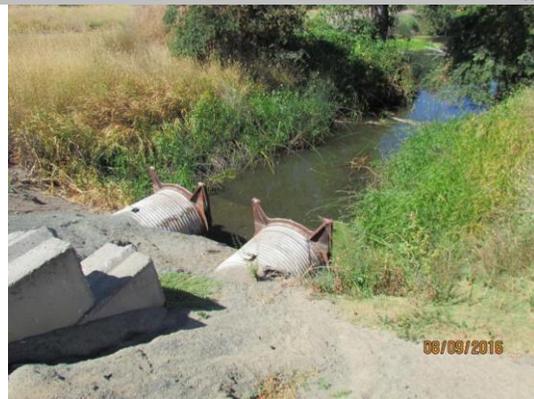
Photo 2 of 2 : ST\_2016\_NA0060\_7\_7\_20160810\_00013.jpg

View of outlet of the structure.

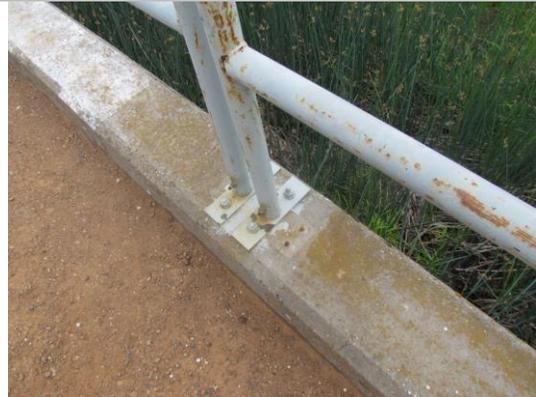
Photo 1 of 2 : ST\_2016\_NA0060\_9\_23\_20160701\_00008.jpg

View of handrails with loose bolts.

LM Start	<b>0.00</b>	Rating **	M	Issue No.	<b>23 (cont)</b>
LM End	<b>0.00</b>	Issue Type +	Ma	Location *

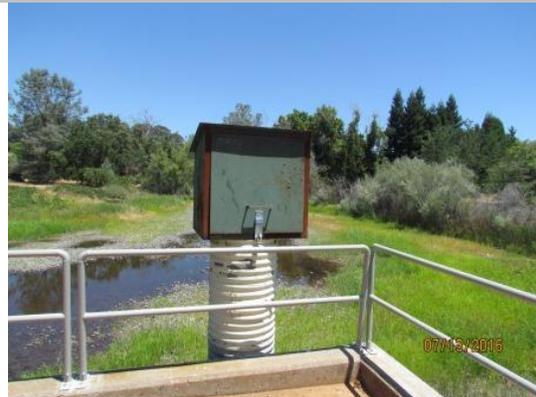
Photo 2 of 2 : ST\_2016\_NA0060\_9\_23\_20160718\_00012.jpg

Typical safety rail around entire structure.

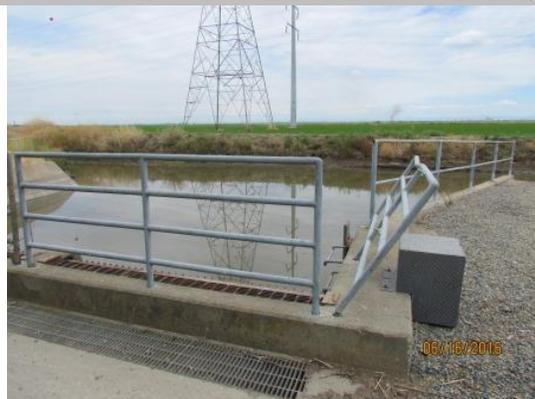
Photo 3 of 3 : ST\_2016\_NA0060\_21\_5\_20160621\_00033.jpg

View of a damaged guard rail. Must be repaired or replaced.

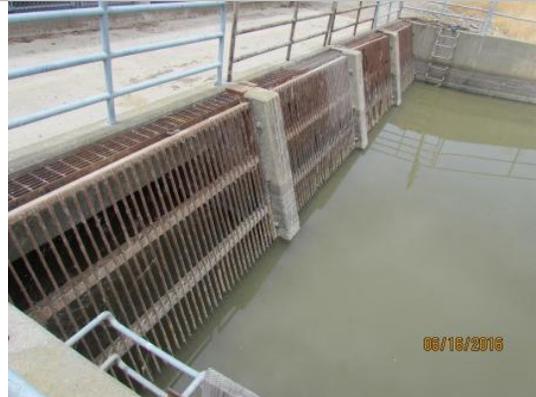
Photo 1 of 1 : ST\_2016\_NA0060\_21\_13\_20160621\_00027.jpg

Photo shows properly maintained trash racks.

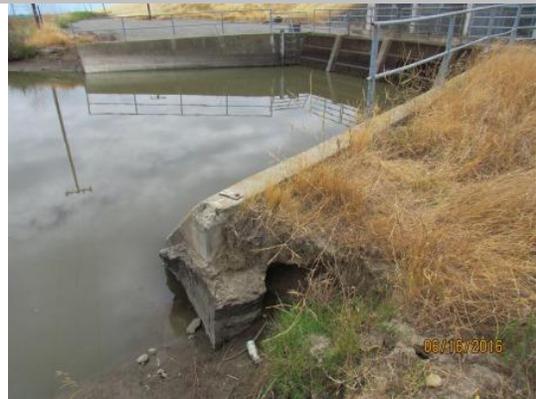
Photo 3 of 3 : ST\_2016\_NA0060\_21\_22\_20160621\_00034.jpg

View of the erosion at the intake walls on the opposite side.

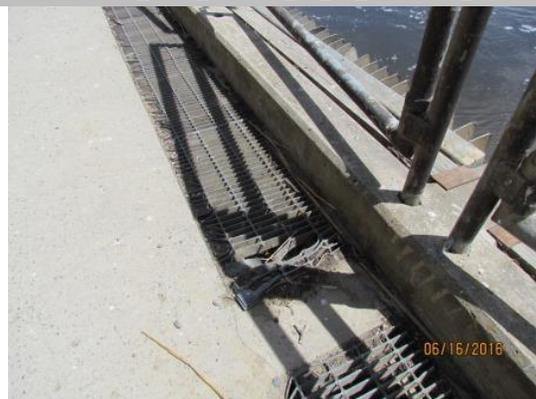
Photo 1 of 3 : ST\_2016\_NA0060\_22\_18\_20160621\_00028.jpg

View of the damaged grate.

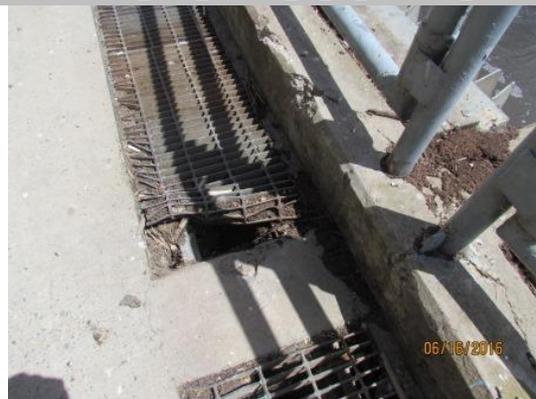
Photo 2 of 3 : ST\_2016\_NA0060\_22\_18\_20160621\_00029.jpg

Another view of the damaged grate.

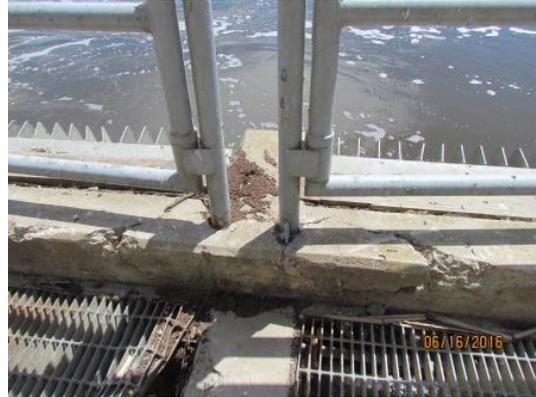
Photo 3 of 3 : ST\_2016\_NA0060\_22\_18\_20160621\_00030.jpg

View of damaged concrete.

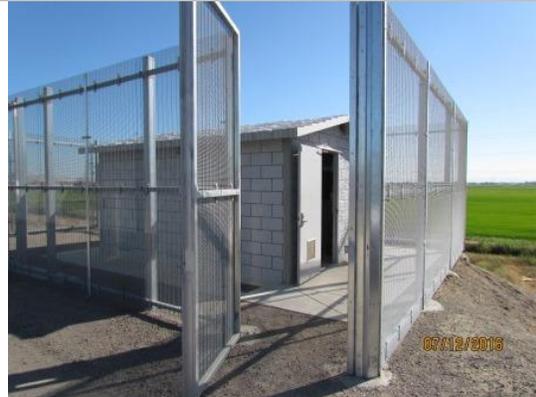
Photo 1 of 2 : ST\_2016\_NA0060\_10\_18\_20160720\_00029.jpg

View of security fence around the compressor building. The fence is very close to the hing point of the slope and does not allow access around the out side of the fence in this location.

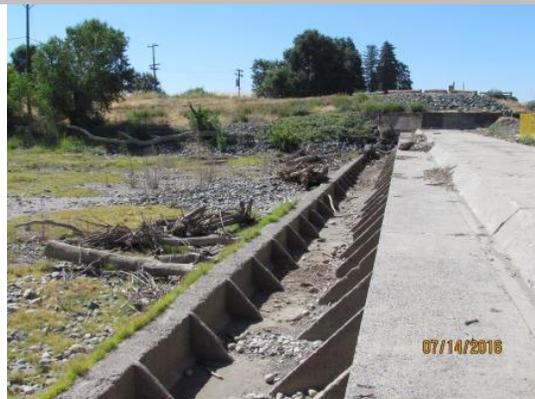
Photo 1 of 3 : ST\_2016\_NA0060\_3\_2\_20160725\_00020.jpg

View of the logs and debris found on the weir facing the right bank of the channel.

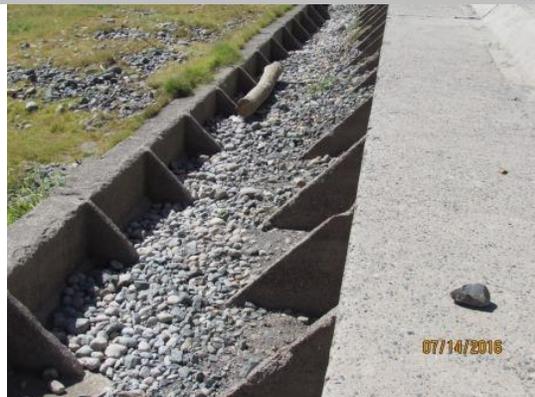
Photo 2 of 3 : ST\_2016\_NA0060\_3\_2\_20160725\_00021.jpg

View of the log found on the weir facing the left bank of the channel.

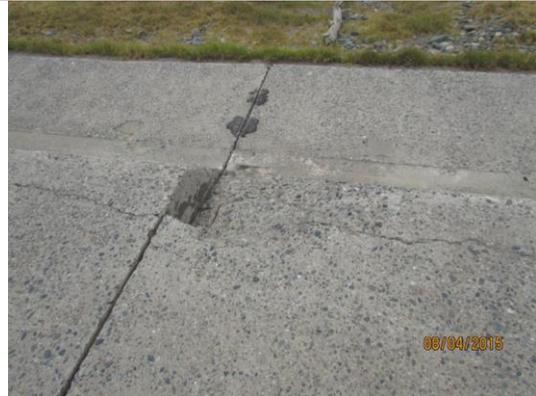
Photo 1 of 10 : ST\_2016\_NA0060\_3\_15\_20160701\_00013.jpg

View of the damaged area. Rebar can be observed.

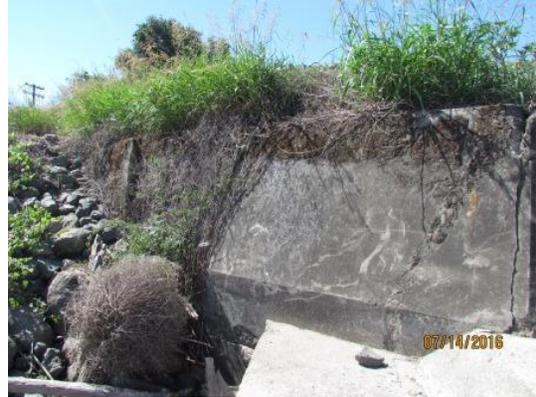
Photo 2 of 10 : ST\_2016\_NA0060\_3\_15\_20160725\_00029.jpg

View of cracks in the right side abutment.

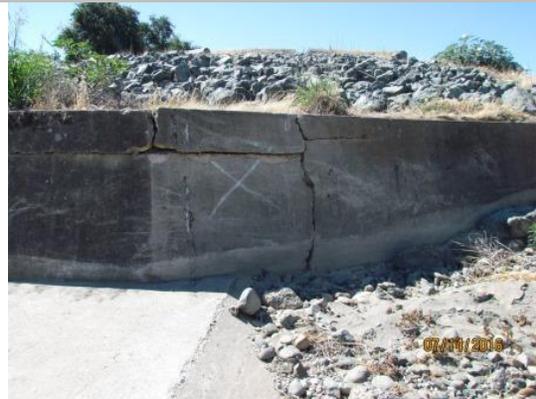
Photo 3 of 10 : ST\_2016\_NA0060\_3\_15\_20160725\_00028.jpg

View of more cracking in the right side abutment.

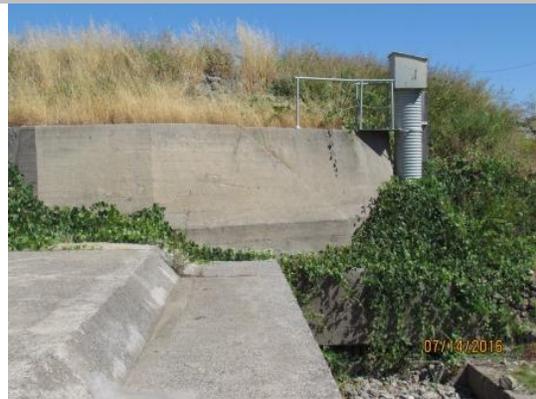
Photo 4 of 10 : ST\_2016\_NA0060\_3\_15\_20160725\_00036.jpg

View of left side abutment, there is missing concrete and exposed rebar at the base of the abutment.

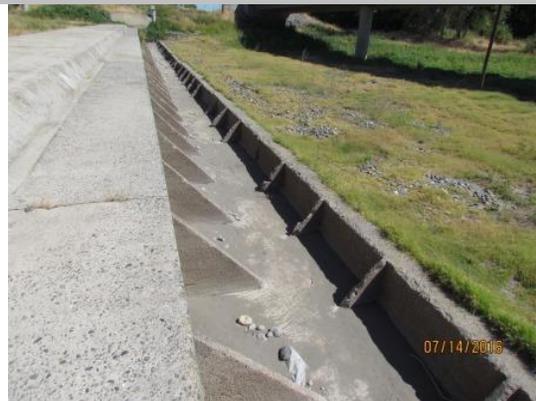
Photo 6 of 10 : ST\_2016\_NA0060\_3\_15\_20160725\_00032.jpg

View of the deteriorating baffle's.

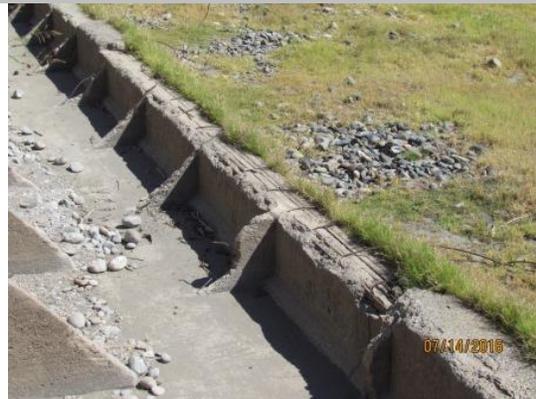
Photo 7 of 10 : ST\_2016\_NA0060\_3\_15\_20160725\_00034.jpg

View of the deteriorating baffle's and exposed rebar.

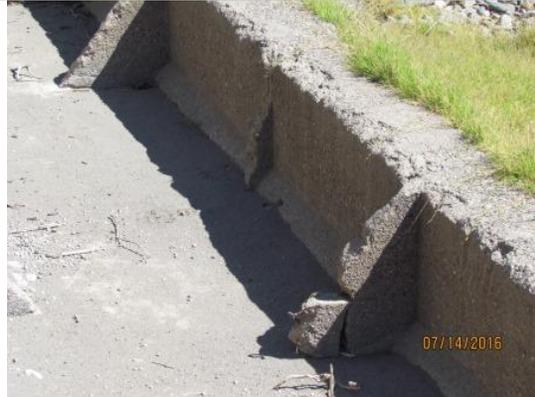
Photo 9 of 10 : ST\_2016\_NA0060\_3\_15\_20160725\_00033.jpg

View of the deteriorating or missing baffle's and exposed rebar.

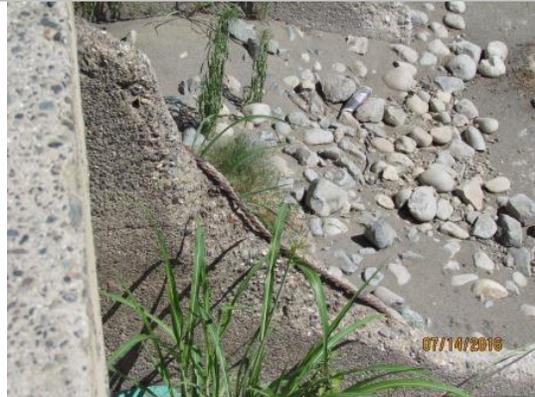
Photo 10 of 10 : ST\_2016\_NA0060\_3\_15\_20160725\_00030.jpg

View of the deteriorating baffle's and exposed rebar.

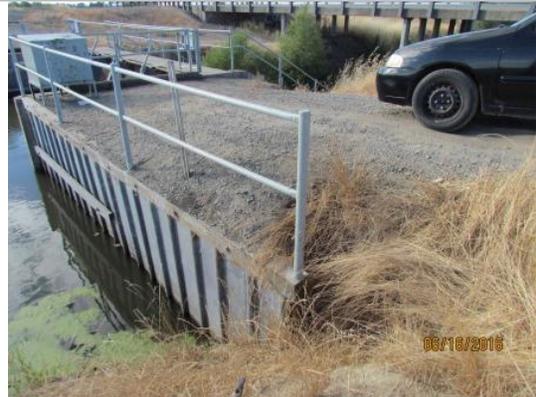
Photo 1 of 1 : ST\_2016\_NA0060\_11\_3\_20160617\_00003.jpg

View of the erosion around the upstream end of the structure.
