Flood Control Project Maintenance
2008 Structure Summary Report
Overall Unit and Item Ratings

Gomes Lake Pumping Plant

2008 Pumping Plant Inspection Results

Date of Inspection	12/3/2008
DWR Inspector	David Pesavento
Pumping Plant Rating	A

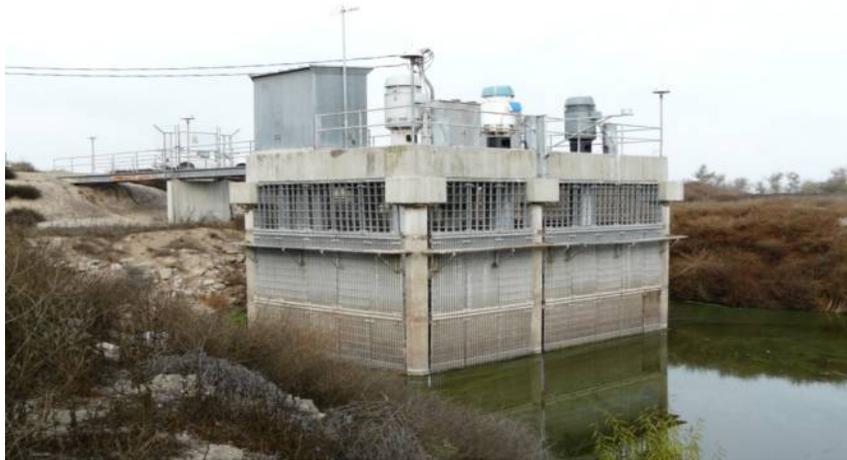
Report Line	3
Location	
Category	Pump Stations
Item	Plant Building

View of pump station from in front of the structure.

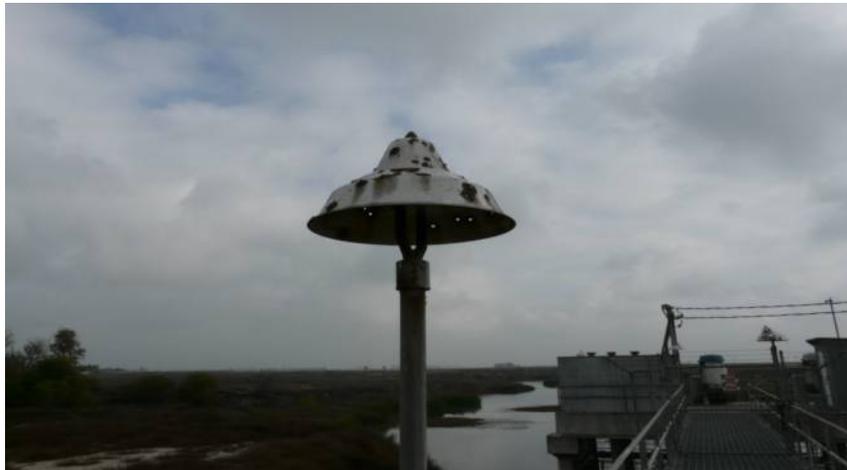
Report Line	3
Location	
Category	Pump Stations
Item	Plant Building

View of one of the shot out light fixtures.

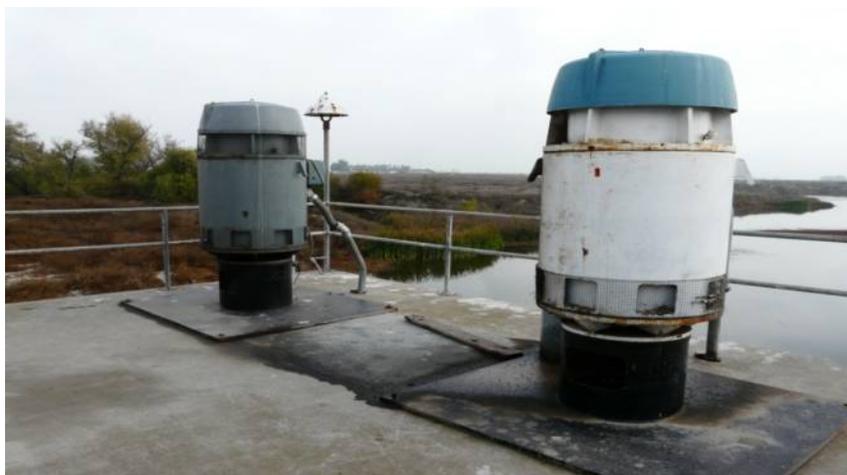
Report Line	7
Location	
Category	Pump Stations
Item	Pumps

6	Pump Stations	Cranes		N	There is no crane located at this station.	°		6
7	Pump Stations	Pumps		A	The pumps appear well maintained. The station operator turned on one pump during the inspection; the pump operated well and a strong draw in the channel could be seen. The station operator stated that the pumps have recently been re-built.	°	Y	7
8	Pump Stations	Power		A	The power source is considered adequate. No generators are located onsite, but the maintaining agency is also the power company and would be able to give priority to restoring power to the station.	°	Y	8
9	Pump Stations	Motors, Engines, Fans & Gear Reducers		A	All equipment associated with the pump appears to be adequately maintained.	°		9
10	Pump Stations	Pump Control Systems		A	The station is with automatic pump control systems and can also be switched to manual control. The control system appeared to be adequately maintained and operational.	°	Y	10

Two of the pumps at the station.

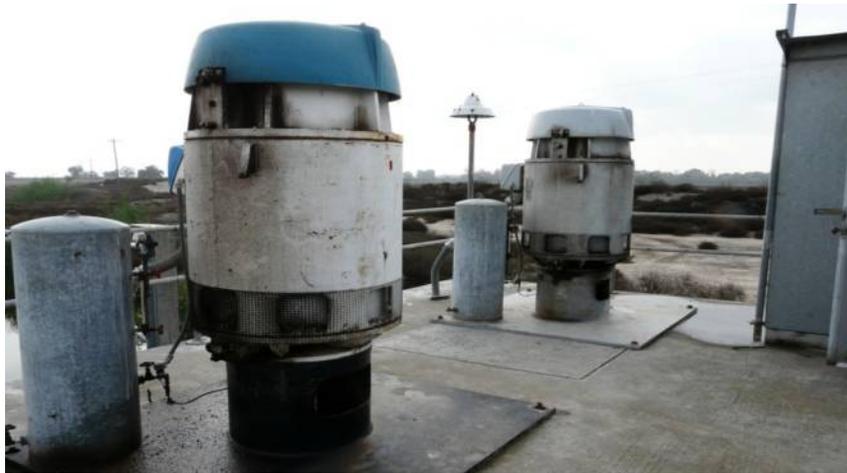
Report Line	7
Location	
Category	Pump Stations
Item	Pumps

Second view of pumps, showing pumps 2 & 3. All three pumps have been recently re-built.

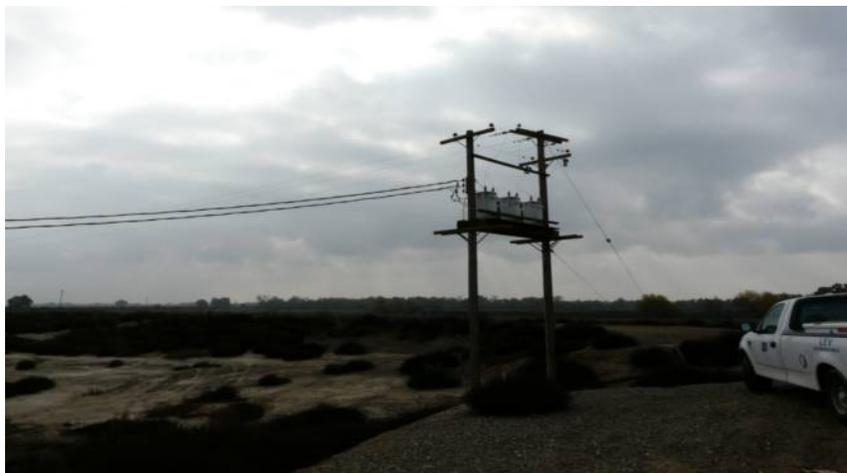
Report Line	8
Location	
Category	Pump Stations
Item	Power

View of electrical transformers adjacent to the station.

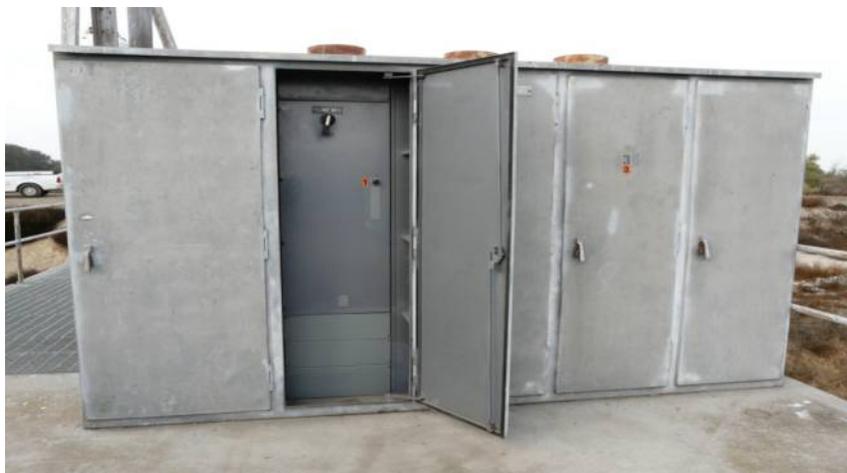
Report Line	10
Location	
Category	Pump Stations
Item	Pump Control Systems

View of power cabinets and primary switching gear.

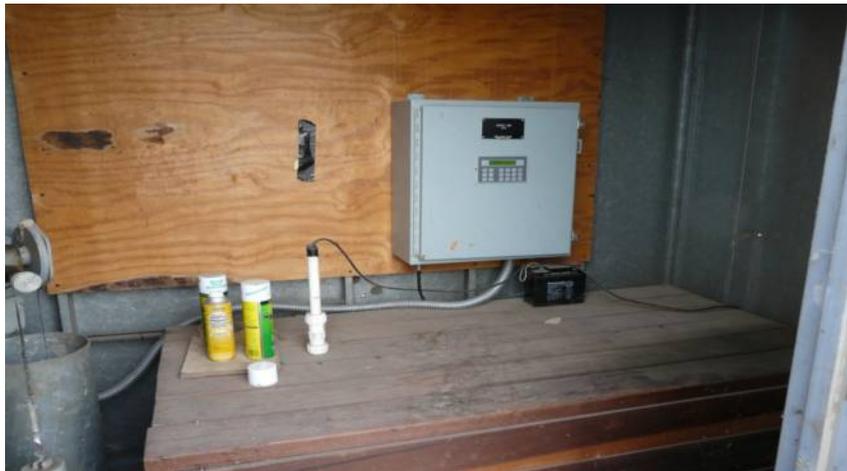
Report Line	10
Location	
Category	Pump Stations
Item	Pump Control Systems
View of automatic/remote switching gear. Also shown is level sensor in the center.

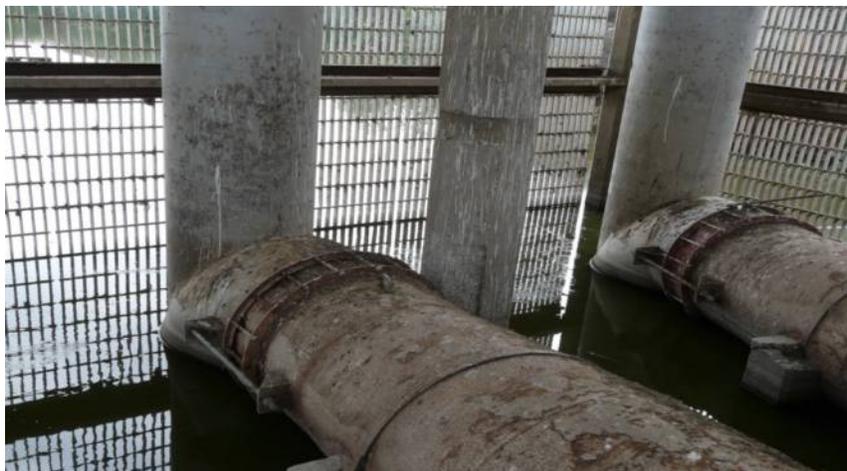
11	Pump Stations	Sumps/Wet Well		A	Sump appears to be adequately maintained and relatively free of vegetation and debris.	°	Y	11
12	Pump Stations	Trash Racks		A	Trash racks completely surround the pump station and appeared to be in adequate condition.	°	Y	12
13	Pump Stations	Trash Rakes		N	The trash rakes are manually cleared with hand tools or an excavator as needed. There are no automatic trash rakes at this station.	°		13
14	Pump Stations	Sluice / Slide Gates		A	The slide gates appear to be in adequate condition and move with relative ease.	°	Y	14
15	Pump Stations	Electric Gate Operators		A	The electric gate operators were not used during the inspection but appeared in adequate condition and capable of performing.	°		15

Report Line	11
Location	
Category	Pump Stations
Item	Sumps/Wet Well
View inside trash rack of sump/wet well.

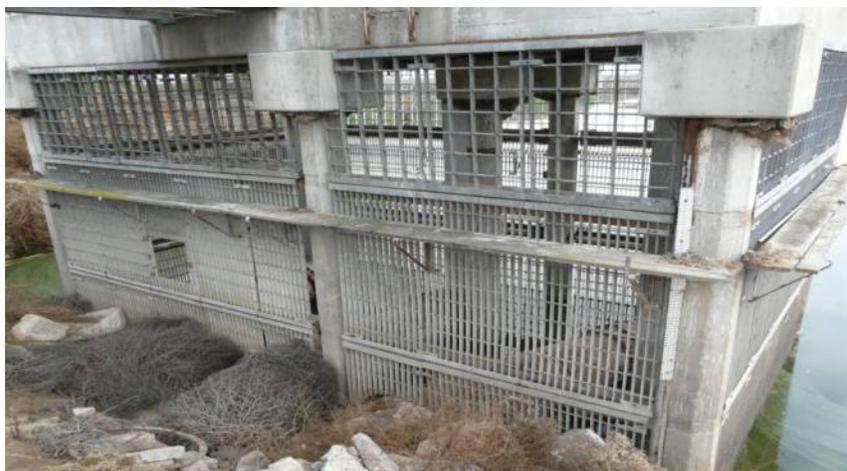
Report Line	12
Location	
Category	Pump Stations
Item	Trash Racks
View of rear of trash racks.

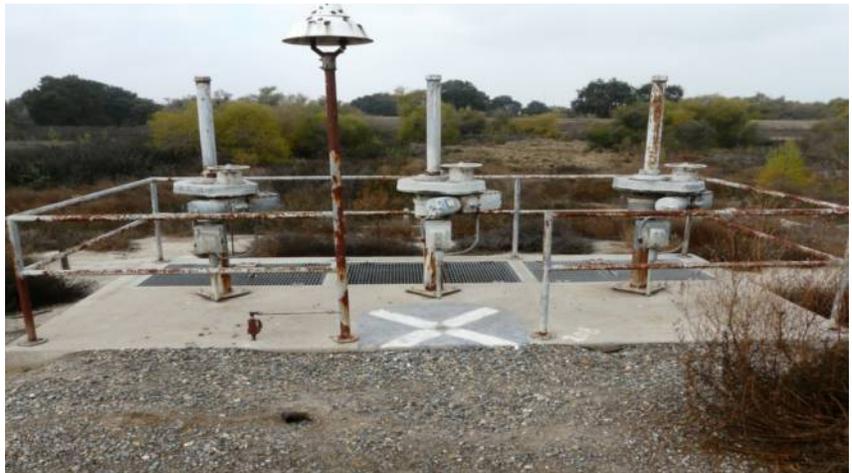
Report Line	14
Location	
Category	Pump Stations
Item	Sluice / Slide Gates
View of slide gate structure and gate operators.

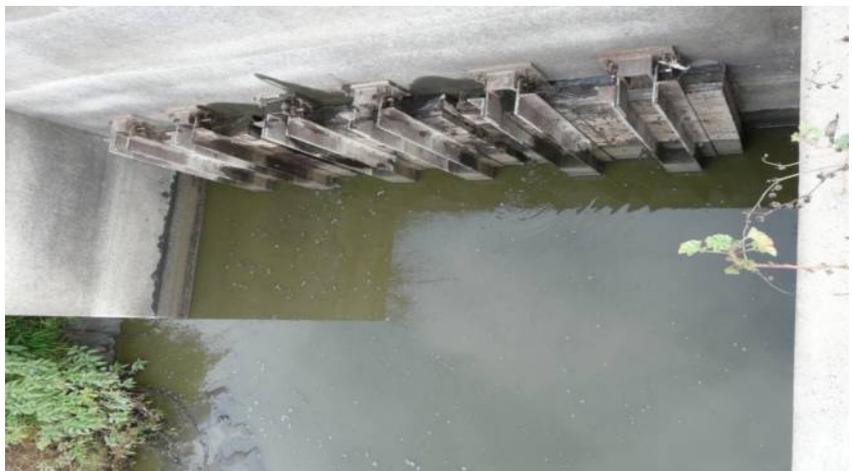
Report Line	18
Location	
Category	Pump Stations
Item	Flap Gates
View of flap gates from wingwall.

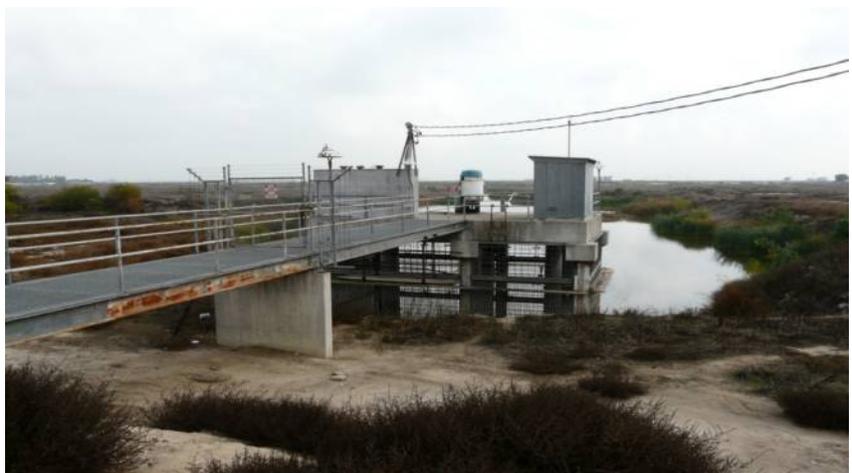
Roll Line	Category	Item	Location *	Rating **	Comment	GPS	Photo	Issue
16	Pump Stations	Manual Gate Operators		A	The manual gate operators appeared in adequate condition and to be maintained well. One operator was turned during the inspection and operated with relative ease.		°	16
17	Pump Stations	Other Metallic Items		A	No metallic items were observed with significant corrosion. The station appears to be adequately maintained and capable of performing.		°	17
18	Pump Stations	Flap Gates		A	Flap gates are installed on the outlet pipes and appeared to be capable of preventing water from flowing from the river through the levee.		°	Y 18
19	Pump Stations	Security Fencing		A	There is a security gate preventing access to the pumps on the station. The gate is in adequate repair and has a specific lock with limited access. The slide gates are outside of the fence but do not have locks on them and can be operated without a key.		°	Y 19

Report Line	19
Location	
Category	Pump Stations
Item	Security Fencing
View of station from levee. Note the security gate on the catwalk.
