Flood Control Project Maintenance
2010 Structure Summary Report
Overall Unit and Item Ratings

Turlock Irrigation District Gomes Lake

Gomes Lake Pumping Plant

2010 Pumping Plant Inspection Results

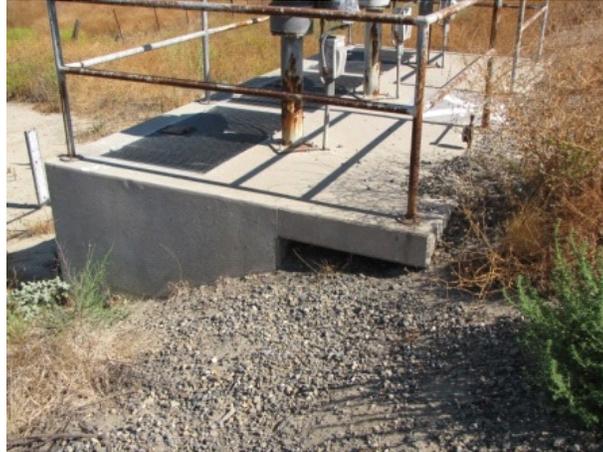
View of cavity forming under sluice gate structure.

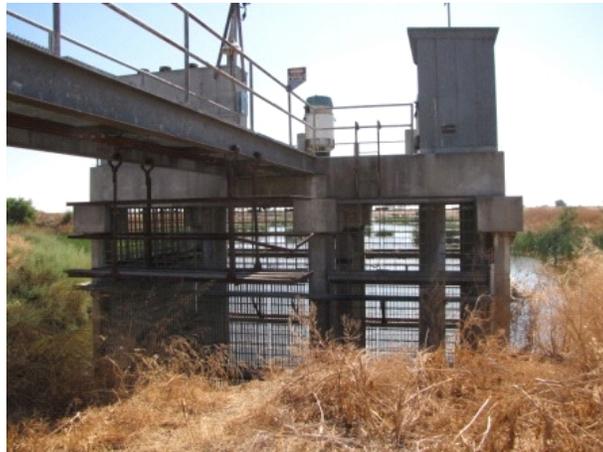
View of station from the southern waterward side.

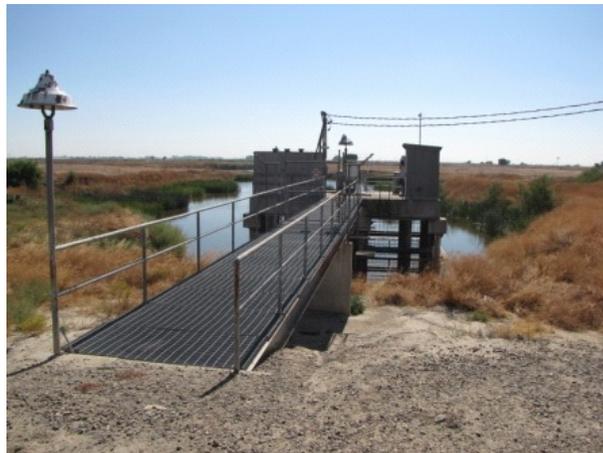
View of the station from the southern crown.

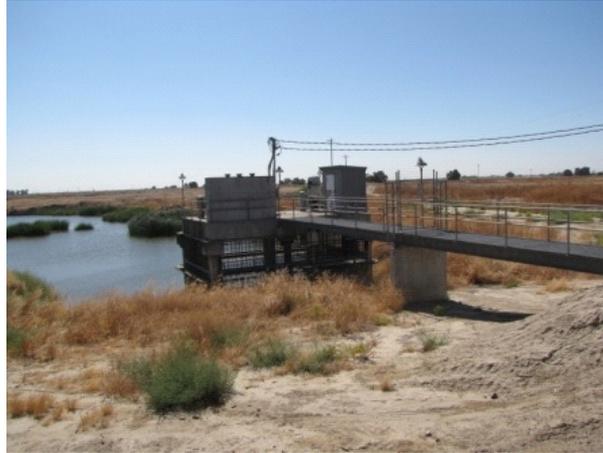
Levee Mile Report Line	3
Start Levee Mile	0.00
End Levee Mile	0.00
Location	
Category	Pump Stations
Item	Plant Building
View of the station from the northern crown.	
dpesaven_t_20100906_122.jpg

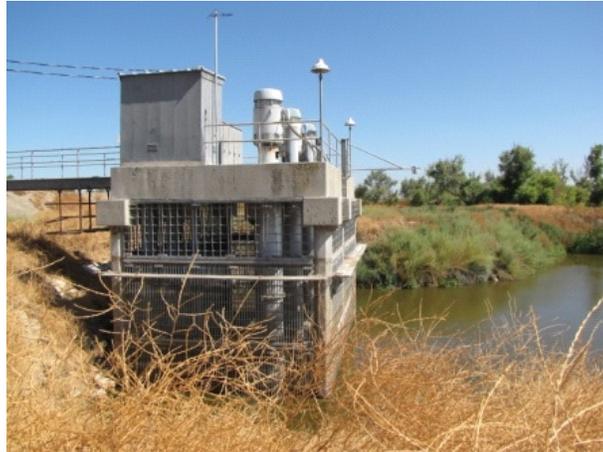
Levee Mile Report Line	3
Start Levee Mile	0.00
End Levee Mile	0.00
Location	
Category	Pump Stations
Item	Plant Building
View of the station from the south.	
dpesaven_t_20100906_123.jpg

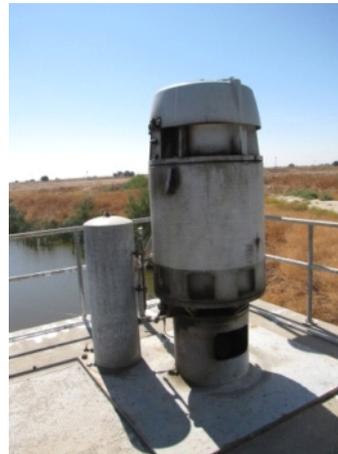
Levee Mile Report Line	7
Start Levee Mile	0.00
End Levee Mile	0.00
Location	
Category	Pump Stations
Item	Pumps
View of one of the pumps.	
dpesaven_t_20100906_127.jpg

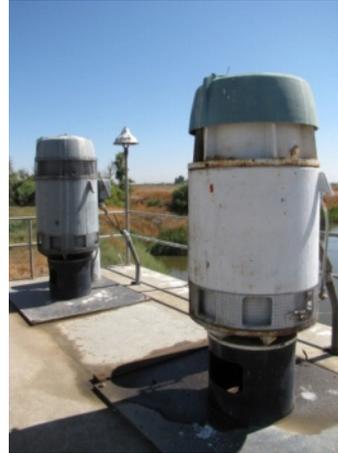
Levee Mile Report Line	7
Start Levee Mile	0.00
End Levee Mile	0.00
Location	
Category	Pump Stations
Item	Pumps
View of two of the pumps.	
dpesaven_t_20100906_128.jpg

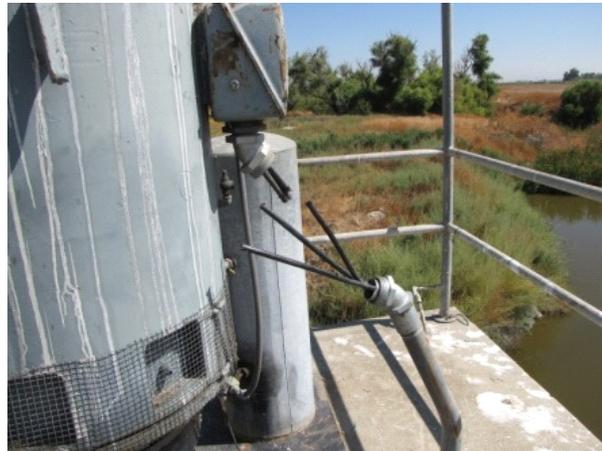
Levee Mile Report Line	7
Start Levee Mile	0.00
End Levee Mile	0.00
Location	
Category	Pump Stations
Item	Pumps
Close-up view of one of the pumps where thieves recently attempted to steal the wiring.	
dpesaven_t_20100906_129.jpg

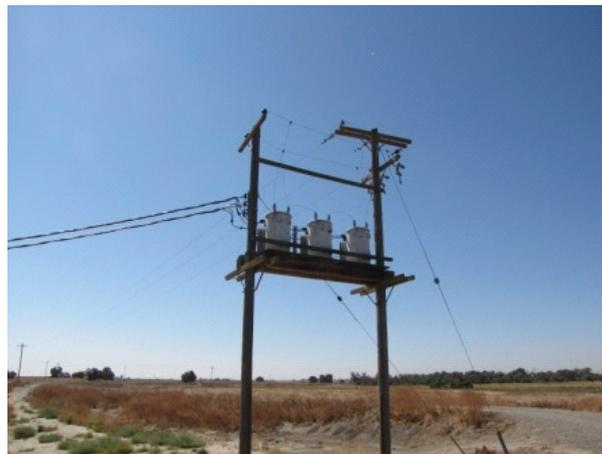
Levee Mile Report Line	8
Start Levee Mile	0.00
End Levee Mile	0.00
Location	
Category	Pump Stations
Item	Power
View of the transformers and power supply for the station.	
dpesaven_t_20100906_126.jpg

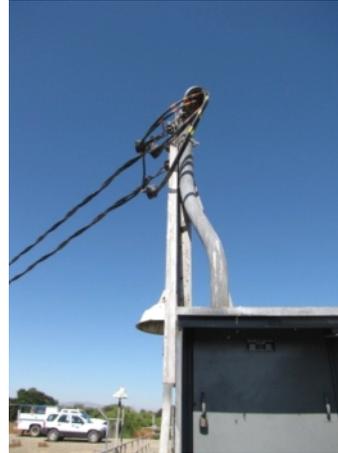
Levee Mile Report Line	8
Start Levee Mile	0.00
End Levee Mile	0.00
Location	
Category	Pump Stations
Item	Power
View of the power connection to the station.	
dpesaven_t_20100906_130.jpg

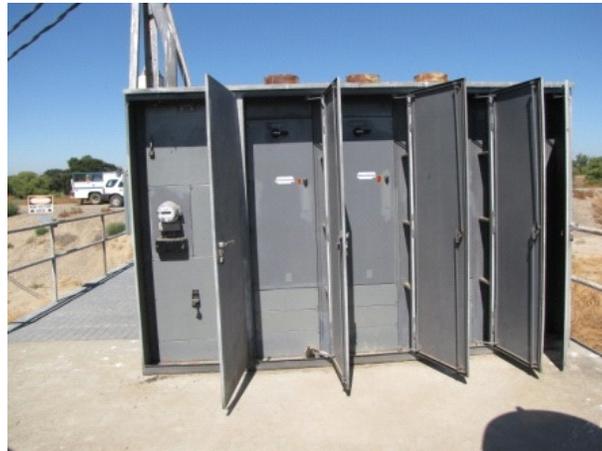
9	0.00	0.00	Pump Stations	Motors, Engines, Fans & Gear Reducers		N	Inspector Comments: There are no electrical or mechanical motors at this plant other than the pumps and gate operators.	37.481567 ° -121.046617 °	37.481567 ° -121.046617 °		9
10	0.00	0.00	Pump Stations	Pump Control Systems		A	Item inspected visually only. Item was not operated during the inspection. Inspector Comments: The equipment appeared to be well maintained and operational. Due to the recent vandalism, the power was turned off during the inspection.	37.481567 ° -121.046617 °	37.481567 ° -121.046617 °	Y	10

Levee Mile Report Line	10
Start Levee Mile	0.00
End Levee Mile	0.00
Location	
Category	Pump Stations
Item	Pump Control Systems
View of the power and control cabinets.	
dpesaven_t_20100906_131.jpg

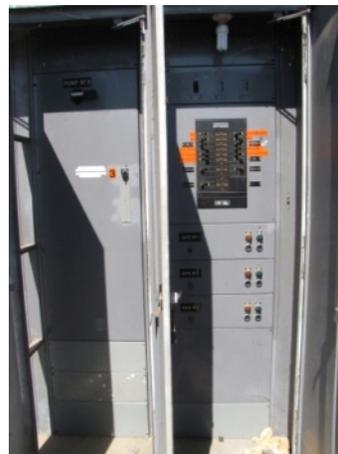
Levee Mile Report Line	10
Start Levee Mile	0.00
End Levee Mile	0.00
Location	
Category	Pump Stations
Item	Pump Control Systems
Closer view of the control cabinet.	
dpesaven_t_20100906_132.jpg

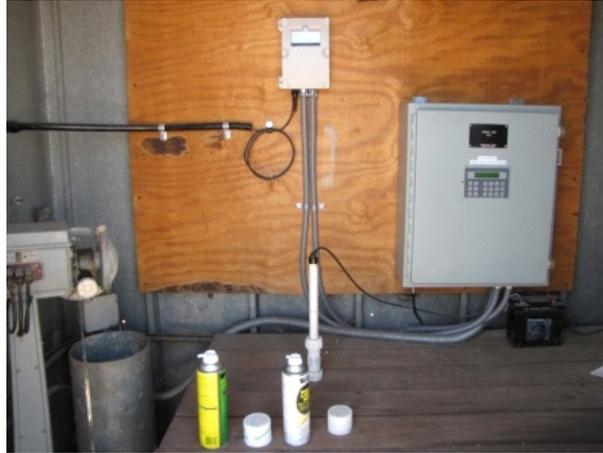
Levee Mile Report Line	10
Start Levee Mile	0.00
End Levee Mile	0.00
Location	
Category	Pump Stations
Item	Pump Control Systems
View of the SCADA and level sensing equipment.	
dpesaven_t_20100906_133.jpg

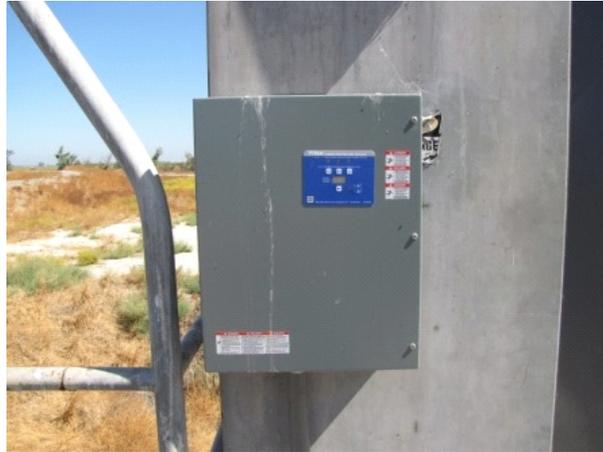
Levee Mile Report Line	10
Start Levee Mile	0.00
End Levee Mile	0.00
Location	
Category	Pump Stations
Item	Pump Control Systems
View of the sonar level sensing control cabinet for monitoring the level outside the sump.	
dpesaven_t_20100906_134.jpg

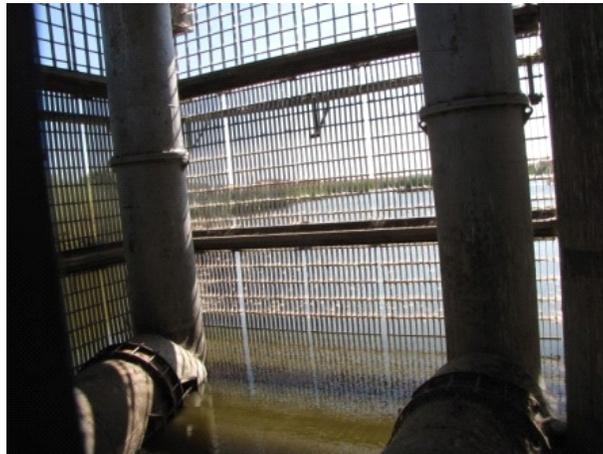
LMR No.	Levee Mile		Category	Item	Location *	Rating **	Action/Comment	GPS Latitude/Longitude		Photo	Issue No.
	Start	End						Start	End		
11	0.00	0.00	Pump Stations	Sumps/Wet Well		A	Inspector Comments: No debris was observed in the sump area.	37.481567 ° -121.046617 °	37.481567 ° -121.046617 °	Y	11
12	0.00	0.00	Pump Stations	Trash Rakes		A	Inspector Comments: The trash rakes appeared to be structurally sound and adequately maintained. No significant debris was observed on them. The hinges on the door to the sump was damaged and a temporary repair in place. A more permanent repair is needed.	37.481567 ° -121.046617 °	37.481567 ° -121.046617 °	Y	12
13	0.00	0.00	Pump Stations	Trash Rakes		N	Inspector Comments: Trash rakes are manually cleared.	37.481567 ° -121.046617 °	37.481567 ° -121.046617 °		13
14	0.00	0.00	Pump Stations	Sluice / Slide Gates		A	Item inspected visually only. Item was not operated during the inspection. Inspector Comments: The gates appeared to be functional but were not moved during this inspection.	37.481567 ° -121.046617 °	37.481567 ° -121.046617 °	Y	14

Levee Mile Report Line	11
Start Levee Mile	0.00
End Levee Mile	0.00
Location	
Category	Pump Stations
Item	Sumps/Wet Well
View of the sump under the plant.	
dpesaven_t_20100906_124.jpg

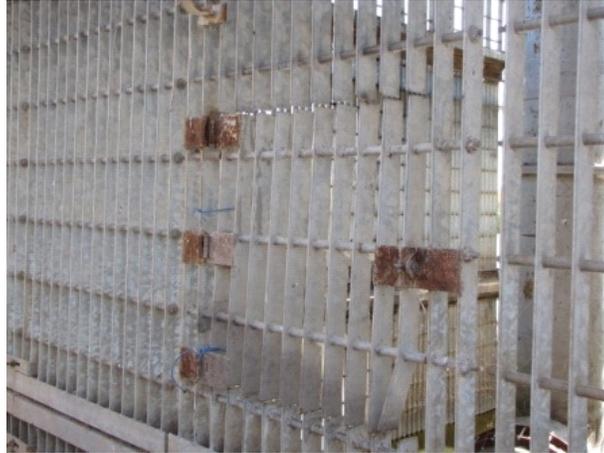
Levee Mile Report Line	12
Start Levee Mile	0.00
End Levee Mile	0.00
Location	
Category	Pump Stations
Item	Trash Racks
View of the gate in the trash rack. Note the wire acting as the hinges.	
dpesaven_t_20100906_125.jpg

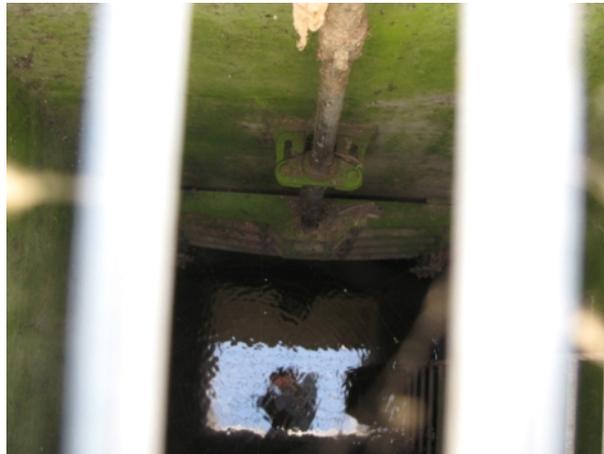
Levee Mile Report Line	14
Start Levee Mile	0.00
End Levee Mile	0.00
Location	
Category	Pump Stations
Item	Sluice / Slide Gates
View of one of the slide gates.	
dpesaven_t_20100722_071.jpg

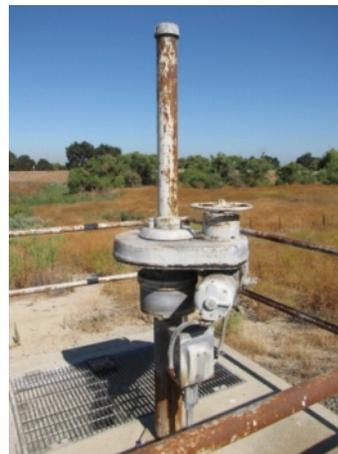
15	0.00	0.00	Pump Stations	Electric Gate Operators		A	Item inspected visually only. Item was not operated during the inspection. Inspector Comments: The operators are control onsite but were not tested during this inspection. They appear to be capable of performing and adequately maintained.	37.481567 ° -121.046617 °	37.481567 ° -121.046617 °	Y	15
16	0.00	0.00	Pump Stations	Manual Gate Operators		A	Inspector Comments: The manual gate operators appeared to be in good repair and one of them was able to be turned freely. Recommend having some tools on hand to engage the manual wheels.	37.481567 ° -121.046617 °	37.481567 ° -121.046617 °		16
17	0.00	0.00	Pump Stations	Other Metallic Items		A	Inspector Comments: Some rust was observed on the handrails and other metal at the plant, but none that would affect the performance of the plant.	37.481567 ° -121.046617 °	37.481567 ° -121.046617 °		17
18	0.00	0.00	Pump Stations	Flap Gates		A	Inspector Comments: The flap gates appeared to be capable of performing as intended.	37.481567 ° -121.046617 °	37.481567 ° -121.046617 °	Y	18

Levee Mile Report Line	15
Start Levee Mile	0.00
End Levee Mile	0.00
Location	
Category	Pump Stations
Item	Electric Gate Operators
View of one of the sluice gate operators.	
dpesaven_t_20100906_116.jpg

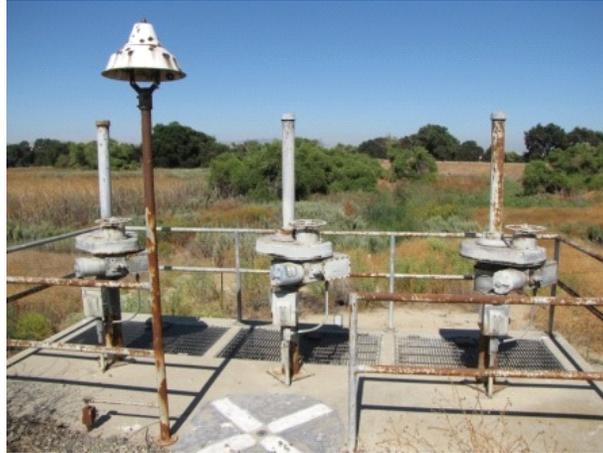
Levee Mile Report Line	15
Start Levee Mile	0.00
End Levee Mile	0.00
Location	
Category	Pump Stations
Item	Electric Gate Operators
Overall view of the three sluice gate operators.	
dpesaven_t_20100906_117.jpg

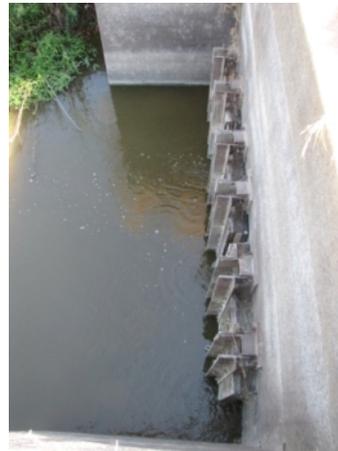
Levee Mile Report Line	18
Start Levee Mile	0.00
End Levee Mile	0.00
Location	
Category	Pump Stations
Item	Flap Gates
View of the outfall and flap gates.	
dpesaven_t_20100906_118.jpg
