Flood Control Project Maintenance
2012 Structure Summary Report
Overall Unit and Item Ratings

Gomes Lake Pumping Plant

2012 Pumping Plant Inspection Results

Pumping Plant Rating	A
Date of Inspection	7/19/2012
DWR Inspector	Pavel Kazi
Accompanied By	Tou Her TID
	Robert Caetano TID

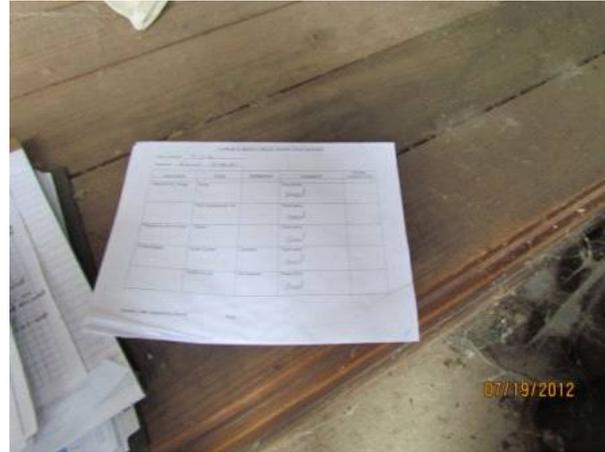
Levee Mile Report Line	1
Start Levee Mile	0.00
End Levee Mile	0.00
Location	
Category	Pump Stations
Item	Operating Log

LIR No.	Levee Mile		Category	Item	Location *	Rating **	Action/Comment	GPS Latitude/Longitude		Issue No. Photo
	Start	End						Start	End	
1	0.00	0.00	Pump Stations	Operating Log		A	Item inspected visually only. Item was not operated during the inspection. Inspector Comments: Operation log was present at the plant, and the log was up to date.	37.481567 ° -121.046617 °	37.481567 ° -121.046617 °	1 Y
2	0.00	0.00	Pump Stations	Operation & Maintenance Manual		A	Item inspected visually only. Item was not operated during the inspection. Inspector Comments: The O&M manual was present at the plant.	37.481567 ° -121.046617 °	37.481567 ° -121.046617 °	2 Y
3	0.00	0.00	Pump Stations	Plant Building		A	Item inspected visually only. Item was not operated during the inspection. Inspector Comments: The plant building appeared to be in good structural condition with no major visible concrete damage.	37.481567 ° -121.046617 °	37.481567 ° -121.046617 °	3 Y

View of the operating log.

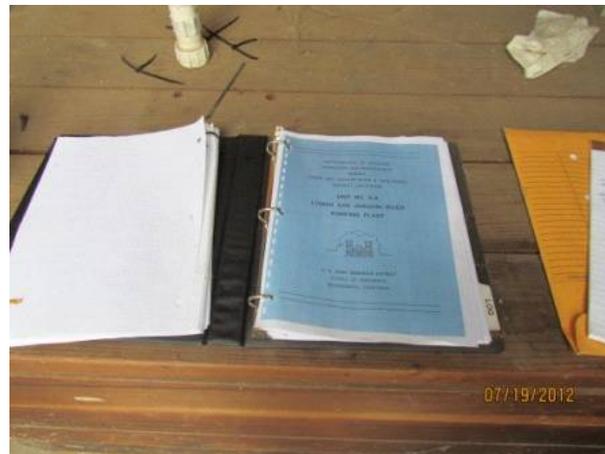
Levee Mile Report Line	2
Start Levee Mile	0.00
End Levee Mile	0.00
Location	
Category	Pump Stations
Item	Operation & Maintenance Manual

View of the O&M manual inside the plant.

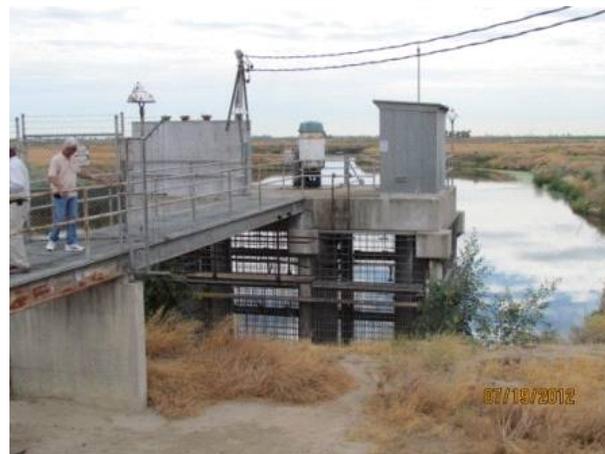
Levee Mile Report Line	3
Start Levee Mile	0.00
End Levee Mile	0.00
Location	
Category	Pump Stations
Item	Plant Building

View of the pumping plant.

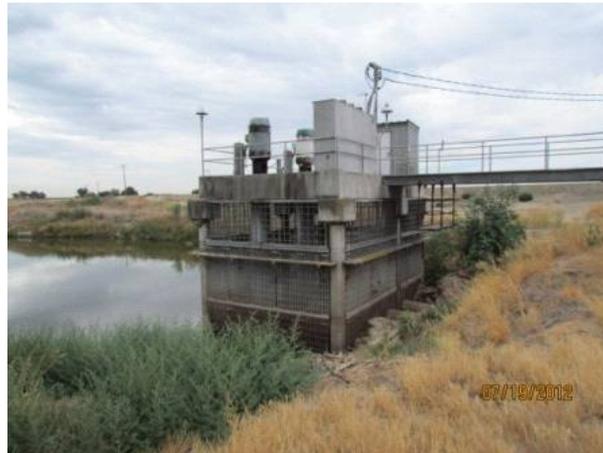
4	0.00	0.00	Pump Stations	Communications		A	Item inspected visually only. Item was not operated during the inspection. Inspector Comments: District personnel carried cell phones.	37.481567 ° -121.046617 °	37.481567 ° -121.046617 °	4 Y
5	0.00	0.00	Pump Stations	Safety		A	Item inspected visually only. Item was not operated during the inspection. Inspector Comments: No significant safety hazard was observed at the plant during inspection. The lights were in working condition along with guard rails around the structure.	37.481567 ° -121.046617 °	37.481567 ° -121.046617 °	5 Y
6	0.00	0.00	Pump Stations	Cranes		N	Item inspected visually only. Item was not operated during the inspection. Inspector Comments: No crane was present at this plant.	37.481567 ° -121.046617 °	37.481567 ° -121.046617 °	6 Y
7	0.00	0.00	Pump Stations	Pumps		A	Item inspected visually only. Item was not operated during the inspection. Inspector Comments: All pumps were properly maintained and lubricated and they were periodically tested before the high water season.	37.481567 ° -121.046617 °	37.481567 ° -121.046617 °	7 Y

Levee Mile Report Line	5
Start Levee Mile	0.00
End Levee Mile	0.00
Location	
Category	Pump Stations
Item	Safety
View of the guard rails around the pumping plant.	
pkazi_t_20120724_142.jpg

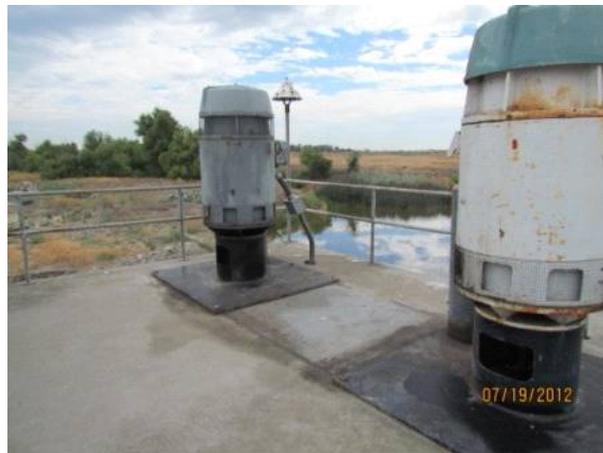
Levee Mile Report Line	7
Start Levee Mile	0.00
End Levee Mile	0.00
Location	
Category	Pump Stations
Item	Pumps
View of the pumps.	
pkazi_t_20120724_143.jpg

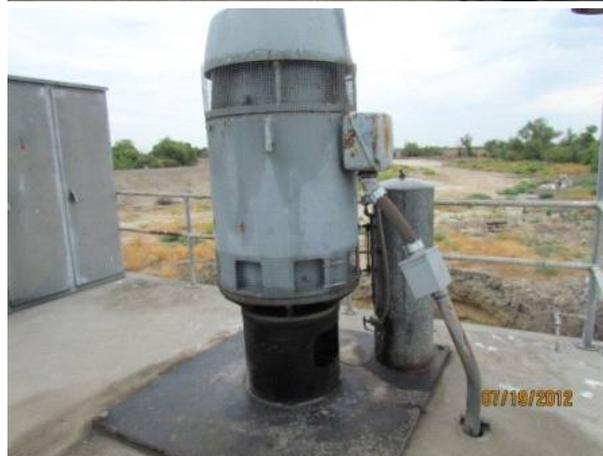
Levee Mile Report Line	7
Start Levee Mile	0.00
End Levee Mile	0.00
Location	
Category	Pump Stations
Item	Pumps
View of one of the pumps.	
pkazi_t_20120724_144.jpg

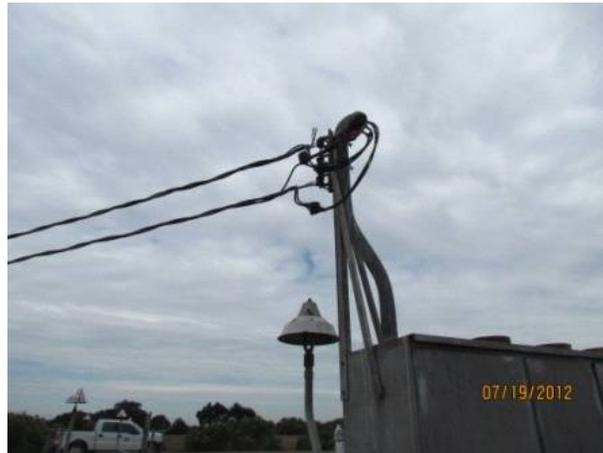
8	0.00	0.00	Pump Stations	Power		A	Item inspected visually only. Item was not operated during the inspection. Inspector Comments: The power source for this plant was delivered by the power grid rather than a generator and it appeared to be adequate and reliable.	37.481567 ° -121.046617 °	37.481567 ° -121.046617 °	8 Y
9	0.00	0.00	Pump Stations	Motors, Engines, Fans & Gear Reducers		N	Item inspected visually only. Item was not operated during the inspection. Inspector Comments: Other than the pump, no gear reducer or any other mechanical motor was present at the plant.	37.481567 ° -121.046617 °	37.481567 ° -121.046617 °	10 Y
10	0.00	0.00	Pump Stations	Pump Control Systems		A	Item inspected visually only. Item was not operated during the inspection. Inspector Comments: The pump control system was operational and appeared to be free of any damage or corrosion.	37.481567 ° -121.046617 °	37.481567 ° -121.046617 °	11 Y

Levee Mile Report Line	8
Start Levee Mile	0.00
End Levee Mile	0.00
Location	
Category	Pump Stations
Item	Power
View of the power source at the plant.	
pkazi_t_20120724_145.jpg

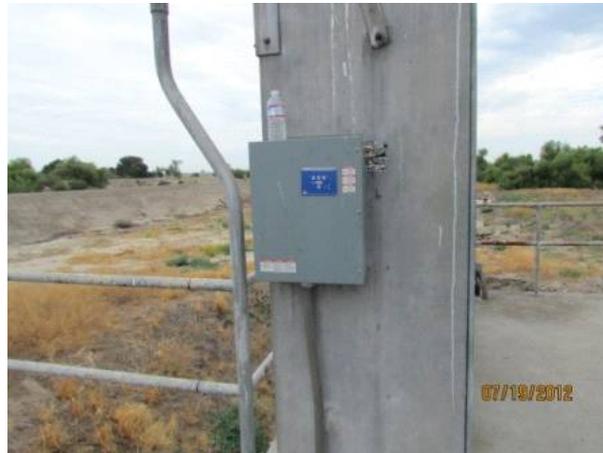
Levee Mile Report Line	10
Start Levee Mile	0.00
End Levee Mile	0.00
Location	
Category	Pump Stations
Item	Pump Control Systems
View of the power control box.	
pkazi_t_20120724_146.jpg

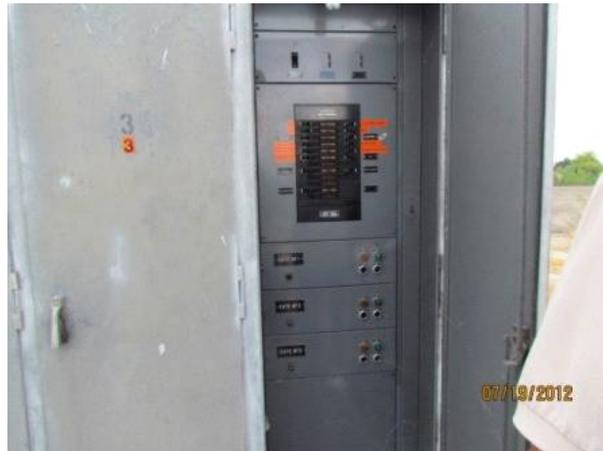
Levee Mile Report Line	10
Start Levee Mile	0.00
End Levee Mile	0.00
Location	
Category	Pump Stations
Item	Pump Control Systems
View of the power switch system.	
pkazi_t_20120724_147.jpg

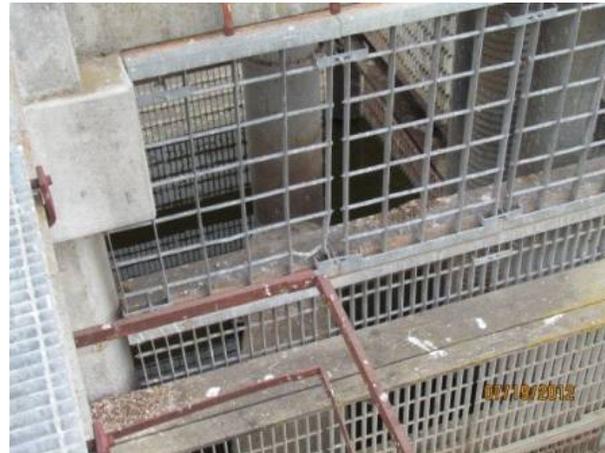
Levee Mile Report Line	11
Start Levee Mile	0.00
End Levee Mile	0.00
Location	
Category	Pump Stations
Item	Sumps/Wet Well

LNI# No.	Levee Mile		Category	Item	Location *	Rating **	Action/Comment	GPS Latitude/Longitude		Issue No. Photo
	Start	End						Start	End	
11	0.00	0.00	Pump Stations	Sumps/Wet Well		A	Item inspected visually only. Item was not operated during the inspection. Inspector Comments: The wet well was clear of excessive debris and other obstructions.	37.481567 ° -121.046617 °	37.481567 ° -121.046617 °	12 Y
12	0.00	0.00	Pump Stations	Trash Racks		A	Item inspected visually only. Item was not operated during the inspection. Inspector Comments: The trash racks were free of debris and appeared to be maintained properly.	37.481567 ° -121.046617 °	37.481567 ° -121.046617 °	13 Y
13	0.00	0.00	Pump Stations	Trash Rakes		N	Item inspected visually only. Item was not operated during the inspection. Inspector Comments: No trash rakes were present at this plant.	37.481567 ° -121.046617 °	37.481567 ° -121.046617 °	14 Y

View of the wet well.

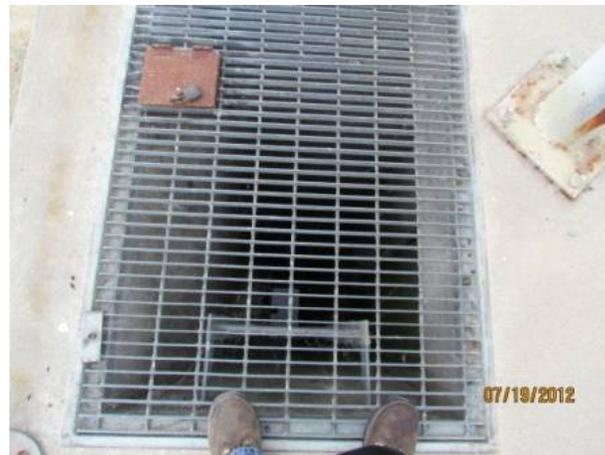
Levee Mile Report Line	14
Start Levee Mile	0.00
End Levee Mile	0.00
Location	
Category	Pump Stations
Item	Sluice / Slide Gates

14	0.00	0.00	Pump Stations	Sluice / Slide Gates		A	Item inspected visually only. Item was not operated during the inspection. Inspector Comments: The slide gates were open during inspection and water was flowing freely when the pump was turned on. The slide gate appeared to be free of sediments and other obstructions.	37.481567 ° -121.046617 °	37.481567 ° -121.046617 °	15 Y
15	0.00	0.00	Pump Stations	Electric Gate Operators		A	Item inspected visually only. Item was not operated during the inspection. Inspector Comments: The electric gate operators were in good working condition.	37.481567 ° -121.046617 °	37.481567 ° -121.046617 °	16 Y
16	0.00	0.00	Pump Stations	Manual Gate Operators		A	Item inspected visually only. Item was not operated during the inspection. Inspector Comments: Manual gate operators appeared to be operational and capable of opening and closing the gate properly.	37.481567 ° -121.046617 °	37.481567 ° -121.046617 °	17 Y

View of the slide gate from the top of the structure.

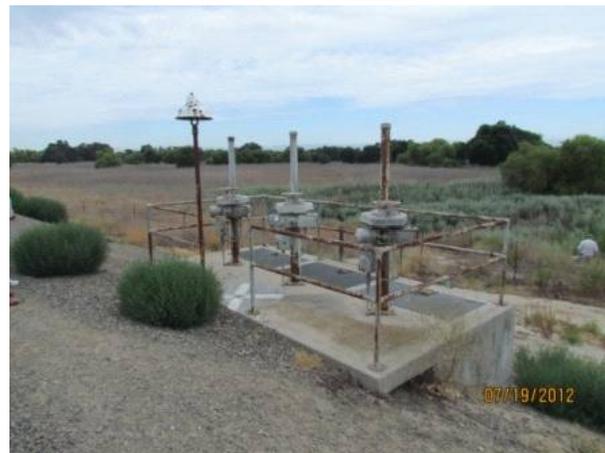
Levee Mile Report Line	16
Start Levee Mile	0.00
End Levee Mile	0.00
Location	
Category	Pump Stations
Item	Manual Gate Operators

View of the manual gates.

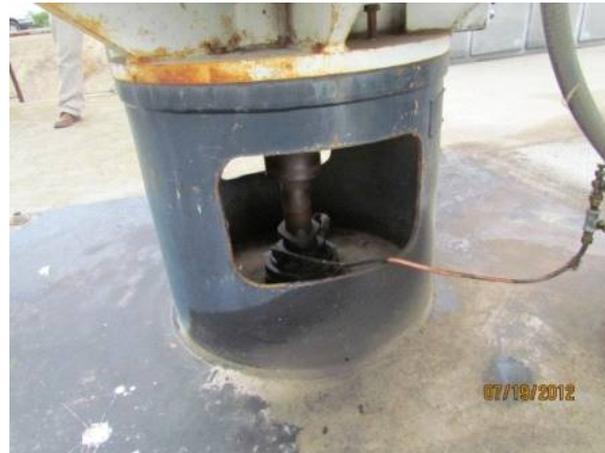
Levee Mile Report Line	17
Start Levee Mile	0.00
End Levee Mile	0.00
Location	
Category	Pump Stations
Item	Other Metallic Items

17	0.00	0.00	Pump Stations	Other Metallic Items		A	Item inspected visually only. Item was not operated during the inspection. Inspector Comments: All the other metal parts in the plant appeared to be in good condition.	37.481567 ° -121.046617 °	37.481567 ° -121.046617 °	18 Y
18	0.00	0.00	Pump Stations	Flap Gates		A	Item inspected visually only. Item was not operated during the inspection. Inspector Comments: The flap gates appeared to be in good working condition and capable of performing as intended.	37.481567 ° -121.046617 °	37.481567 ° -121.046617 °	19 Y
19	0.00	0.00	Pump Stations	Closure Structures		N	Item inspected visually only. Item was not operated during the inspection. Inspector Comments: No closure structure exists at this plant.	37.481567 ° -121.046617 °	37.481567 ° -121.046617 °	20 Y
20	0.00	0.00	Pump Stations	Security Fencing		A	Item inspected visually only. Item was not operated during the inspection. Inspector Comments: The security fencing appeared to be in good condition and should provide protection against unauthorized access.	37.481567 ° -121.046617 °	37.481567 ° -121.046617 °	21 Y

Detail view of bottom of a pump.

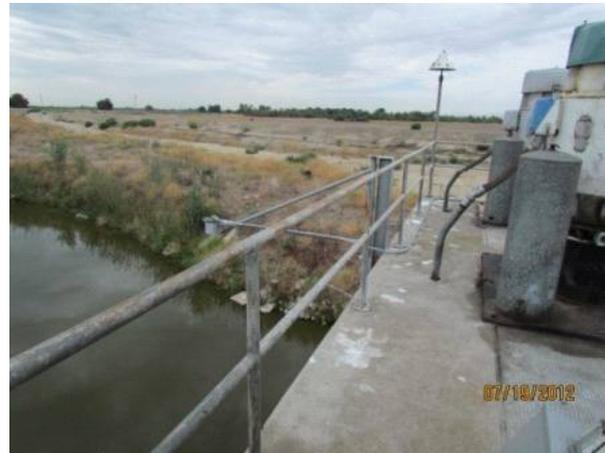
Levee Mile Report Line	17
Start Levee Mile	0.00
End Levee Mile	0.00
Location	
Category	Pump Stations
Item	Other Metallic Items

View of the pumps.

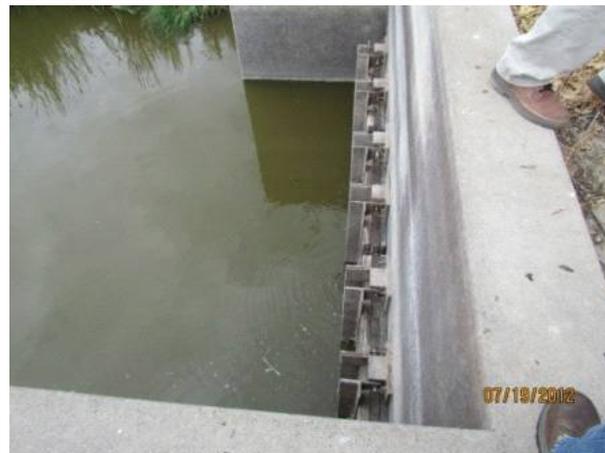
Levee Mile Report Line	18
Start Levee Mile	0.00
End Levee Mile	0.00
Location	
Category	Pump Stations
Item	Flap Gates

View of the flap gates.

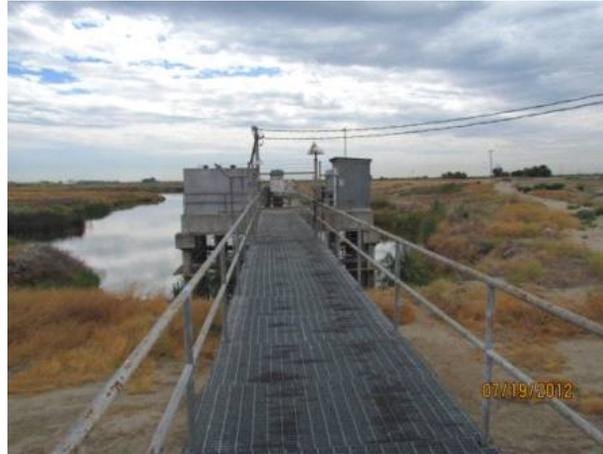
Levee Mile Report Line	20
Start Levee Mile	0.00
End Levee Mile	0.00
Location	
Category	Pump Stations
Item	Security Fencing
View of the fences around the pumping plant.	
pkazi_t_20120724_154.jpg
